# Effects of Vegetation and Land Use on Channel Morphology

CATHERINE CLIFTON<sup>1</sup>

**Abstract.**—Spatial and temporal morphologic variability in mountain streams may be attributed to local prevailing conditions. Morphologically distinct reaches of Wickiup Creek, in the Blue Mountains of central Oregon, result from differences in the composition and structure of streamside vegetation, physiography, and land use. Comparisons of grazed and ungrazed meadow reaches and a forested reach loaded with large organic debris reveal specific differences related to the local environmental setting. Overall, width, depth, and cross section area do not increase systematically downstream. The greatest widths are found in the forested reach. Stream depths are at a maximum through the ungrazed meadow reach. Spatial variability results from prevailing vegetation conditions. Temporal variability in the ungrazed enclosure results from the exclusion of livestock and subsequent revegetation of the meadow. Over a 50-year period without grazing, a 94% reduction in channel cross section area occurred.

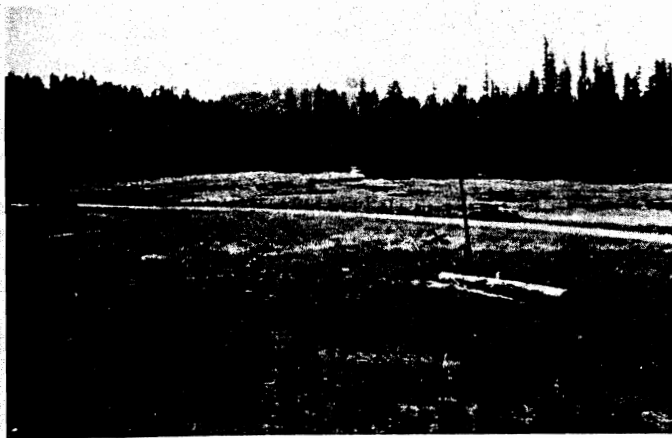
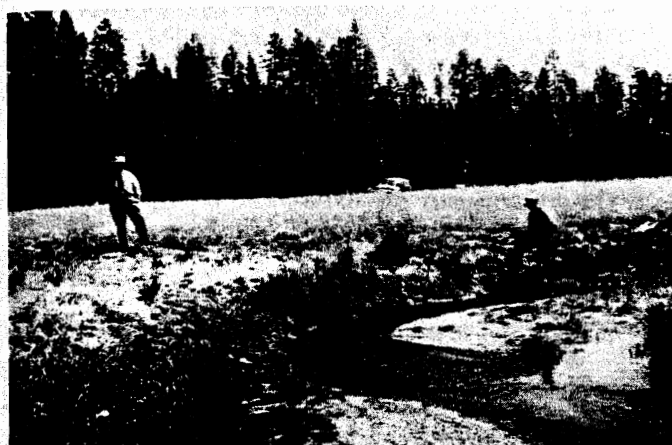
Figure 8.—Historic photos of exclosure: overview and channel following fencing, 1948. (Malheur National Forest files).

Historic photo documentation in the enclosure (reach 2b) provides information on vegetation trends and morphologic adjustments. Prior to the establishment of the enclosure, the meadow appears barren of vegetation and mineral soil is exposed (Figure 7a). The stream channel has banks approximately 1.3-m high. No channel bank vegetation is evident, and the channel has a trapezoidal shape with outsloped banks (Figure 7b). By 1948, 10 years after the establishment of the enclosure, the meadow had revegetated, the channel bed had aggraded approximately 0.60 m, and vegetation had become reestablished on the channel banks (Figures 8a and 8b). Continued revegetation occurred in the enclosure after 1948 so that, by 1956, the channel banks were partially obscured by thick bank vegetation and the channel was still narrower (Figure 9a). Willow, completely absent in 1933, gradually recovered. By 1980 the channel is almost completely obscured by grasses and sedges, and willow thickets are evident in the foreground (Figure 9b).

Estimates of channel dimensions from the 1933 and 1948 photographs provide evidence of stream channel adjustments within the enclosure (Table 6). Between 1933 and 1948 there was a 64% reduction in channel cross section area. Between 1948 and 1986, a cross sectional area reduction of 82% occurred. Overall, in 50 years without grazing, a 94% decrease in channel area occurred. Although the figures are estimates only, the total reduction represents an order of magnitude change in channel area. Channel adjustments in the enclosure are predominantly the result of the absence of livestock and channel bank revegetation.

Historic adjustments in the morphology of Wickiup Creek were observed in the enclosure. Historic photos show a dramatic change in vegetative cover from 1933 to 1980. In 1933 the entire reach and adjacent meadow were barren of vegetation. Cattle were excluded in 1938, and by 1948 the site had revegetated and the channel had narrowed and deepened. By 1986 the channel had undergone an order of magnitude reduction in bankfull channel cross section area. Today, thickly vegetated overhanging banks obscure a narrow and deep channel.

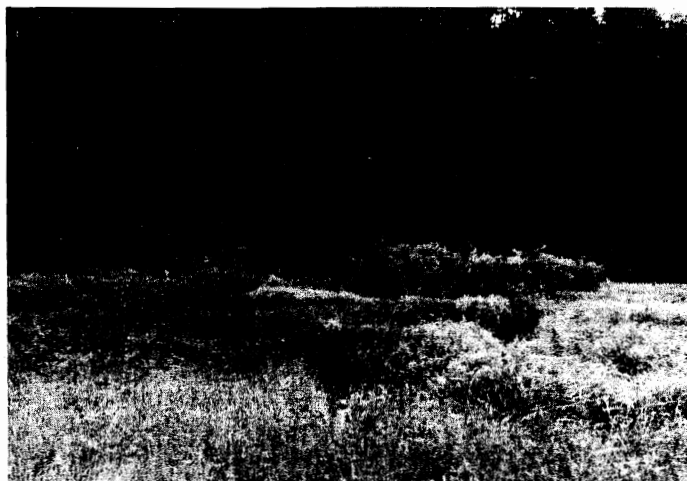
Figure 9.—Historic photos of channel in exclosure: 1956 and 1980. (Malheur National Forest files).
