Stress Corrosion Cracking ¹

Stress Corrosion Cracking Study ¹ Long-Term Retardant

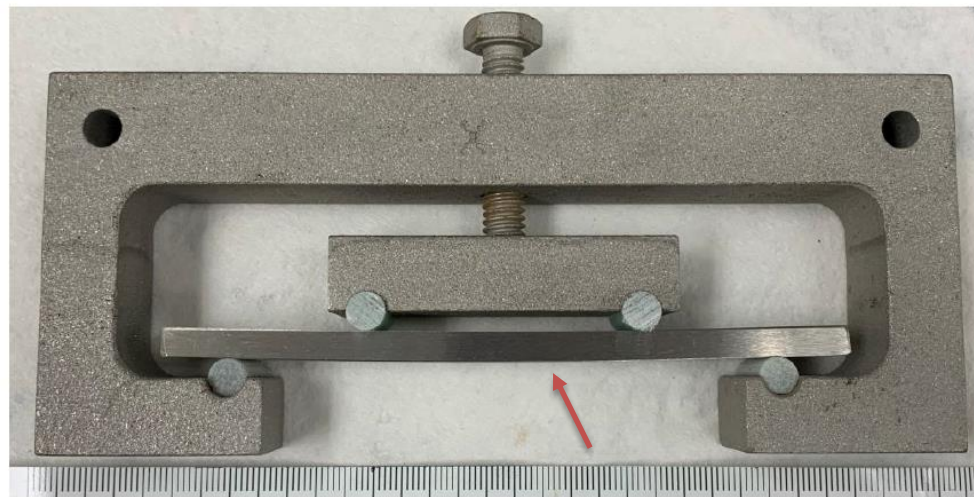
Figure 1-Example of loaded FPB specimen. (excerpt from report)

The following table is a summary of the findings. Triplicate specimens were exposed to each solution, fully immersed at 120°F for 30 days. All products were tested at their qualified mix ratio listed on the Qualified Products List (QPL). Stress levels were applied using a four-point bend (FPB) test configuration as shown in Figure 1.
