Effects of Wildfires on Riparian Restoration Sites

Abstract

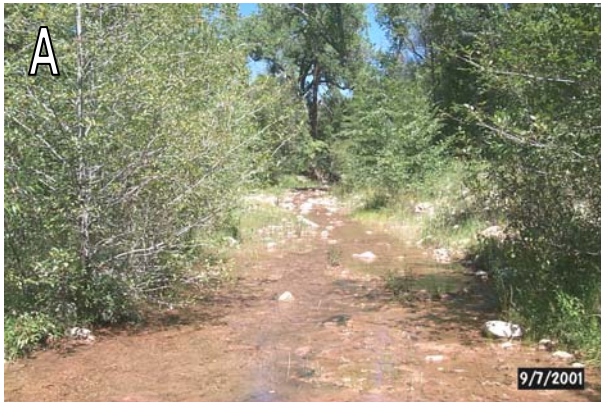
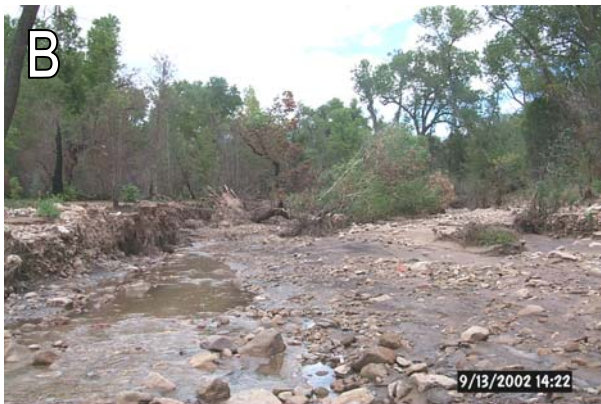
Figure 4: Start of Limestone Canyon Reach 1, facing upstream, before the fire in September 2001 (A), and after flooding in September 2002 (B). The channel incised and widened considerably due the post-fire flooding.

Initial floods after the Rodeo-Chediski fire coated the channel at the Limestone Canyon site with fine sediments, but they did not cause extensive changes in channel shape (Figs. 2A and 2B). However, a tropical storm in September extensively reworked the channel, creating an avulsion that left Reach 3 high and dry (Fig. 2C). The other reaches in Limestone Canyon (including 1, 2, 4, and 5) experienced extensive channel incision and widening. For example, the active channel at Reach 1 downcut by 0.6 m while doubling in width to 17.4 m (Figs. 4A and 4B). Almost all vegetation in the active channel was either scoured or buried along these reaches. Alders (*Alnus oblongifolia*) were removed from the streambanks as the channel widened (Fig. 4B).

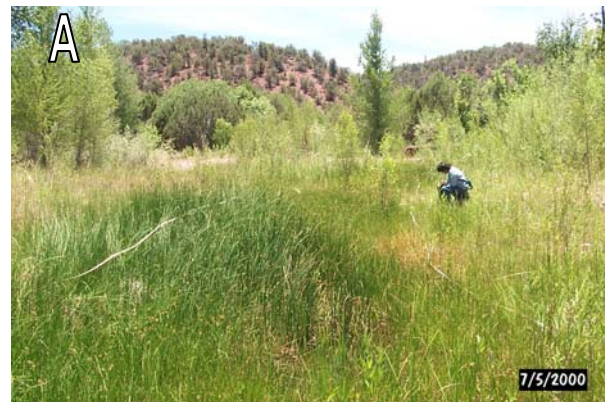
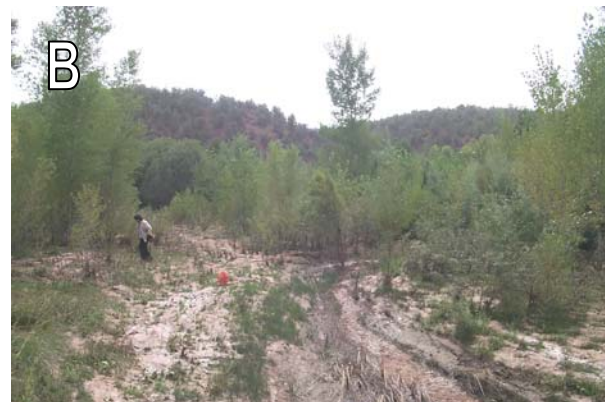
Figure 5: East Cedar Creek Reach 1 before and after the Kinishba wildfire. (A) July 2000, following four years of grazing exclusion. (B) September 2003, after post-fire flooding deposited fine sediments throughout the reach.

Floods following the Kinishba fire coated the channel of East Cedar Creek with fine sediments (Fig. 5). The process of aggradation that had been occurring since 1995 continued at most reaches, including Reach 1 (Fig. 6). Only a very short section at the bottom of the excluded reach experienced significant scour (Fig. 7). Vegetation cover decreased as a result of sedimentation, but most of the plants remained intact

across the channel bottom and in the floodplain (Figs. 5 and 7).
