Interagency Aviation SAFETY ALERT

No. IASA 22-01

Subject: Esmet 3000 Pound Capacity Cargo Swivel

Area of Concern: Self Locking Hook Roll Pin Movement

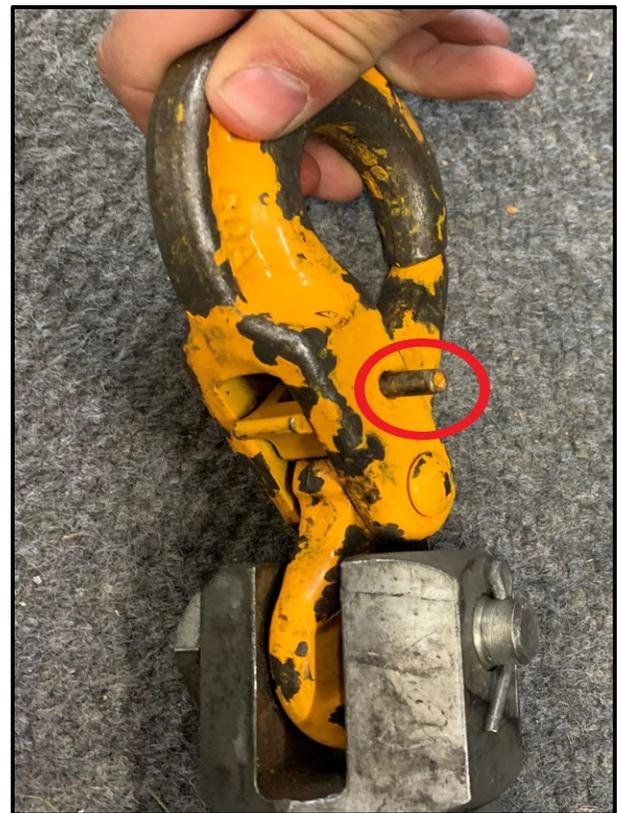
Discussion: Recently, an Exclusive Use Helitack crew was conducting an inspection of their equipment and discovered an Esmet Inc, Cargo 3000 lb. capacity swivel, which had been on their support vehicle over the winter, had the “roll pin” which holds the locking gate in its position protruding out approximately 3/4 of an inch. (Figure 1). They were able to push the pin into it’s proper position and then out of position by hand ([SAFECOM 22-0316](#)).

Figure 1. Esmet Swivel showing protruding roll pin.

[NWCG Standards for Fire Equipment Storage and Refurbishing, PMS 448](#), addresses specific fire equipment items used within the National Fire Equipment System. For Self Locking Hooks, 3000 lb. capacity, it states: Ensure lock latch pin is secure and flush with the latch. If latch is damaged, does not operate as required, is missing hardware, or does not meet dimensional requirements remove from service. Refer to the [PMS 448](#) for more general inspection and refurbishment guidelines.

Action Required: In accordance with [NWCG Standards for Helicopter Operations, PMS 510](#), prior to operations all equipment should be inspected. Any equipment that does not comply with the inspection criteria shall be removed from service.
