Forest Service
U.S. DEPARTMENT OF AGRICULTURE

FS-1191 | February 2022

Watershed Condition Framework

2011–2020 | 10 Years of Restoration

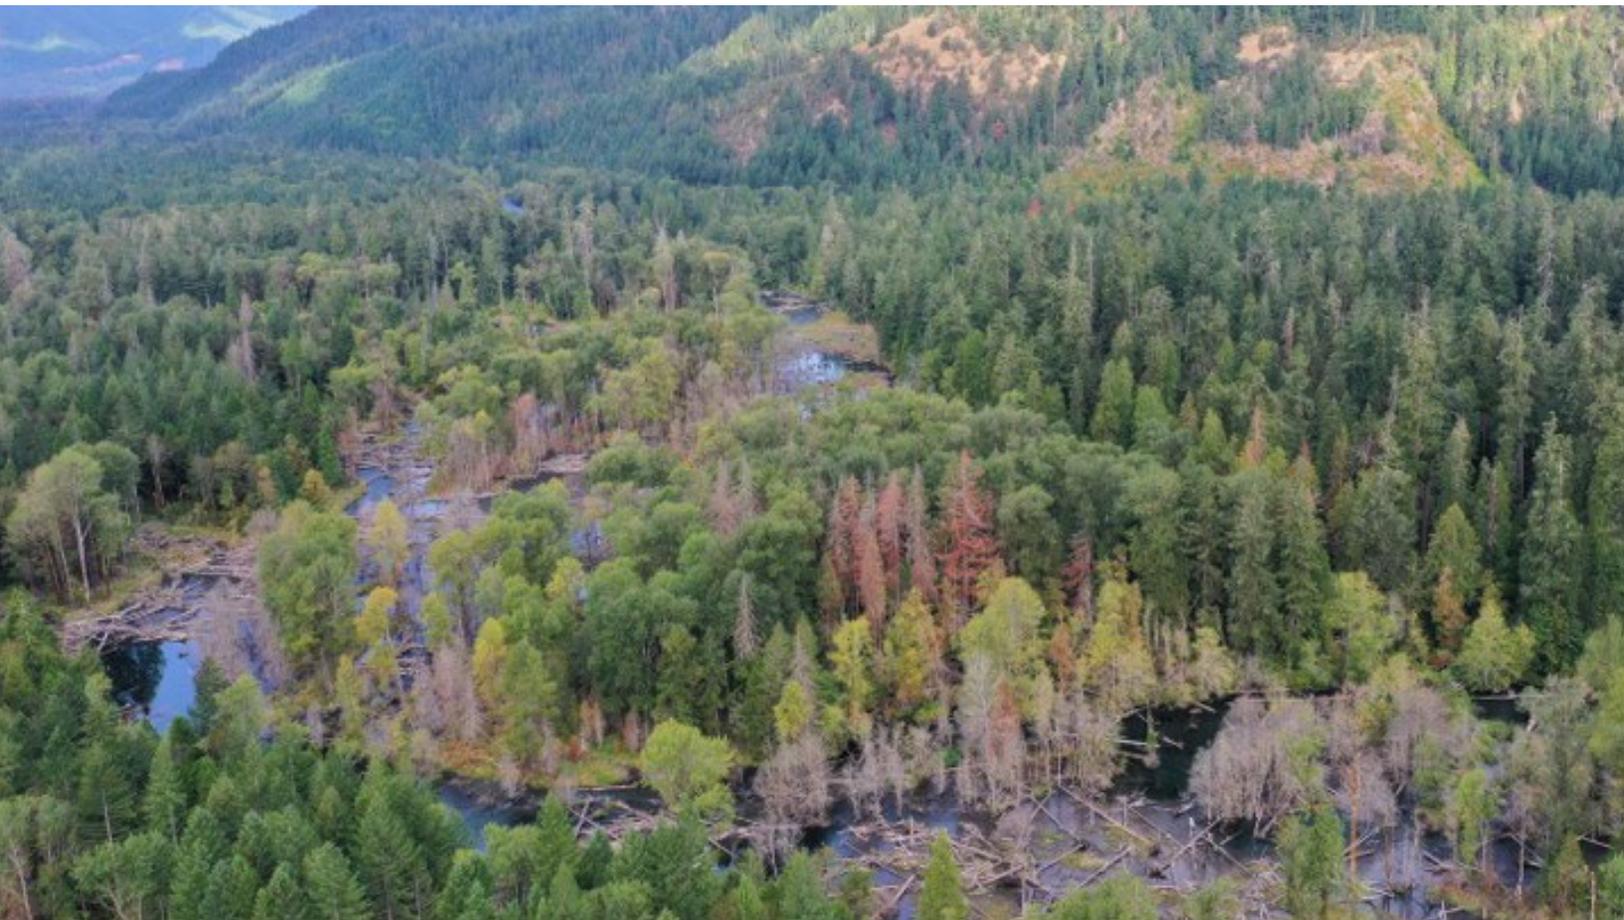
Cover photo: South Fork McKenzie River, Willamette National Forest, OR, after restoration of full hydrologic connectivity and complexity to 200 acres of the watershed through removal of levees, filling and aggrading the incised channel, and placement of large wood. USDA Forest Service photo.

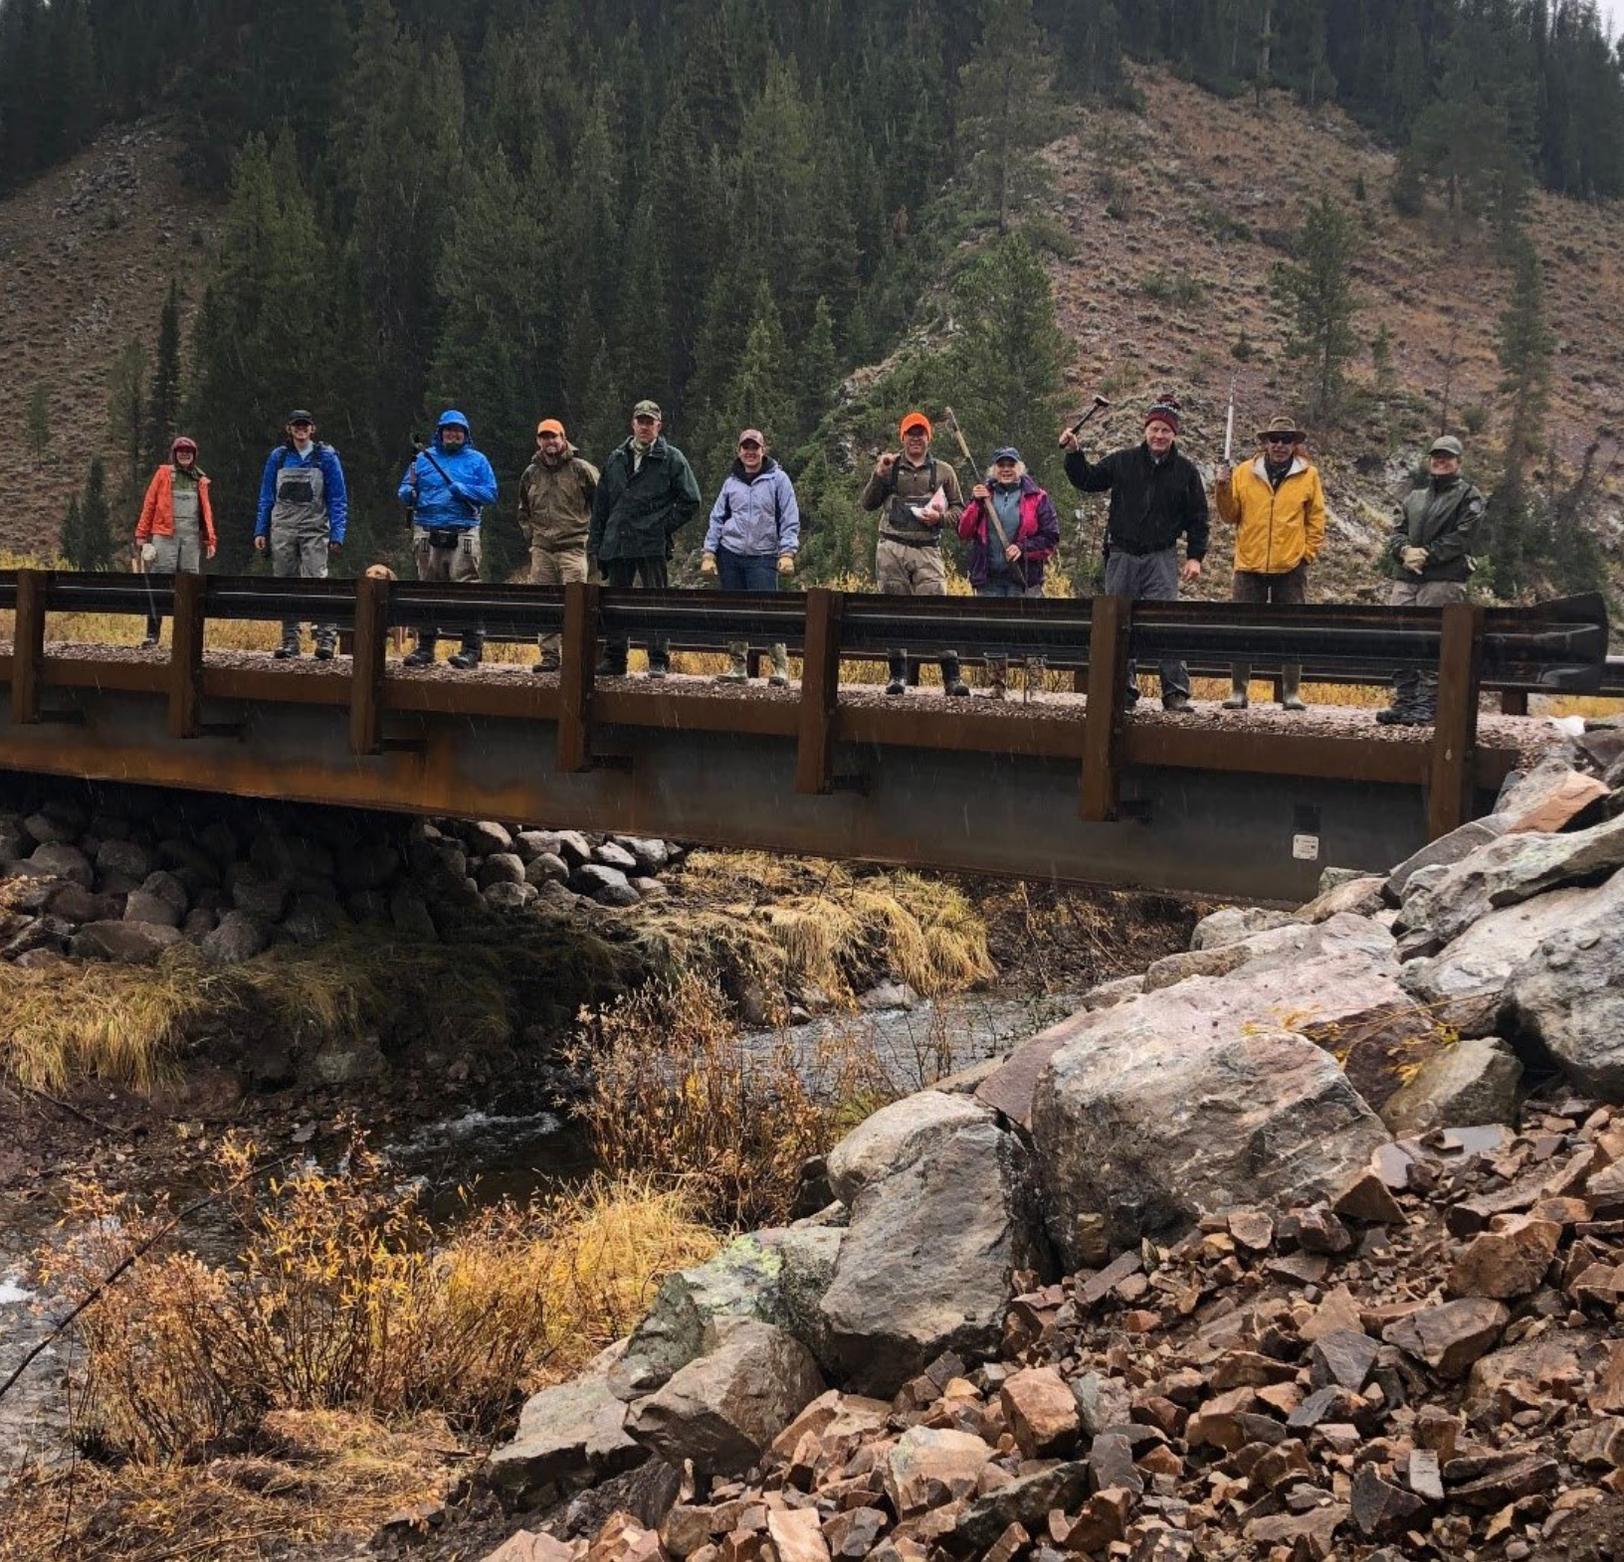
Above photo: Newly installed 52-foot bridge in place of previously perched culvert on the Greys River, Bridger-Teton National Forest, WY, enabling successful fish passage to the Greys River headwaters. The scour pool was filled in with boulders and grade control structures were placed downstream and upstream of the new bridge. Willows were planted on the banks by Trout Unlimited volunteers and Bridger-Teton fisheries biologists on Wyoming Public Lands Day. Courtesy photo by Leslie Steen, Trout Unlimited

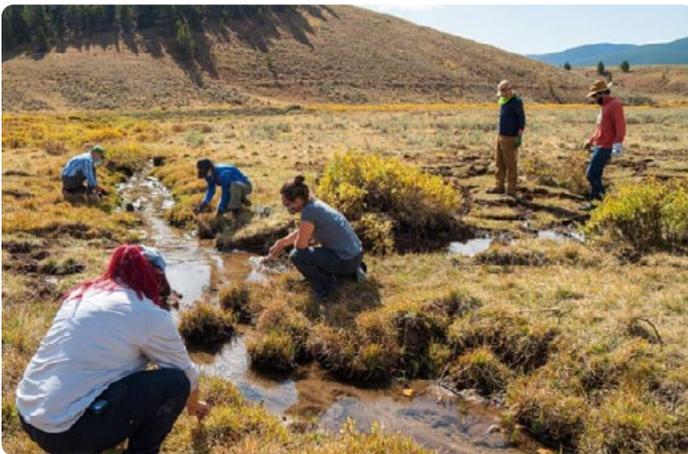
Stream crossing restoration site on the Gunnison Ranger District, Grand Mesa, Uncompaghre, and Gunnison National Forests, Colorado. First, a contractor ripped the illegal crossing with a bulldozer and used a backhoe to reshape the banks and place willow plugs. Then, High Country Conservation Advocates volunteers planted over 500 additional willows between plugs and along the streambank for added stabilization. USDA Forest Service Photo.

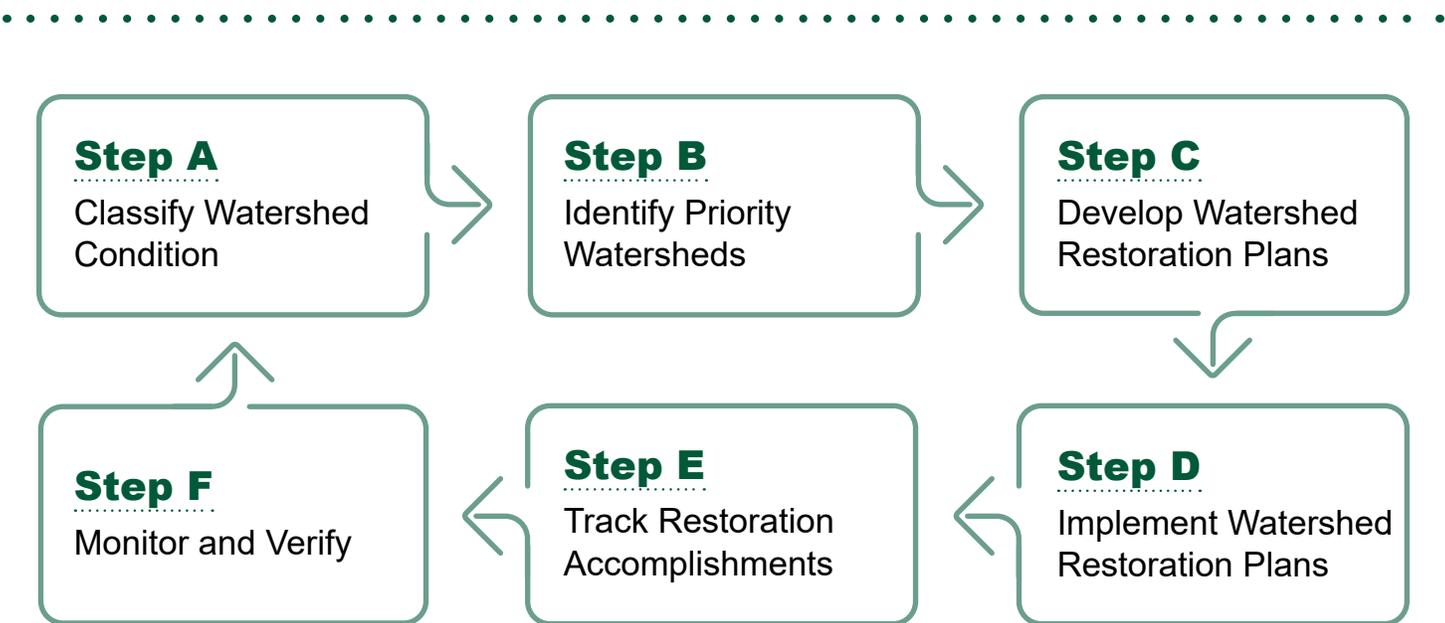
Figure 1. Watershed Condition Framework Process.

The WCF is a six-step process that helps land managers identify, develop, implement, and monitor watershed projects. In step A, watershed condition (the state of the physical and biological characteristics and processes within a watershed that affect the soil and hydrologic functions supporting aquatic ecosystems) is assessed at the

subwatershed scale (6th level, 12-digit hydrologic unit [HU12]) using a weighted 12-indicator protocol.⁴ All 15,082 subwatersheds containing at least 5 percent NFS land were initially assessed in 2010, and 24 percent have been reassessed in the past 10 years because of changing conditions or new information. From 2011 to 2020, the total number of watersheds functioning properly increased slightly from 7,892 to 7,995, while both the total number of watersheds functioning at risk and functioning impaired have decreased (6,759 to 6,703 and 430 to 424, respectively). As of 2020, 53 percent of NFS watersheds were functioning properly, 44 percent were functioning at risk, and 3 percent had impaired function (fig. 2). A partial reassessment in fiscal year 2021 updated information on the condition of about 3,300 subwatersheds.

Step B, the prioritization of watersheds, is a locally based interdisciplinary process with the goal of aligning watershed restoration work with both agency and community priorities. Designating a “priority watershed” is intended to concentrate restoration

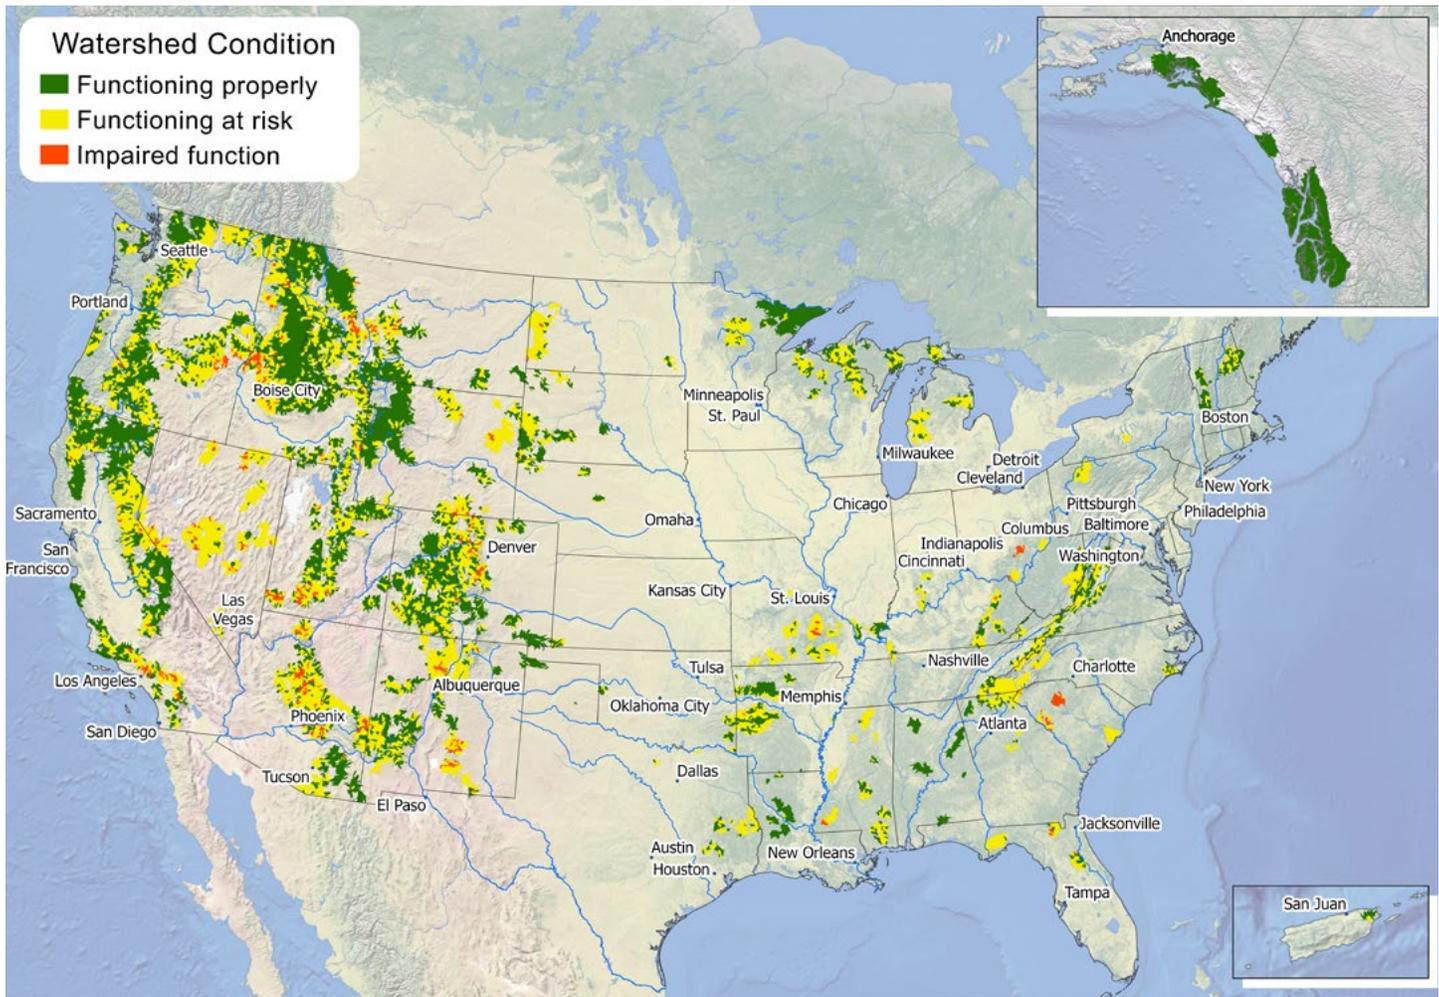
Figure 2. Watershed condition on National Forest System lands as of 2020.

As of 2020, 53 percent of NFS watersheds were functioning properly, 44 percent were functioning at risk, and 3 percent had impaired function.

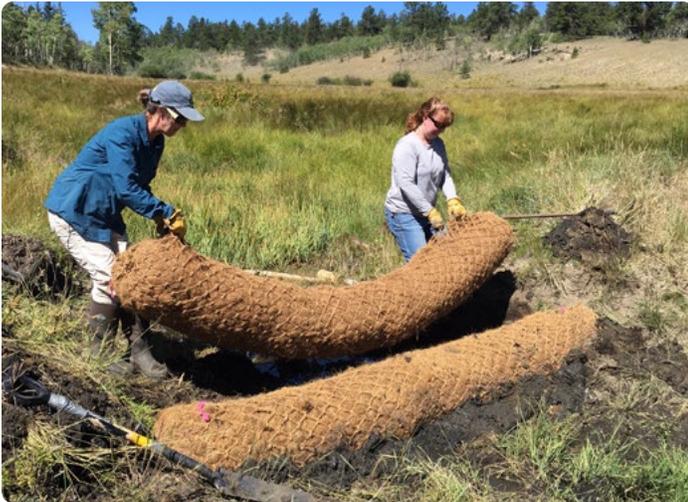
Forest Service staff install coir logs in a breached, abandoned beaver dam to restore water flow to the wetland above the site. Willow stakes are planted in the coir logs after installation. Pike and San Isabel National Forests, Colorado. USDA Forest Service photo.

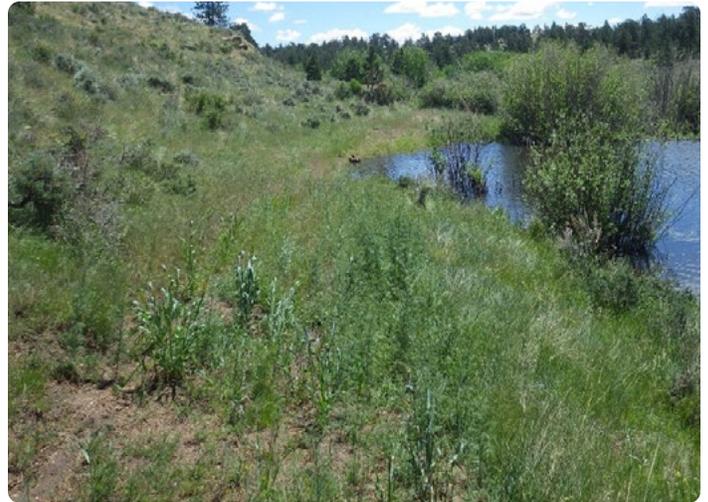
Functioning wetland after restoration of adjacent decommissioned road. Medicine Bow-Routt National Forest and Thunder Basin National Grassland, Wyoming. USDA Forest Service photo.

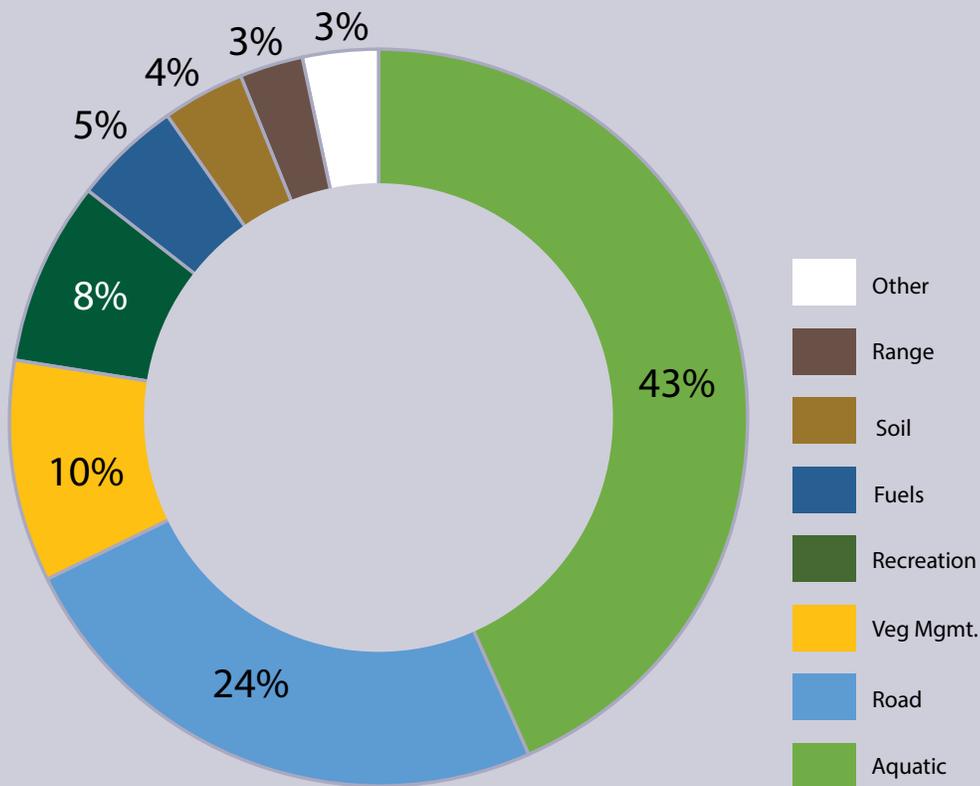
Figure 4. Percent of essential projects by category for all National Forest System priority watersheds completed, 2011–2020.

For purposes of this report, essential projects were organized into seven descriptive categories: aquatic and riparian, hazardous fuels, range vegetation, forest vegetation, recreation, roads, and soils. The most common types of essential projects (fig. 4) are those that directly benefit aquatic and riparian areas (43 percent) and decommissioning or improving roads (24 percent).

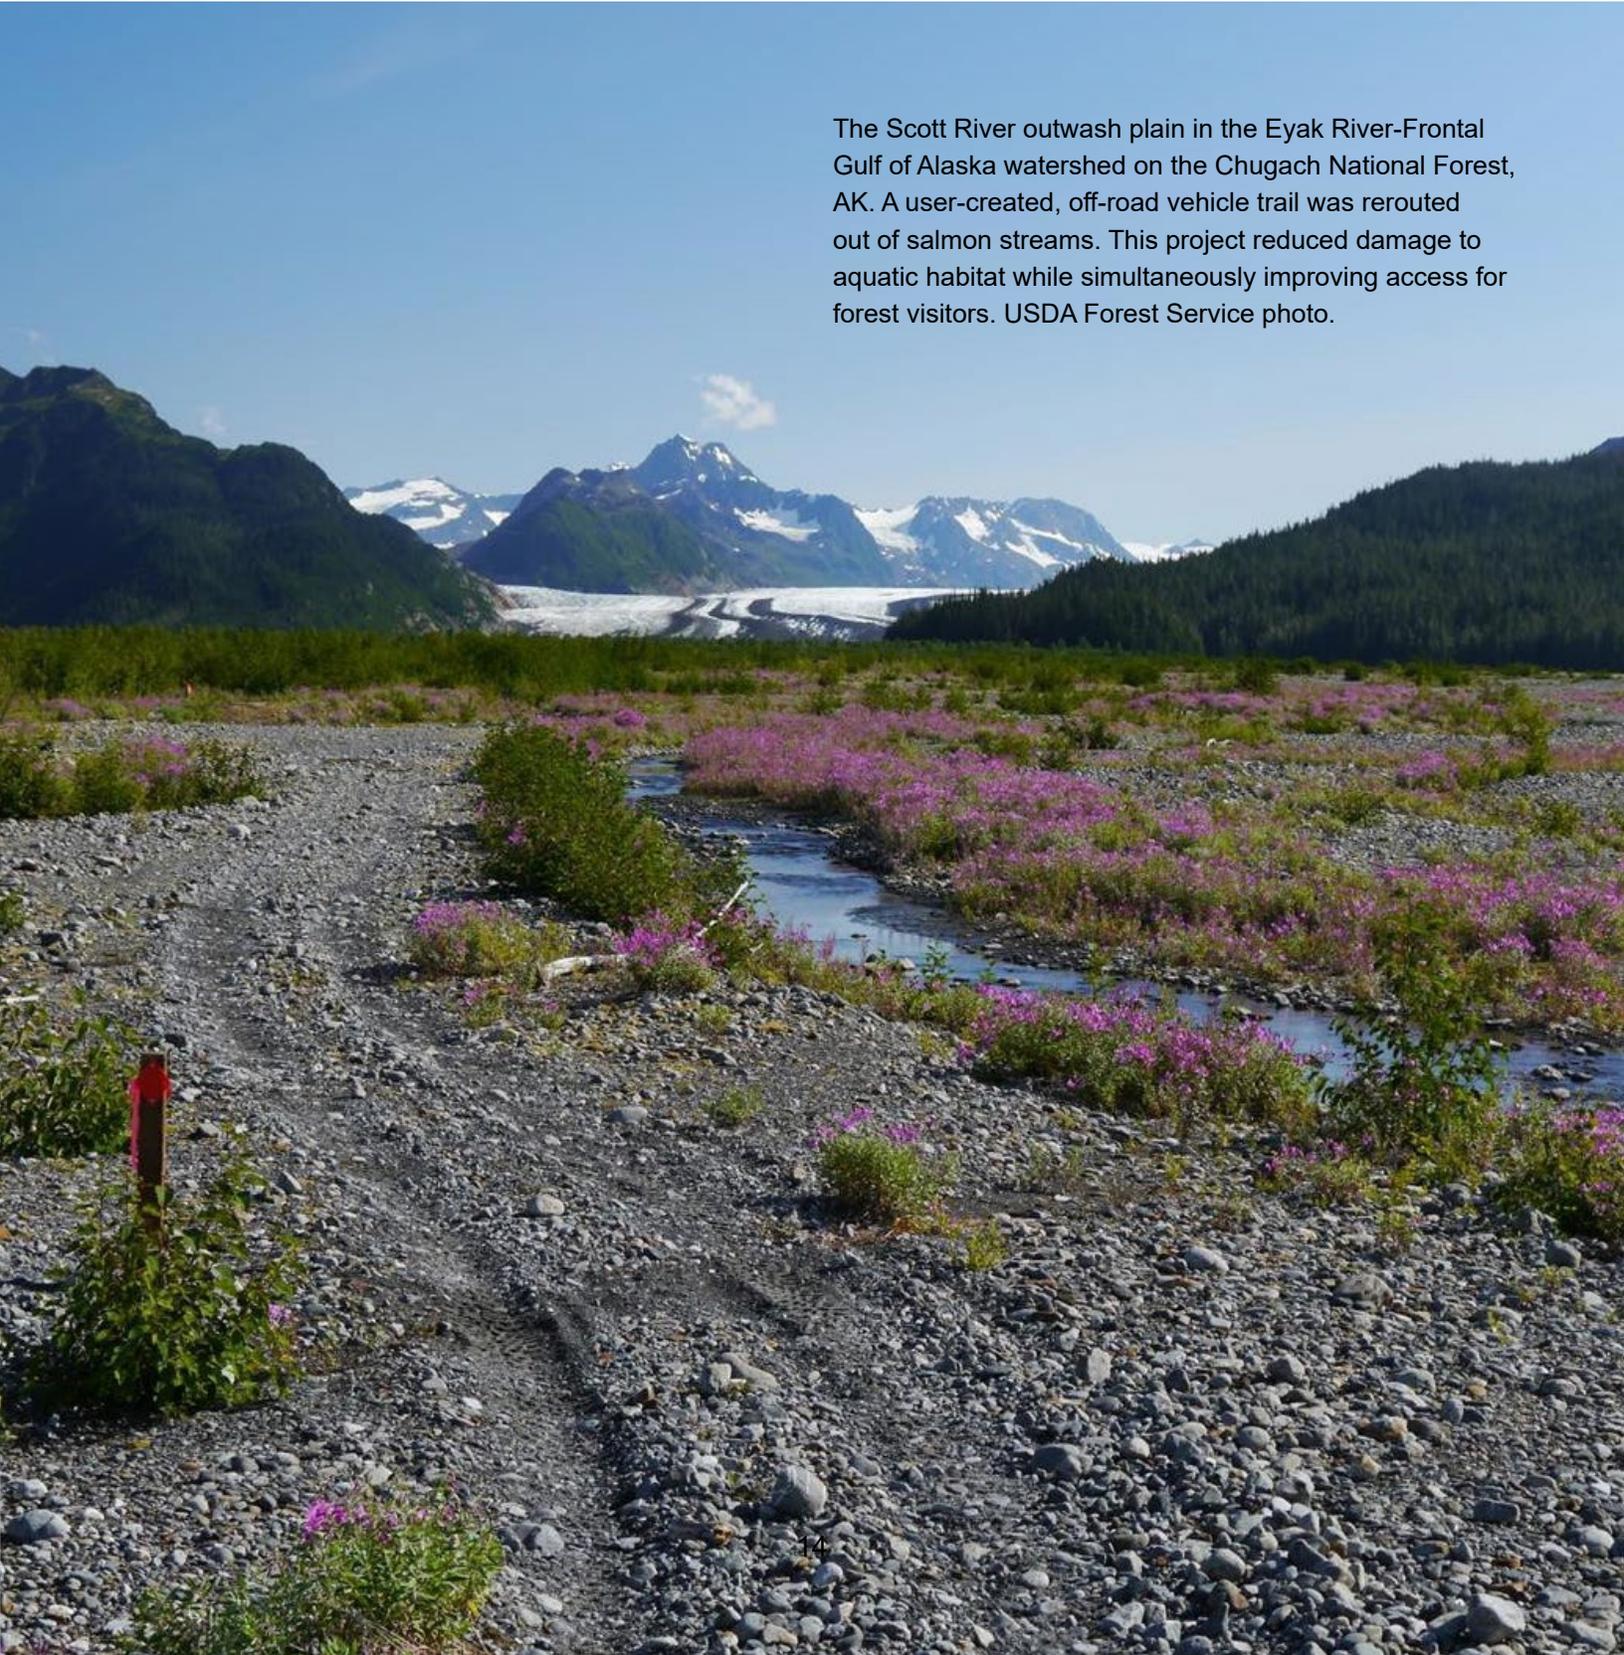
The Scott River outwash plain in the Eyak River-Frontal Gulf of Alaska watershed on the Chugach National Forest, AK. A user-created, off-road vehicle trail was rerouted out of salmon streams. This project reduced damage to aquatic habitat while simultaneously improving access for forest visitors. USDA Forest Service photo.

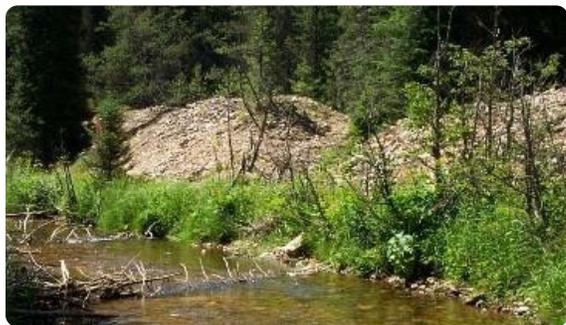
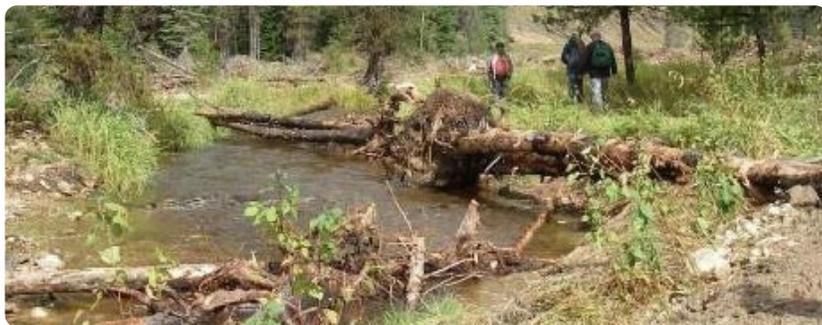
Before (left) and after (right) photos of Upper Newsome Creek on the Nez Perce-Clearwater National Forests in Idaho. Relict dredge piles restricted the flood plain, and the straight stream channel did not provide aquatic or riparian habitat. During restoration, dredge piles were removed, the flood plain was widened, and a meandering channel now exists to provide good woody habitat. USDA Forest Service photos.

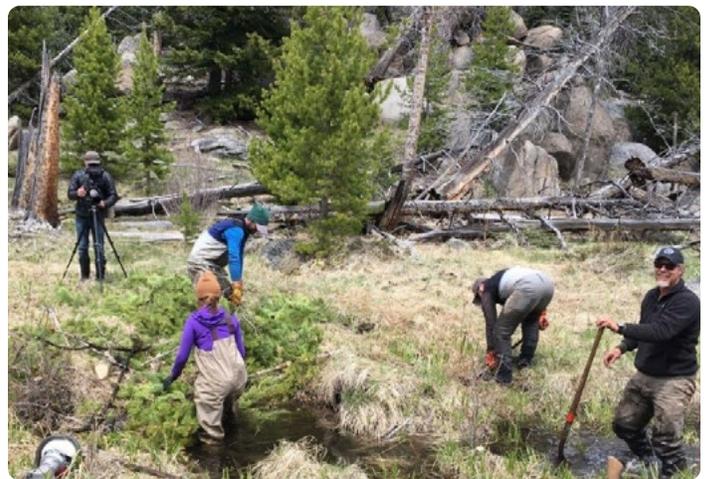
Volunteers construct a beaver dam analog using fallen conifers. USDA Forest Service photo.

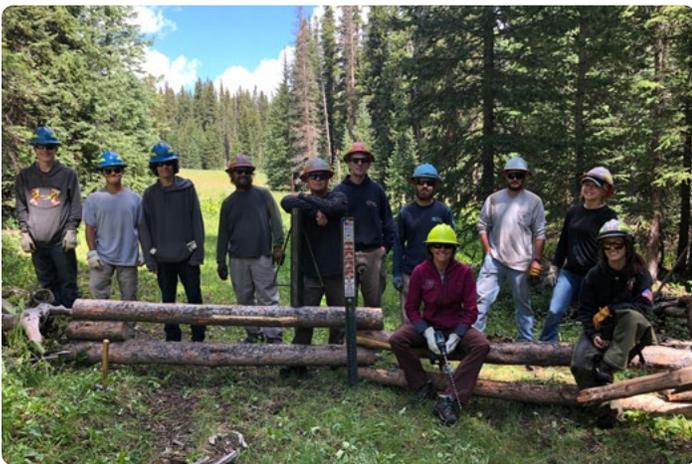
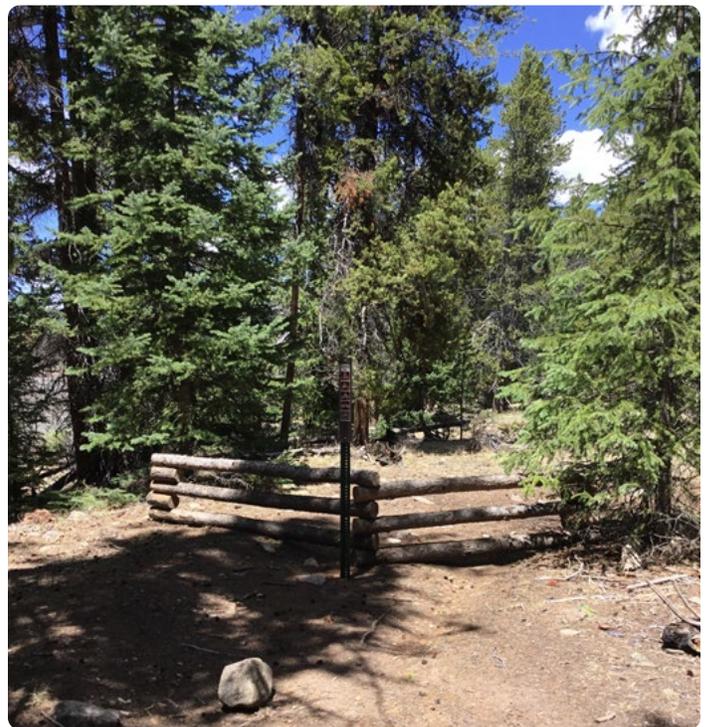
Volunteers and Forest Service staff (pictured above) closed 2.3 miles of illegal routes in the Oh-be-Joyful Slate River watershed on the Grand Mesa, Uncompahgre, and Gunnison National Forests in Colorado. Fences and signs (pictured right) were used to close user-created routes. USDA Forest Service photos.

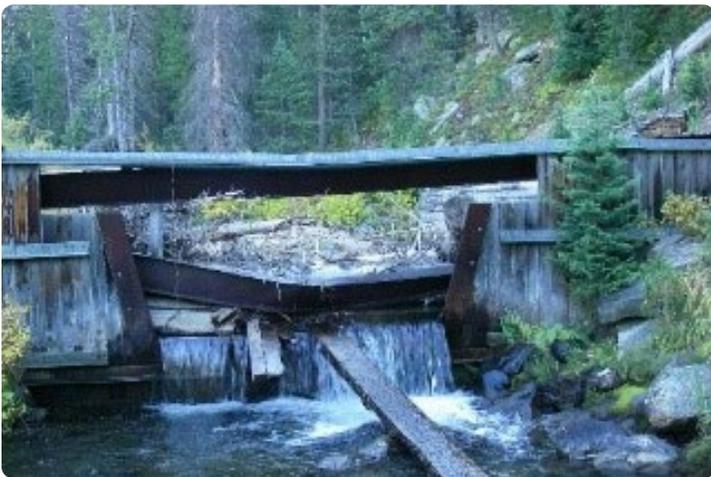
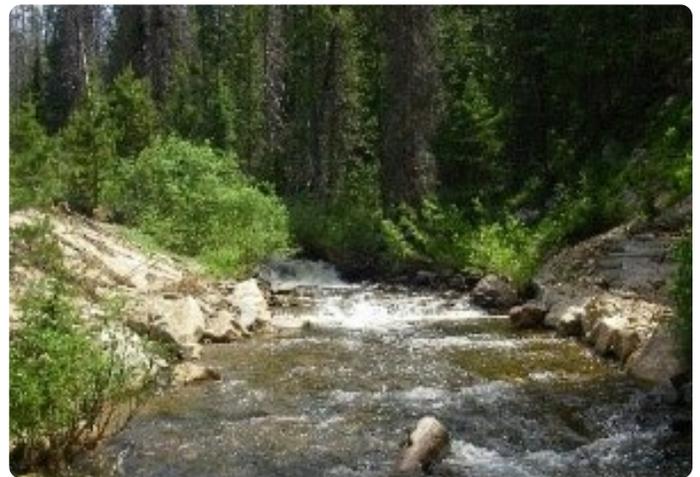
Before (left) and after (right) photos of Coon Creek in the East Fork Encampment River watershed. The weir was a barrier to aquatic organism passage, restricting upriver and downriver movement of fish and other aquatic organisms. After the removal of the weir, fish and other aquatic organisms have unobstructed access to additional habitat. USDA Forest Service photos.

The primary concern within the watershed was aquatic habitat fragmentation due to three streamflow measurement weirs and several road culverts which were acting as barriers to aquatic organism passage. A secondary concern was a dense road network in timber harvest areas located on the eastern and southern portions of the watershed. Most of the roads within timber harvest areas had been closed to the public but remained system roads, so there was still potential for these roads to contribute sediment material to local streams. Another concern was aquatic habitat alterations caused by excessive livestock grazing in some areas, resulting in altered stream channel morphology and riparian and wetland vegetation.

- Removed three streamflow measurement weirs and one road culvert to restore connectivity to 19.5 miles of fish habitat.
- Fenced an 11-acre expanse of vulnerable wetland/riparian area to protect and improve riparian and wetland conditions.
- Decommissioned 8 miles of unnecessary roads to decrease the amount of fine sediment entering streams (actions were taken to stabilize and restore these unneeded roads to a more natural state).
- Performed maintenance on 7 miles of trail to reduce the sediment being added to local streams.
- Relocated segments of the East Fork Trail so that the trail no longer closely parallels the stream or repeatedly crosses wetlands.
- Approximately 14 acres of streamside and wetland areas are no longer being negatively impacted by the trail.

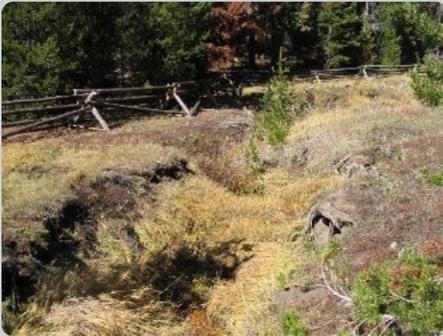
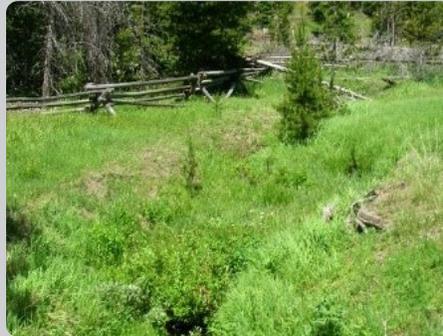
Wetland area before cattle enclosure fence (left) and after fence installation (right). USDA Forest Service photos.

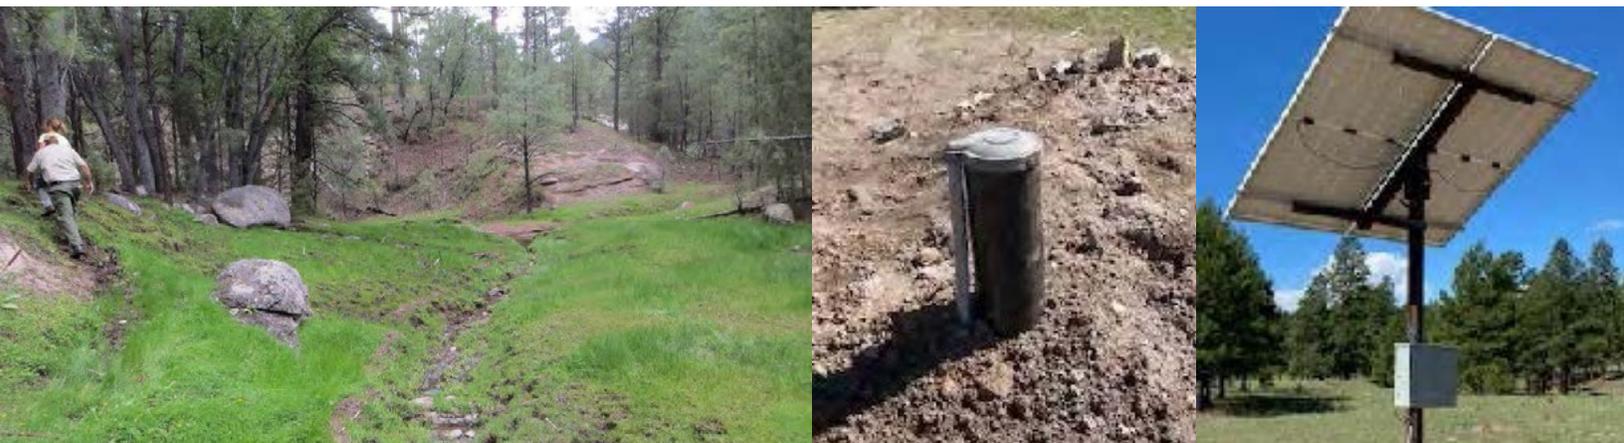
The Adair Spring on the Gila National Forest in New Mexico is an important water source for livestock. Before work began in the Big Canyon-San Francisco River watershed, livestock directly utilized the spring head of Adair Spring, resulting in trampled ground and dewatering of the spring and adjacent meadow (left). With support from the Upper Gila Watershed Alliance in the form of a river stewardship grant from the New Mexico Environment Department and donated materials from the oil and gas industry in Farmington, NM, the spring head was fenced and a new, solar-powered well was installed to provide an alternate water source for the livestock (right). USDA Forest Service photos.

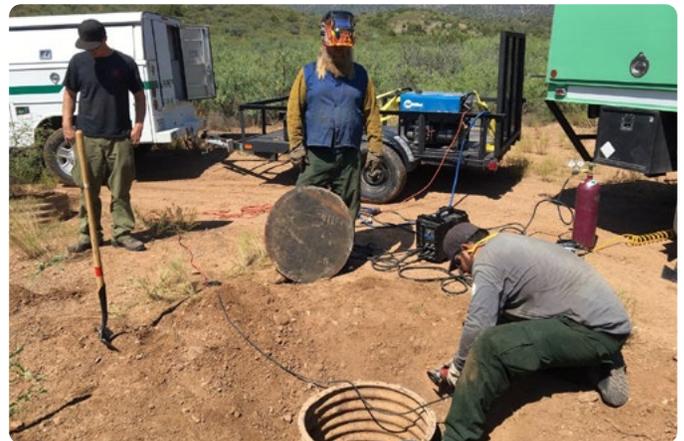
Abandoned well closure. Managing and closing abandoned wells is an important activity that improves water quality. USDA Forest Service photo.

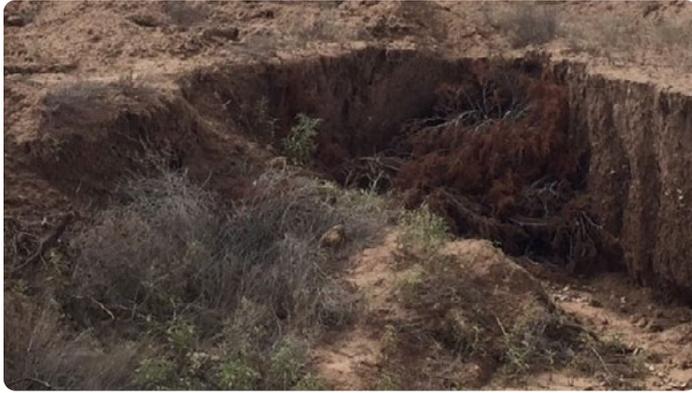
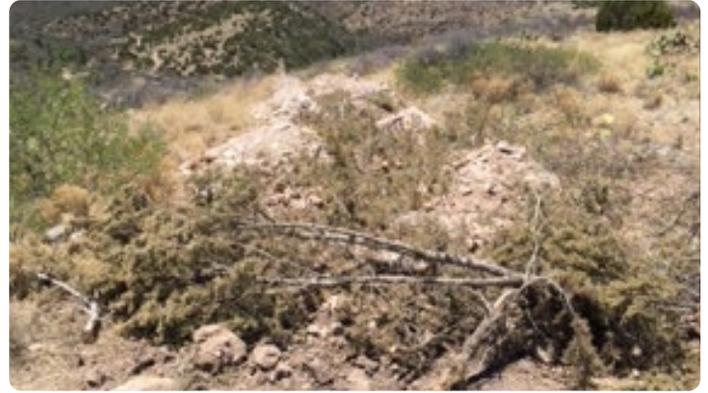
Moguling (left) was conducted to abate active gully. Spreading slash across the previous road entrance of decommissioned roads helps prevent access and limit erosion (right). USDA Forest Service photos.

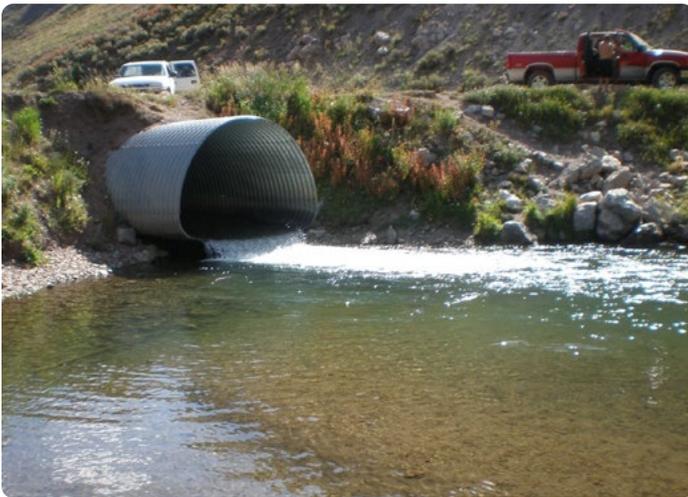
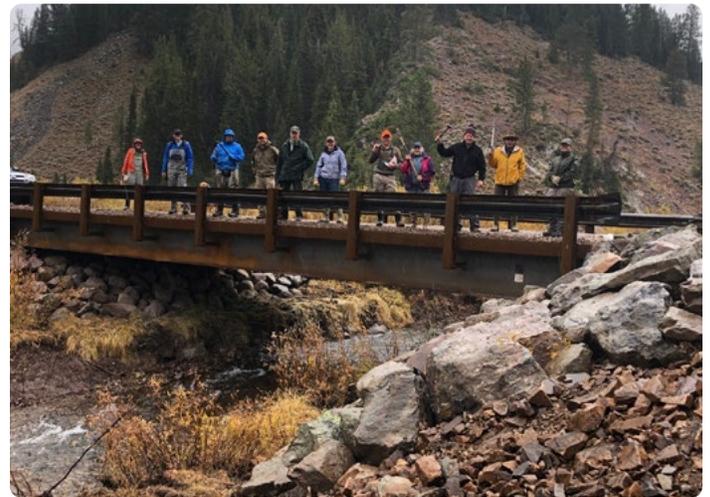
The upper Greys River-Spring Creek watershed on the Bridger-Teton National Forest in Wyoming suffered from deferred road maintenance for many years. Sedimentation issues and degraded fish spawning conditions from the existing road network and several aquatic organism passage (AOP) barriers negatively impacted native Snake River fine-spotted cutthroat trout habitat. Left photo: A perched 12-foot AOP barrier on Greys River creating a large scour pool below the structure. The structure blocked fish passage to upstream tributaries and the main stem of the Greys River, blocking approximately 15 miles of high-quality Snake River fine-spotted cutthroat trout spawning habitat. Right photo: The newly installed 52-foot bridge in place of the previously perched culvert on the Greys River now enables successful fish passage to the Greys River headwaters. The scour pool was filled in with boulders and grade control structures were placed downstream and upstream of the new bridge. Willows were planted on the banks by Trout Unlimited volunteers and Bridger-Teton fisheries biologists. USDA Forest Service photo (left). Trout Unlimited photo (right).

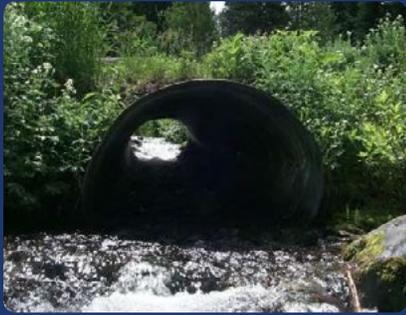
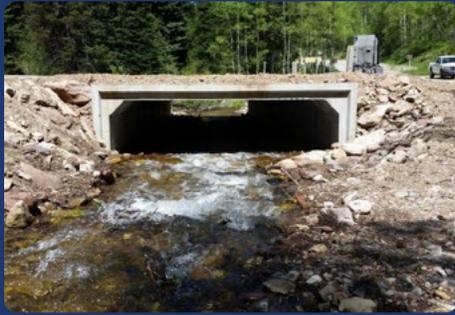
Culvert replacements went from undersized pipes (left) to enlarged box culverts (right) to improve AOP. USDA Forest Service photos.

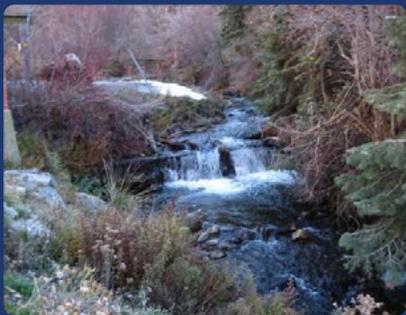
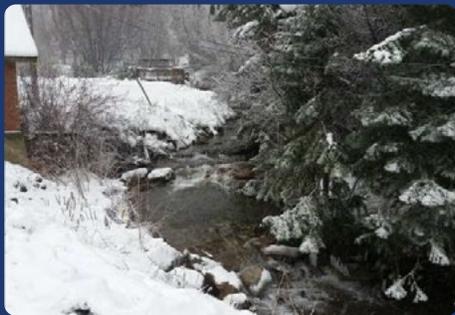
A diversion weir (left) was eliminated by building up the streambed to allow fish to swim over the barrier (right). USDA Forest Service photos.

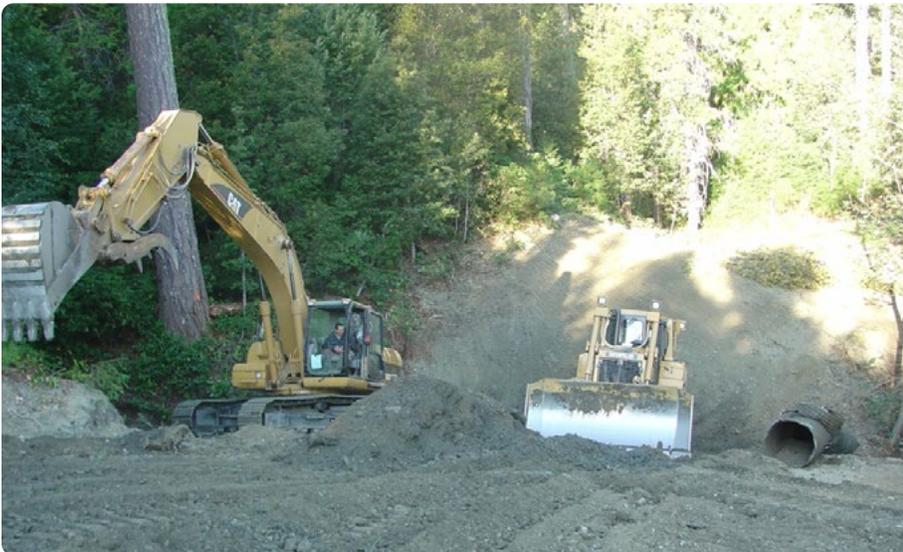
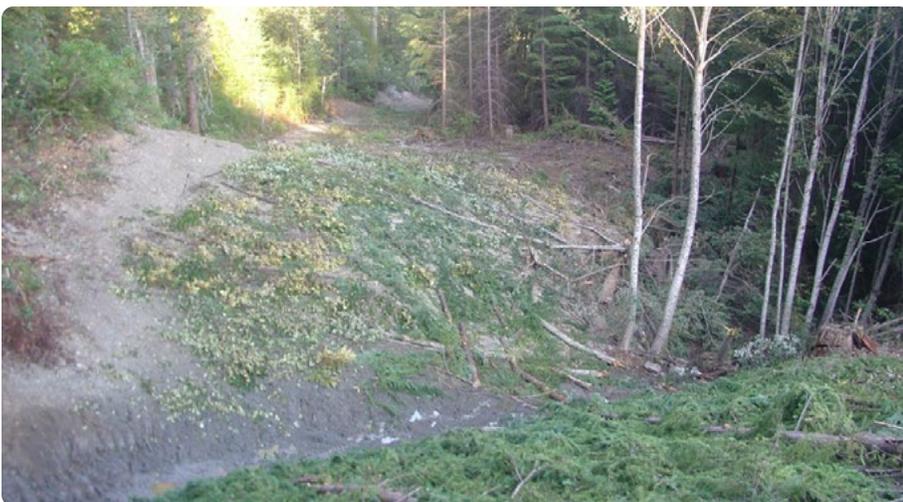
On Six Rivers National Forest in California, roads are a leading source of management-related sediment inputs and are predominantly associated with mass wasting features such as shallow debris slides and debris torrents. Much road-related erosion and sediment delivery occur with large storm events that trigger culvert failures, stream diversions, and mass wasting such as debris slides and smaller slumps within the roadbed. In the Bluff Creek watershed, road decommissioning is a key tactic for reducing sediment input to streams. One section of FSR 11N19 was decommissioned by removing a culvert (top) and recontouring to a more natural stream channel morphology (bottom). USDA Forest Service photos.

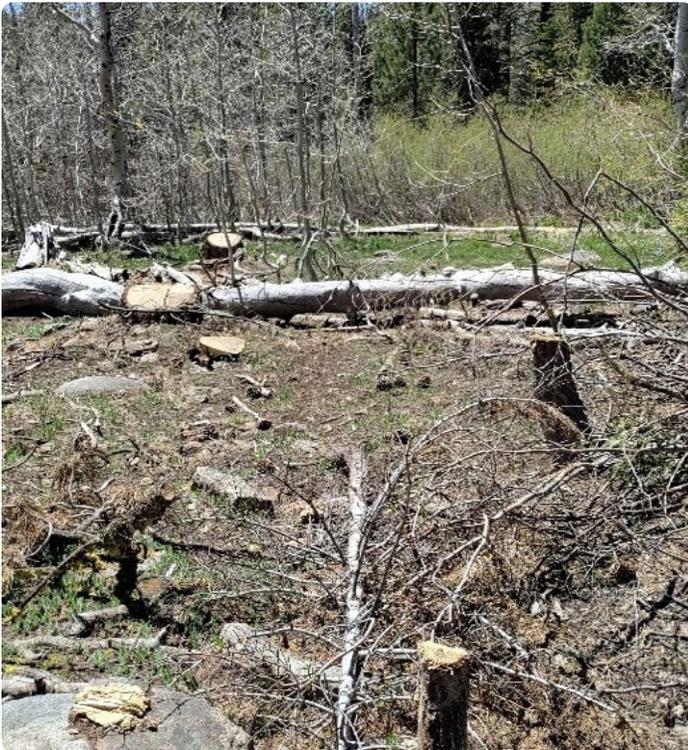
Removal of encroaching conifers in a meadow promotes replacement with wetland vegetation and habitat. USDA Forest Service photo.

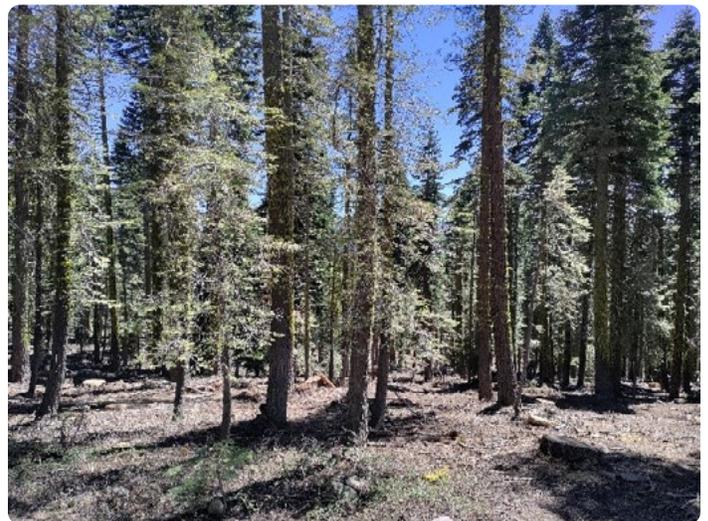
Commercial thinning of forest stands reduces the buildup of fuels that contribute to high-severity wildland fire which can destabilize soils and create sediment runoff into adjacent streams. USDA Forest Service photo.

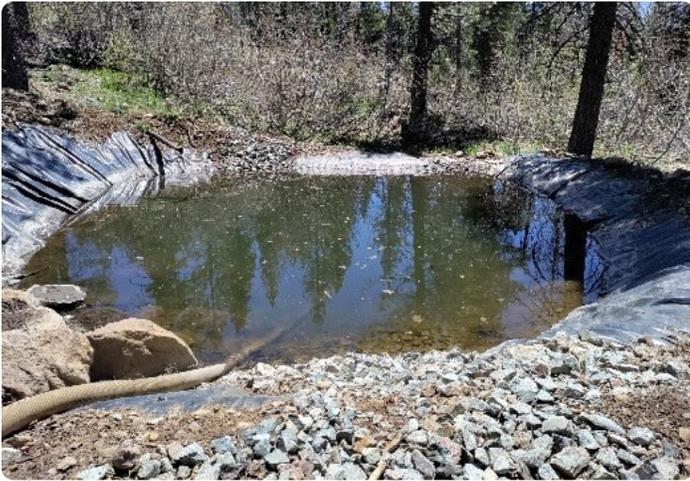
Off-channel water sources help reduce grazing impacts on stream banks and adjacent riparian areas by providing livestock with a steady water supply. USDA Forest Service photo.

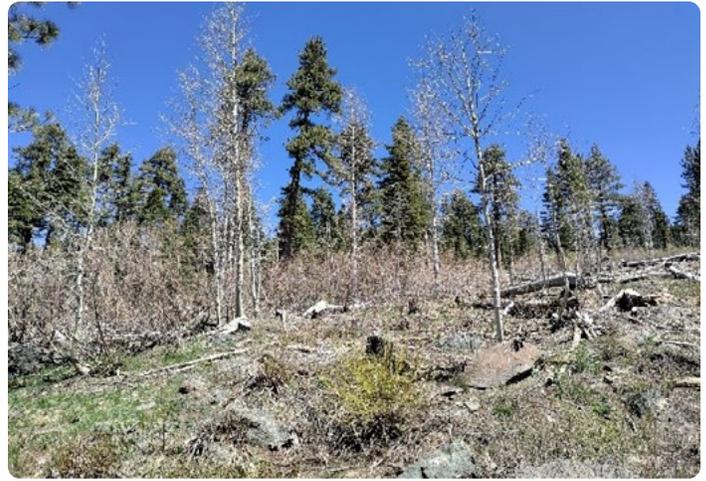
Removal of encroaching conifers in aspen stands promotes aspen replacement. Aspen are a key species for riparian ecologic function. USDA Forest Service photo.

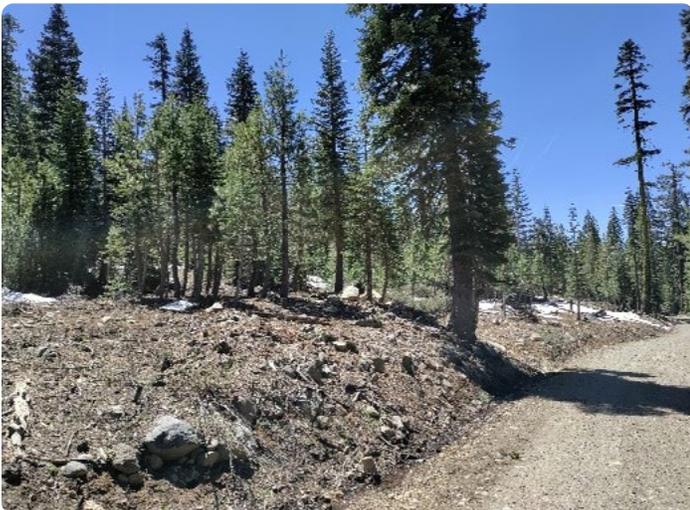
Prescribed fire (control line pictured here) is a key tactic used to reduce overloaded fuels in forest stands. Overloaded fuels contribute to high-severity fire which can lead to increased sedimentation of impacted soils to adjacent streams. USDA Forest Service photo.

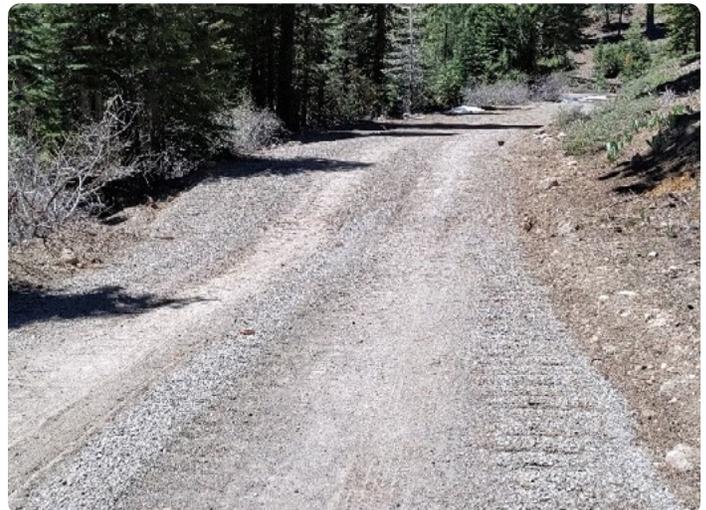
Road drainage improvement helps reduce sediment runoff from roads and increases the longevity of the road by reducing erosion during storm events. USDA Forest Service photo.
