Forest Service
U.S. DEPARTMENT OF AGRICULTURE

FS-1191 | February 2022

Watershed Condition Framework

2011–2020 | 10 Years of Restoration

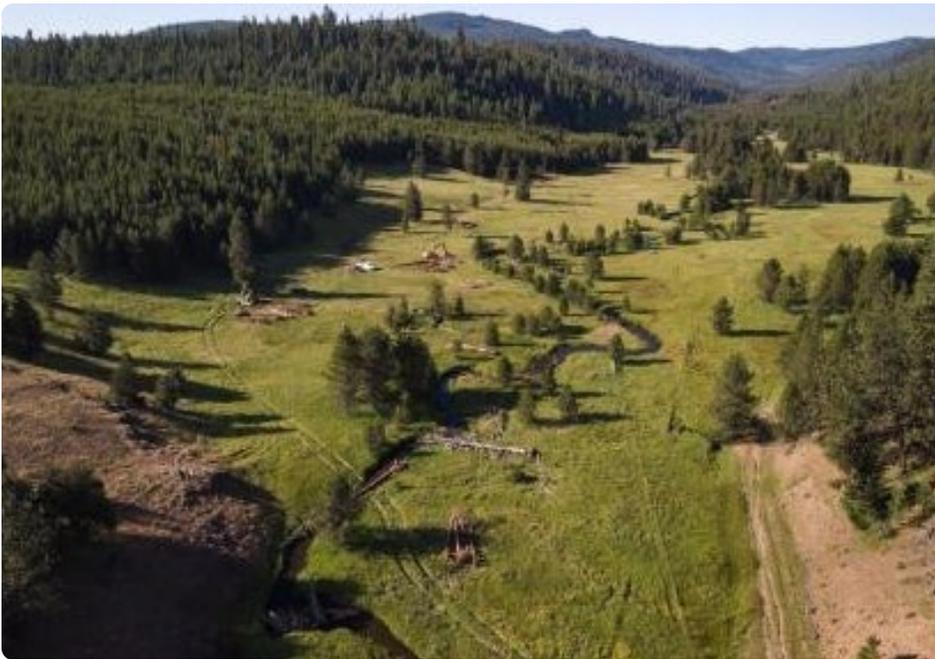
Partners invested \$1.7 million in the Sheep Creek watershed (top left) on the Wallowa-Whitman National Forest in Oregon. Work included wood placement for stream channel function (top right) and upgrading aquatic organism passage structures to provide increased habitat connectivity (left). USDA Forest Service photos.

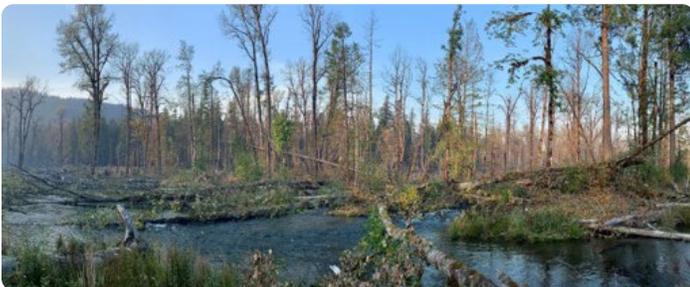
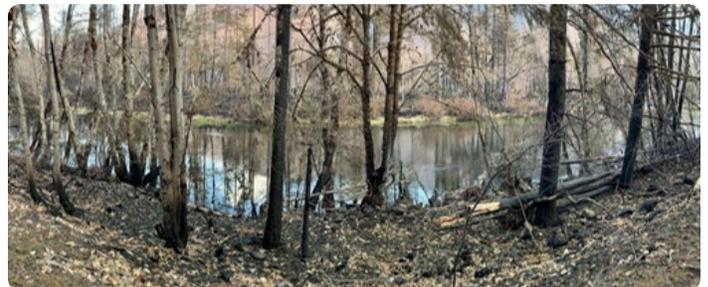
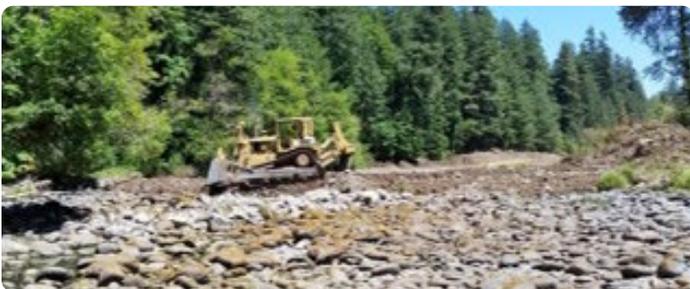
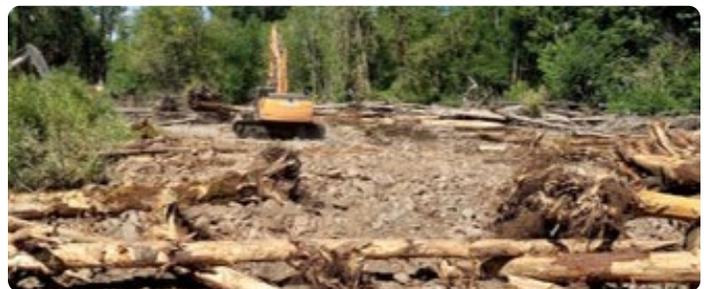
Observations after the 2020 Holiday Farm Fire indicate that healthy watersheds (top left) can reduce the intensity of wildland fire compared to areas with less hydrologic connectivity (top right). Filling of incised stream channels (bottom left) and placement of large wood (bottom right) restore hydrologic connectivity and complexity to support the recovery of ESA-listed fish. USDA Forest Service photos.

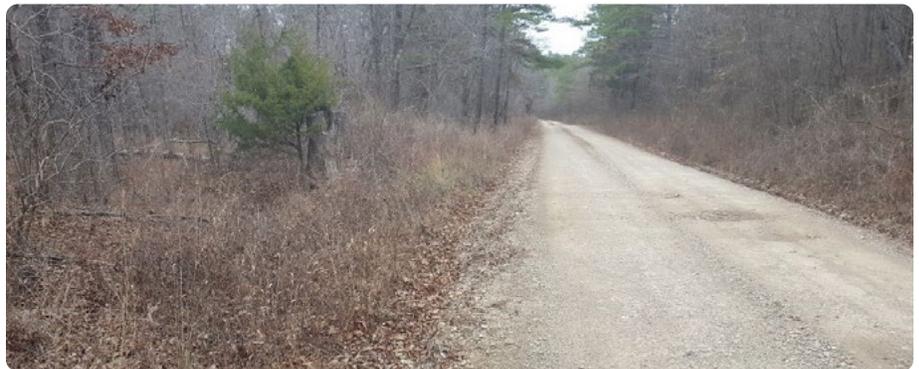
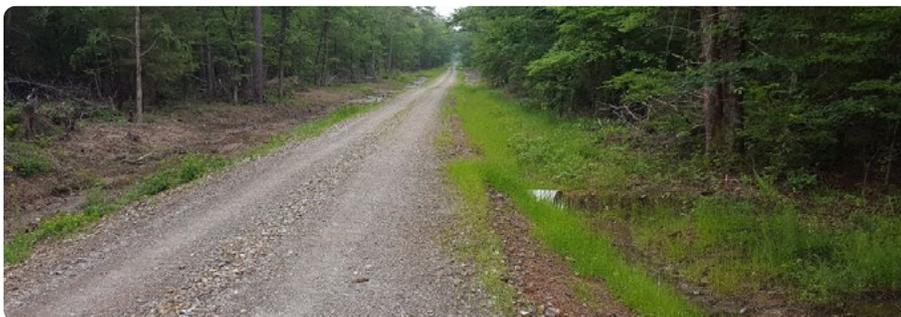
Road 68 after reconstruction is elevated above the surrounding terrain and provides adequate cover above right-sized culverts. Flat-bottom ditches reduce erosion and efficiently convey water without concentrating flow. USDA Forest Service photo.

including resurfacing and culvert replacements. Many of these improvements were made in concert with timber sales to improve haul routes. During a closeout inspection of the watershed, an additional project, Road 68, was identified and added to the WRAP.

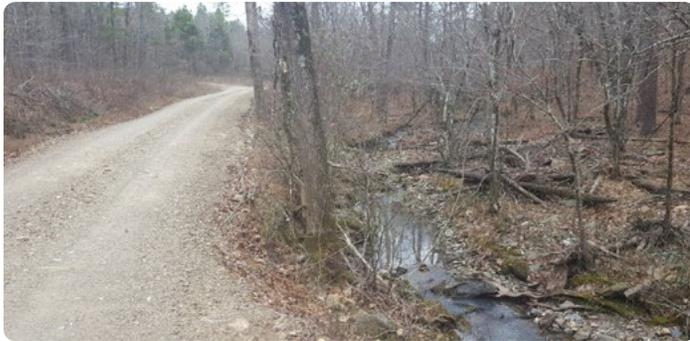
Road 68 before relocation paralleling the South Fork Ouachita River. Flow is from the top of the photo to the bottom. During high-flow events, the stream would impinge on the bank and undermine the roadway. Bank- and road-derived sediment would enter the stream and travel downstream where it could impact known populations of the Arkansas fatmucket. USDA Forest Service photo.

1 mile of graveled system road by elevating the road surface more than 1 foot above the surrounding terrain, construction of flat-bottom ditches, and enlarging cross-draining culverts. Finally, a 0.25-mile section of Road 68 that was being directly impacted by impinging flows of the South Fork Ouachita River was relocated to a benched hillside to reduce bank erosion and improve long-term stability of the road.

An additional \$25,000 of 2018 Joint Chiefs Landscape Restoration Partnership funds was directed toward the reconstruction of Road 68. In 2018, the watershed was reevaluated, and all projects identified in the WRAP, including Road 68, were certified as completed. The watershed remains classified as “functioning properly,” and the road and trail network subscore is improved one class to “functioning at risk.”

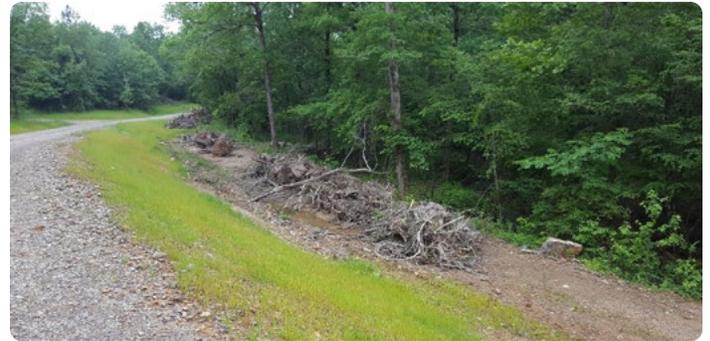
Following relocation, Road 68 is shown upslope and away from the South Fork Ouachita River (within the tree line). Roots and slash are seen along the relic roadbed. High flows no longer impinge on the roadway and a vegetated buffer reduces sediment delivery from the roadway to the stream. USDA Forest Service photo.

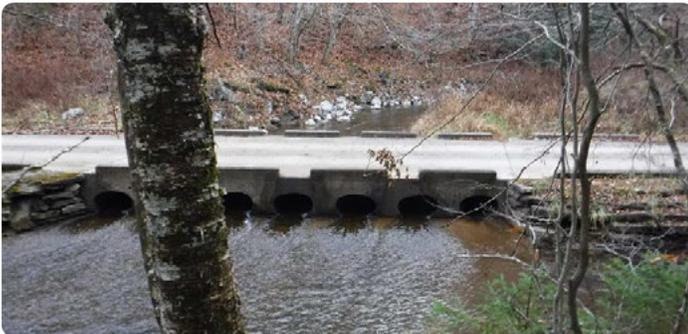
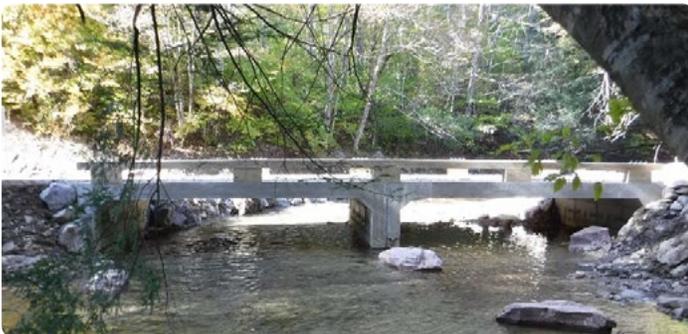
The Monongahela National Forest in West Virginia has worked in partnership with Trout Unlimited to implement various essential projects in designated priority watersheds. Partnership accomplishments during FY 2019 included the completion of two aquatic organism passage (AOP) projects in WCF priority watersheds that reconnected 23 miles of high-quality stream habitat for populations of brook trout and other native coldwater-associated species such as the federally listed (endangered) candy darter and eastern hellbender, listed as a Regional Forester Sensitive Species. Pictured at left, AOP project site WF15 in the Little River priority watershed is shown during preproject base flow condition (top), preproject bankfull flow condition (middle), and postproject implementation base flow condition (bottom). Simulation design for road-stream crossing structures reduces risks to public safety and vital infrastructure, restores continuity of inherent stream functions such as aquatic habitat connectivity, and improves soil and water quality. These project results greatly reduce the frequency and cost associated with infrastructure maintenance while enhancing the resiliency of aquatic ecosystems. Proactively managing for benefits such as these becomes increasingly important with changing climate that can produce more frequent environmental irregularities and extremes (e.g., stream flows and temperatures). USDA Forest Service photos.

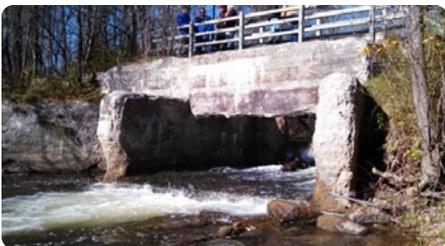
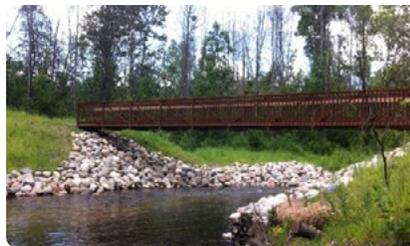
Buhl Dam (left) presented an obstacle to aquatic organism passage. A new pedestrian footbridge replaced the previous dam (right) and now provides improved AOP and visitor access. USDA Forest Service photos.

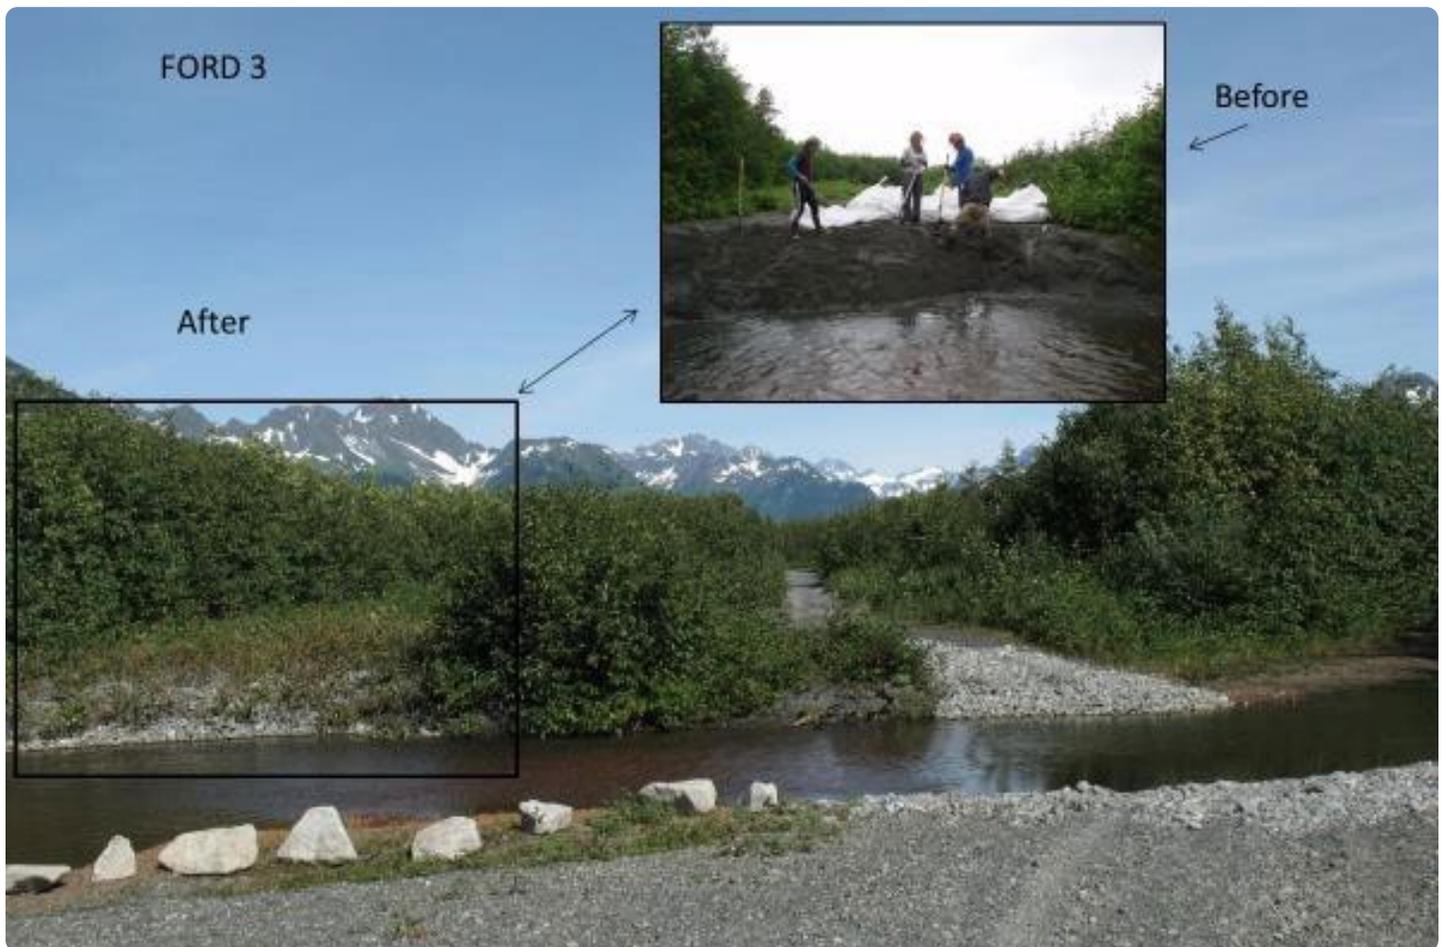
Heavy use by subsistence and recreational anglers has impacted streambank and watershed condition along Eyak River and Ibeck Creek on the Chugach National Forest in Alaska. Hardening low-water crossings helps reduce these impacts. Student Conservation Association crew members helped the Forest Service stabilize an eroding streambank and apply coarse substrate to prevent stream widening and erosion at this active ford (inset). USDA Forest Service photos.

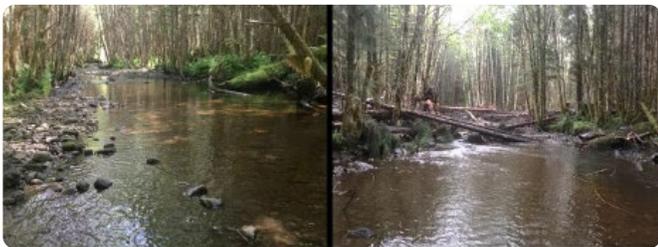
A 2018 stream restoration project in Scout Creek, a tributary to East Middle Fork Staney Creek. Photos compare prerestoration in 2016 (left) to postrestoration in 2017 (right). USDA Forest Service photos.

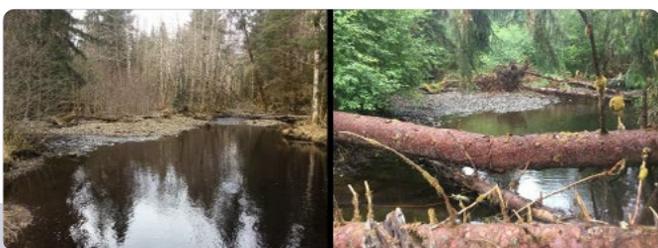
A 2018 stream restoration site in East Middle Fork Staney Creek. Photos compare prerestoration in 2017 (left) to postrestoration in 2018 (right) to bolster existing large wood in the floodplain and create more pools and habitat diversity. USDA Forest Service photos.

The objectives for Staney Creek included restoring stream condition, stream channel processes, natural quantities of large wood, and fish habitat, as well as maintaining optimum water temperatures for fish. By leveraging internal and external partnerships, stream restoration was completed using heavy equipment and hand tools; work included riparian thinning, extensive road decommissioning and storage (reclassifying a road to eliminate vehicle travel), and culvert replacements.

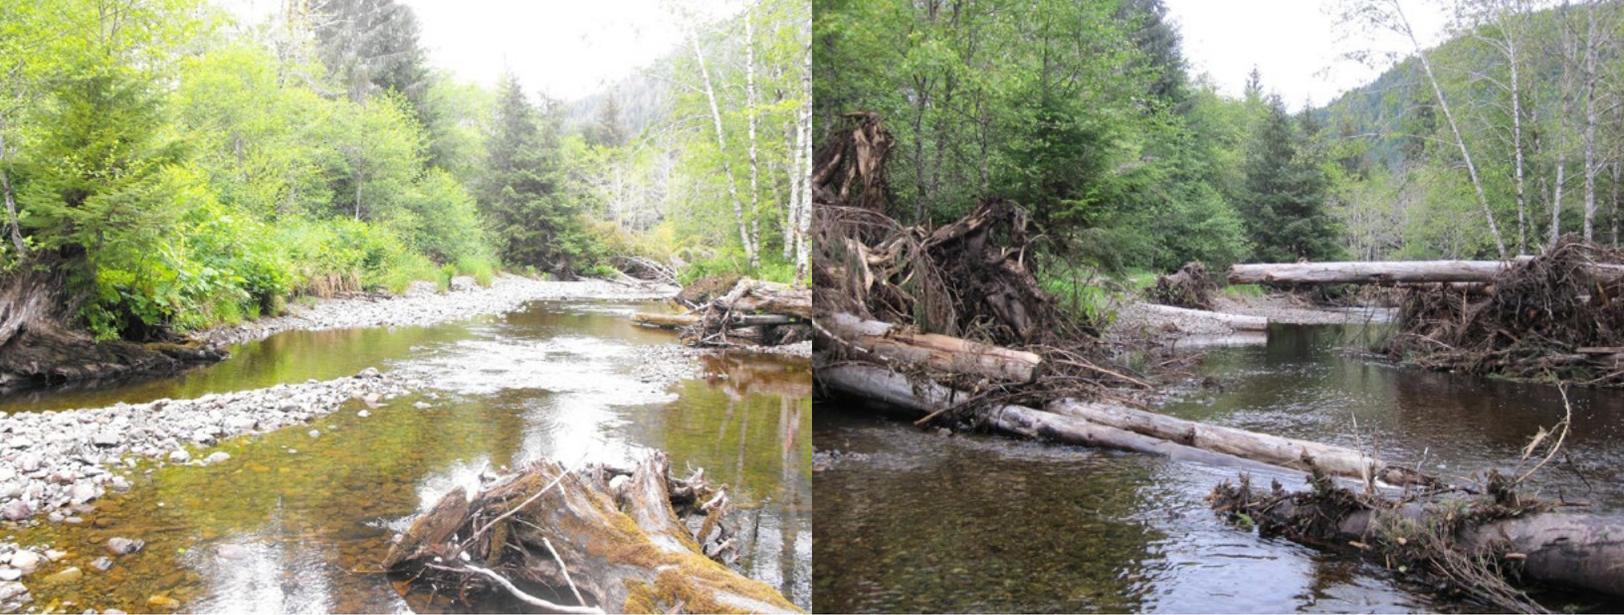
The Stoney West-Middle Fork before restoration (left) and after restoration (right). Large wood was added to the stream to restore natural wood quantities that provide key habitat and channel structure. USDA Forest Service photos.
