Case Study 16. Sibley Creek Vented Ford

Washington. Mt Baker-Snoqualmie National Forest. Mt Baker Ranger District. Cascade River Road (County Road No. 15, Milepost 10.2).

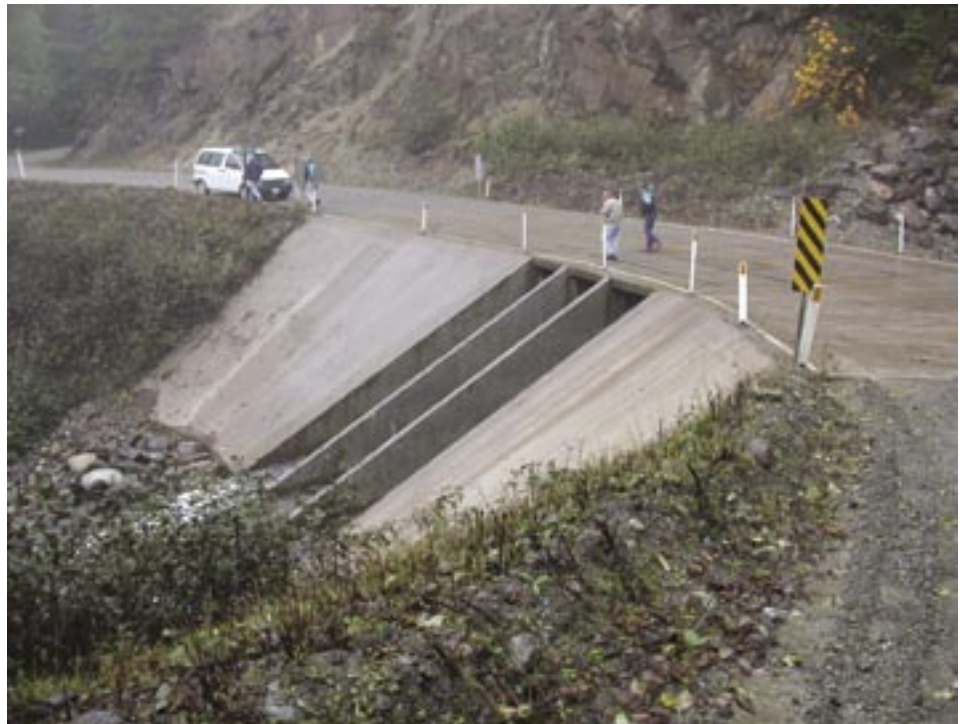
Figure A105. Sibley Creek vented ford.

This massive vented ford was constructed in 1997, after rain-on-snow floods washed out the crossing. The stream is very steep and prone to debris torrents, and previous drainage structures have failed repeatedly over the years. The road is closed in winter, but is a major access route to North Cascades National Park, and long-term traffic interruptions (which occur when this crossing washes out) are not desirable. The structure is a large concrete edifice with three box culverts with removable concrete tops (figure A105). The design allows it to pass large rocks and debris over the top, and to withstand the high stream power at this location.

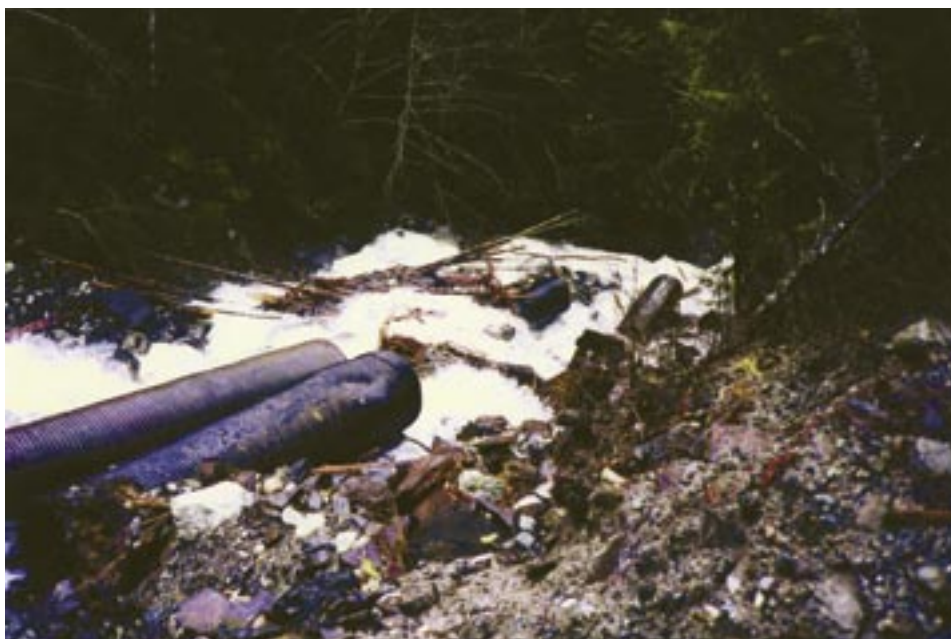
Figure A106. Two-culvert crossing on Sibley Creek blew out in November 1995.

Previous structures at this site have included multiple culverts, which have been washed out at least 6 times since 1960 (1962, 1976, 1988, 1989, 1990, and 1995) (figure A106). Those events had resulted in significant sediment deposition of roadfill material in coho salmon spawning areas in lower Sibley Creek, as well as temporary loss of public recreation access.

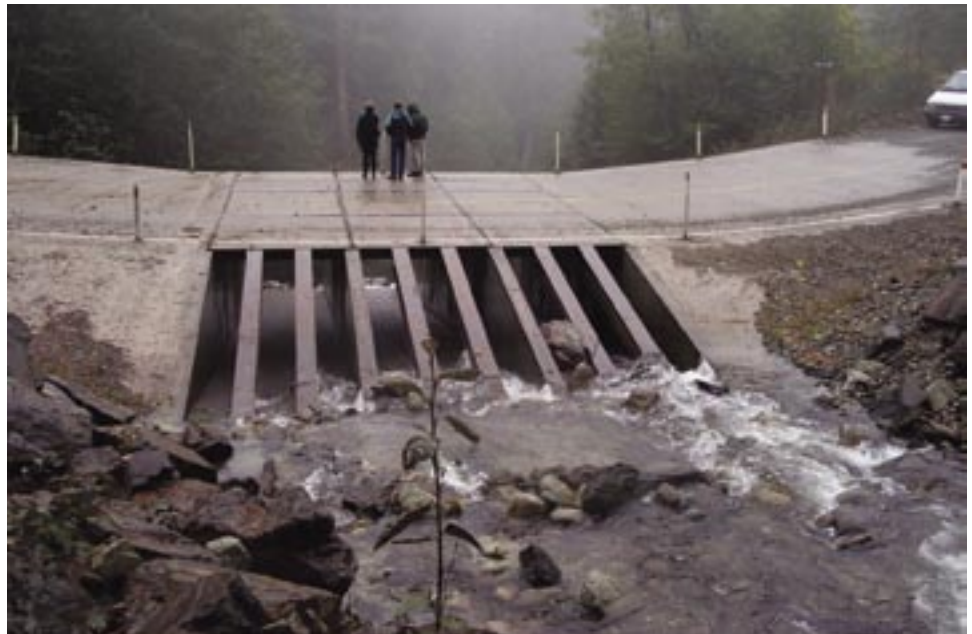
Figure A108. Looking downstream at the ford.

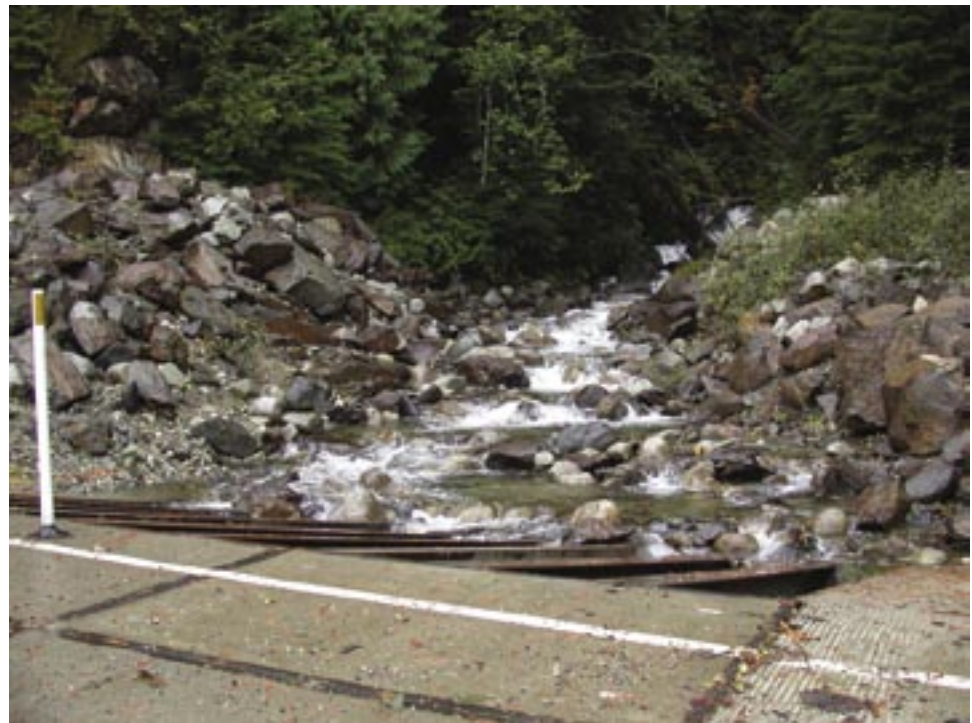
Figure A109. Sibley Creek currently approaches the inlet at a slight angle.

Bank stabilization and approaches: The graveled road approaches slope at between 3 and 6 percent into the ford. Riprap was used above the inlet to stabilize the streambanks, which may erode somewhat because the structure is not aligned perfectly perpendicular to the stream (figure A109). In this location where deposition is expected during major storms, the riprap is a temporary solution until the next major event. Downstream, large rock was placed at the toe of the concrete apron to avoid undermining.

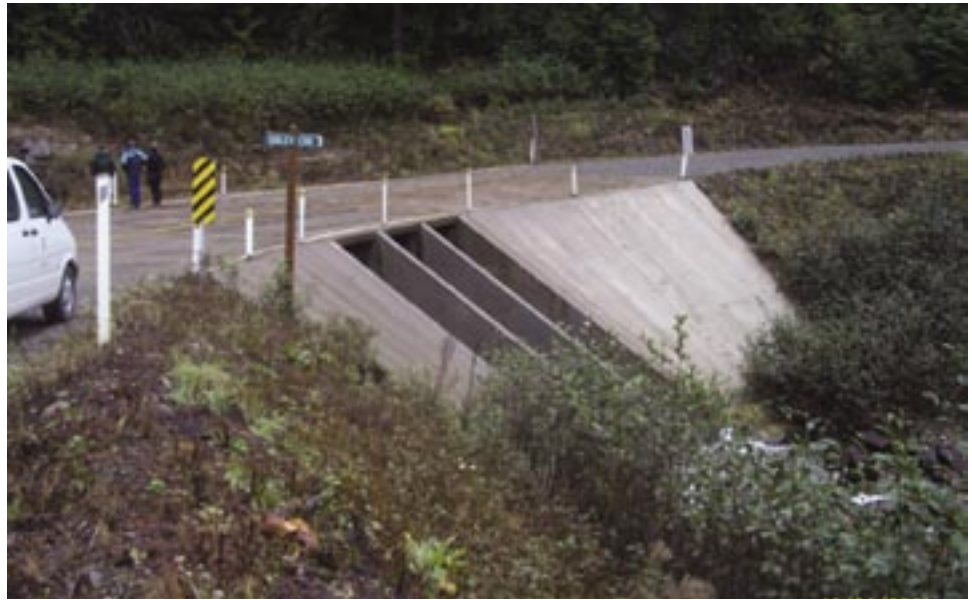
Figure A110. Safety markers on ford and approaches.

Safety: Delineator posts define the road edges and type III object markers are at both ends and both sides of the ford to focus traffic toward the road center (figure A110).

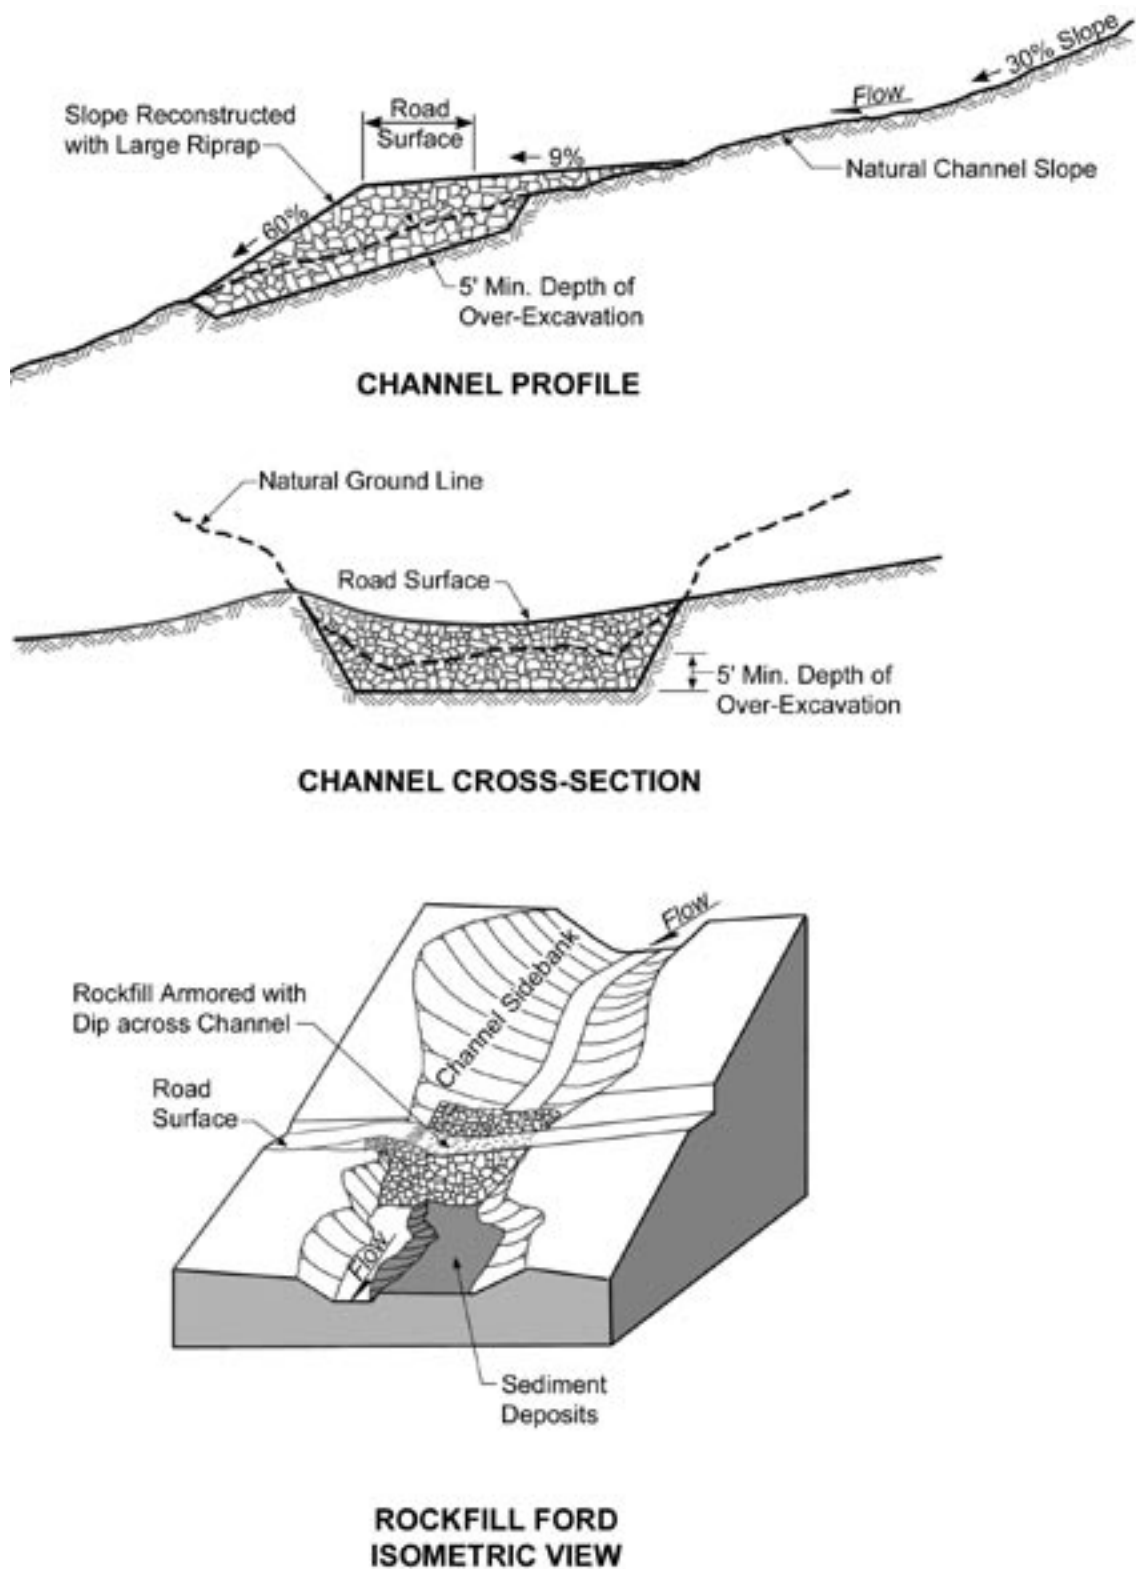
Figure A111. Stream and ford longitudinal profile, Catherine Creek, Vancouver, B.C. Redrawn from Askin 1992.

Robert Askin (Askin 1992) describes a rockfill ford on a similar channel in the Catherine Creek watershed on Vancouver Island, British Columbia. The ford was designed for a new (1992) logging road to cross a channel that had a 27-percent slope and a serious risk of debris torrents. Objectives were to keep costs low, pass water and debris, and avoid diverting flood flows down the road. After overexcavating the channel bed below the predicted depth of scour, large riprap was interlocked to construct a foundation, and the structure was built up to grade using coarse fill materials (figure A111). The crossing surface is about 8 feet above the natural channel bed, and it is outsloped at 9 percent to permit debris to move over the surface. Low flows move either through or over the permeable ford.
