## Quit Eating My Signs! Pepper-Based Coating Discourages Animals from Damaging Structures

*Kathleen Snodgrass, Project Leader*

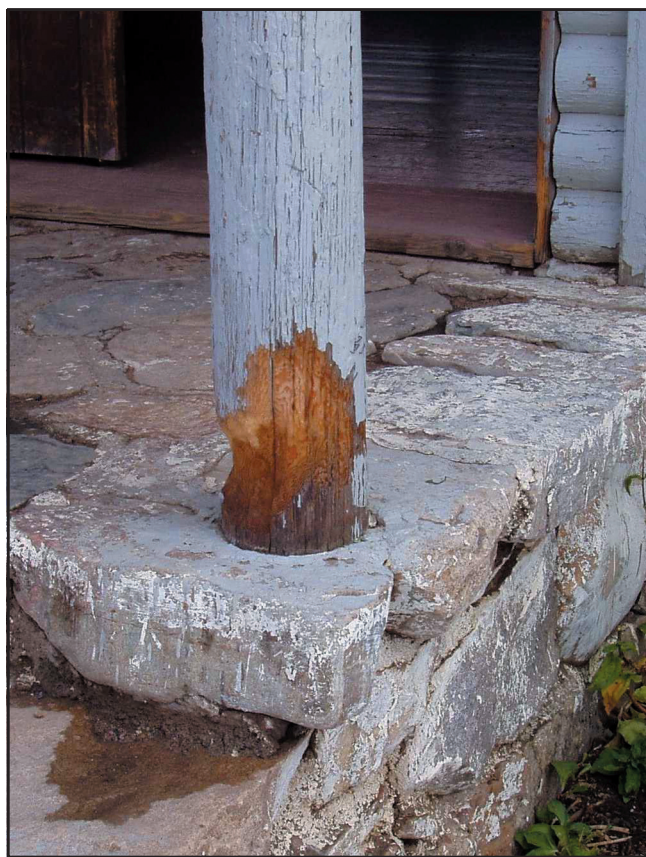
Figure 1 — This porch post at a historic ranger station in the Intermountain Region was damaged by a beaver or porcupine during the winter of 2003–2004.

Animals peck and chew buildings, signs, and utility lines and cables at U.S. Department of Agriculture Forest Service facilities across the nation (figure 1). Forest Service employees have tried many methods to discourage animal damage. Some methods have worked better than others, but all seem to have their limitations. The Forest Service's Technology and Development program has been asked to investigate methods to prevent animals from damaging facilities many times over the years and has produced several recent reports on the topic, including:

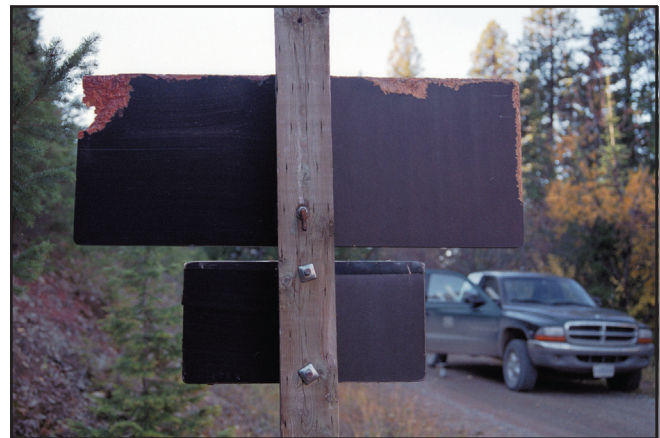
Figure 2—The back of the Dry Creek road sign in the Helena National Forest's Lincoln Ranger District in October 2003 just after the left half of the sign was painted with habanero coating.

The results of the field tests at the Sawtooth National Recreation Area, the Lincoln Ranger District, and the private corral were dramatic. Figures two and three show the difference in damage done to coated and uncoated halves of a roadway sign on the Dry Creek Road (No. 4106) in the Lincoln Ranger District of the Helena National Forest. Three other signs along the Dry Creek Road also were treated, with the same results. The test showed that porcupines prefer not to chew on coated signs.

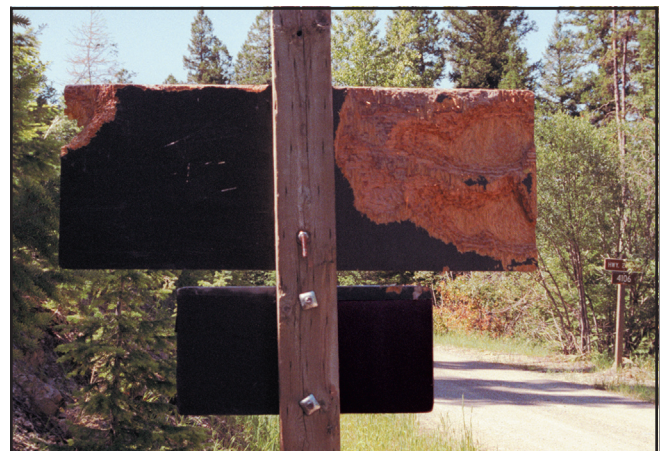
Figure 3—The back of the Dry Creek road sign in July 2004. The treated (left) half of the sign shows no further damage, while the untreated (right) half has been chewed severely.

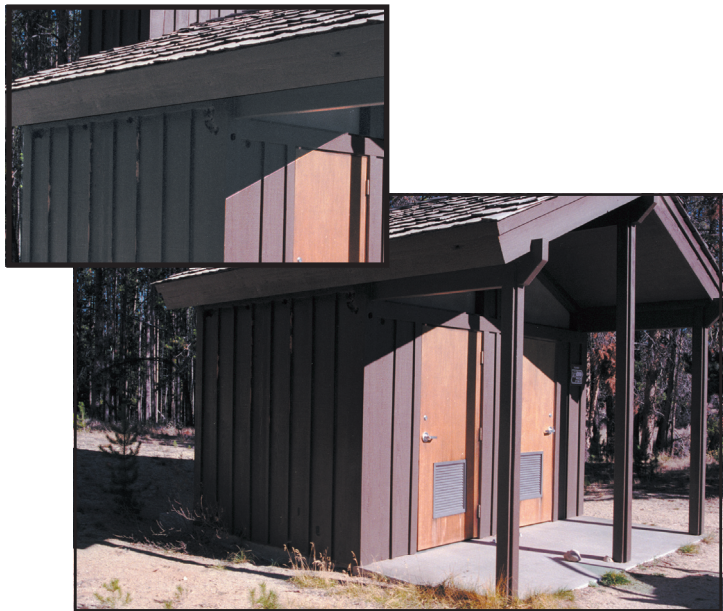
Figure 4—The Pettit Lake vault toilet already had some woodpecker damage when the habanero coating was applied to the left side of the structure in October 2003.

The results were similar at a Pettit Lake Campground vault toilet in the Sawtooth National Recreation Area, ID, where woodpeckers were damaging the wooden siding. There was little new damage to the coated areas, but woodpeckers had made several new holes and abrasions on the areas that were not coated (figures 4 and 5).

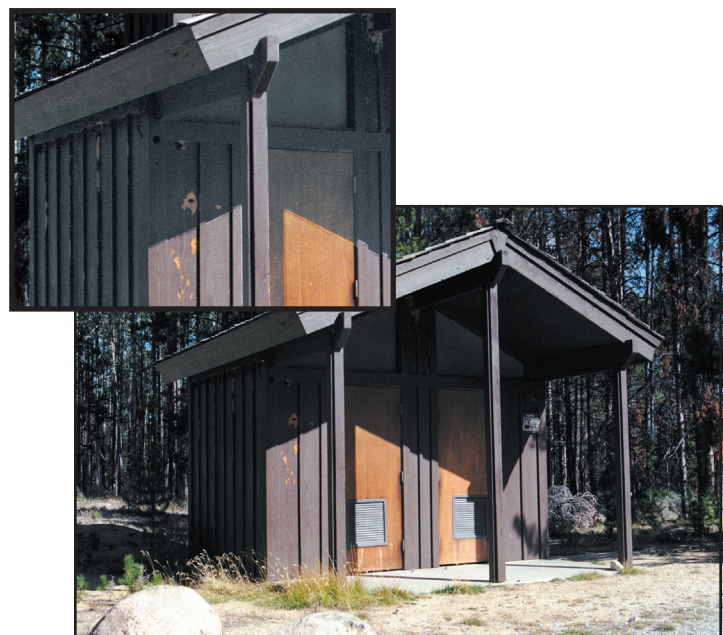
Figure 5—In October 2004, new woodpecker damage was minimal on the left side of the structure, which was treated, but damage was substantial on the front of the building, which was untreated.

The woodpeckers evidently preferred to peck where there was no habanero coating. Because only part of the structure was coated, it is not clear whether the birds would leave a completely coated structure alone.

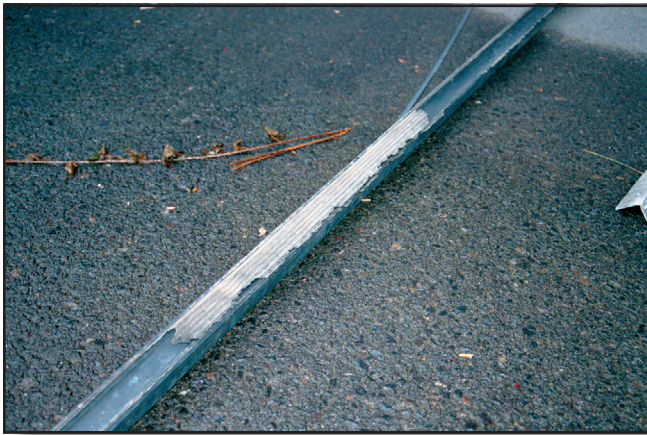
Figure 6—Chipmunks severely damaged overhead door seals, which were replaced every year or two at the maintenance shop in the Mount St. Helens National Volcanic Monument.

The only test application with ambiguous results was at the Mount St. Helens maintenance shop. Chipmunks had chewed through the seals at the bottom of four overhead doors to get into the maintenance shop, damaging the seals almost every day. The damage was so severe that the seals were replaced every year or two (figure 6). Clear habanero coating was applied to the seals at the bottom of two of the overhead doors in October 2003. After 8 months, only one hole had appeared in any of the door seals. It was an exit hole in one of the treated seals (figure 7). Ten months after treatment, another small exit hole appeared, this time in an untreated door seal. No further holes had appeared 16 months after treatment.

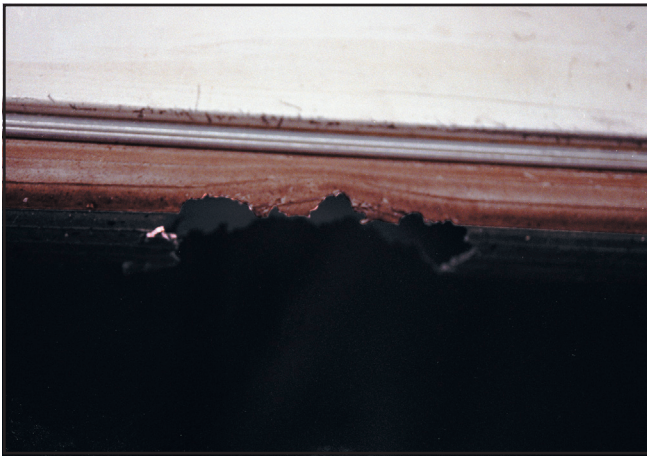
Figure 7—This hole was the only damage to the door seal 8 months after the habanero coating was applied.

It is difficult to draw any conclusions from this test. Why did the chipmunks make so few new holes? Why were the two new holes both exit holes when all previous damage had begun with entrance holes? Was the coating applied less thoroughly to the inside of the door seals? Did the cool, damp weather on the day of application affect the coating or the adhesion of the coating to the seals? Controlled research tests would be needed to provide answers.

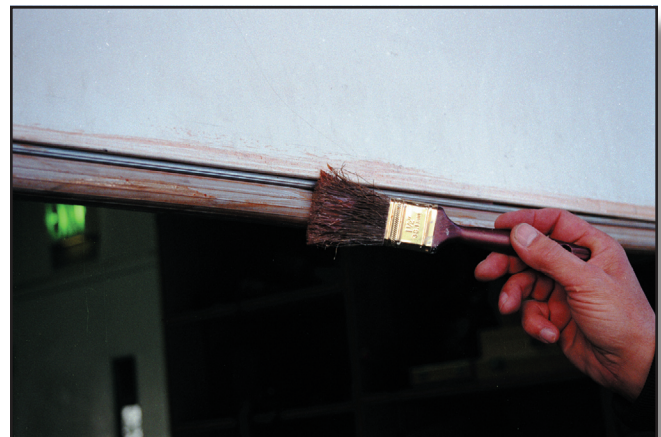
Figure 8—Habanero coating was painted on the overhead door seals at the maintenance shop in the Mount St. Helens National Volcanic Monument. The freshly applied coating had an orange tint, but the coating became clear after several weeks.

In all tests, the elastomeric (flexible) sealant coating and the lanolin-based product were applied with a regular paintbrush. Care was taken to completely coat the surface, leaving no gaps in the coverage. The elastomeric coating had a slight orange color when applied, but the coating became clear after several weeks (figure 8). Surfaces treated with the elastomeric coating have a slight sheen, similar to the sheen of a semigloss paint finish. The lanolin product also seems to have a slight orange tint when applied, but the tint fades away within a few weeks. Unfinished wood surfaces that have been treated with the lanolin product have the appearance of oiled wood, but the surface is dry to the touch.
