Quit Eating My Signs! Pepper-Based Coating Discourages Animals from Damaging Structures

Snodgrass, Kathleen. 2005. Quit eating my signs: pepper-based coating discourages animals from damaging structures. Tech Tip 0573–2313–MTDC. Missoula, MT: U.S. Department of Agriculture, Forest Service, Missoula Technology and Development Center. 6 p.

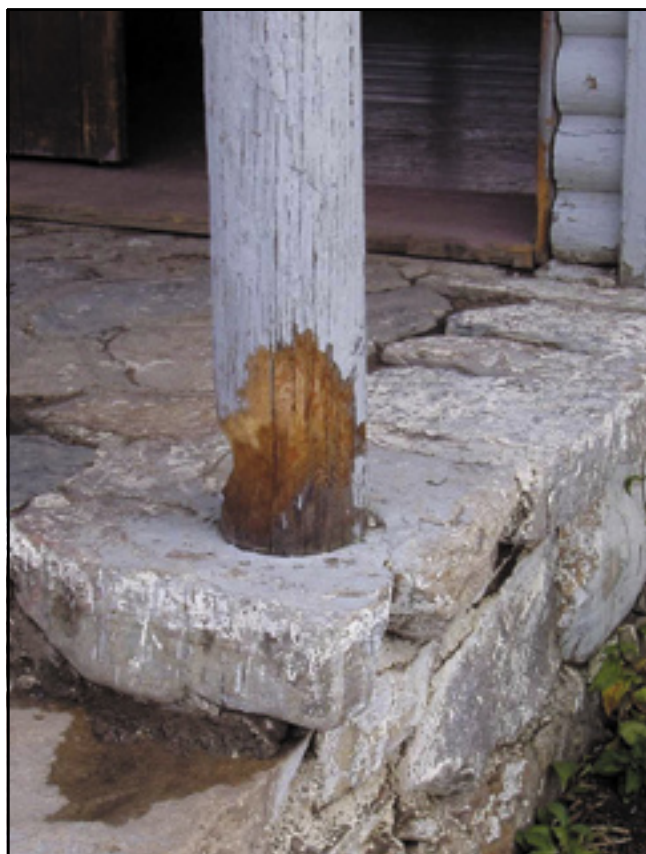
Figure 1 — This porch post at a historic ranger station in the Intermountain Region was damaged by a beaver or porcupine during the winter of 2003–2004.

Animals peck and chew buildings, signs, and utility lines and cables at U.S. Department of Agriculture Forest Service facilities across the nation (figure 1). Forest Service employees have tried many methods to discourage animal damage. Some methods have worked better than others, but all seem to have their limitations. The Forest Service's Technology and Development program has been asked to investigate methods to prevent animals from damaging facilities many times over the years and has produced several recent reports on the topic, including:

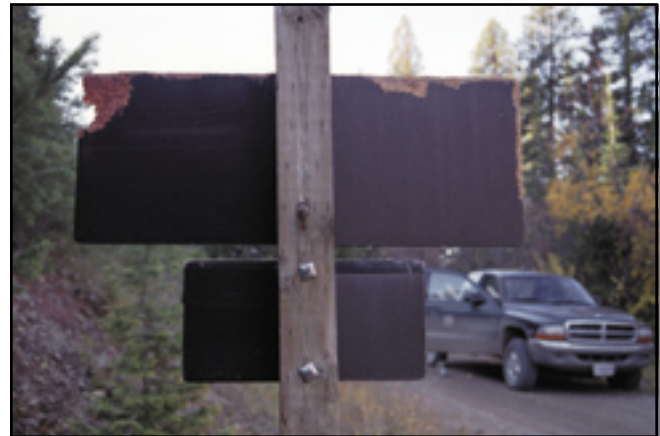
Figure 2—The back of the Dry Creek road sign in the Helena National Forest's Lincoln Ranger District in October 2003 just after the left half of the sign was painted with habanero coating.

The results of the field tests at the Sawtooth National Recreation Area, the Lincoln Ranger District, and the private corral were dramatic. Figures two and three show the difference in damage done to coated and uncoated halves of a roadway sign on the Dry Creek Road (No. 4106) in the Lincoln Ranger District of the Helena National Forest. Three other signs along the Dry Creek Road also were treated, with the same results. The test showed that porcupines prefer not to chew on coated signs.

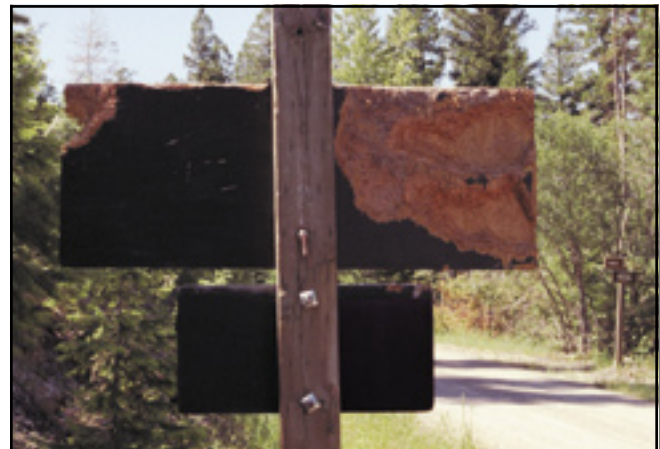
Figure 3—The back of the Dry Creek road sign in July 2004. The treated (left) half of the sign shows no further damage, while the untreated (right) half has been chewed severely.

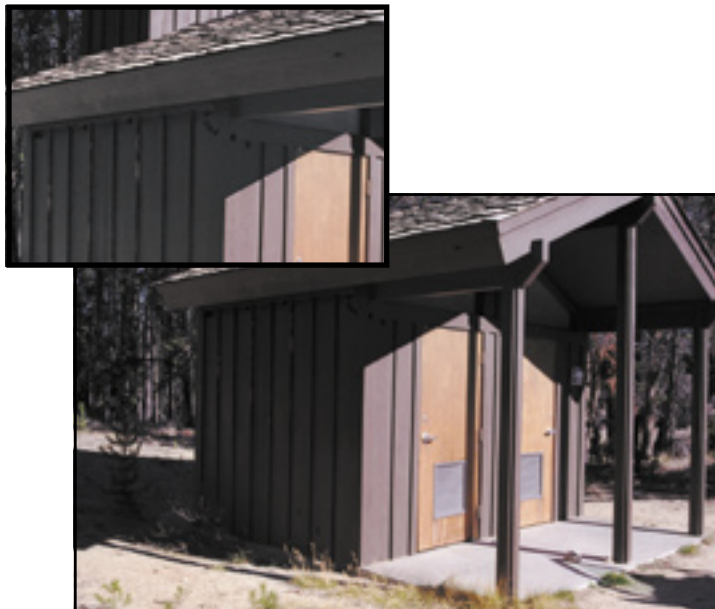
Figure 4—The Pettit Lake vault toilet already had some woodpecker damage when the habanero coating was applied to the left side of the structure in October 2003.

The results were similar at a Pettit Lake Campground vault toilet in the Sawtooth National Recreation Area, ID, where woodpeckers were damaging the wooden siding. There was little new damage to the coated areas, but woodpeckers had made several new holes and abrasions on the areas that were not coated (figures 4 and 5).

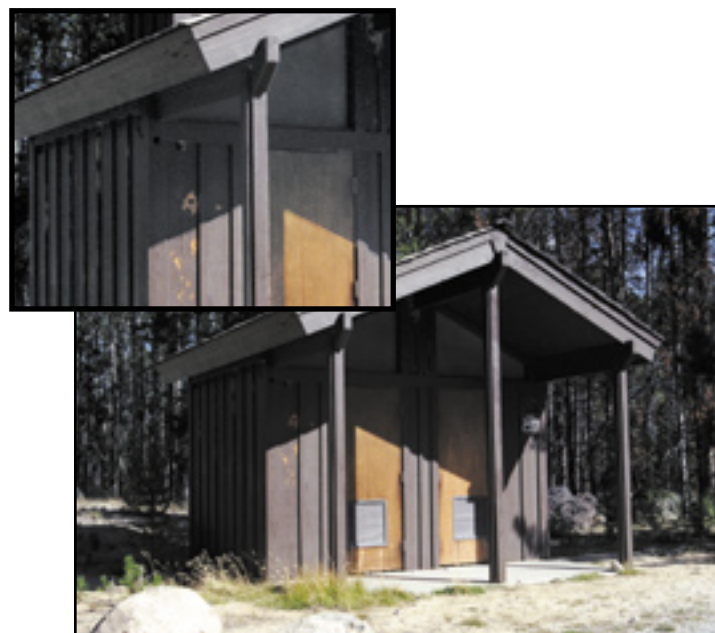
Figure 5—In October 2004, new woodpecker damage was minimal on the left side of the structure, which was treated, but damage was substantial on the front of the building, which was untreated.

The woodpeckers evidently preferred to peck where there was no habanero coating. Because only part of the structure was coated, it is not clear whether the birds would leave a completely coated structure alone.

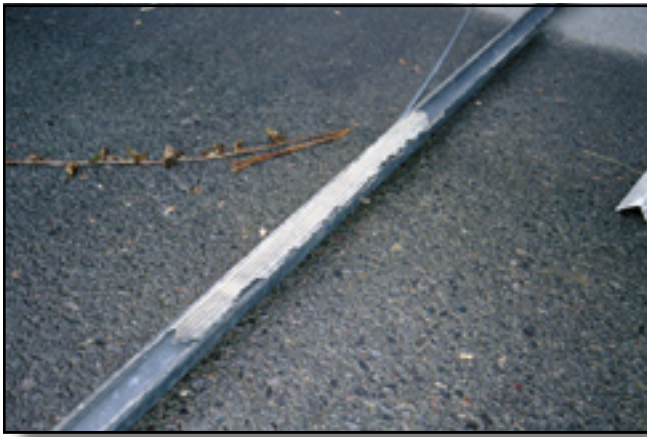
Figure 6—Chipmunks severely damaged overhead door seals, which were replaced every year or two at the maintenance shop in the Mount St. Helens National Volcanic Monument.

The only test application with ambiguous results was at the Mount St. Helens maintenance shop. Chipmunks had chewed through the seals at the bottom of four overhead doors to get into the maintenance shop, damaging the seals almost every day. The damage was so severe that the seals were replaced every year or two (figure 6). Clear habanero coating was applied to the seals at the bottom of two of the overhead doors in October 2003. After 8 months, only one hole had appeared in any of the door seals. It was an exit hole in one of the treated seals (figure 7). Ten months after treatment, another small exit hole appeared, this time in an untreated door seal. No further holes had appeared 16 months after treatment.

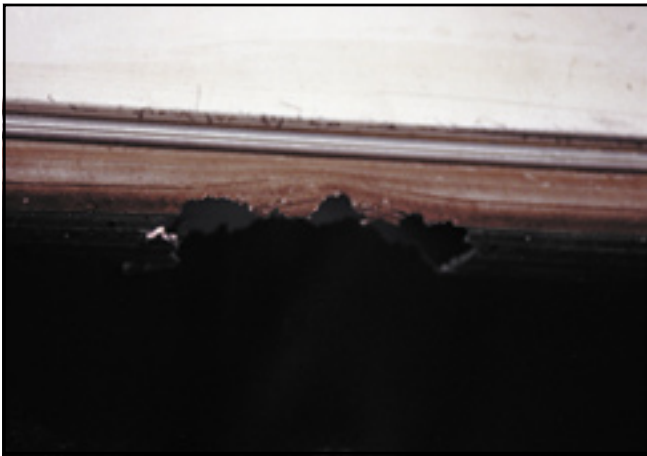
Figure 7—This hole was the only damage to the door seal 8 months after the habanero coating was applied.

It is difficult to draw any conclusions from this test. Why did the chipmunks make so few new holes? Why were the two new holes both exit holes when all previous damage had begun with entrance holes? Was the coating applied less thoroughly to the inside of the door seals? Did the cool, damp weather on the day of application affect the coating or the adhesion of the coating to the seals? Controlled research tests would be needed to provide answers.

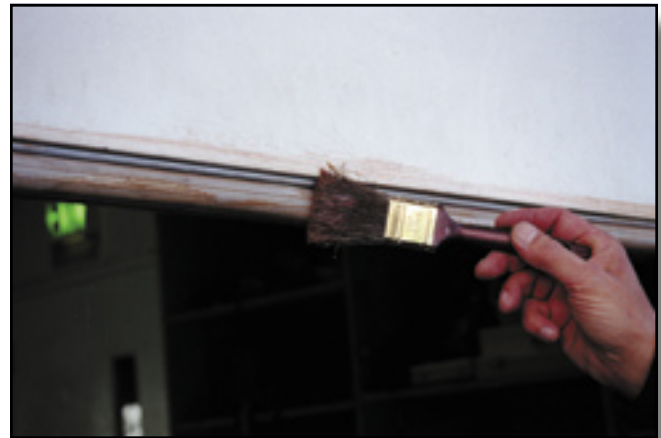
Figure 8—Habanero coating was painted on the overhead door seals at the maintenance shop in the Mount St. Helens National Volcanic Monument. The freshly applied coating had an orange tint, but the coating became clear after several weeks.

In all tests, the elastomeric (flexible) sealant coating and the lanolin-based product were applied with a regular paintbrush. Care was taken to completely coat the surface, leaving no gaps in the coverage. The elastomeric coating had a slight orange color when applied, but the coating became clear after several weeks (figure 8). Surfaces treated with the elastomeric coating have a slight sheen, similar to the sheen of a semigloss paint finish. The lanolin product also seems to have a slight orange tint when applied, but the tint fades away within a few weeks. Unfinished wood surfaces that have been treated with the lanolin product have the appearance of oiled wood, but the surface is dry to the touch.
