**ENGINEERING  
TECHNICAL  
INFORMATION  
SYSTEM**

**VOLUME 7 NUMBER 6  
REVISED**

## CONCRETE CRIB CHECK DAMS

Robert M. Gallup  
Civil Engineer  
San Dimas Equipment Development Center

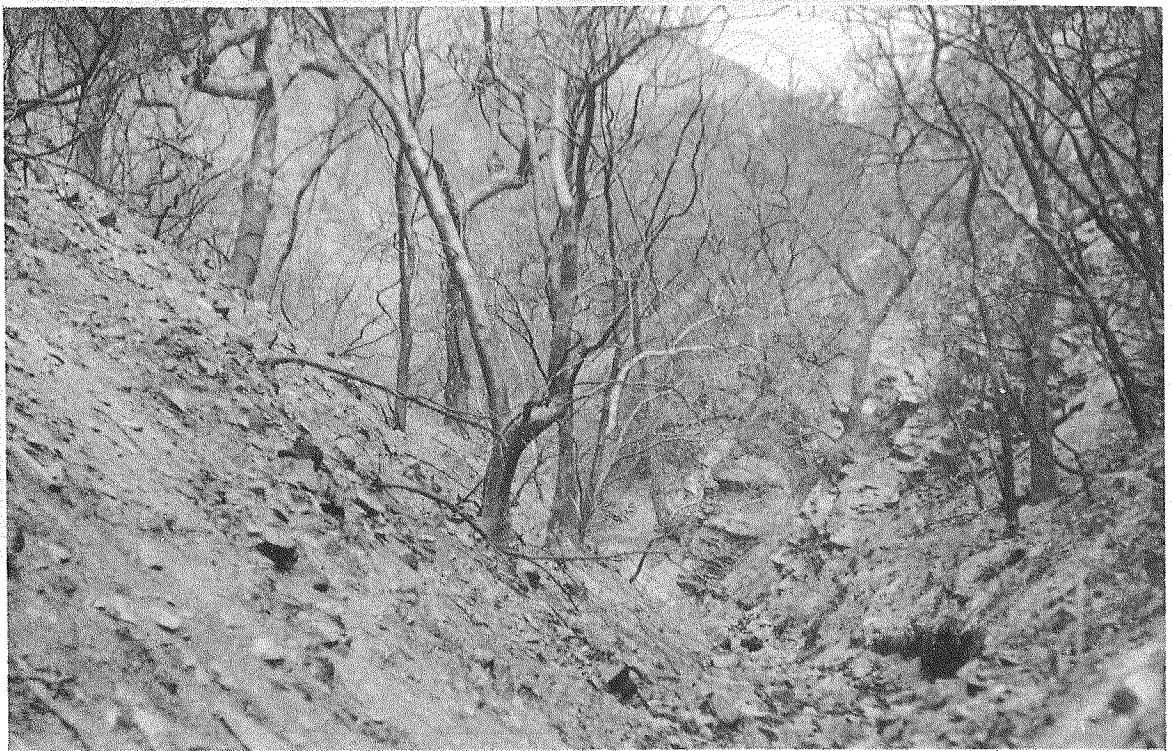
*Figure 5. — An unstable channel showing effects of dry erosion.*

In very steep mountain streams the presence of solid-rock outcrops in the stream bottom and on the canyon walls is considered a stable condition. Large quantities of debris, debris movement, and steep channel-bottom grades are evidence of an unstable stream. Loose, sloughing, steep canyon walls of soil with an absence of rock outcrops are also conditions of instability. A further evidence of instability is the dry erosion of loose soil on hillsides caused by gravity and wind (fig. 5).

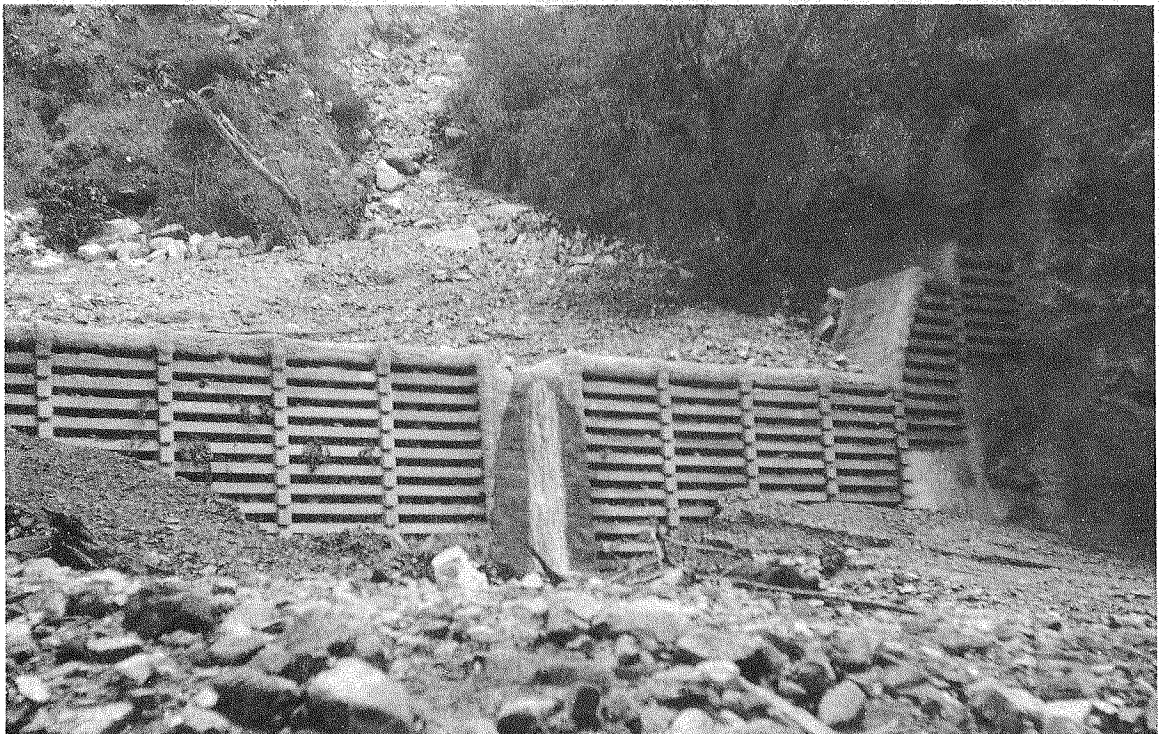
*Figure 7. — A debris cone in a side stream and upper end of a debris cone.*

Debris — including boulders, rocks, soil, mud, and other substances — end up being stored behind the check dams. Unlike a pond of water which lies level behind a dam, the surface of the debris cone forms a gradient which is 0.7 of the original gradient of the channel (fig. 6). The 0.7 value was obtained from projects in the Alps and has been verified in profiles taken of channels in the Los Angeles River basin. The debris cone is very stable at the spillway, but fluctuates at the upper end. Figure 7 shows a debris cone in a side channel (background) and the upper end of a debris cone (foreground) from a check dam which is further downstream.

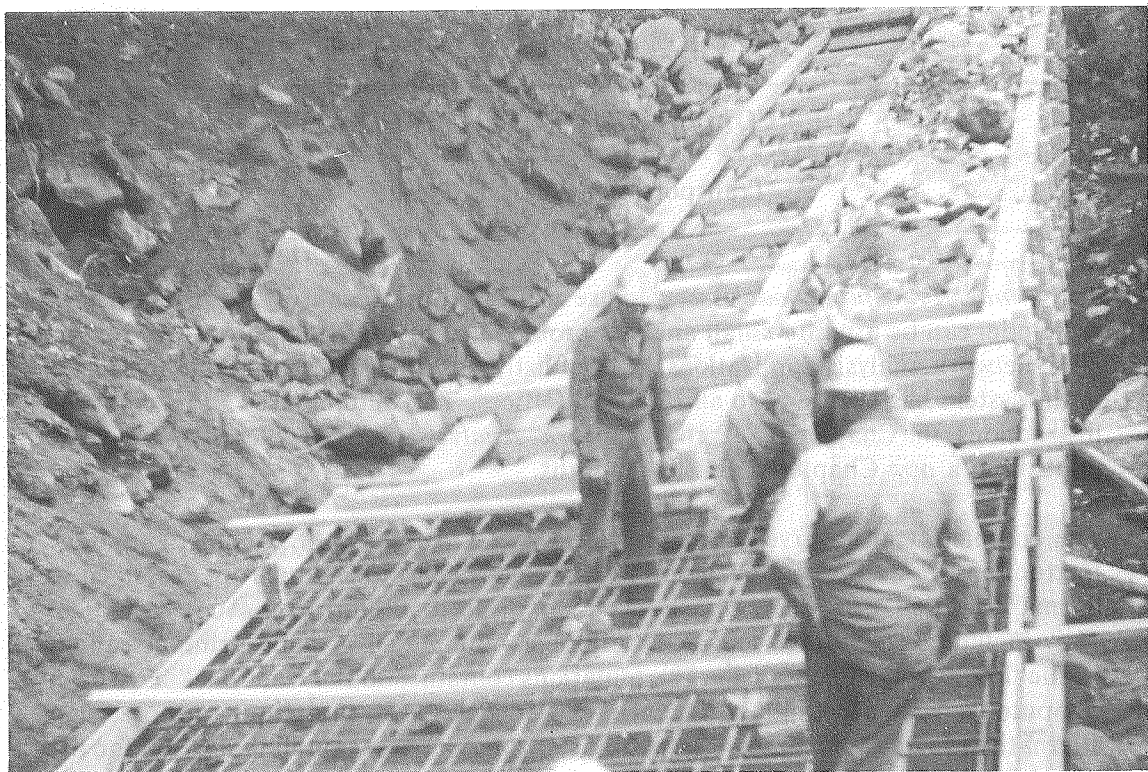
*Figure 14. — Construction of step slab.*

Cribs are placed to form bays and are filled with cobble rock or native fill. They are filled in 4-foot high lifts. Backfill is placed in the lifts behind the dam (figs. 12 and 13). This prevents the cribs built on a batter (fig. 8) from sliding. Concrete is placed between the end bays and the canyon walls to form abutments. When the distance between the bay and the canyon wall becomes 6 feet wide, a slab is placed on top of the concrete abutment and another bay of cribs is placed above the slab. This is called a step slab (fig. 14).

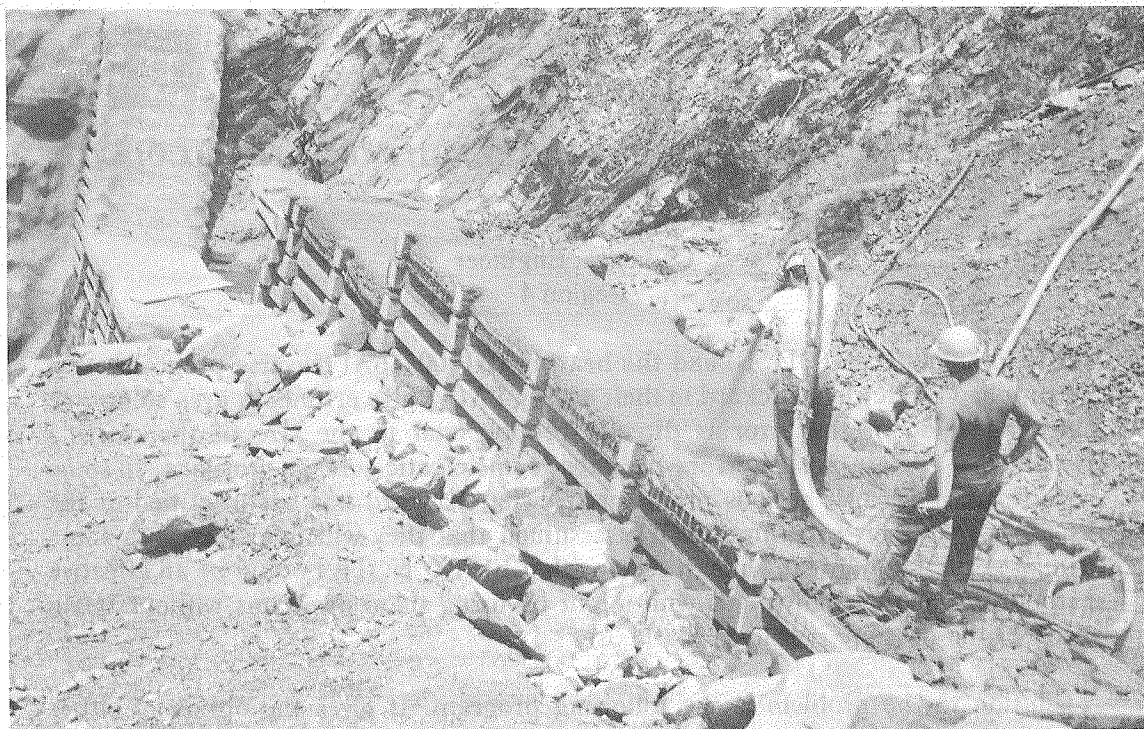
*Figure 15. — Guniting top of dam.*

After the dam has been erected a gunite cap is applied to the crest and the abutments (fig. 15).
