**ENGINEERING
TECHNICAL
INFORMATION
SYSTEM**

VOLUME 9 NUMBER 3

The Problems of Using Standard Specifications
Without Adjusting for Specific Design Conditions

Polypropylene Fabric as a Reinforcement of Muskeg
Subgrades in Road Construction

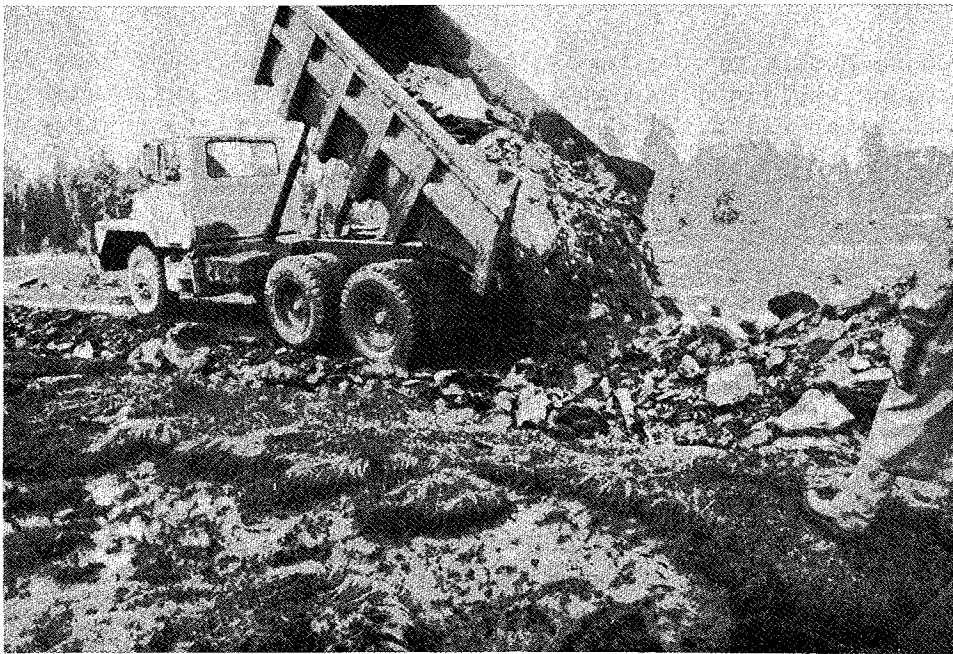
Figure 3. End dumping pit-run rock. The area shown illustrates the results of a typical bearing capacity failure. Severe subsidence of the road embankment and upheaval of the adjacent muskeg occurred immediately. Note the lack of water on the unvegetated muskeg in the foreground; that bare area had about 6 inches of groundwater covering it immediately prior to end dumping.

The overlay construction techniques are illustrated in figures 3 and 4. A Cat-loader (Model 977L) with a gross weight of 41,000 pounds was used for spreading the rock embankment, while dump trucks (tandem axle/dual wheel) with a gross weight of 80,000 pounds were used for hauling the rock. Figures 5 and 6 summarize the as-built conditions of the road. For a more detailed discussion of the techniques, see footnote².

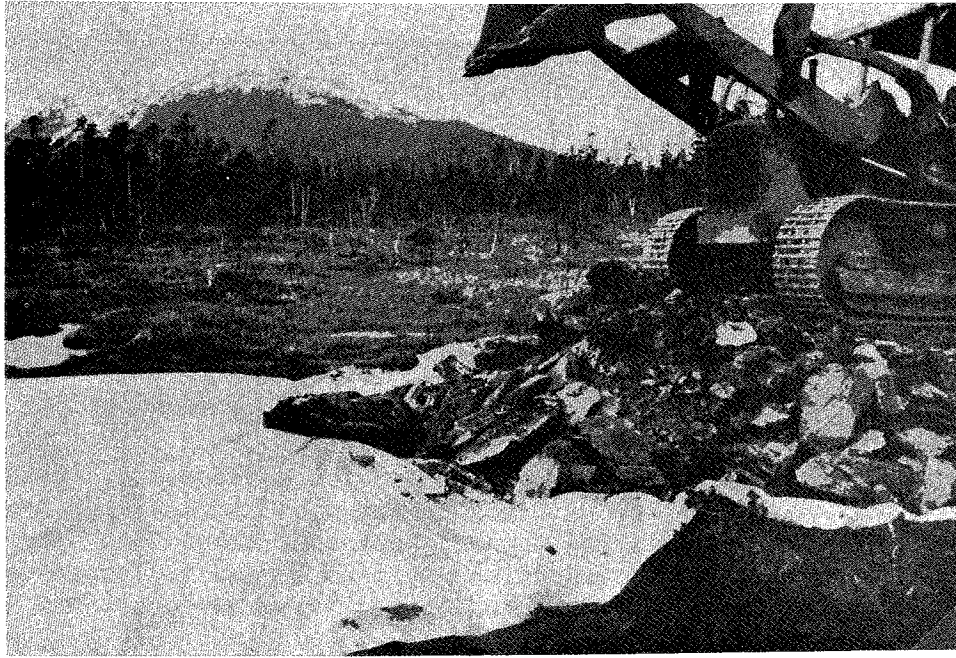
Figure 4. Spreading the pit-run rock.
