Engineering Field Notes

Engineering Technical Information System

25th Anniversary – Historical Articles	1
“Watts” Happening in Energy Conservation: Tips for Saving Energy in Facilities, Part III	5
Canyon Creek Bluffs Rock Slope Stabilization Sweet Home, Oregon	9
The Marking of a Man	31
Chunkwood Roads	39
Evaluating GPS in a Dense Tree Canopy	43
Barrier Free Accessible Trail Surface Materials—Northern Region Materials Engineering Investigations	53

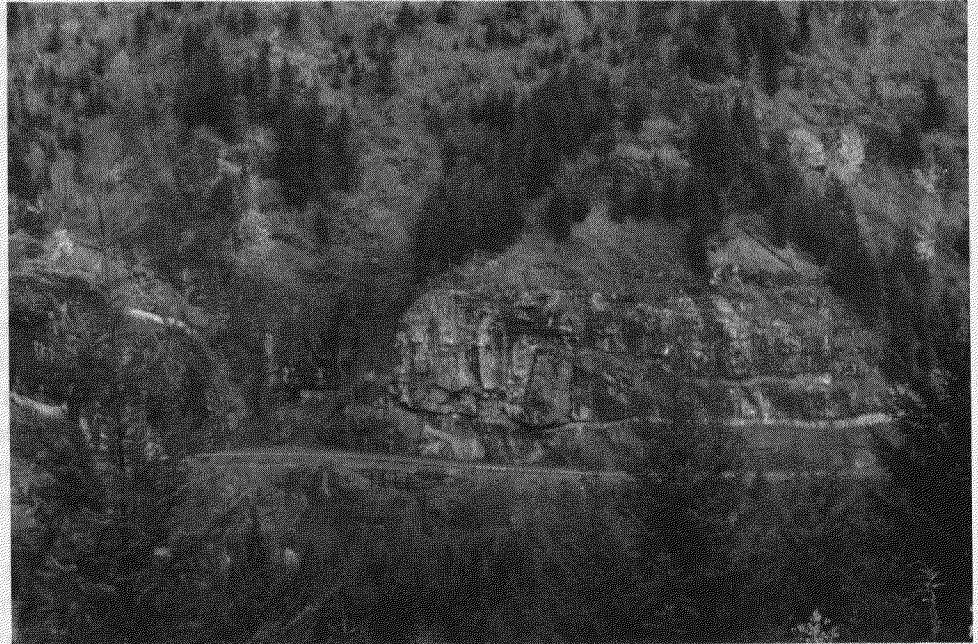
The bluffs are composed of a series of Miocene basalt flows, overlying and interbedded by lapilli tuff (Walker and Duncan 1989; Baldwin 1981). The road cut through the section forms rock slopes from 40 to 130 feet in height with slope angles ranging from 70° to overhanging (figure 2).

Figure 2.—The Canyon Creek Bluffs.

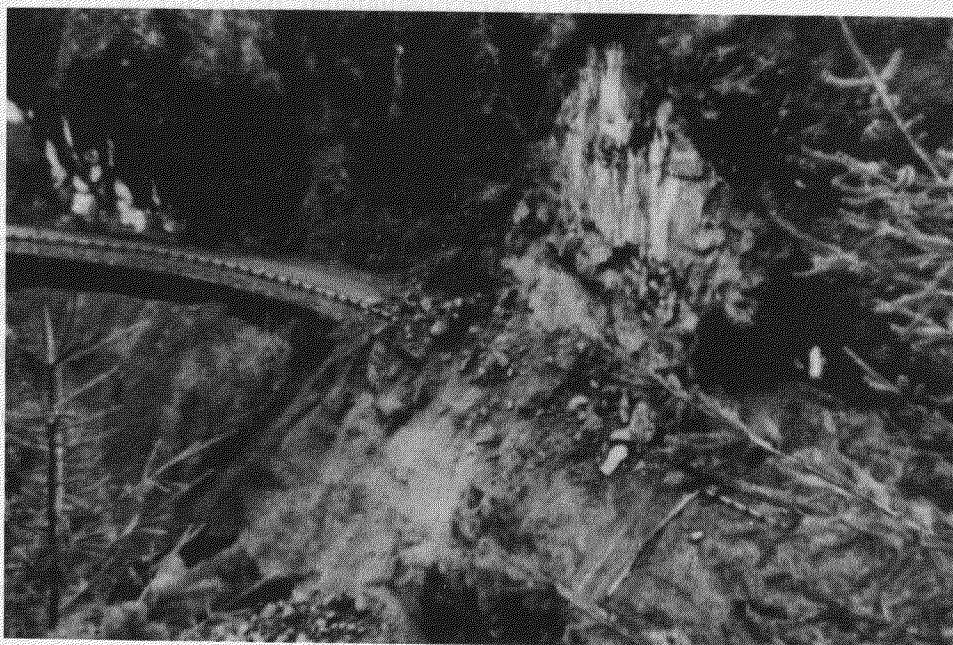
In 1985, approximately 2,000 cubic yards of the overhanging rock slope failed, destroying the road prism and the southern retaining wall. Rock and soil were deposited for approximately 200 feet below the road and into Canyon Creek (figure 3). This material was removed and the

Figure 3.—1985 slope failure.

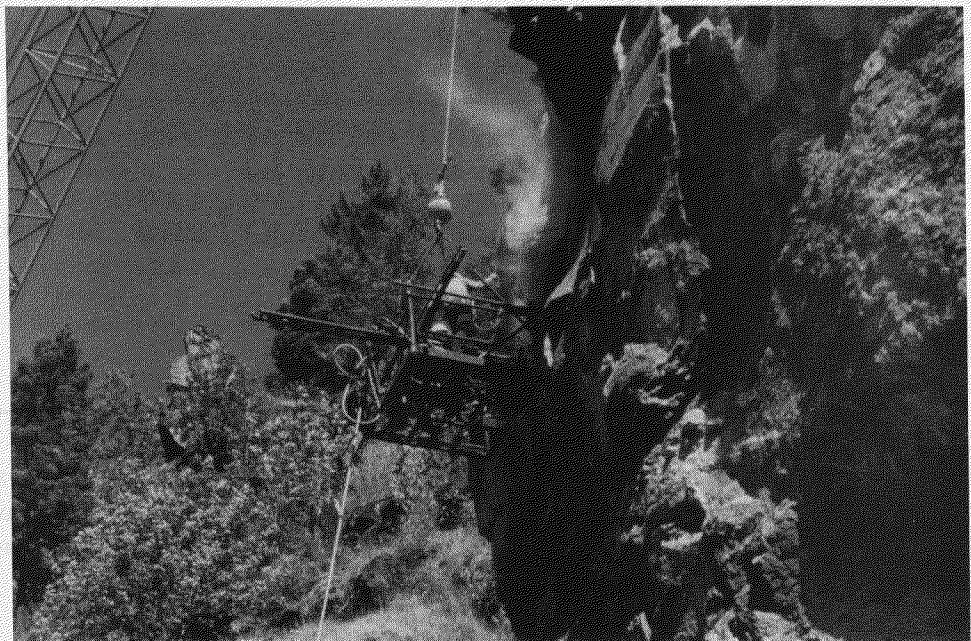
Continental Drilling used a 75-ton crane with a 150-foot boom to raise the drill and lift basket. A pneumatic rotary-percussion drill was mounted in a lift basket. The crane was able to lift the basket to practically any location on the slope (figure 9).

Figure 9.—Lift basket and drill used to install rock bolts.

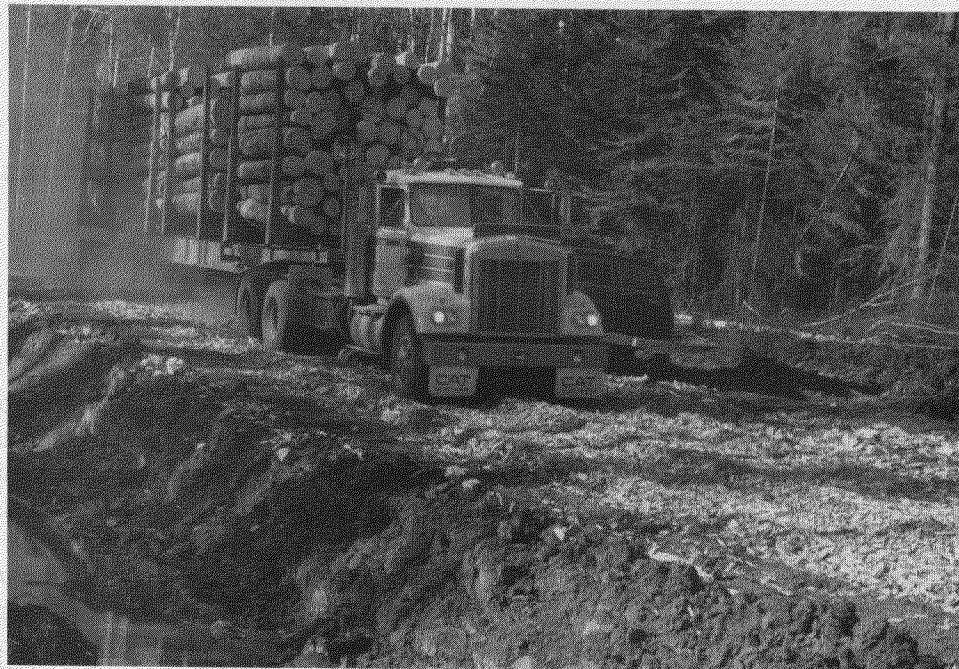
Figure 1.—Chunkwood used on a temporary road.

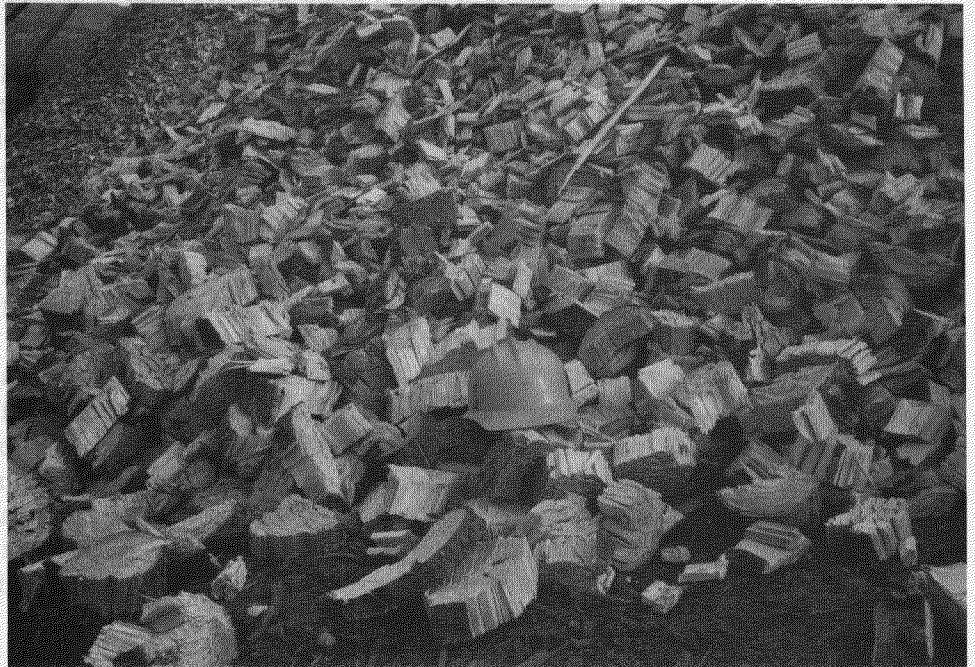
Figure 2.—Typical chunkwood particles.

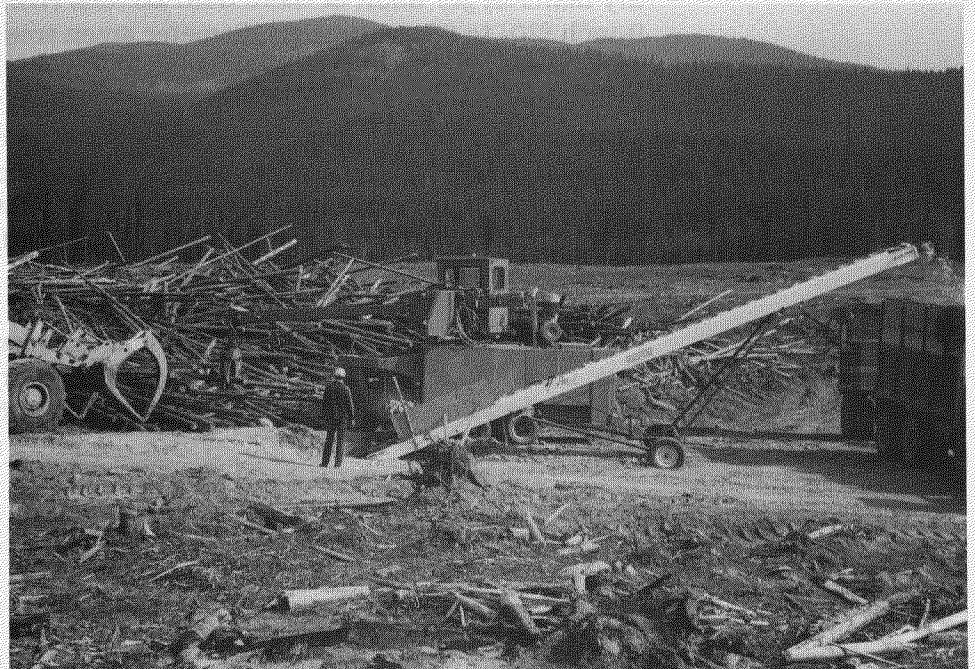
Chunkwood does have other applications. The MTDC chunker can be used to help remove slash and other debris (figure 3). Chunking this material will reduce potential fire hazard and remove unacceptable residue.

Figure 3.—The MTDC chunker.

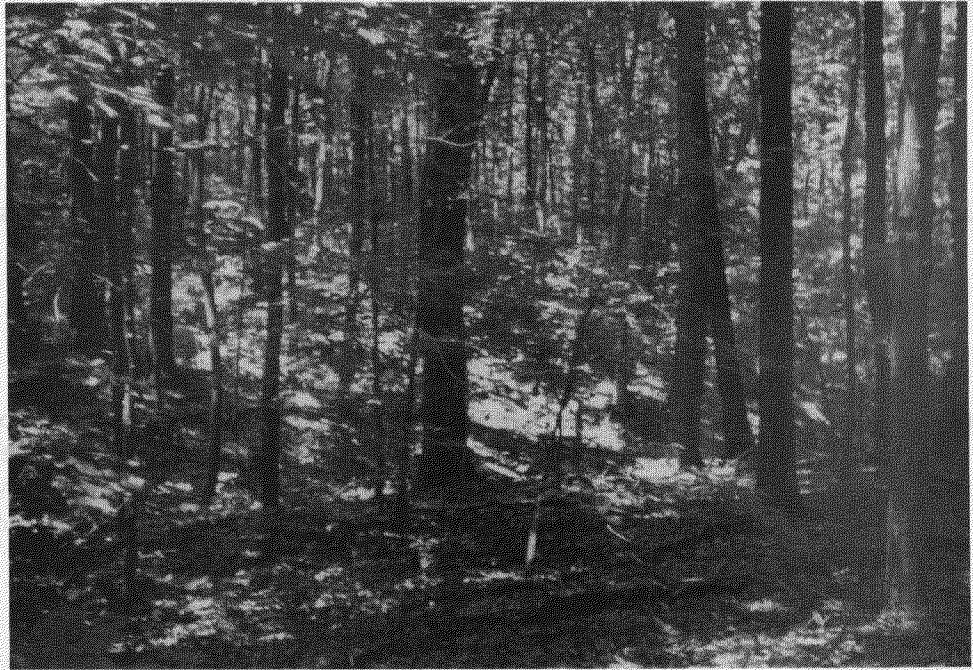
Data collection under dense canopies has been a longstanding problem for GPS users (figure 1). The receiver encounters a multitude of signal conditions that affect its operation. The signal can be fairly strong where no foliage interferes with it, or it can be completely blocked. It can also be anywhere in between and vary to both extremes from second to second. The amount of foliage in the signal path can change rapidly due to movement from the wind. Small movements of the antenna and movement of the satellite also affect the signal. As the signal gets weaker, the receiver has a harder time tracking it and consequently starts picking up noise, causing a degradation in position accuracy. Thus, improvements in the signal tracking ability of the receiver are expected to greatly improve the operation efficiency and accuracy under the canopy.

Figure 1.—Typical dense forest canopy.
