# *ABBREVIATED PRELIMINARY ASSESSMENT*

# *NEW YORK MINE*

Wallowa-Whitman National Forest
Grant County, OR

August 2006

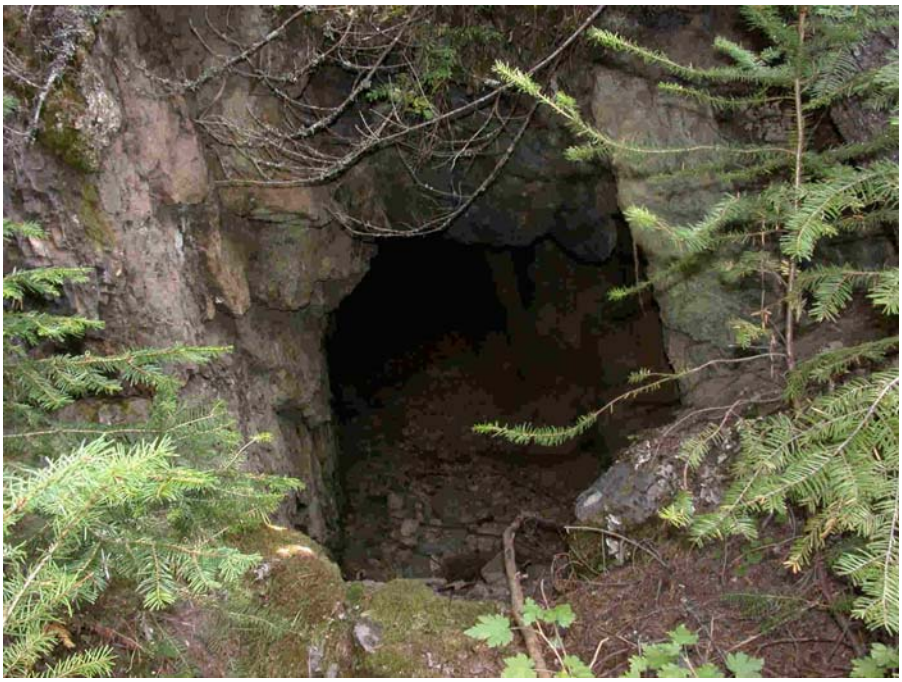
- Standing water was observed within the adit, but no seepage was observed.
- Adit #5
    - Lat/Long: 44° 50’ 40”N/118° 24’ 14”W
    - This adit is open and posses a safety risk.

Photo 17. Portal (Adit #5). Lat/Long: 44° 50’ 40”N/118° 24’ 14”W
(Photo by D. Boles)
