January 12, 2018 20170115

Focused Site Inspection for the Cabins Area
Mammoth Mill Site
Mono County, California

Enclosure 3. Photographic Log

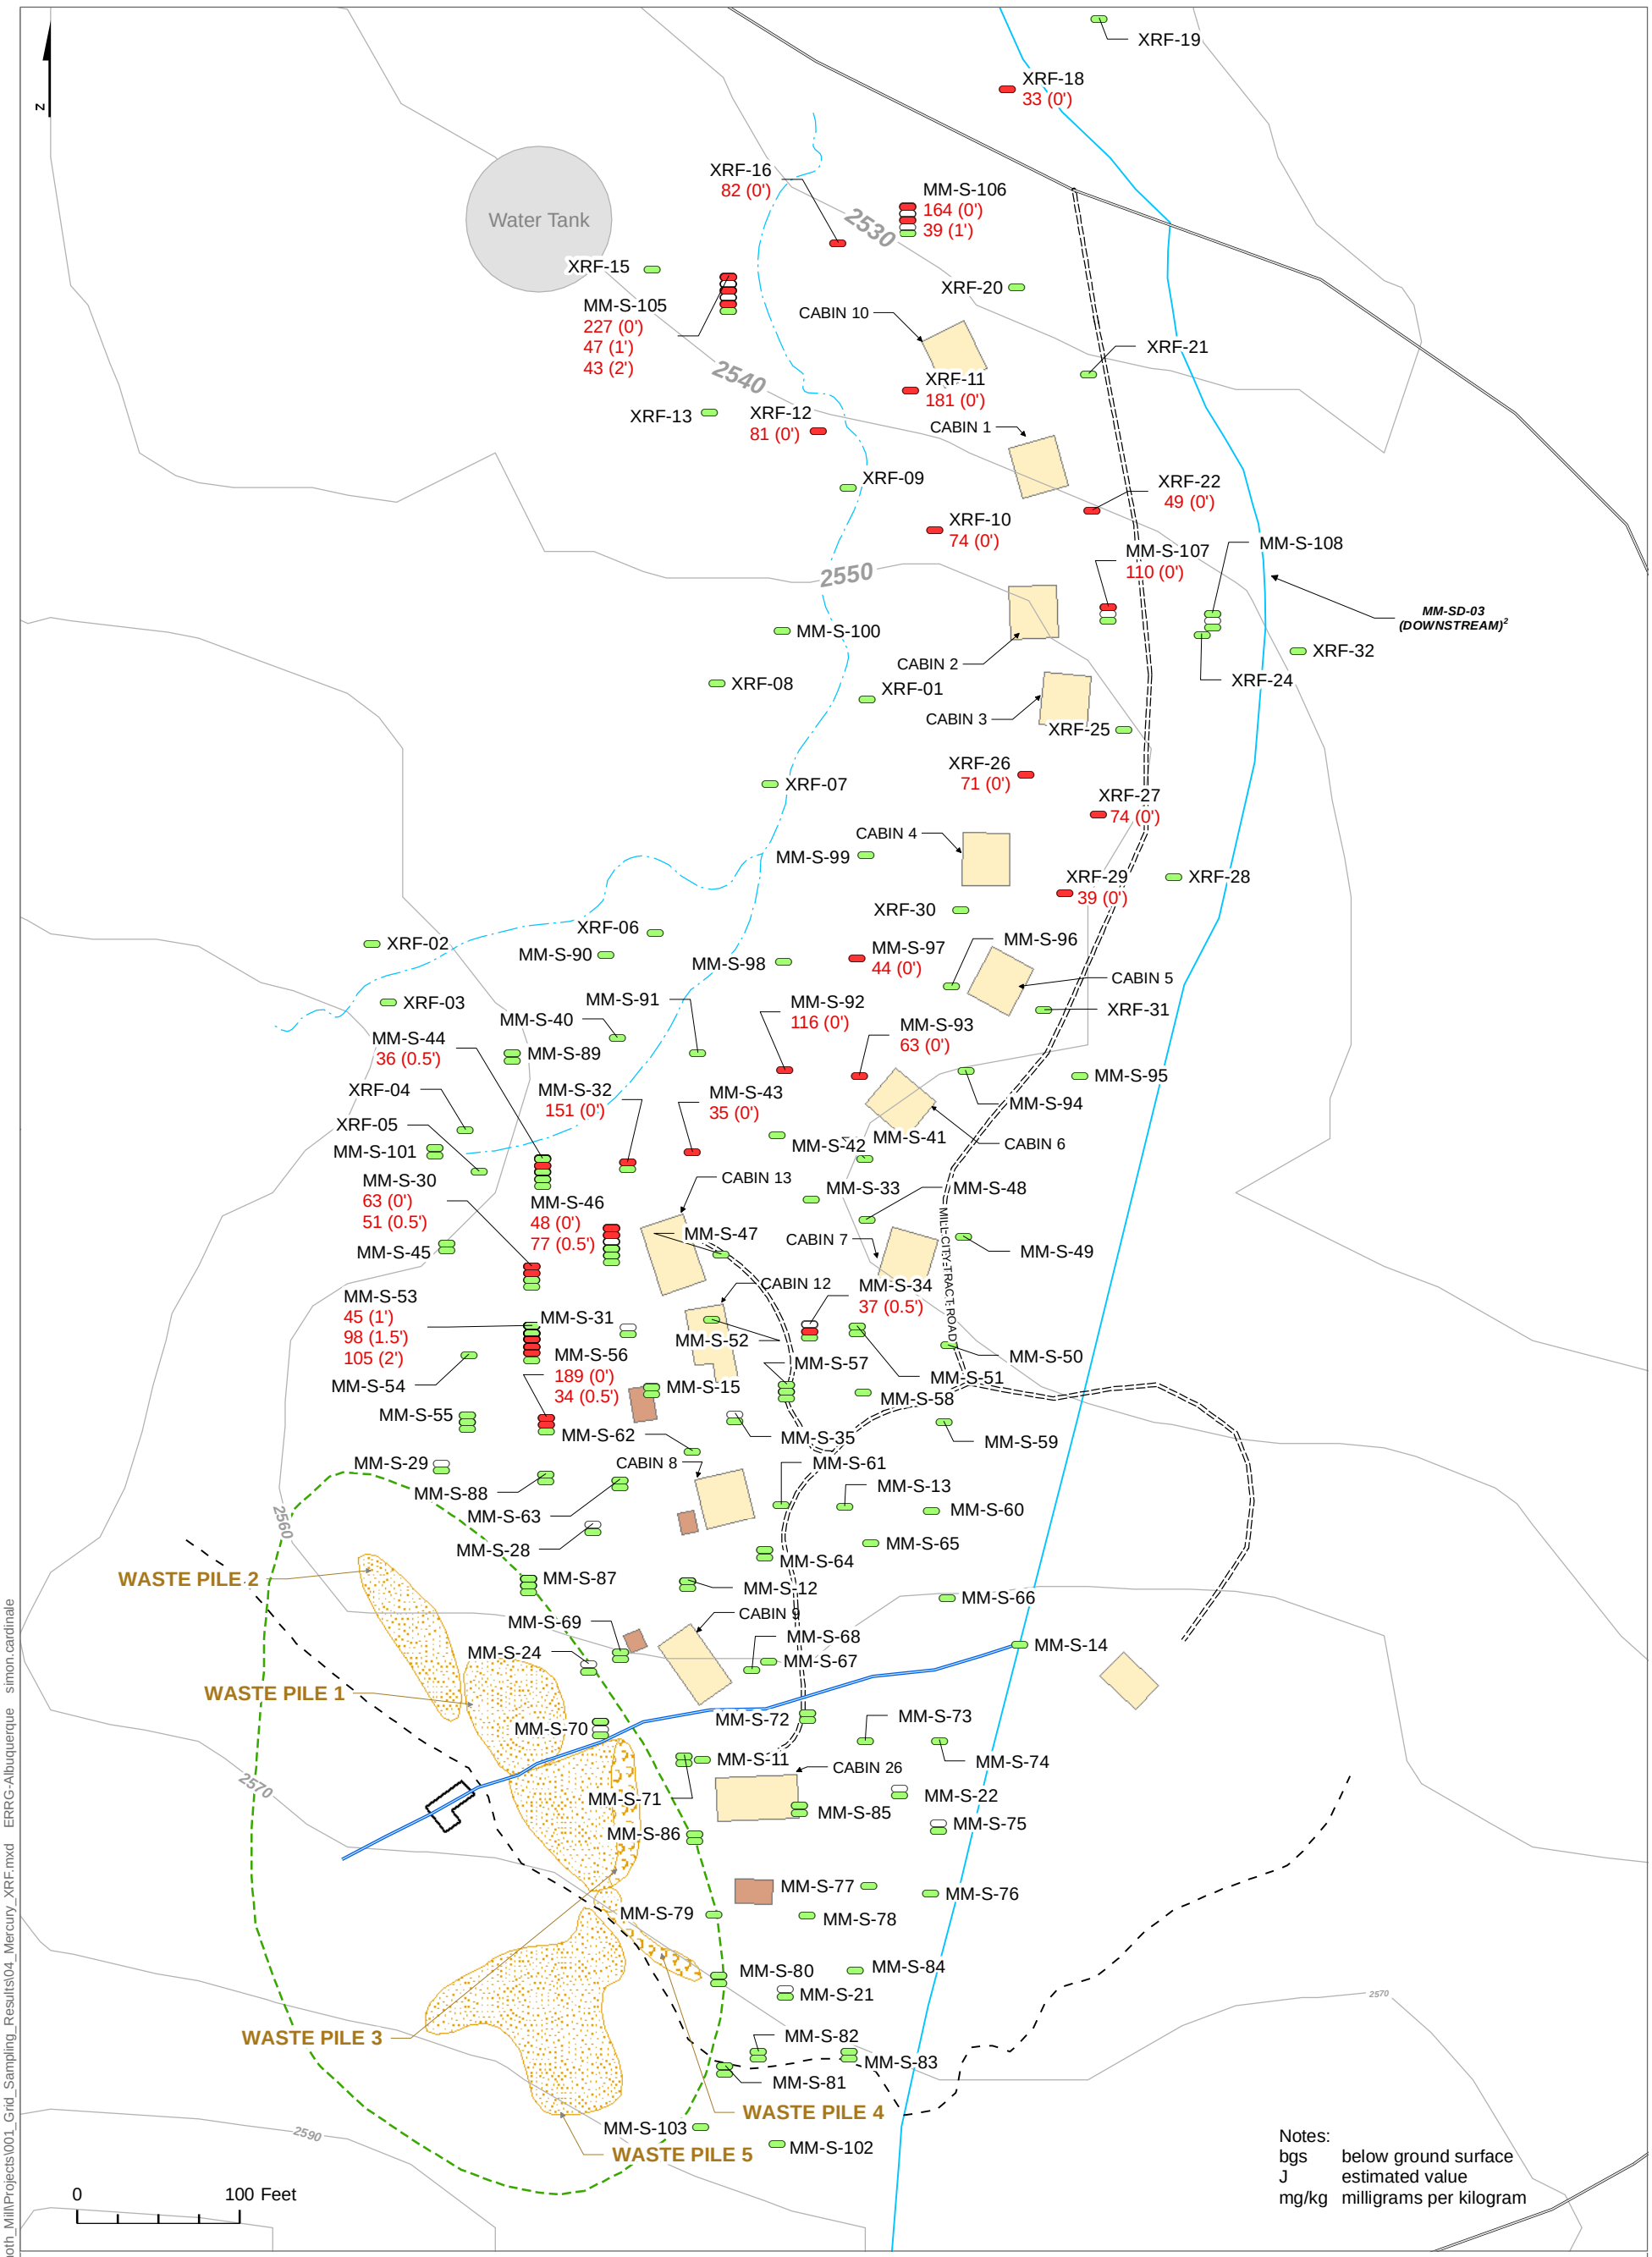
Figure 2. Mercury X-Ray Fluorescence Readings

Table 1 (Enclosure 2) and Figures 2 through 5 (Enclosure 1) present all XRF and laboratory data results.

ERRG screened all XRF and laboratory data against the established cleanup goals for the site as presented in Table 1 (Enclosure 2) and Figures 2 through 5 (Enclosure 1). Data were then evaluated to estimate the

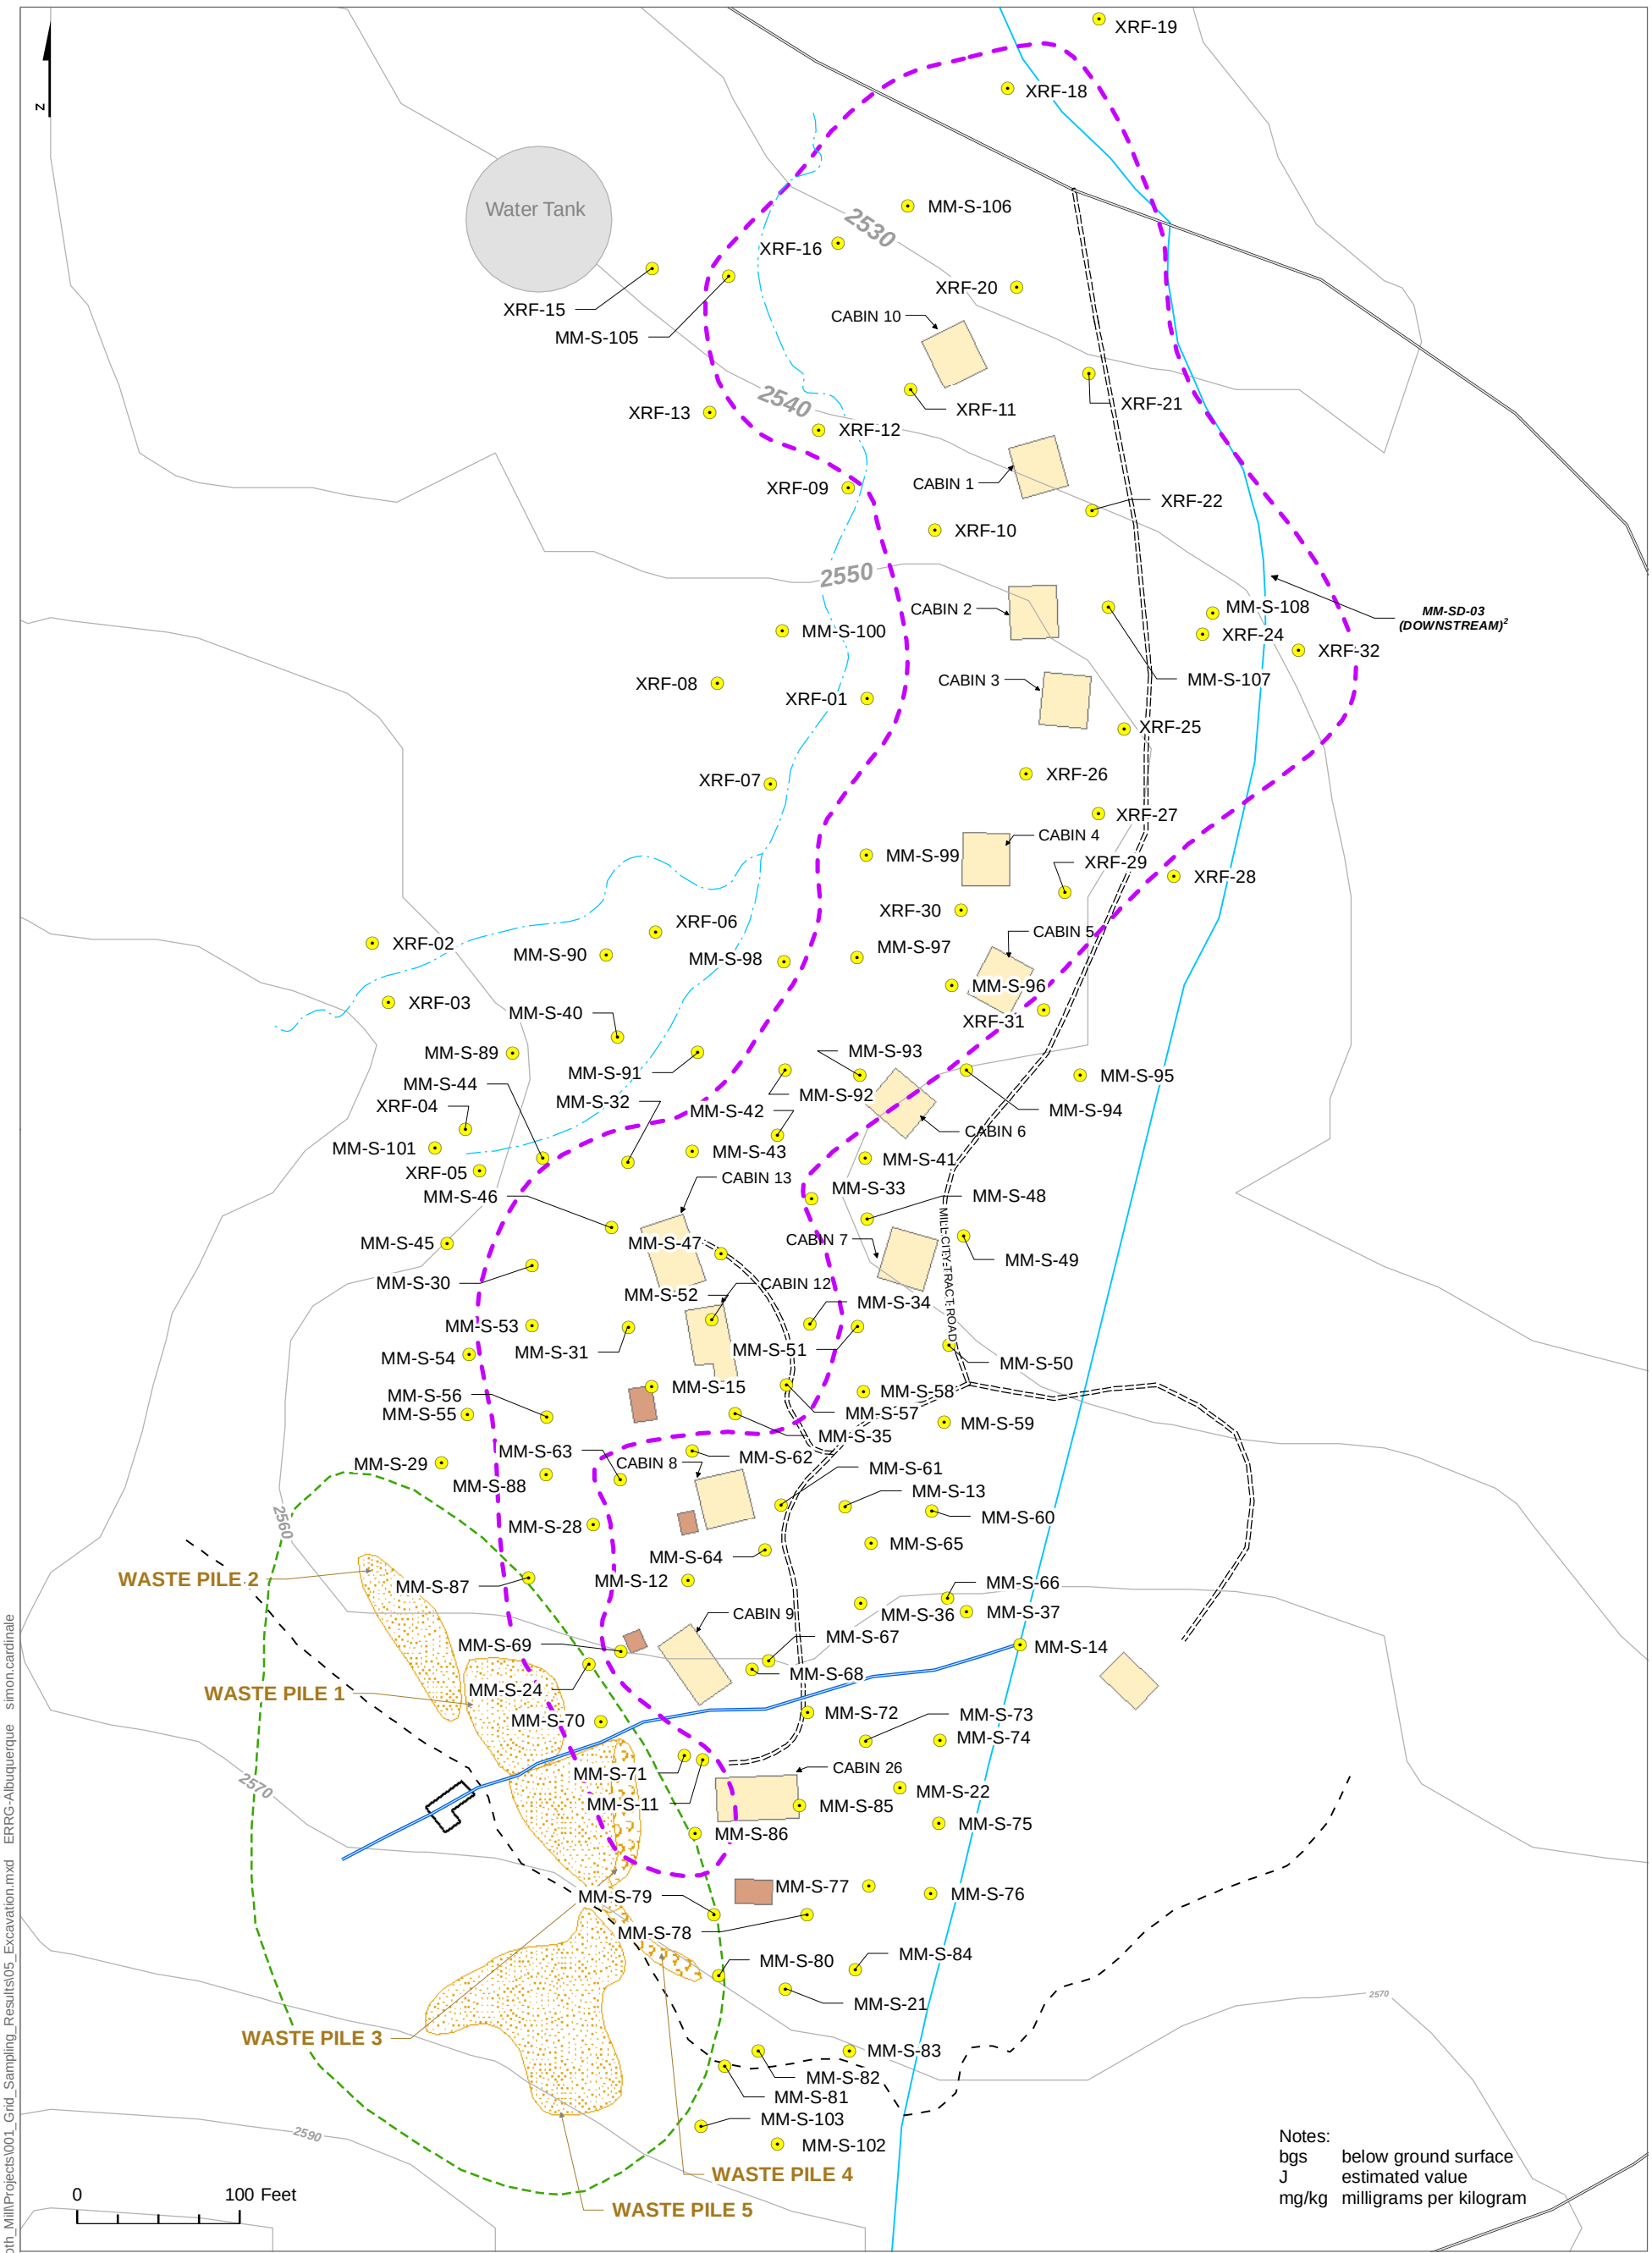
Figure 6. Approximate Extent of Excavation Area

The resulting removal area is shown on Figure 6 (Enclosure 1).

The removal area comprises approximately 205,694 square feet (Figure 6; Enclosure 1). Assuming an average depth of 1.5 feet across the area, this corresponds to a removal volume of approximately 11,427 cubic yards (note: this includes approximately 420 cubic yards contained within the previously designated Mill Area, but that overlap with the area of the cabins).

The lateral and vertical extent of impacted soil in the area from approximately Cabin 13 and south is considered well defined. Because only six subsurface laboratory sample locations are available for the area north of Cabin 13, the northern portion of the removal area is not considered well delineated laterally or vertically.

To fully delineate the northern portion of the removal area, additional sampling should be considered. In the event that additional delineation sampling is not completed prior to removal activities, a confirmation sampling and over-excavation approach should be included in the removal action work plan.
