BUILDING INFORMATION SHEET

Facility: Ashland R.S.
Date: 9-1-93
Building Name: Forester's Garage
Building Number: 1500
Inspector: YAM
Page:

Ashland R. S. – Forester Garage

USDA Forest Service
Custer National Forest

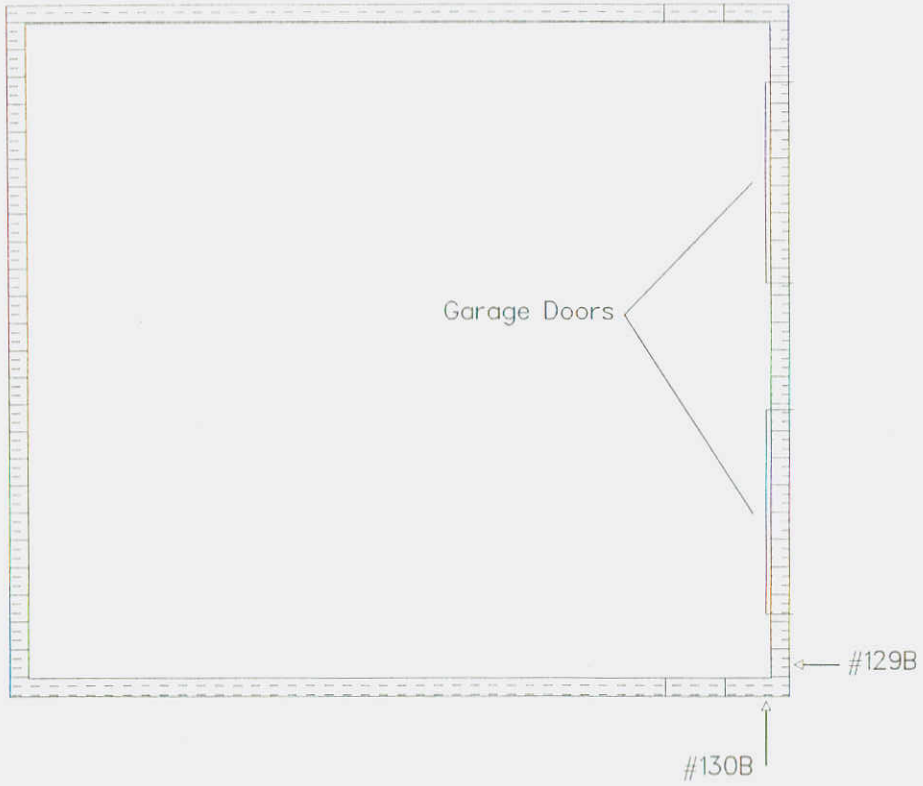
ACM – Siding
