VISUAL CONTRAST RATING WORKSHEET

1. Project Name: GARKANE EIS
2. Key Observation Point: (#1) US 89 - NORTH OF HATCH
3. VRM Class: III
4. Location
   Township: 36 S
   Range: 5 W
   Section: 10
5. Location Sketch

1. Project Name: GARKANE EIS

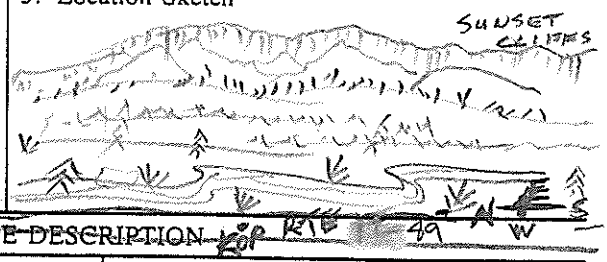
STRONG form contrasts as it approaches US 89 scenic highway, dominating the view of southbound passengers. Silhouette effects would be obvious to casual viewer

(1) edge feathering to reduce line + color contrasts from transmission line cleared areas:

(2) preserve low-lying vegetation within line safety area to reduce line + color contrasts

(3) topographic hiding wherever possible within ROW to reduce form contrasts

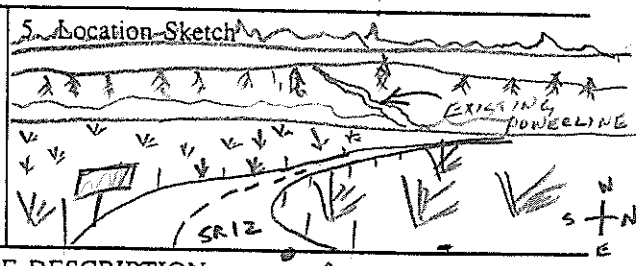
Existing surface disturbances would reduce impacts of new disturbance, the viewing distance to new ROW T line would mitigate some line, form, color, texture impacts along SR 12. Probably attract attention, but not dominate the view

edge-feathering, irregular thinning and low, visually debris left on distant ROW cut would reduce impacts on the forested slope
