Culvert Scour Assessment

Inter-Fluve, Inc.,

U.S. Forest Service

October 2009

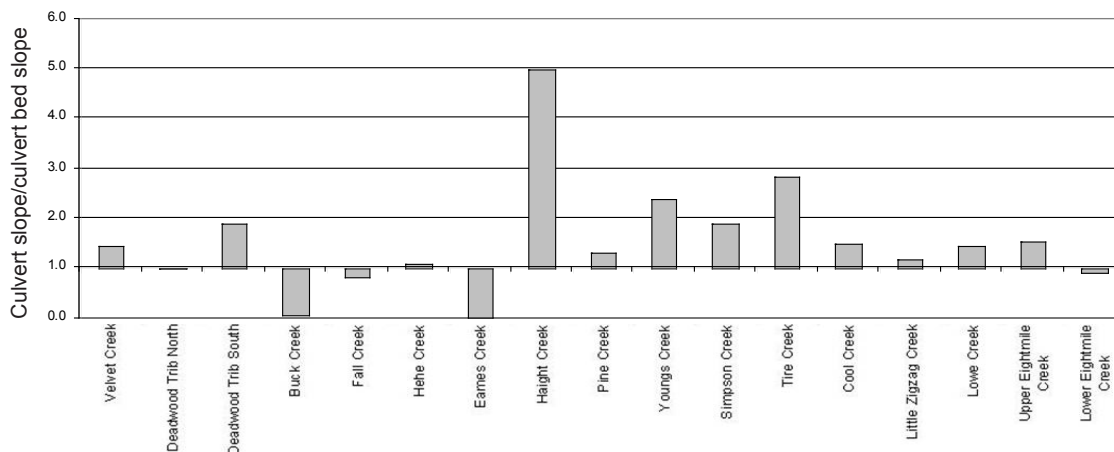
A common condition found at many of the sites is the adjustment of the channel bed post installation. Survey measures indicate that many sites have culvert beds that have a flatter slope than the culvert structure itself. Assuming that culvert beds were originally constructed at the same slope as the culvert structure, these sites have adjusted since installation through inlet scour, aggradation in the downstream portion of the pipe, or a combination of the two. At many sites, bed degradation at the upstream portion of the pipe and aggradation of material in the downstream portion were clearly visible. Figure 3.4-1 shows the incidence of culvert-bed flattening among all sites.

Figure 3.4-1. Ratio of culvert slope to culvert-bed slope. Culvert slope is the slope of the actual culvert structure. Culvert-bed slope is the slope of the thalweg profile through the culvert.

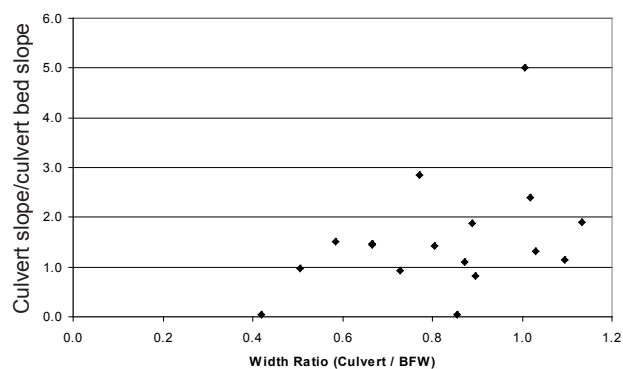
The occurrence of culvert-bed flattening was plotted against the width ratio in order to evaluate the effect of culvert widths on culvert-bed slope (figure 3.4-2). This comparison shows no relationship between culvert-bed adjustment and culvert width as it related to bankfull width. There is no relationship present, suggesting that different culvert widths have little effect on culvert bed slope adjustment.

Figure 3.4-2. Relationship of culvert slope/culvert-bed slope ratio to the width ratio.

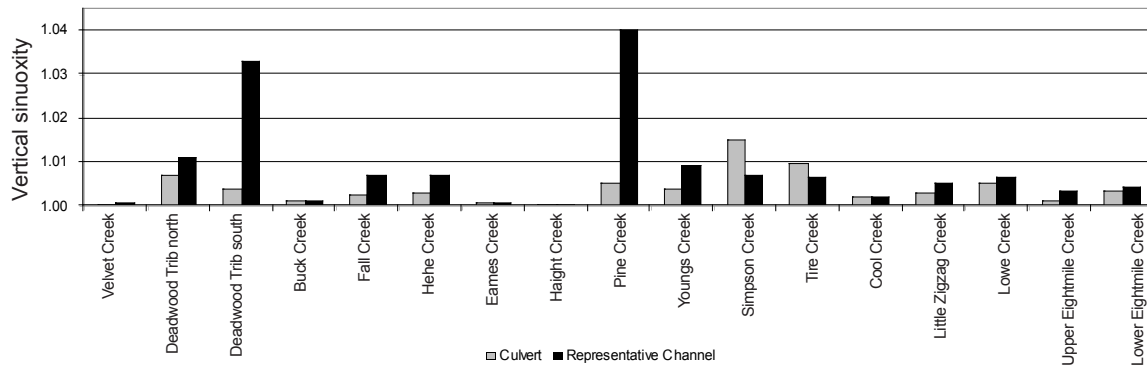
Vertical sinuosity and residual depth. Vertical sinuosity in the natural channel was consistently greater than that in the culvert except for Simpson Creek and Tire Creek, where culvert-bed sinuosity was greater (figure 3.5-1). This indicates that, in nearly all cases, the culvert beds reviewed have less complex bed topography than their corresponding natural channels. Values generated in the profile complexity analysis are included in appendix A.

Figure 3.5-1. Vertical sinuosity in the culvert and natural channel at each study site. For sites with more than one reference segment, the vertical sinuosities were averaged. Reference channel values are significantly greater than the culvert values using a one-tailed paired t-test ($\alpha = 0.05$).

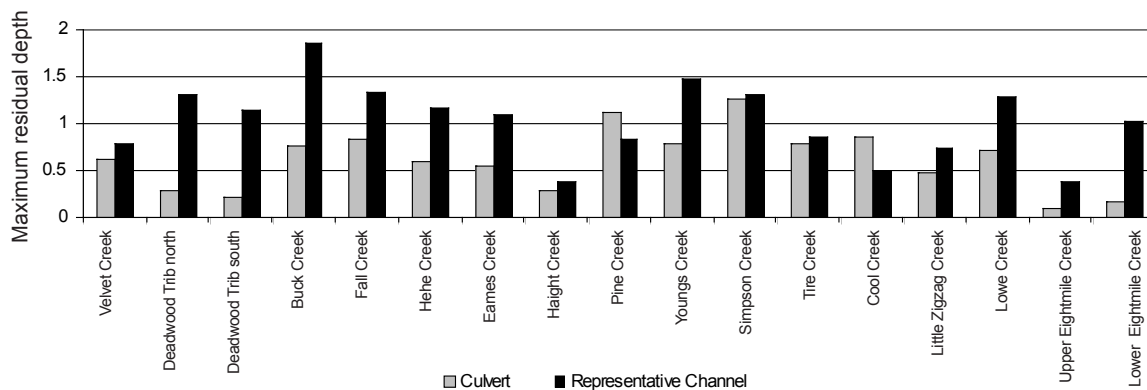
Maximum residual depth is greater in the natural channel than in the culvert for all but two sites; Pine Creek and Cool Creek (figure 3.5-2). On average, maximum residual depth in the culverts reviewed was about 0.6 that of the natural channel. This is consistent with the results of the vertical-sinuosity assessment. Greater pool depths would generally be associated with greater vertical sinuosity. Values generated in the residual-depth analysis are included in appendix A. Factors contributing to similarities and differences in residual depths at individual sites are discussed in the site evaluations in appendix A.

Figure 3.5-2. Maximum residual depth in the culvert and natural channel. For sites with more than one representative natural channel segment, the residual depths were averaged. Values for culverts and reference channels are significantly different using a paired t-test at $\alpha = 0.05$.

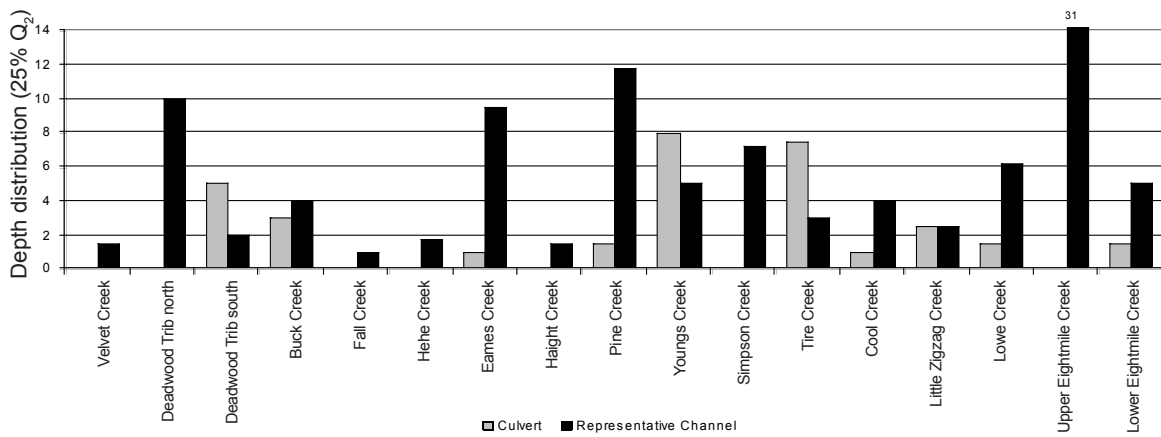
Depth distribution. At the 25-percent Q_2, the depth distribution analysis showed that at least one cross section in the culvert had less available shallow water habitat at 13 of 17 sites. The following sites had at least one cross section with depth-distribution values within or greater than the range found in the natural channel: Tire Creek, Buck Creek, Little Zigzag Creek, Deadwood Tributary South, Fall Creek, Lowe Creek, Lower Eightmile Creek, Pine Creek, and Youngs Creek.

Figure 3.5-3. Depth distribution results for all sites. Bars depict the number of cross-section increments with depths less than 0.3 feet.

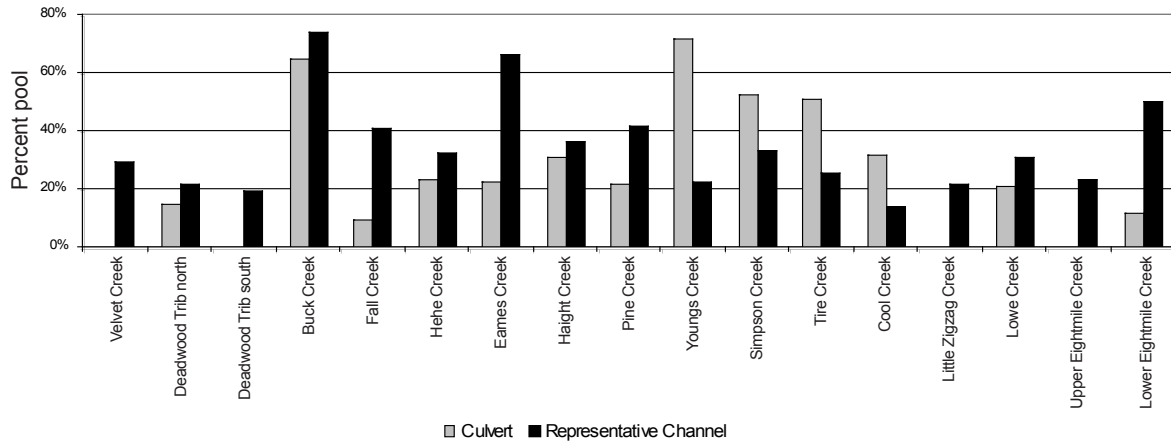
Channel units and LWD. The distribution of channel-unit types differs between culverts and natural channels. In general, pools and steps are more common in natural channels, riffles are about equally as common in natural channels and culverts, and glides are more common in culverts. Percent pool values for all sites are displayed in figure 3.5-4. Percentage of pools is greater in natural channels for 13 of 17 sites. Total habitat-unit composition results for all sites are included in appendix A.

Figure 3.5-4. Percent pool (as percent of total stream-surface area) of natural channels and culverts for all sites. For sites with two representative natural channel segments, percent pool values were averaged. Natural channel values are significantly greater than culvert values using a paired t-test (one-tailed) at α=0.10.

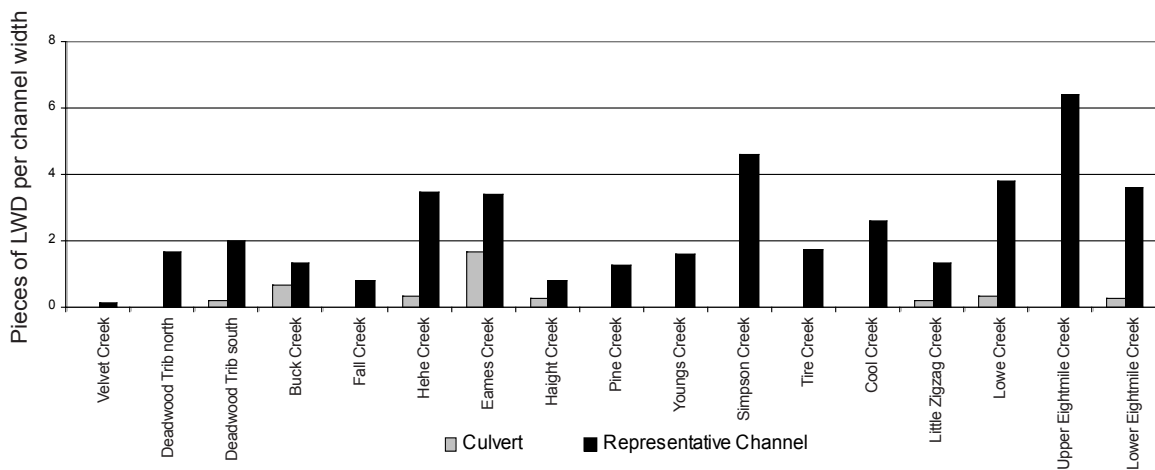
LWD loading is considerably different between the culverts and natural channels. In all cases, LWD per channel width is greater in representative channel segments (figure 3.5-5). The data from the LWD analysis is provided in appendix A. An LWD loading of two pieces per channel width is considered "good" according to the Washington State standards (WFPB 1997). Natural-channel segments in only six sites exceed this target, although several other sites have between one and two pieces per channel width. Wood is absent in most culverts, with only one or two pieces counted at seven of the sites.

Figure 3.5-5. Counts of LWD per channel width for culverts and natural channels. For sites with two representative natural-channel segments, LWD and channel-width values were averaged.

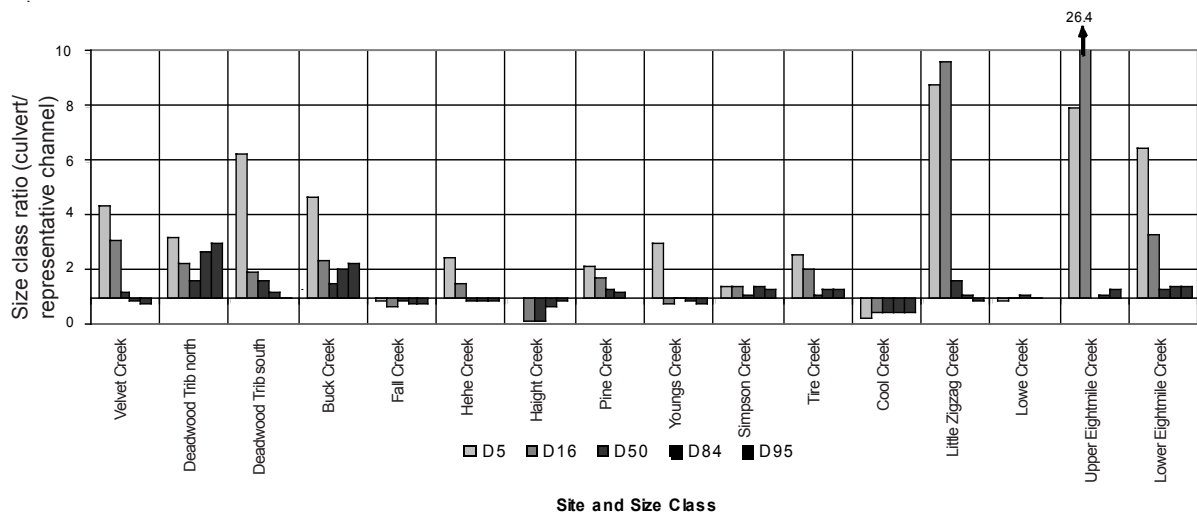
Figure 3.6-1. Size-class ratios for each site (culvert/representative natural channel). Data from pools are excluded.

Coarser bed material in culverts compared to natural channels is a ubiquitous condition measured at nearly all the study sites (figure 3.6-1). Differences in bed material size are most pronounced for the smaller grain sizes, with culverts typically having much less of the smaller material that is found in the natural channels. In some cases, the differences are severe, such as in Velvet Creek, Deadwood Tributary South, Buck Creek, Little Zigzag Creek, Upper Eightmile, and Lower Eightmile, where the size of the smaller size classes far exceed the natural channel conditions. Only Haight Creek and Cool Creek have culvert material that is significantly smaller than the representative channels. In Haight Creek this is likely the result of backwater influence from the mainstem Siuslaw River, which is a short distance from the culvert outlet.

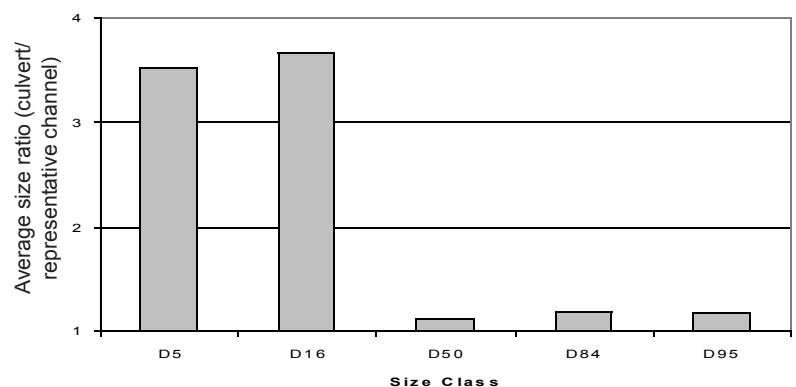
Figure 3.6-2. Ratios (culvert/representative natural channel) for a range of size classes.

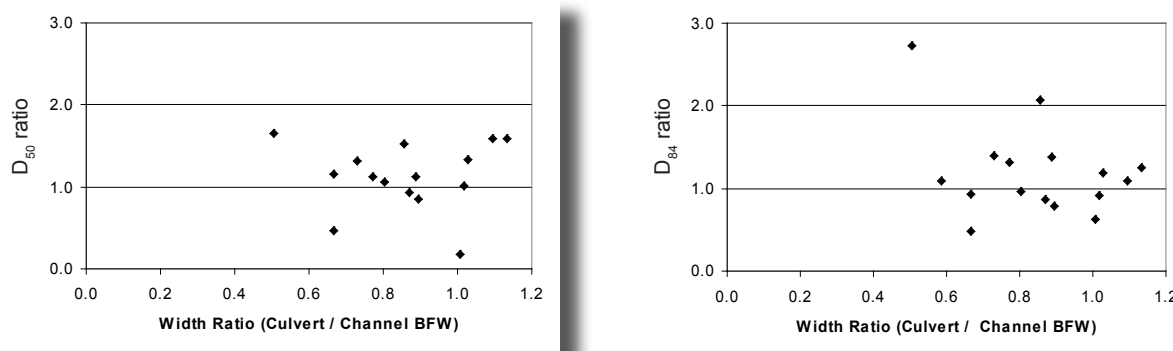
Substrate size ratios were compared to stream width ratios to see if culvert width had an impact on the size of material in the culvert. The width ratio did not appear to impact the size of the D_{50} or D_{84} (figure 3.6-3).

Figure 3.6-3. Effect of width ratio (culvert/natural channel bankfull width) on the D_{50} (left) and D_{84} (right) ratios. There are no significant correlations. Upper Eightmile Creek was removed as an outlier from the D_{50} analysis because of the effect of a large sand deposit on the D_{50} for the natural channel. Pebble-count data in pools are not included in these data.

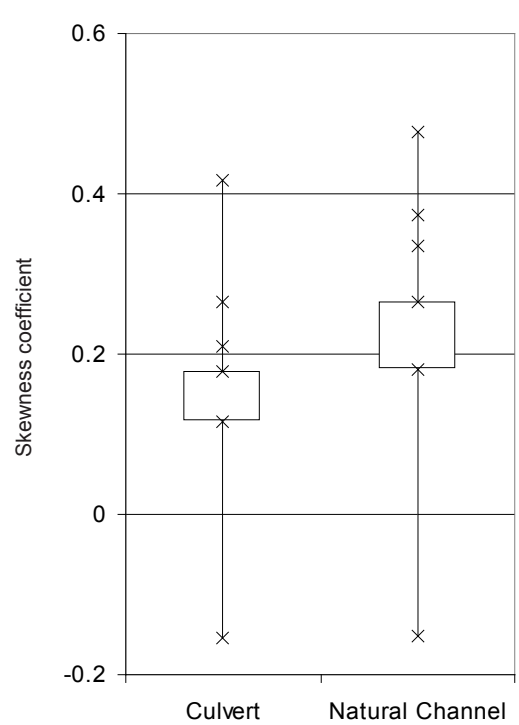
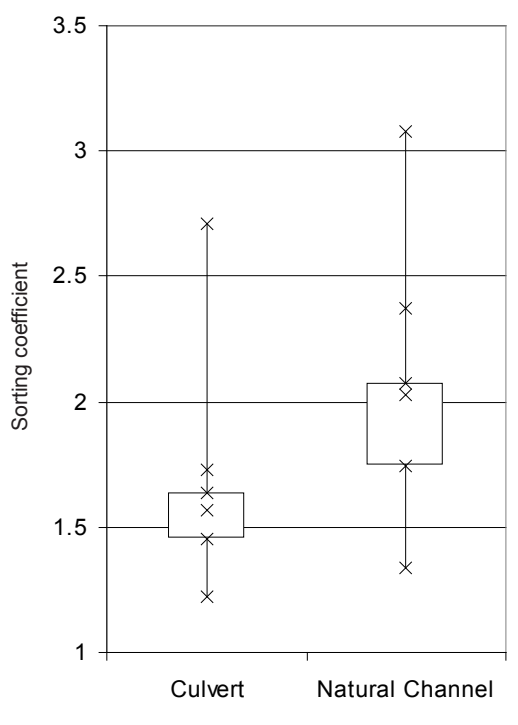
Figure 3.6-4. Box plots of sorting coefficients (left) and skewness coefficients (right).
