Culvert Scour Assessment

Prepared by:

Inter-Fluve, Inc.,

U.S. Forest Service

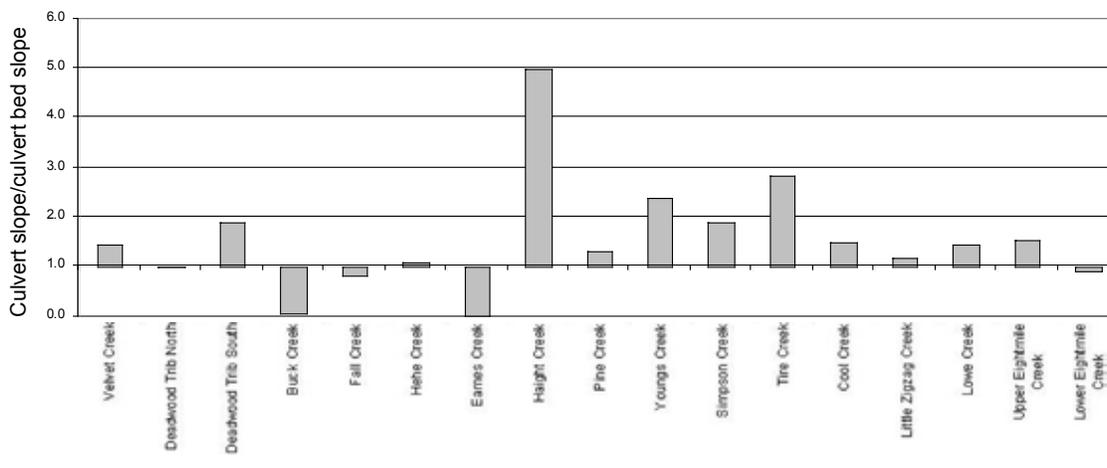
A common condition found at many of the sites is the adjustment of the channel bed post installation. Survey measures indicate that many sites have culvert beds that have a flatter slope than the culvert structure itself. Assuming that culvert beds were originally constructed at the same slope as the culvert structure, these sites have adjusted since installation through inlet scour, aggradation in the downstream portion of the pipe, or a combination of the two. At many sites, bed degradation at the upstream portion of the pipe and aggradation of material in the downstream portion were clearly visible. Figure 3.4-1 shows the incidence of culvert-bed flattening among all sites.

Figure 3.4-1. Ratio of culvert slope to culvert-bed slope. Culvert slope is the slope of the actual culvert structure. Culvert-bed slope is the slope of the thalweg profile through the culvert.

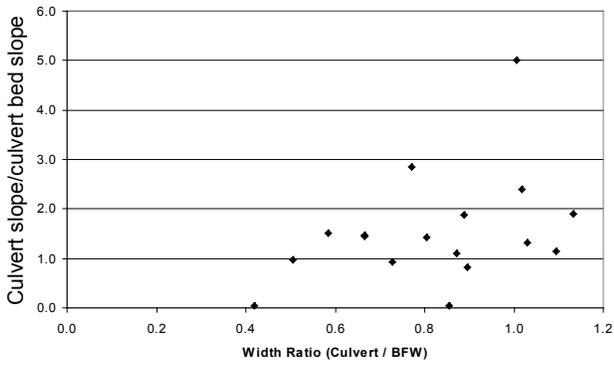
The occurrence of culvert-bed flattening was plotted against the width ratio in order to evaluate the effect of culvert widths on culvert-bed slope (figure 3.4-2). This comparison shows no relationship between culvert-bed adjustment and culvert width as it related to bankfull width. There is no relationship present, suggesting that different culvert widths have little effect on culvert bed slope adjustment.

Figure 3.4-2. Relationship of culvert slope/culvert-bed slope ratio to the width ratio.

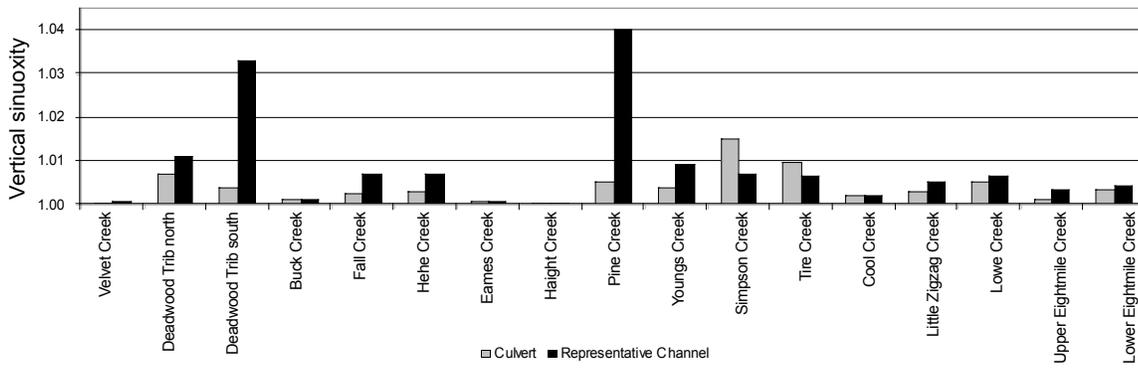
Vertical sinuosity and residual depth. Vertical sinuosity in the natural channel was consistently greater than that in the culvert except for Simpson Creek and Tire Creek, where culvert-bed sinuosity was greater (figure 3.5-1). This indicates that, in nearly all cases, the culvert beds reviewed have less complex bed topography than their corresponding natural channels. Values generated in the profile complexity analysis are included in appendix A.

Figure 3.5-1. Vertical sinuosity in the culvert and natural channel at each study site. For sites with more than one reference segment, the vertical sinuosities were averaged. Reference channel values are significantly greater than the culvert values using a one-tailed paired t-test (α = 0.05).

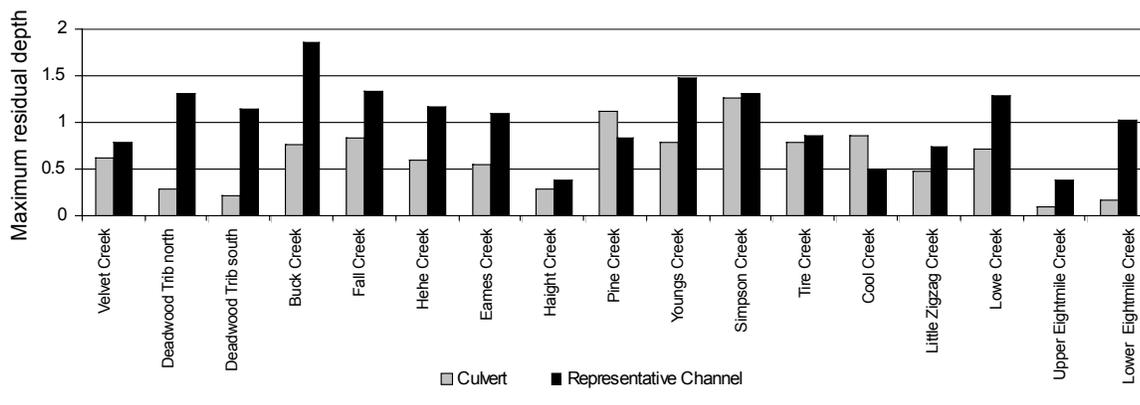
Maximum residual depth is greater in the natural channel than in the culvert for all but two sites; Pine Creek and Cool Creek (figure 3.5-2). On average, maximum residual depth in the culverts reviewed was about 0.6 that of the natural channel. This is consistent with the results of the vertical-sinuosity assessment. Greater pool depths would generally be associated with greater vertical sinuosity. Values generated in the residual-depth analysis are included in appendix A. Factors contributing to similarities and differences in residual depths at individual sites are discussed in the site evaluations in appendix A.

Figure 3.5-2. Maximum residual depth in the culvert and natural channel. For sites with more than one representative natural channel segment, the residual depths were averaged. Values for culverts and reference channels are significantly different using a paired t-test at α = 0.05.

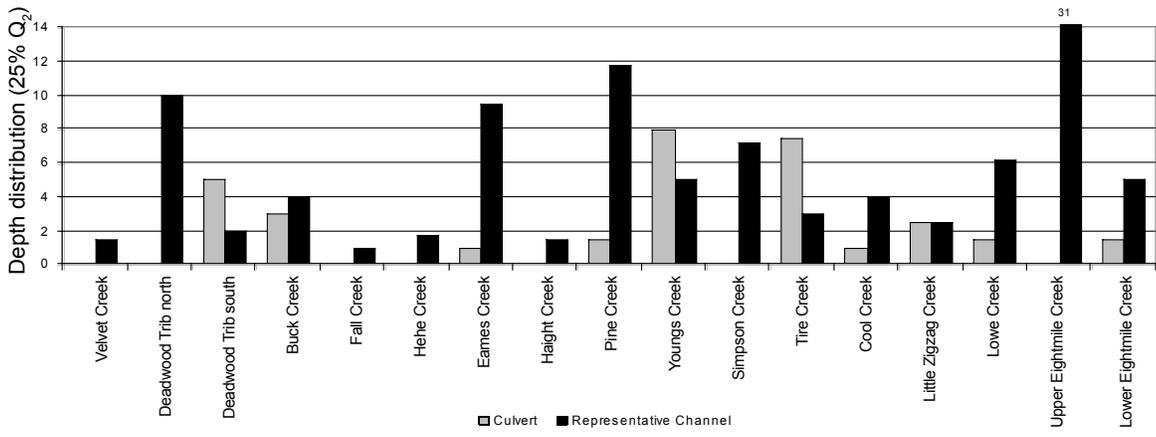
Depth distribution. At the 25-percent Q_2, the depth distribution analysis showed that at least one cross section in the culvert had less available shallow water habitat at 13 of 17 sites. The following sites had at least one cross section with depth-distribution values within or greater than the range found in the natural channel: Tire Creek, Buck Creek, Little Zigzag Creek, Deadwood Tributary South, Fall Creek, Lowe Creek, Lower Eightmile Creek, Pine Creek, and Youngs Creek.

Figure 3.5-3. Depth distribution results for all sites. Bars depict the number of cross-section increments with depths less than 0.3 feet.

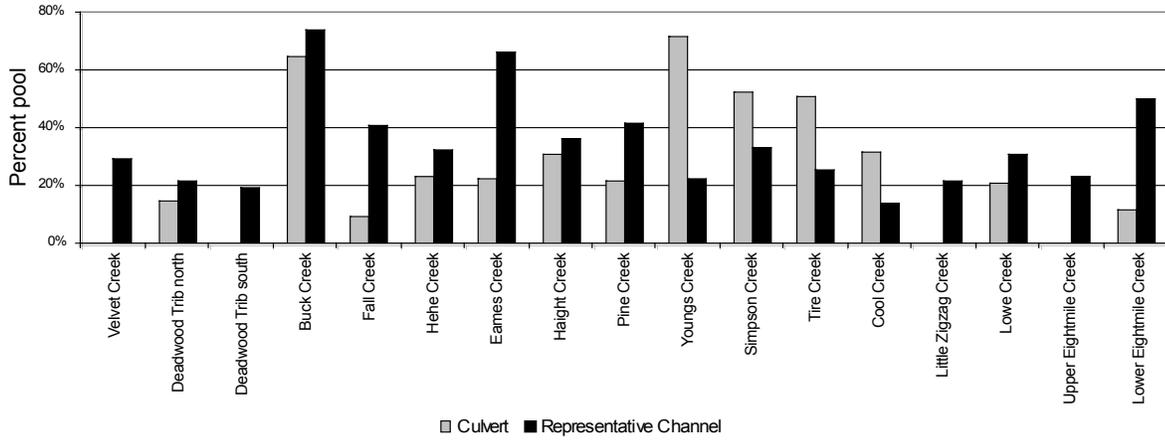
Channel units and LWD. The distribution of channel-unit types differs between culverts and natural channels. In general, pools and steps are more common in natural channels, riffles are about equally as common in natural channels and culverts, and glides are more common in culverts. Percent pool values for all sites are displayed in figure 3.5-4. Percentage of pools is greater in natural channels for 13 of 17 sites. Total habitat-unit composition results for all sites are included in appendix A.

Figure 3.5-4. Percent pool (as percent of total stream-surface area) of natural channels and culverts for all sites. For sites with two representative natural channel segments, percent pool values were averaged. Natural channel values are significantly greater than culvert values using a paired t-test (one-tailed) at α=0.10.

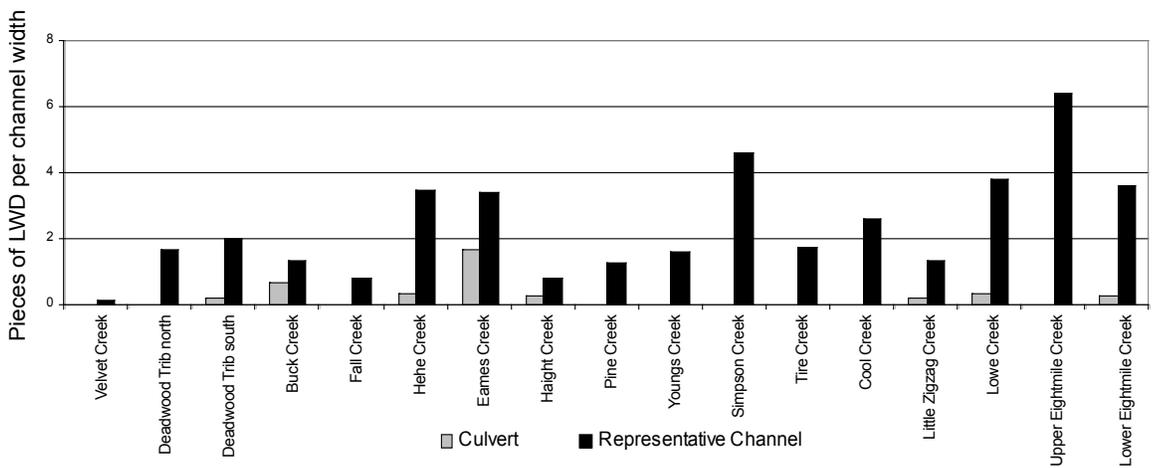
LWD loading is considerably different between the culverts and natural channels. In all cases, LWD per channel width is greater in representative channel segments (figure 3.5-5). The data from the LWD analysis is provided in appendix A. An LWD loading of two pieces per channel width is considered "good" according to the Washington State standards (WFPB 1997). Natural-channel segments in only six sites exceed this target, although several other sites have between one and two pieces per channel width. Wood is absent in most culverts, with only one or two pieces counted at seven of the sites.

Figure 3.5-5. Counts of LWD per channel width for culverts and natural channels. For sites with two representative natural-channel segments, LWD and channel-width values were averaged.

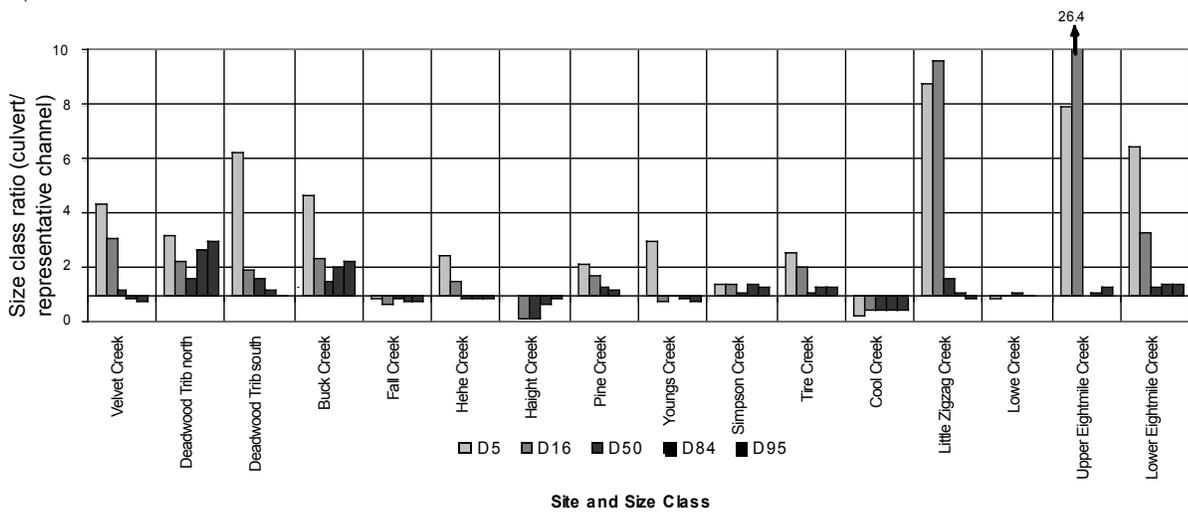
Figure 3.6-1. Size-class ratios for each site (culvert/representative natural channel). Data from pools are excluded.

Coarser bed material in culverts compared to natural channels is a ubiquitous condition measured at nearly all the study sites (figure 3.6-1). Differences in bed material size are most pronounced for the smaller grain sizes, with culverts typically having much less of the smaller material that is found in the natural channels. In some cases, the differences are severe, such as in Velvet Creek, Deadwood Tributary South, Buck Creek, Little Zigzag Creek, Upper Eightmile, and Lower Eightmile, where the size of the smaller size classes far exceed the natural channel conditions. Only Haight Creek and Cool Creek have culvert material that is significantly smaller than the representative channels. In Haight Creek this is likely the result of backwater influence from the mainstem Siuslaw River, which is a short distance from the culvert outlet.

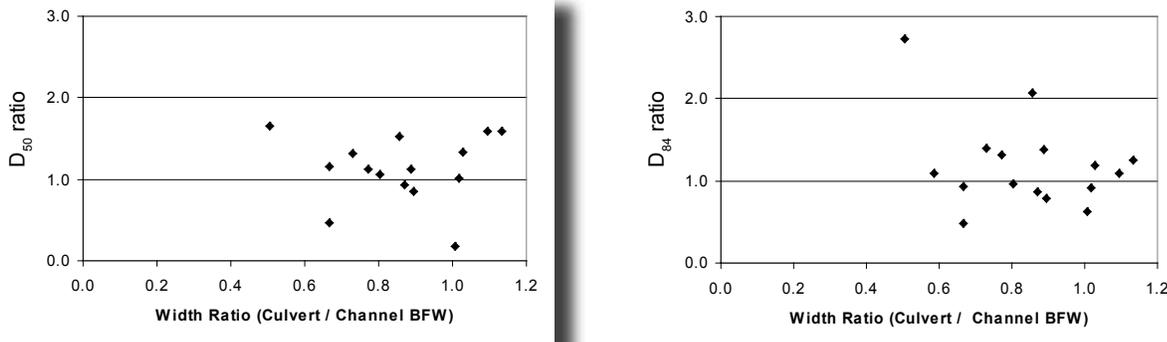
Substrate size ratios were compared to stream width ratios to see if culvert width had an impact on the size of material in the culvert. The width ratio did not appear to impact the size of the D_{50} or D_{84} (figure 3.6-3).

Figure 3.6-3. Effect of width ratio (culvert/natural channel bankfull width) on the D_{50} (left) and D_{84} (right) ratios. There are no significant correlations. Upper Eightmile Creek was removed as an outlier from the D_{50} analysis because of the effect of a large sand deposit on the D_{50} for the natural channel. Pebble-count data in pools are not included in these data.

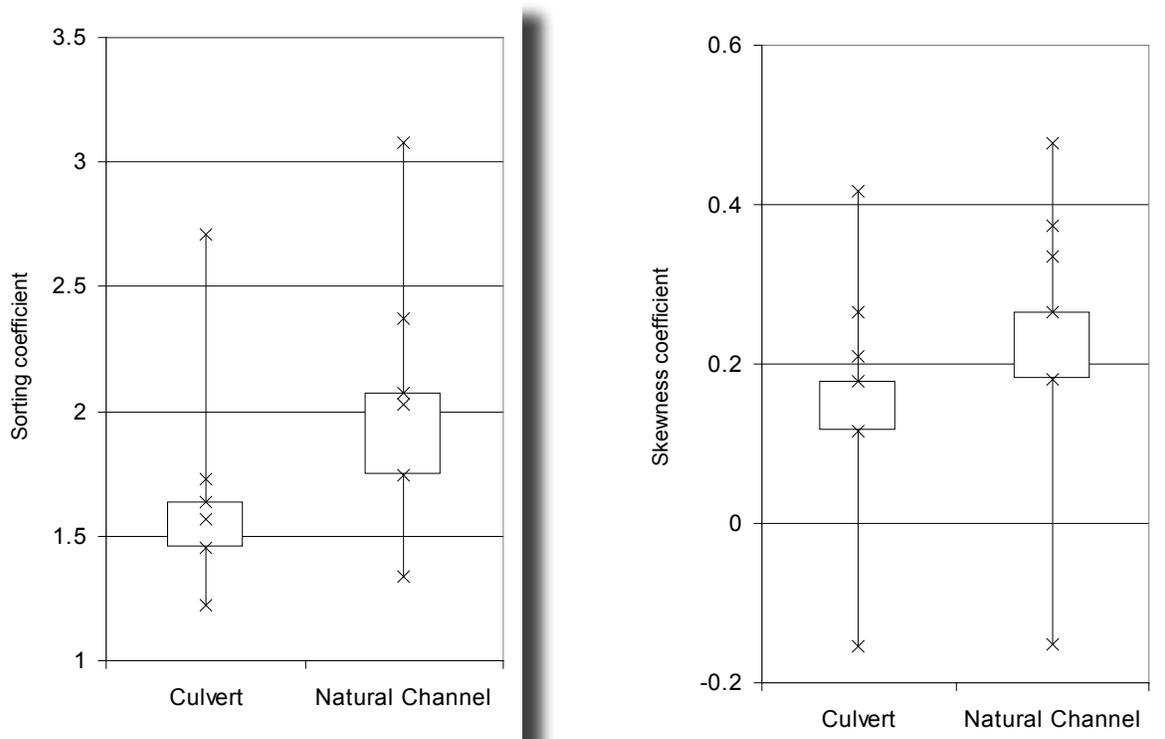
Figure 3.6-4. Box plots of sorting coefficients (left) and skewness coefficients (right).

Sorting and skewness. In order to look at broad trends in bed-material sorting and skewness among all sites, the values for each location (natural channel or culvert) at each site were averaged and ratios were developed for each site. The sorting and skewness coefficients are displayed in table 3.6-1. Guidelines for evaluating these coefficients are included in table 3.6-2 and table 3.6-3. Box plots are also included that show the range of data (figure 3.6-4). Culverts tend to have lower sorting coefficients than the natural channels. This corresponds to a greater degree of sorting; that is, culvert beds tend to be more "well-sorted" than the natural channel. This implies a narrower size range of particle sizes in
