Case Study 12. Grubbs Concrete Slab Vented Ford

Appendix A—Case Study 12

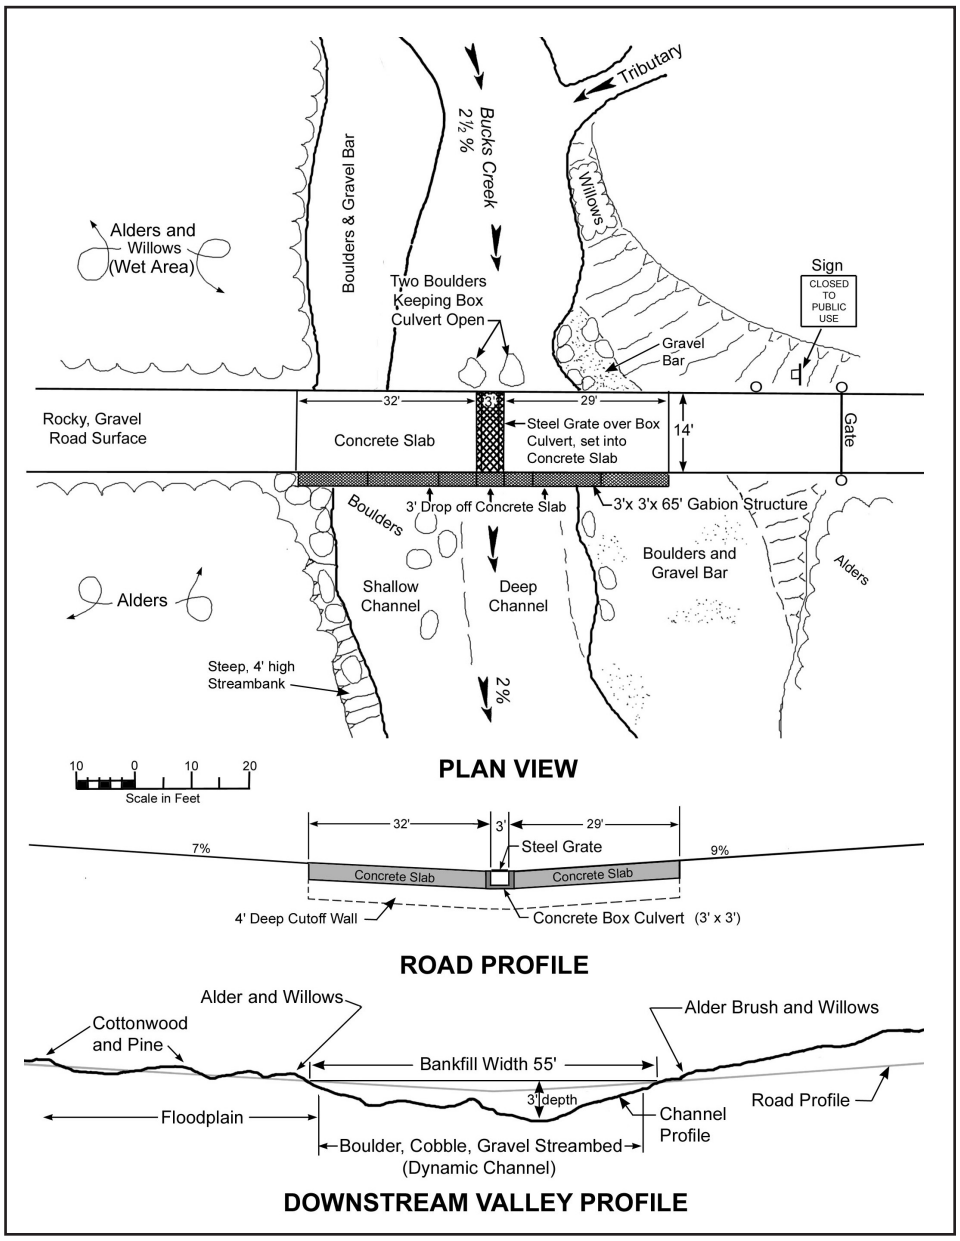
Figure A77. Site plan view and cross-section sketch.

Bank and bed stabilization and approaches: The ford slopes into the channel at 7 to 9 percent (figure A77). Four-foot-deep concrete cutoff walls were constructed along both edges of the roadway for scour prevention. The downstream edge was also armored with two rows of gabions. The upper row sits on a concrete sill attached to the wall of the structure, and the lower row sits directly on the streambed.
