Storms of July and August, 2015

Preliminary Observations of Storm Effects Music, Walker, Grider, Beaver, and McGuffy Creeks and Little Deer Mountain

By: Juan de la Fuente

9-16-15

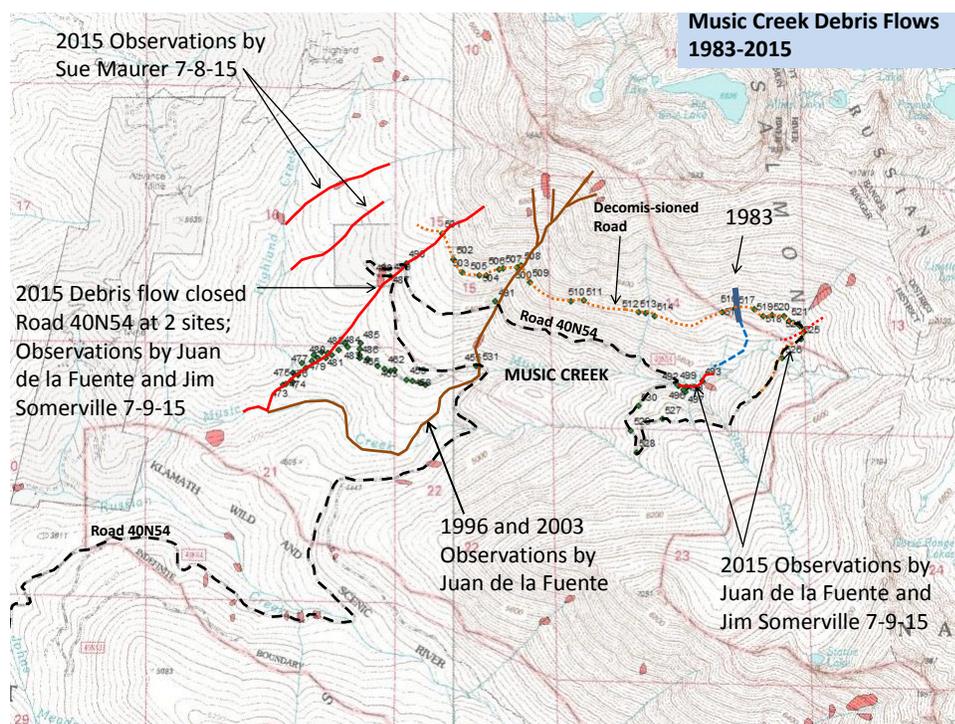
Map 3: Debris flows in Music Creek 1983-2015; GPS points show field traverse;

The storm which caused the severe erosion in the Music Creek watershed occurred on the evening of July 5. The largest debris flow occurred in an unnamed southwesterly flowing tributary to Highland Creek and closed Road 40N54 in two places at a switchback (Map 3). It originated above a decommissioned road, around 7000' in elevation, and joined Highland Creek at 3820'. The debris flow carried rocks up to 6 feet in diameter as well as logs, and the road crossings had little effect on its behavior, other than providing a gentle area where sediment was deposited. The debris flow averaged 8' in depth, and the width of the scoured channel varied from 20-30 feet. Near its junction with Highland Creek, the debris flow made a right turn and super-elevated about 20 feet on the left bank while scour on the right bank was 10 feet high. The average gradient of the channel from its junction with Highland Creek to around 4,400' elevation is about 45%, and it flows on bedrock over numerous cascades and falls. The gradient of Highland Creek near the junction is about 17%.

Highland Creek (tributary to Music Creek) does not appear to have experienced a debris flow immediately above its junction with the main 2015 debris flow track shown on Map 3. This reach of Highland Creek is about 30 feet wide, and the gradient is about 15%, with a bedrock bottom. The water rose to a depth of about 4-5 feet in this segment. Field observations suggest that debris flows did occur in two tributaries upstream from this segment (Map 3) as documented by Sue Maurer on 7-8-15. However, they appear to have dissipated a short distance downstream. A small log jam was observed on the west bank of Highland Creek a couple of hundred feet below the junction with the main 2015 debris flow channel shown on Map 3.

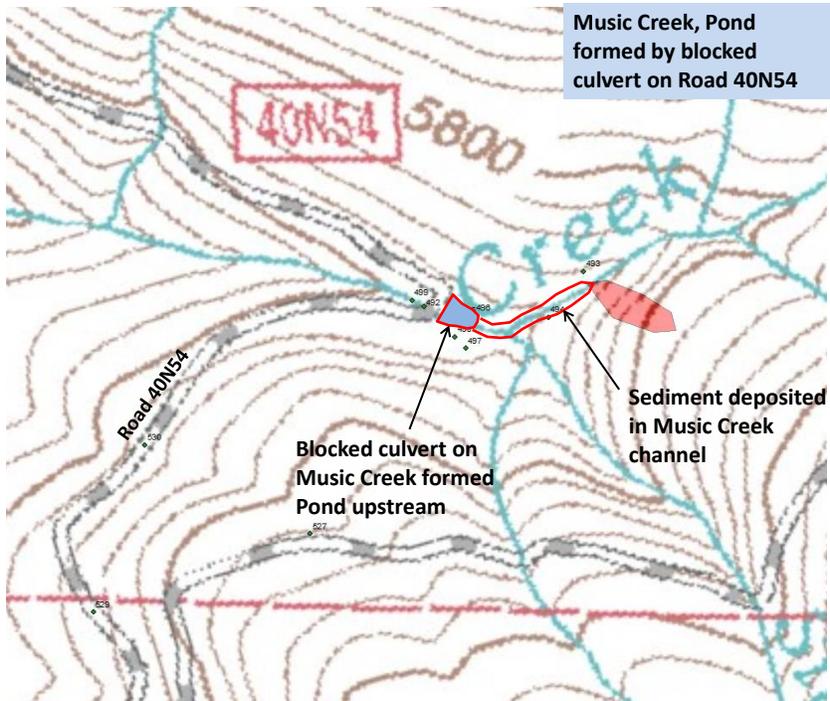
Map 5: Clogged culvert on Road 40N54 on main stem Music Creek; GPS points show field traverse;

Music Creek: Blocked Culvert and resulting pond on Road 40N54 (Map 5) 7-9-15

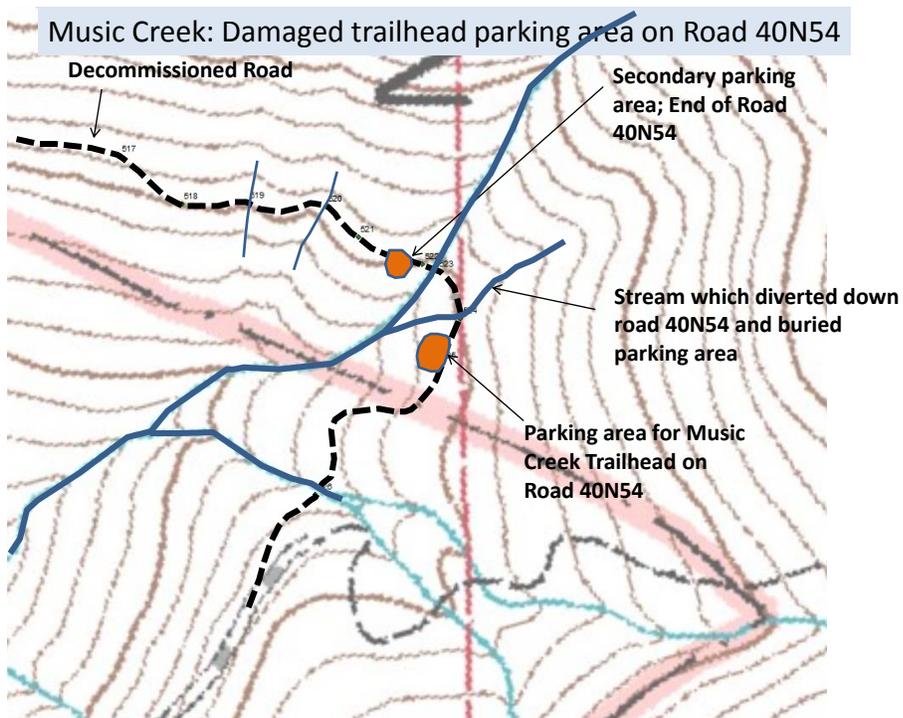
Map 6: Music Creek trailhead parking area damaged by flooding; GPS points show field traverse;

The Music Creek trailhead parking area at the end of Road 40N54 was flooded when a small stream in the headwaters of Music Creek was diverted down the road immediately north of the parking area (Map 6). Sediment laden flows came out of the easternmost of two channels, and buried the parking area with sand, gravel, and cobbles up to a foot in diameter. The area adjacent to the trail burned at low severity in the fire, yet it experienced severe sheet wash and rilling, despite being under a green timber canopy. This was likely caused by a large area of higher severity burn further upslope and to the east of the trail (see air reconnaissance photograph).

Campgrounds and Trailheads- It is recommended that the campground at Grider Creek, and the trailhead parking lot at Music Creek be evaluated more closely regarding the exposure of Forest users to debris flow and flash flood hazards. Options for limiting public exposure to future events could include things like seasonal closures or restricting/redirecting access within the facilities. In the meantime, signs should be placed there informing users of the hazard. This action should also be considered at other sites where debris flow or flash flooding hazards have been identified, and where the public is likely to congregate. Such signs would inform Forest visitors of these specific hazards, and would augment signs already in place, which state: “Entering Hazardous Area”. Signs advising of debris flow and flash flood hazards have been obtained by the Forest, and are scheduled for deployment.

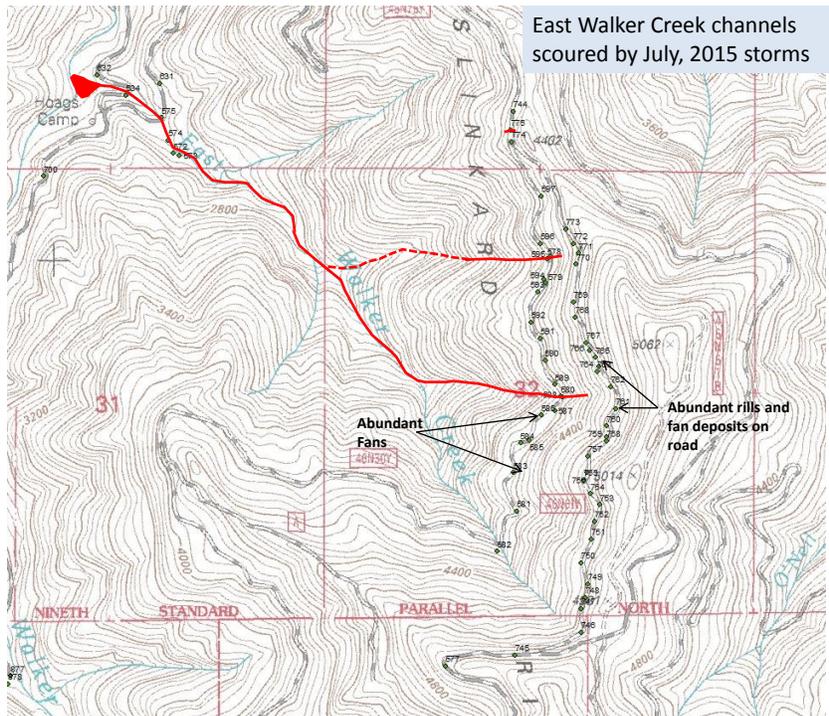
Map 11: Scoured Channels in East Walker Creek; GPS points show field traverses;

Walker Creek experienced the most severe effects of the watersheds visited, and the largest debris flow by far occurred in East Walker Creek. This debris flow took out road 46N64 and 46N65 a short distance upstream of the junction with main Walker Creek. Channel gradients on many of the debris flow channels in the Walker drainage are very steep (>40%), which produced high velocity debris flows which splattered mud on channel banks and trees as they traveled rapidly down the channels.

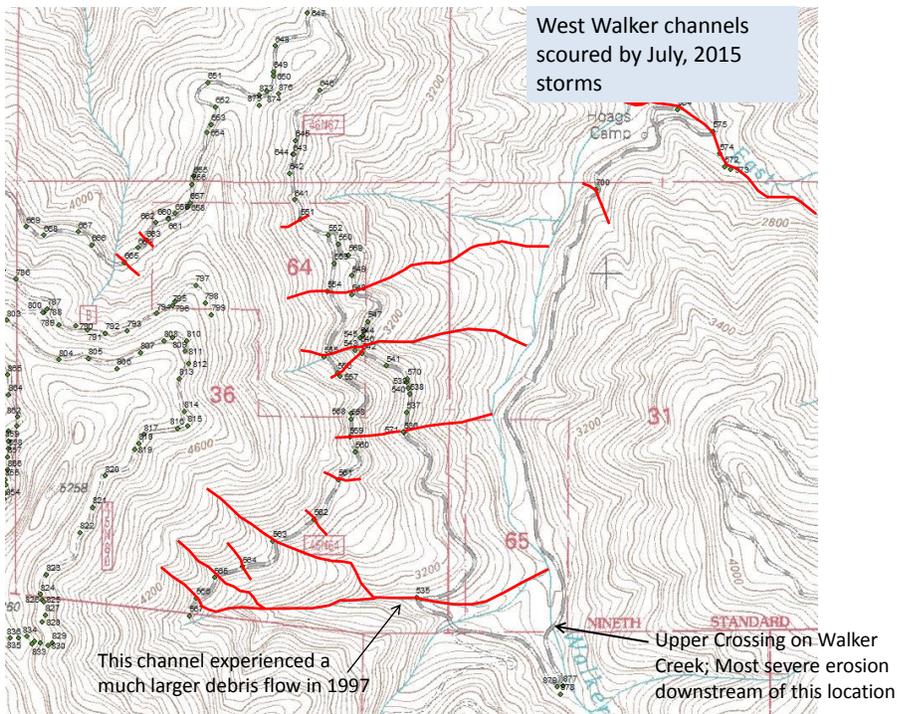
Map 12: West Walker Creek scoured channels from July 2015 storms; GPS points show field traverses;

The upper crossing on main Walker Creek (multiple pipes) survived the event and most of the debris flows appear to have entered Walker below this crossing (crossing location indicated on Map 12). Above the crossing, fire severity was mostly low and some moderate. Most of the storm-affected area is underlain by granitic rock (Map 7).

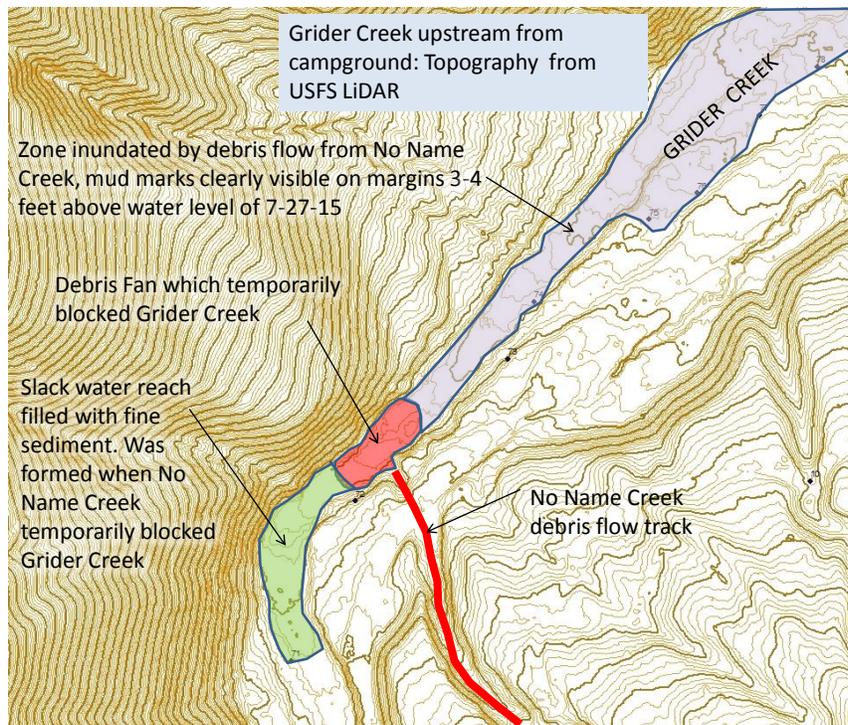
Map 13: Grider Creek showing deposits from debris flow in No Name Creek

The debris flow continued down Grider Creek for at least $\frac{1}{2}$ mile, as indicated by mud marks and unsorted debris on the channel banks. Some of this material remains in the channel, raising the bed elevation. This condition will make the campground more susceptible to flooding than before the event. At the bridge on Road 46N65, the mud marks were no longer visible, so the debris flow likely dissipated upstream of this location. The junction of Salt Creek and Grider Creek a short distance above the road bridge was not examined. There were no indications at the bridge on Grider Creek that a large debris flow had occurred in Salt Creek.

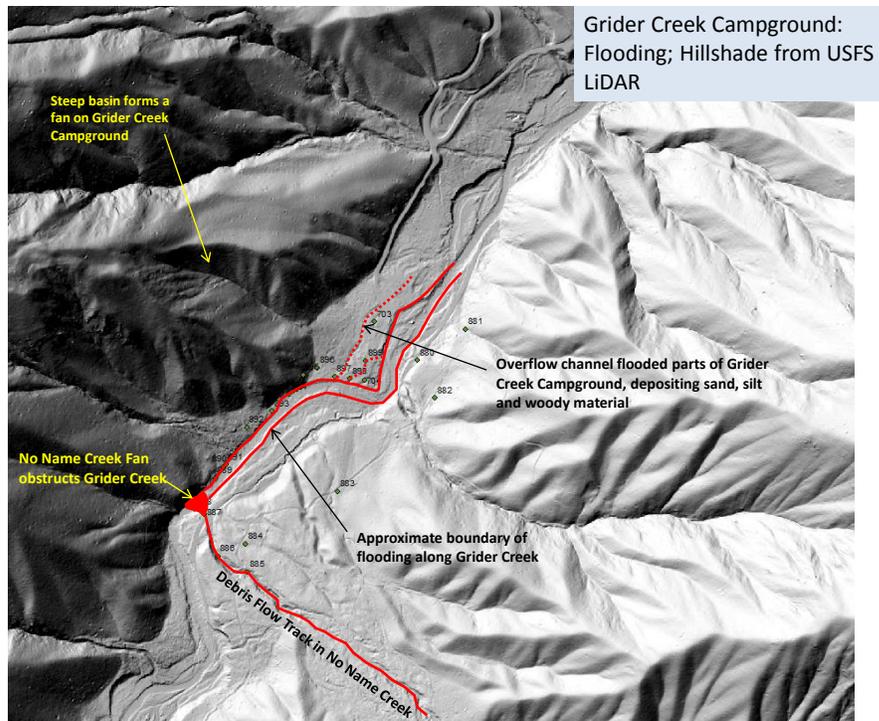
Map 14: Flooding in Grider Creek Campground

Flooding occurred at the Grider Creek campground, where high flows overflowed the banks at the SW end of the campground, where the creek makes an abrupt bend to the East (Map 14). Something similar happened in 1997, but the effects were more severe. At the foot bridge, water and mud marks on the banks showed that peak flows in Grider Creek were about 60 feet wide and 4' deep and the gradient is about 1%. The presence of muddy debris flow deposits on the sides of Grider Creek suggests that the debris flow traveled at a relatively slow speed, perhaps the speed of a rapid, walk, or 4 miles an hour. In addition to the flooding/debris flow problem from Grider Creek, there is a small unnamed tributary creek immediately west of the campground which is very steep and burned at high and moderate severity. Hillshade images of this area reveal the steepness of this small basin, a prominent fan at the mouth, and the presence of older debris slide scars in the SW portion of the headwaters. There is a need to evaluate the short and long term use of the campground. The public should be advised of the potential for future fire-related debris flows and flooding associated with intense summer storms, and also for debris flows, flooding, and landslides during severe winter storms.

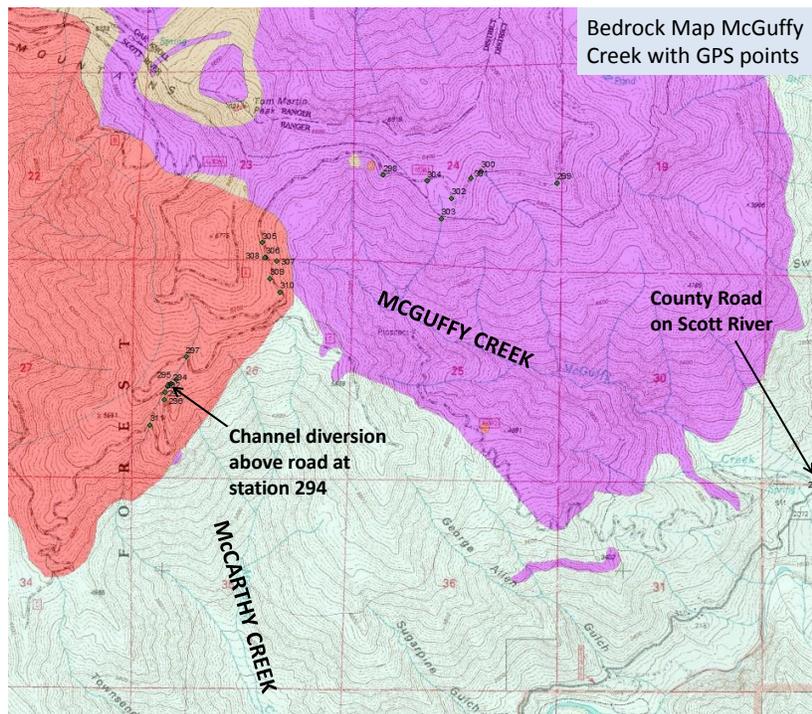
Map 16: Bedrock at McGuffy Creek; Purple polygons are ultramafic rock, red is granitic, and green is metamorphic;

Rocked dips worked well, and rills generally initiated above the road and crossed over the road, depositing small fans there. There was a channel diversion in the McCarthy Creek watershed at one site (Map 16) where an abandoned logging road captured a small stream and diverted it out of the channel and down the road. The flow formed a rill about 2' wide and a few inches deep and deposited some material on the main road below. Total volume is probably less than a few cubic yards, and much of it was woody material. The diversion occurred at GPS location 294, and flowed down the old road (not shown on map) to the main road, and then left the main road and flowed back into the stream at location 296. This issue can be easily repaired with a backhoe or excavator.
