Executive Summary

In October 2014, the Surface Water Quality Bureau sampled Cold Spring Creek to determine if there had been negative impacts to water quality following flooding and erosion earlier in the year. Cold Spring Creek is listed as an impaired water of the State due to excessive concentrations of cadmium and lead. Historic mines in the upper watershed are the proximal source of the metal contamination, and the flooding caused significant erosion and mobilization of tailings that lie in the stream channel on both public and private land. The landowner, Ms. Karren Weathers, can no longer cross Cold Spring Creek to access a portion of the property that contains valuable equipment due to deep down cutting between the access road and the building. Ms. Weathers was concerned that any repairs to the road could mobilize additional tailings and sediment causing further water quality degradation. The sampling plan was developed to determine if there was a significant change to water quality following the flooding and erosion and gauge whether emergency repairs would further exacerbate water quality concerns.

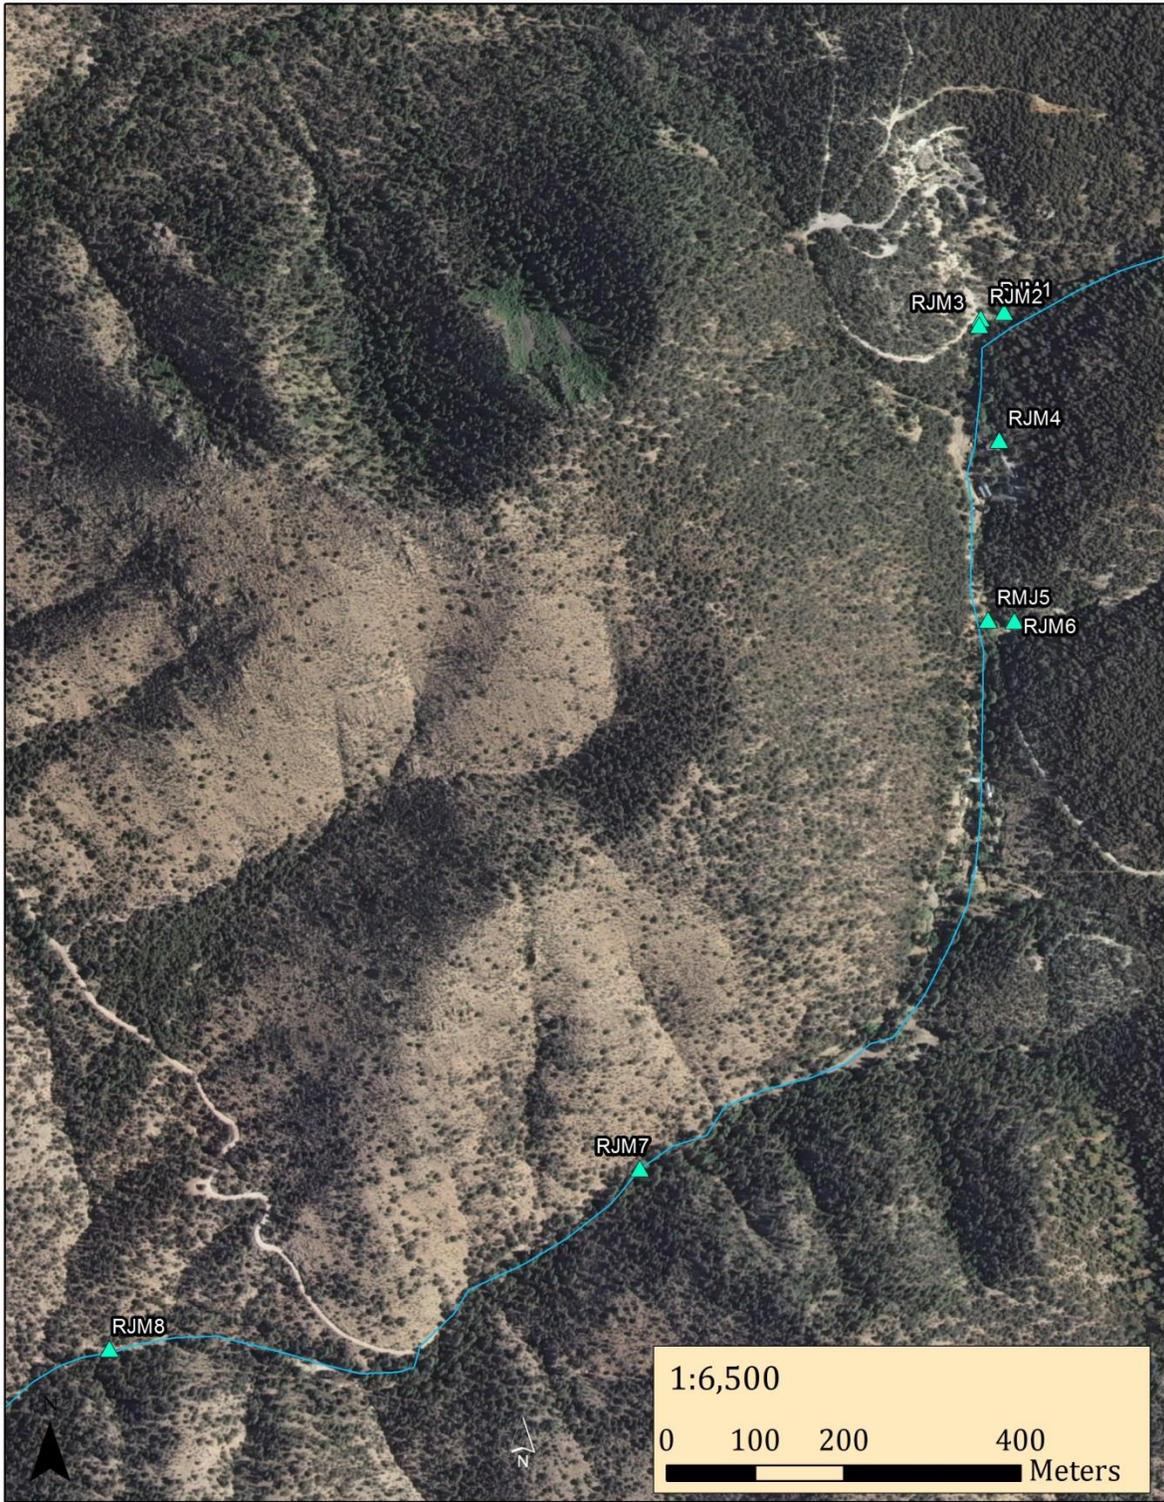
Figure 3. Map of water quality sampling points from October 2014. Areas of erosion and tailings lie between points 3 and 5. Sampling point 4 is Ms. Weathers' domestic water source.
