# Rio Guadalupe

## *Stream Inventory Report*

Santa Fe National Forest  
Surveyed: June – July 2004  
Forest Fisheries Crew

Santa Fe National Forest  
February 2006

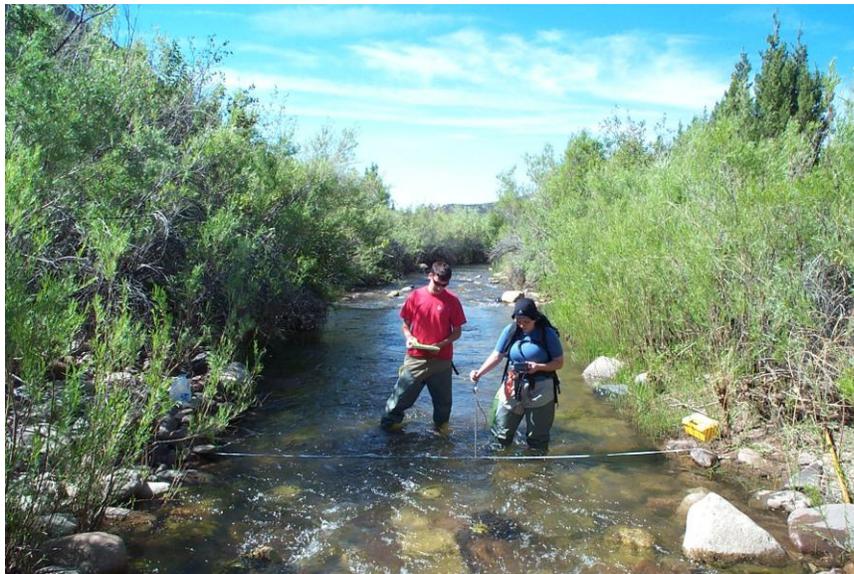
spaced sections. At each section, flow was taken at 60% of the depth in twenty-second intervals. The average flow is recorded from each section and related to area to calculate the stream flow. The Rio Guadalupe flow on June 14<sup>th</sup> was 11.7 cubic feet per second (cfs).

**Photo 5.** Stream flow station at the start of Reach 2 (14-June-2004).

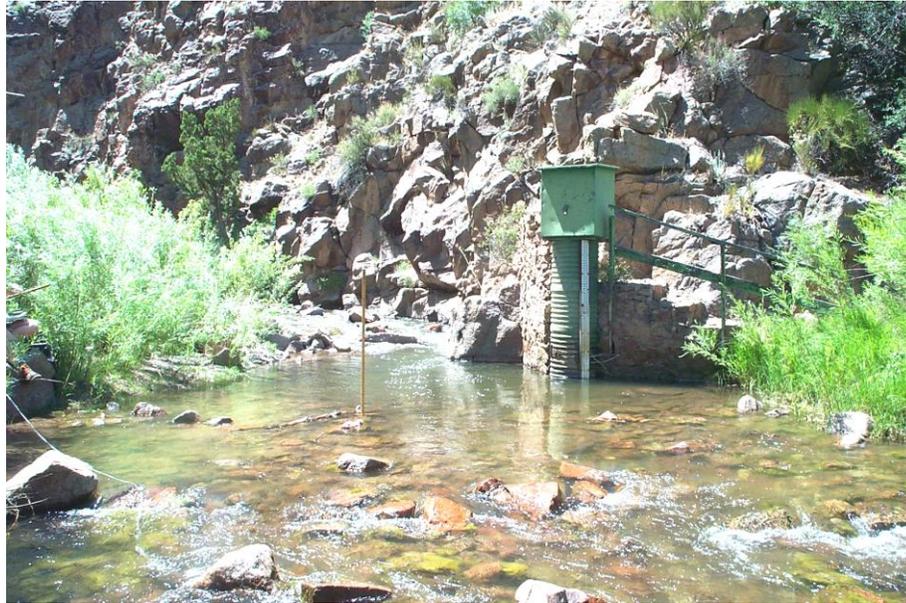
**Photo 6.** Reach 3, NSO 24, P4. Thermograph site at the USGS gauge site (15-June-2004).

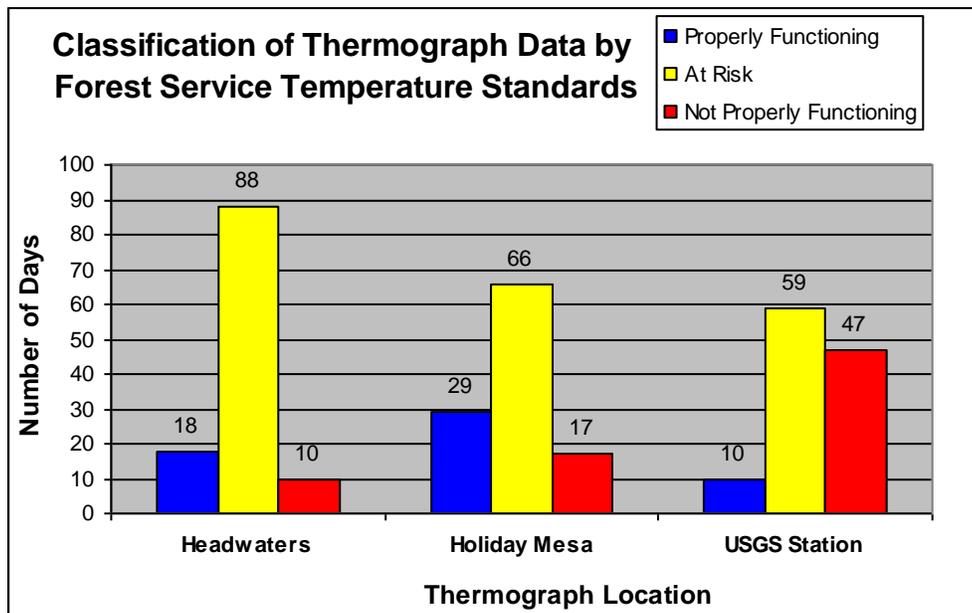
**Figure 1.** A comparison of at risk and properly functioning days at the thermograph sites on the Rio Guadalupe between June 1st and September 30th, 2004. Classification based on SFNF Water Quality Standards of 7-day average max temperatures.

When Forest standards are applied to the thermograph data, all three of the stations are **not properly functioning**. All of the sites had more at risk days than days properly functioning. The Holiday Mesa Station had the least days of at risk and not properly functioning (see Figure 3).

All of the stations recorded **not fully supporting** conditions for high quality cold water fisheries when classified by NMED standards. Though the thermographs were collecting data every four hours (instead of once every hour as required by NMED protocol) the 73.4°F maximum was exceeded resulting in not fully supporting conditions (see Figure 3).

The **NPF and NFS** classification of multiple sites by both the Forest and NMED water quality standards implies that water temperature should be a management consideration for the Rio Guadalupe. Temperature mitigating strategies should be applied to protect the integrity of the coldwater fishery. Increasing LWD and pool development to create a narrower and deeper channel along with planting native riparian vegetation and protecting bank stability in high use areas are means of decreasing water temperatures on the Rio Guadalupe.

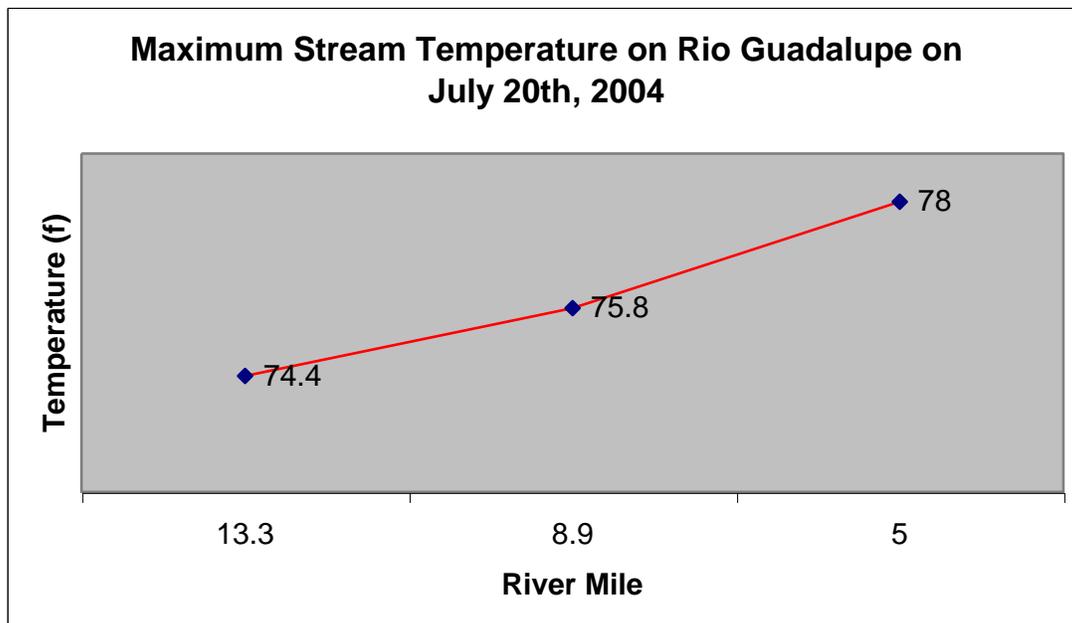
**Figure 3.** Maximum temperatures at the three thermograph sites on the Rio Guadalupe on a particularly warm day. The sites are listed from the highest (Mouth) to the lowest (USGS Station) and demonstrate the change of temperature with distance.

Diurnal or daily high to low temperature fluctuations are analyzed from the thermograph stations. On July 20<sup>th</sup>, 2004, a particularly warm day, diurnal fluctuations ranged from 12.4°F at the Holiday Mesa Site to 12.0° F at the USGS Station.

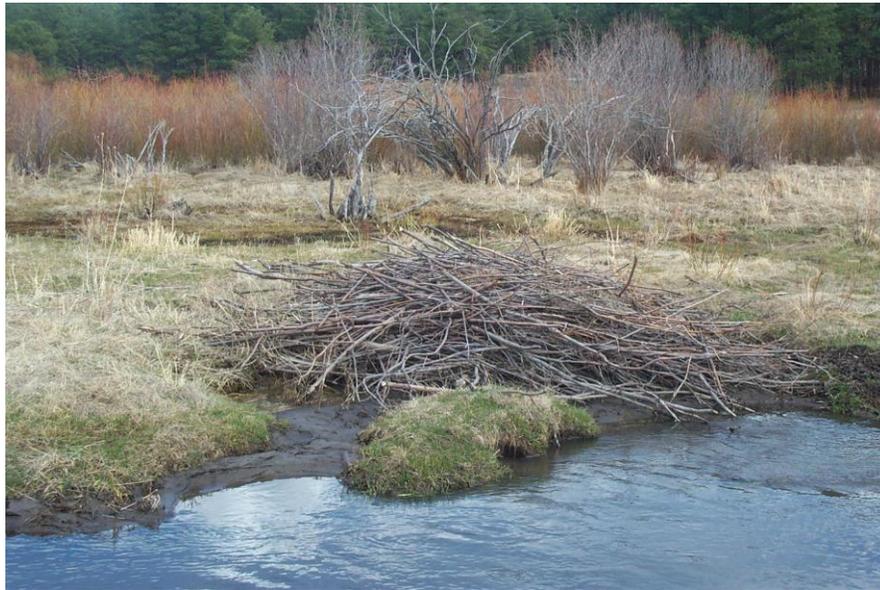
**Photo 8.** Beaver activity on the Rio Cebolla (4-1-2004).

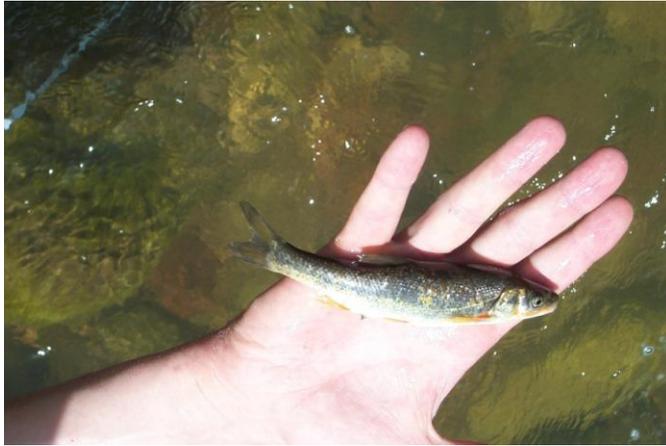
**Photo 10.** Native Rio Grande chub found dead in reach 2 (7/15/2004).

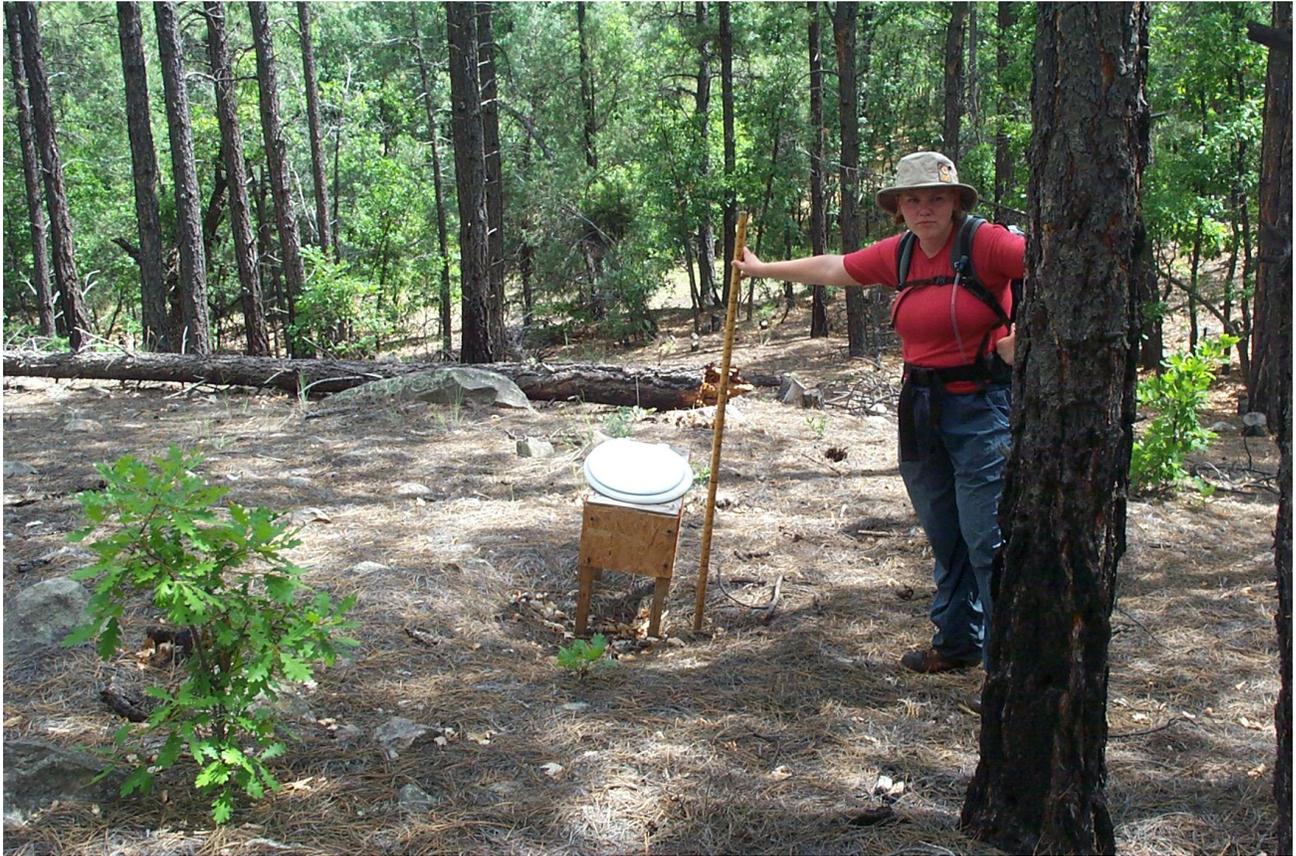
**Photo 15.** T. Anderson at a campsite in Reach 6 (22-July-2004).

- Modifying dispersed campsites that encroach on the stream banks;
- FR 376 road to river closure for all vehicles;
- Converting Deer Creek Landing, a popular swimming hole, into a “Day Use Only” area;
- Replanting degraded riparian areas with native vegetation;
- Educational signing placed throughout the watershed to inform visitors on low impact camping, native ecosystems, and the ideas behind restoration.

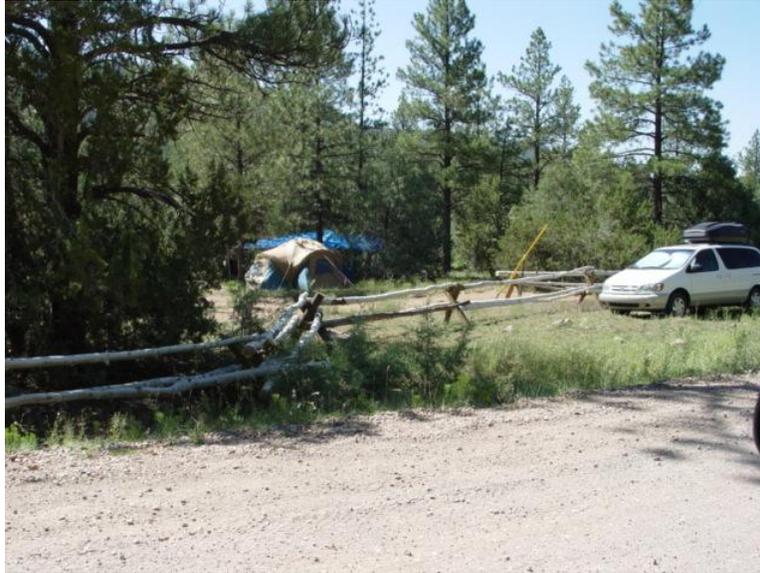
**Photo 16.** Campers respecting road to river vehicle closure (17-July-2004).

- Augment current riparian area density by planting native species by historic dispersed recreation
- Reduce number and limit the use of dispersed trails and campsites within the riparian zone.
- Maintain vehicle closure and barriers.

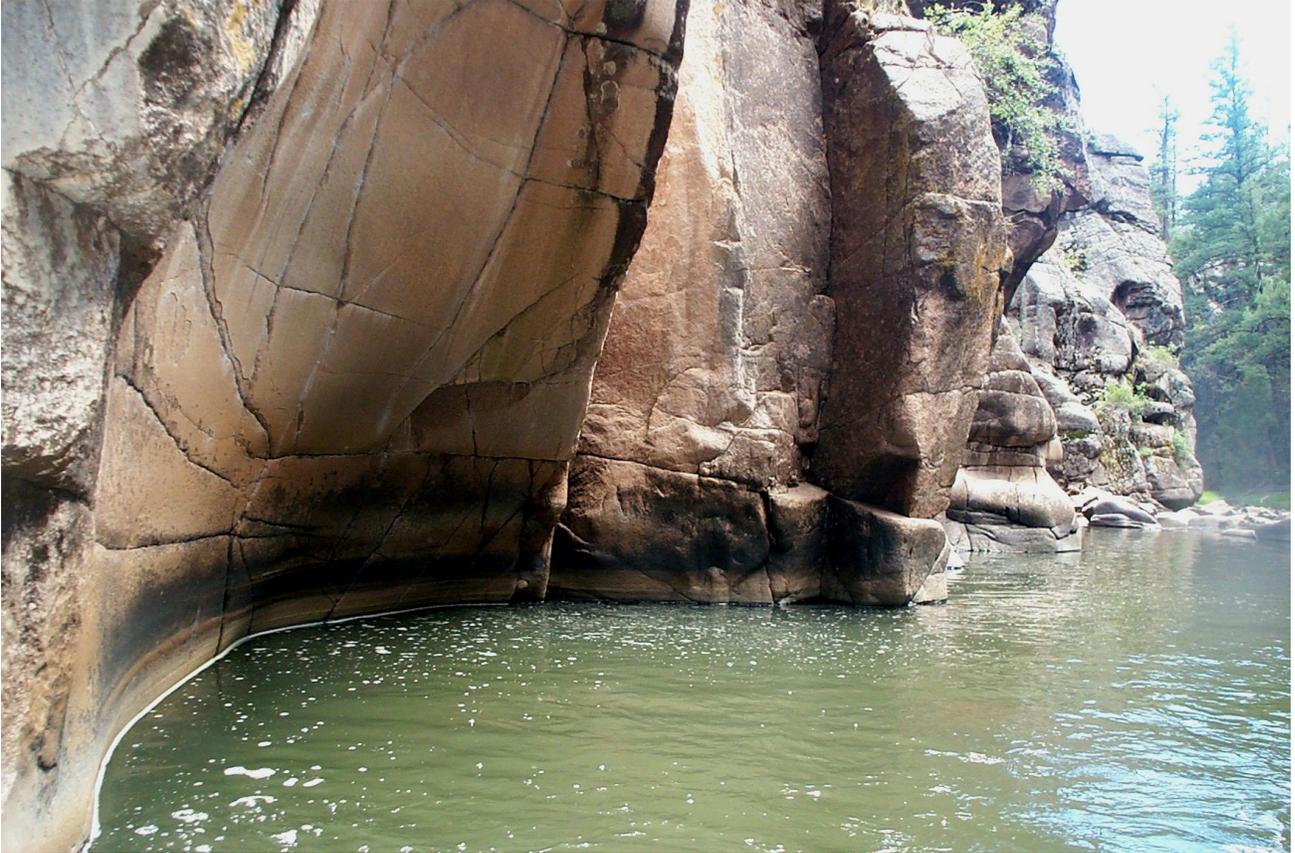
**Photo 18.** Reach 5, NSO 197, P62. Bed-rock wall and a defined bankfull line (8-July-2004).

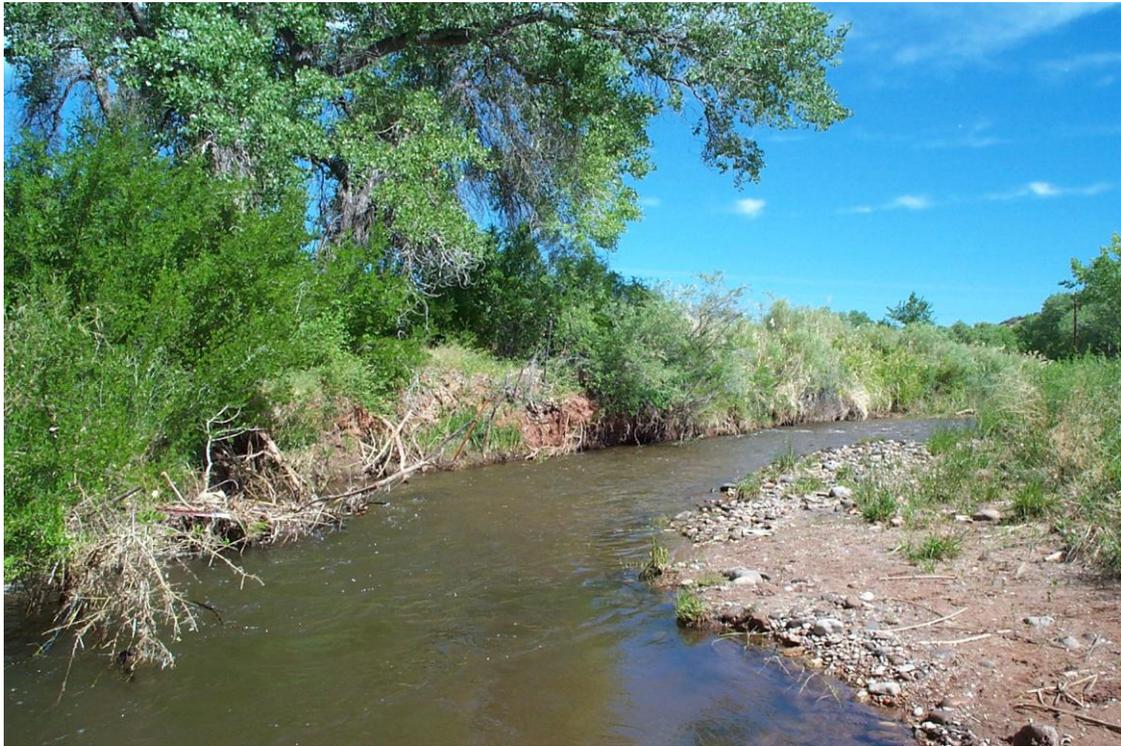
**Photo 19.** Rio Guadalupe looking upstream from at the mouth (May 2004).

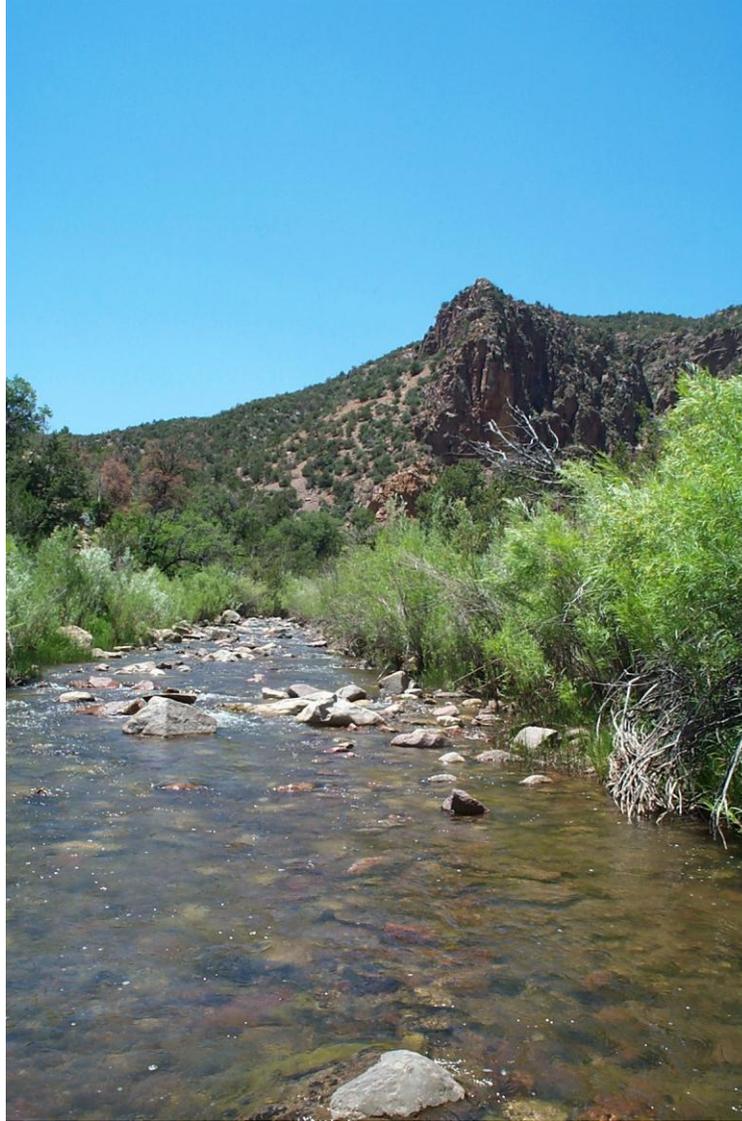
**Photo 20.** Reach 2, NSO 21, R17. Looking downstream at a typical riffle with Gilman Peak in the background (15-June-2004).

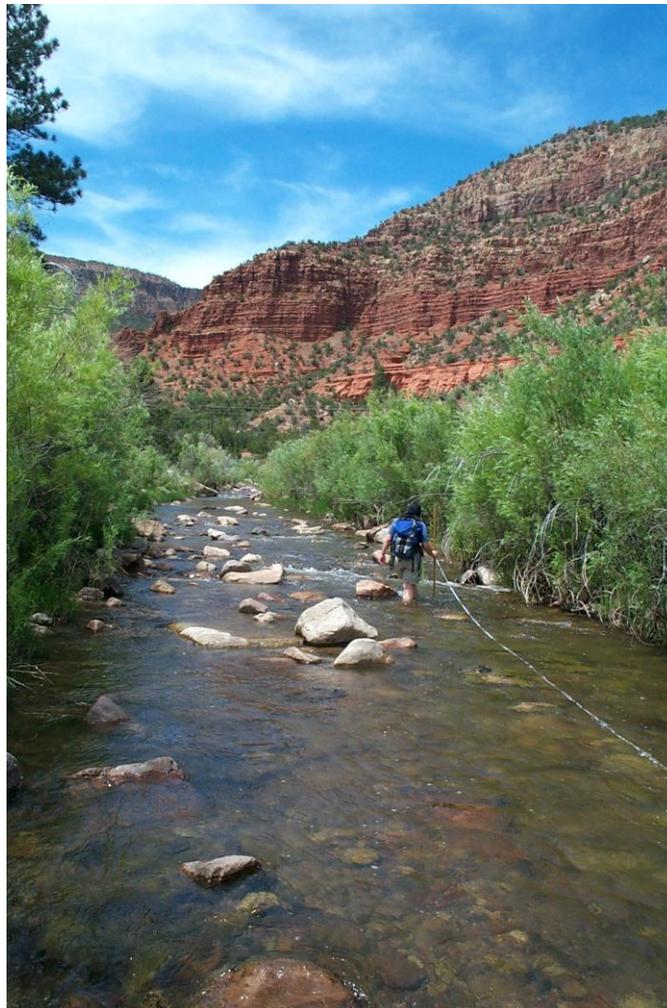
All factors related to riffle habitat are **properly functioning**.

**Photo 22.** NSO 15, R13. Typical riffle looking upstream (14-June-2004).

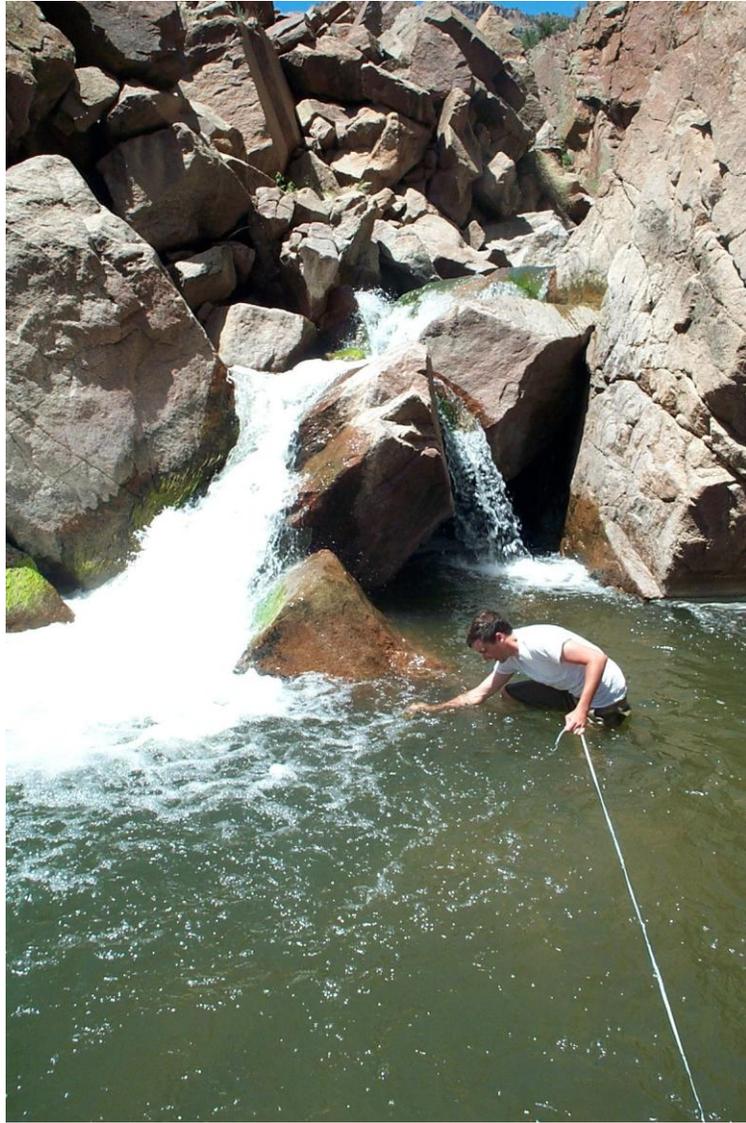
**Photo 24.** NOS 46, P13. D. Hoffman looking for max depth in a pool below a chute (16-June-2004).

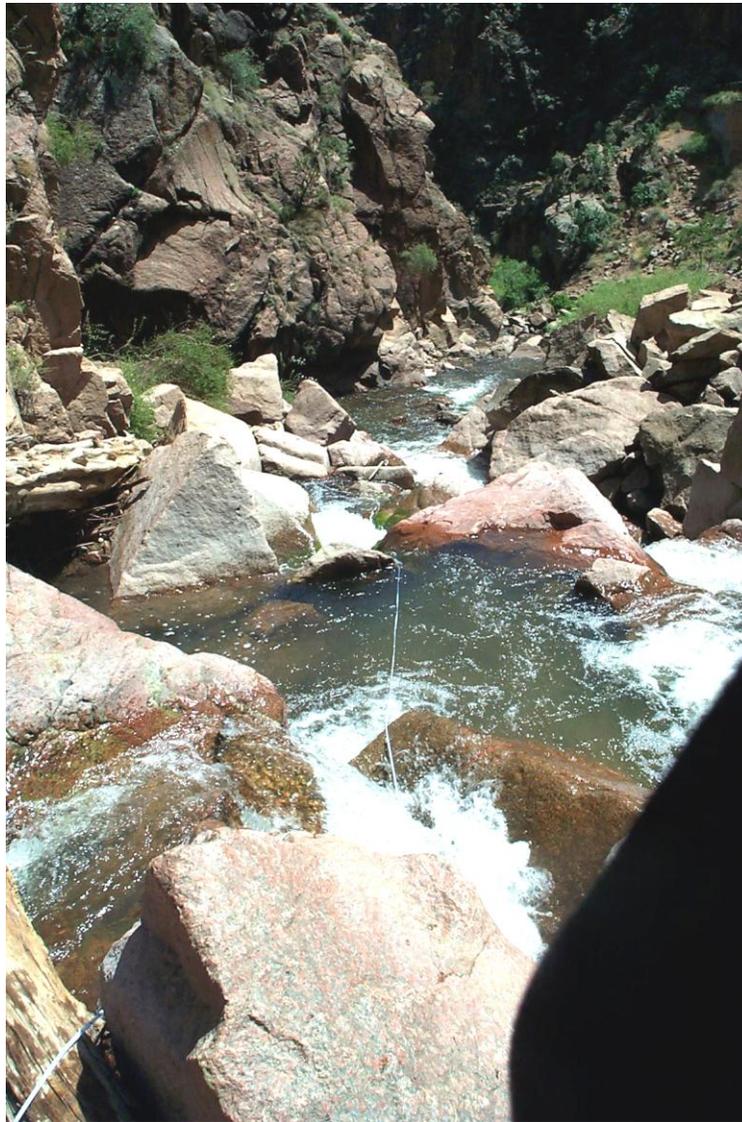
**Photo 25.** NOS 49, R29. Looking at a riffle downstream. Notice the gradient and valley confinement (16-June-2004).

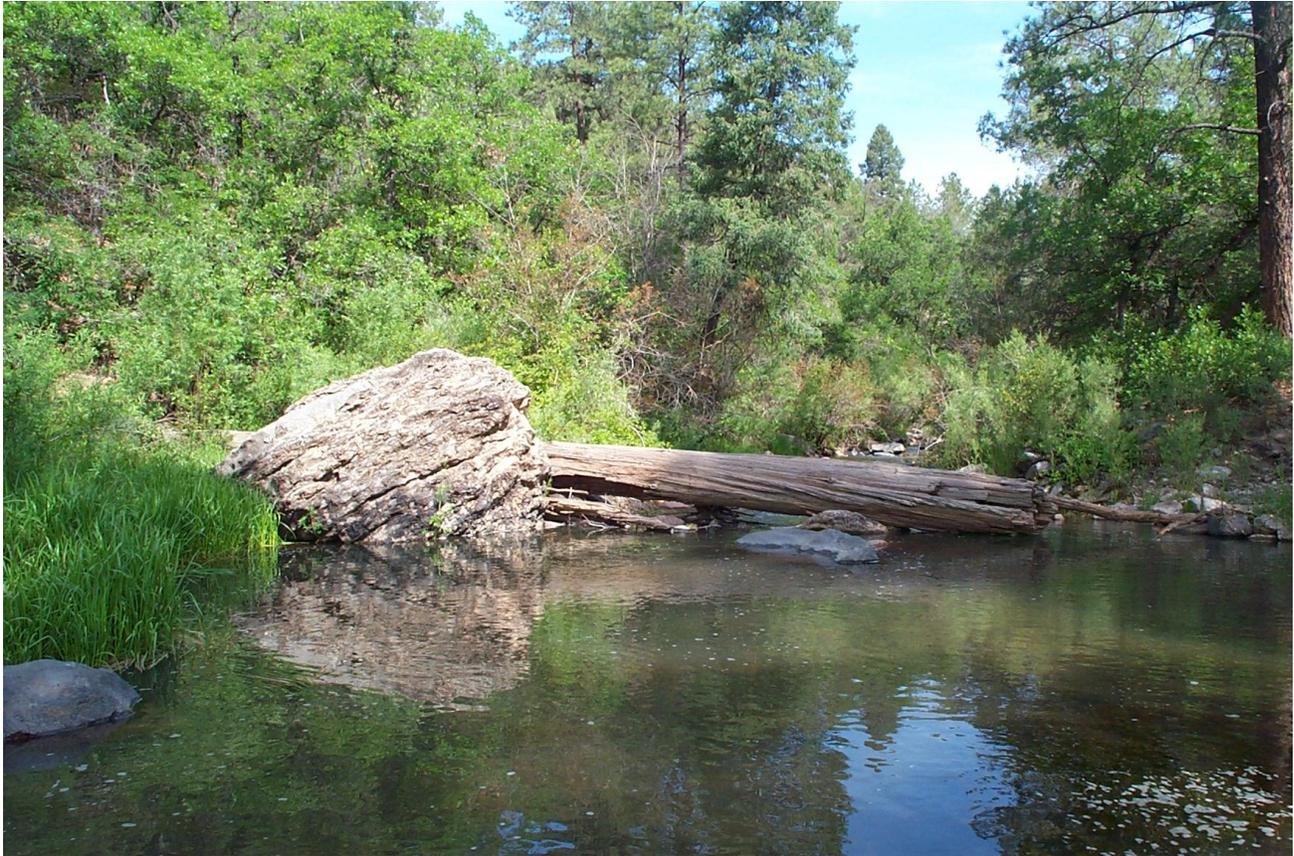
**Photo 27.** Reach 4, NSO 108, P31. Looking upstream at LWD at the top of a pool (28-June-2004).

LWD density in Reach 4 is **not properly functioning**. Four pieces of LWD are located in the reach, creating a density of 1.1 pieces per mile (see Table 29). LWD density is far below the greater than 30 pieces per mile matrix standard and could be attributed to historic use in the area (logging, dispersed recreation, and fuel wood removal). Recent studies have found that LWD is an essential part of pool formation and critical in providing complex fish habitat (Fausch and Northcote 1992).

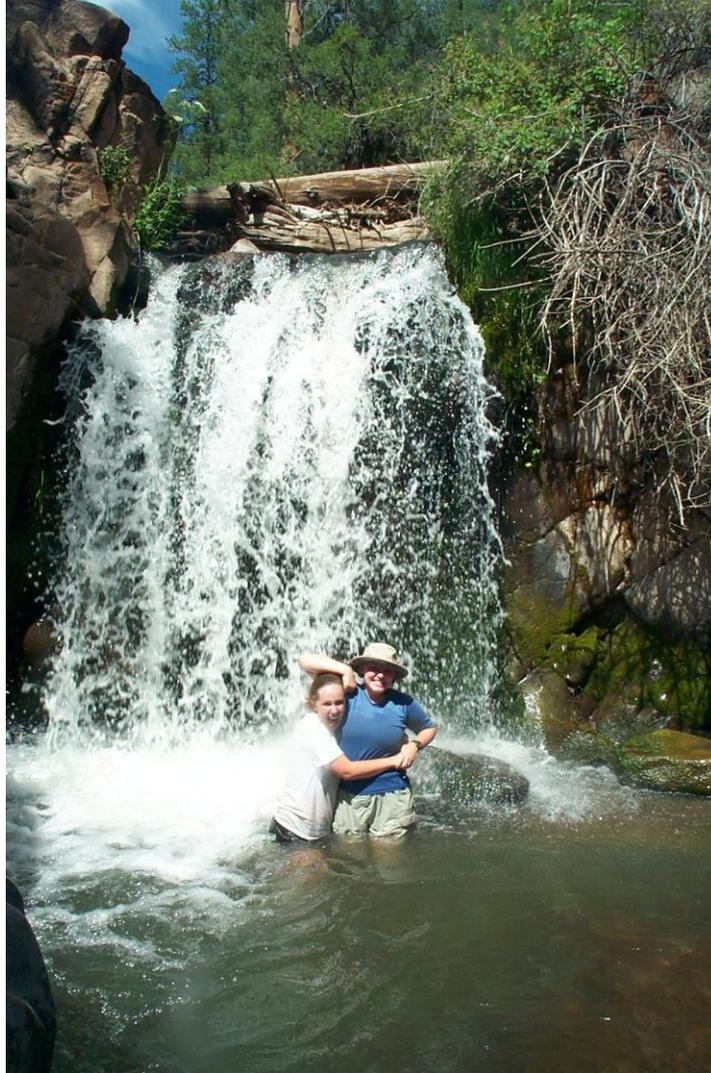
**Photo 31.** NSO 203, F15. T. Anderson and A. Kirkpatrick in front of falls with a ten foot drop (8-July-2004).

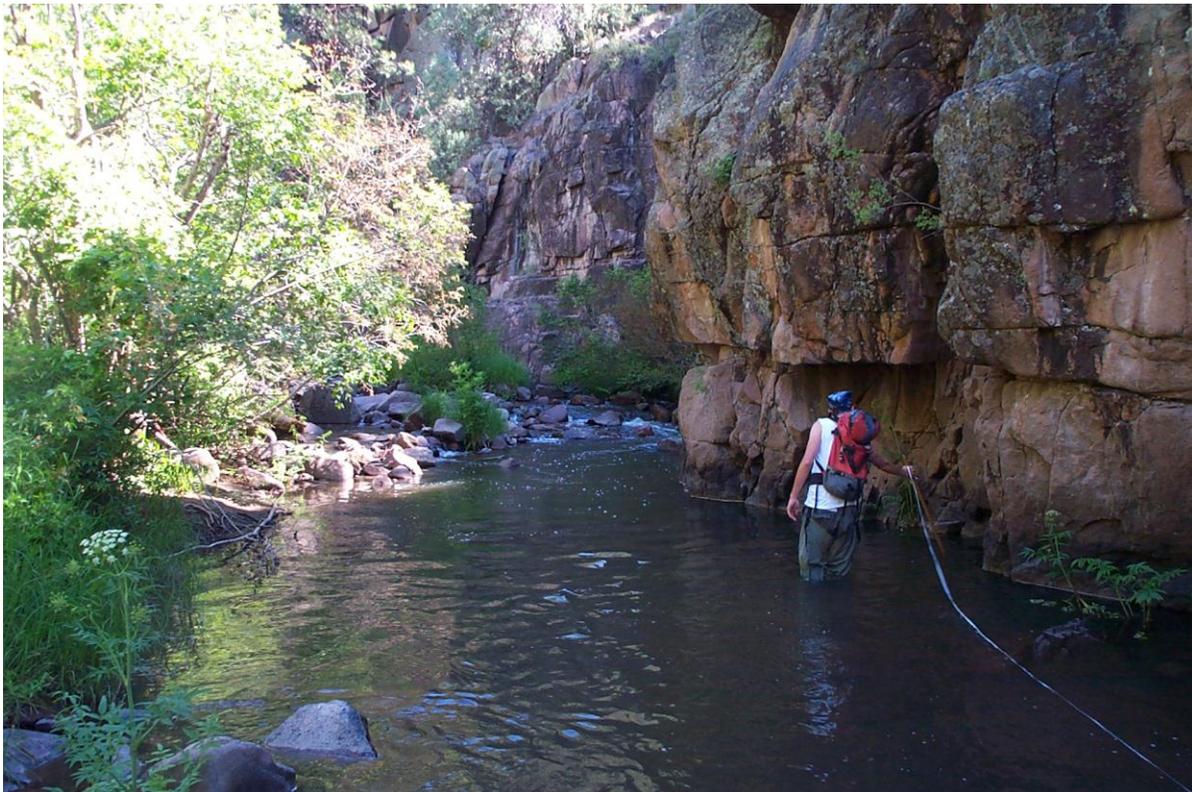
**Photo 32.** NSO121, P34. D. Hoffman surveying a pool with bedrock confinement, common throughout Reach 5 (1-July-2004).

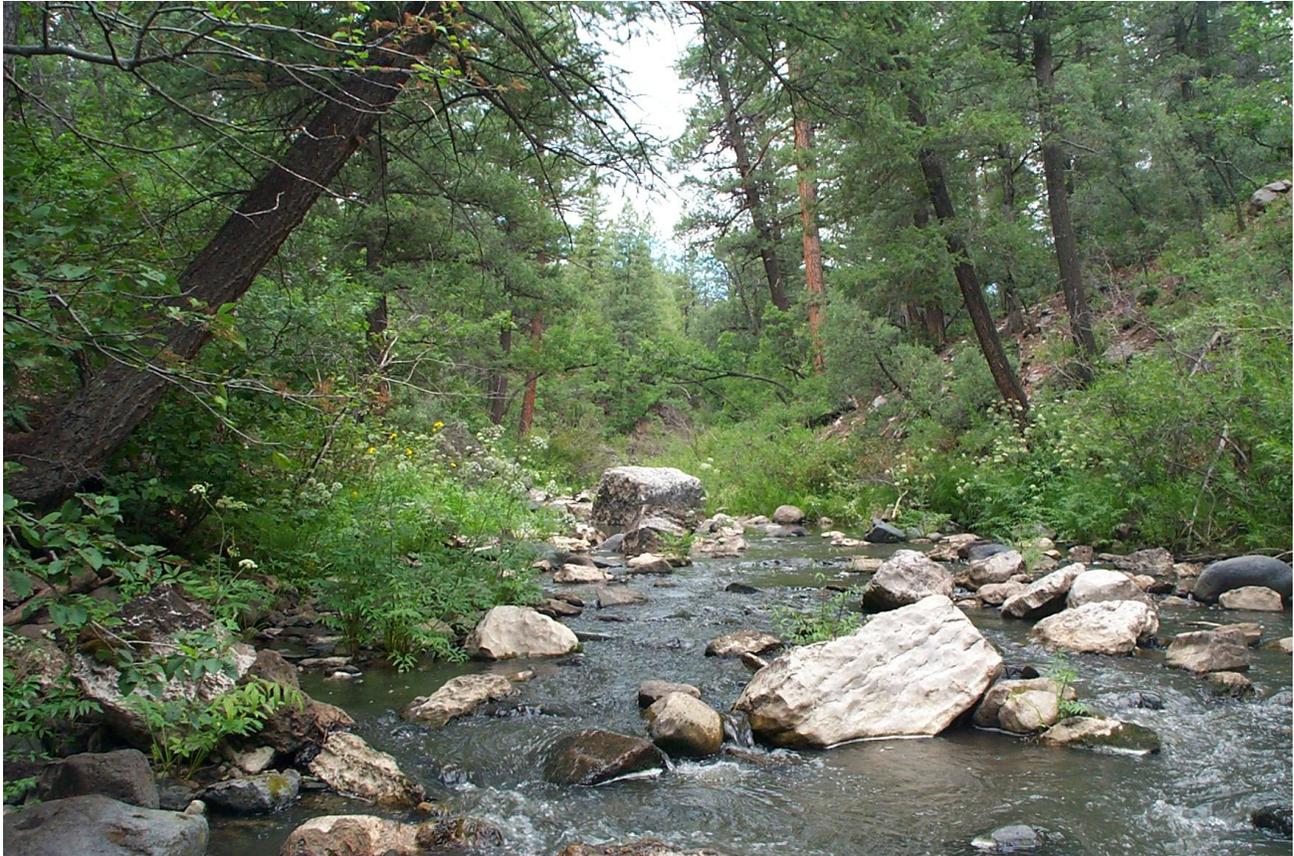
**Photo 34.** NSO 233, R126. Looking upstream at a typical riffle (21-July-2004).

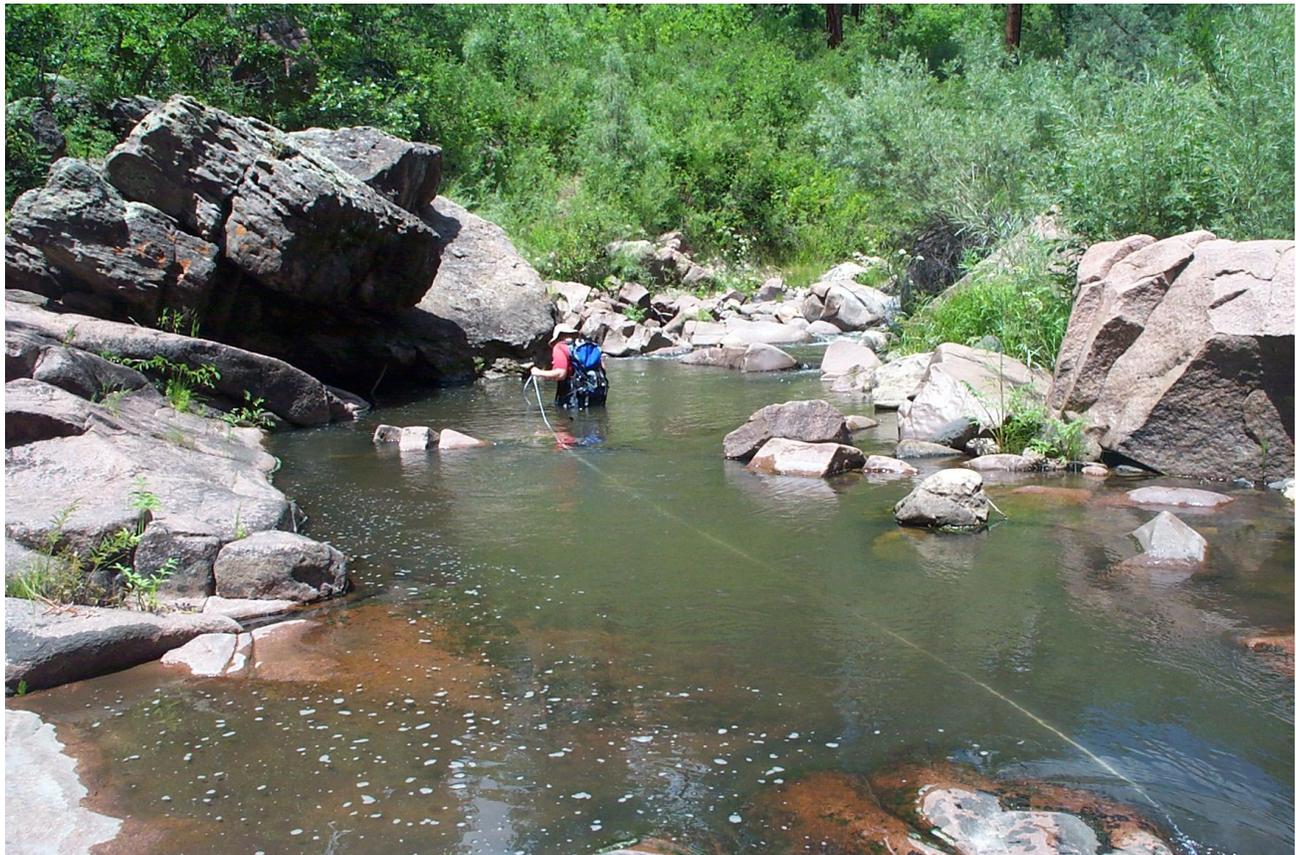
Pool habitat is related to both **properly** and **not properly functioning** matrix parameters. Pool quality is properly functioning as determined by residual depth. Average residual depth is 2.8 feet, well above the 1 foot standard. Many of the deep pools of Reach 6 are formed by large bedrock features, creating pools greater than 5 feet in depth (see Photo 35). Several small pools were created by stream improvement structures spread throughout the reach. No information is available about these structures. Pool development is **not properly functioning**. Pool development by area of pool is determined by the length of pool habitat relative to the other habitat types (see Table 34).

**Photo 35.** NSO 214, P67. Tara in a typical pool (21-July-2004).
