## Road 3015, MP 1.773 and 8.743, Thorne Bay Ranger District, Tongass National Forest

September 16, 2014

### Background

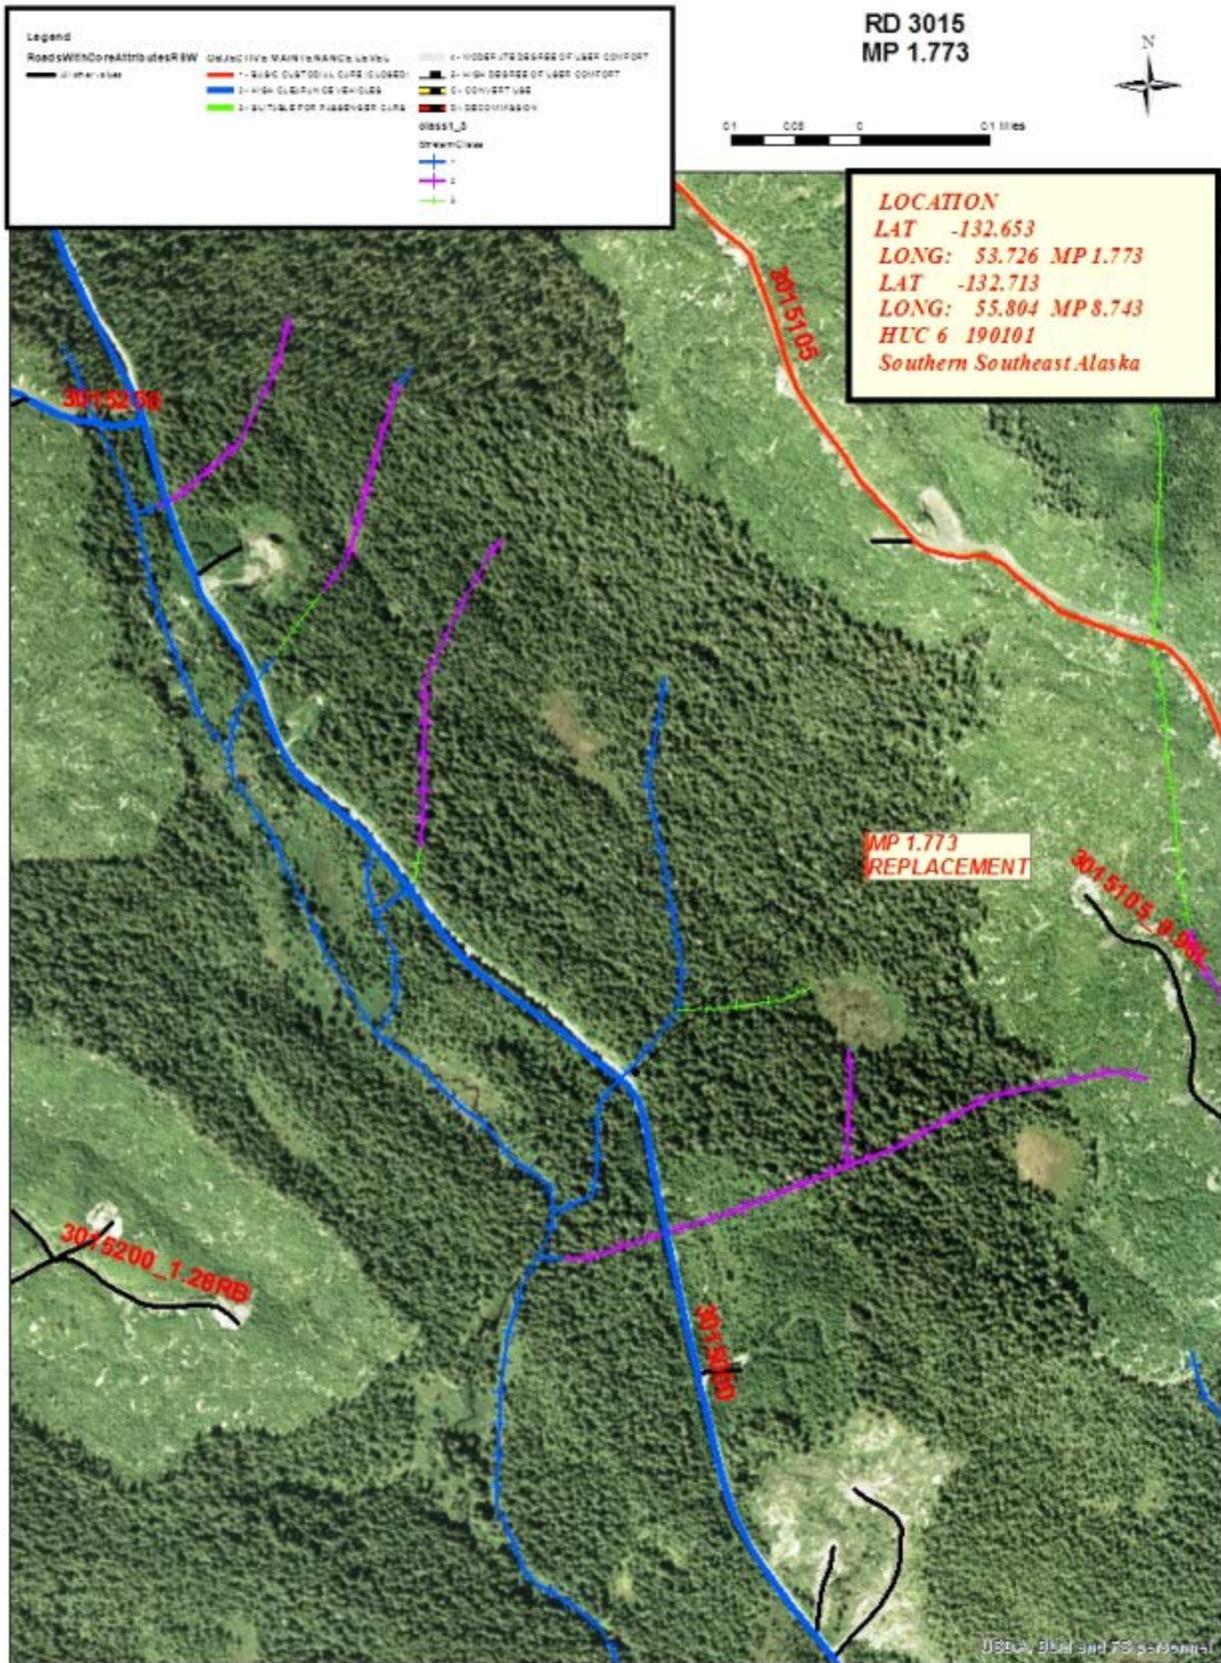
Road 3015 Figure 3. Milepost 1.773

**MP 1.773** – This culvert is three years old and was graded this year (2014). The length of road evaluated was 0.5 mile. The length of the road segment near the aquatic management zone (AMZ) was 240 feet.

**MP 1.773** – It took a year or two for rock to get into the pipe. The simplified stream simulation surcharges sediment above the pipe and the stream moves it into the pipe. This one did not fill immediately.

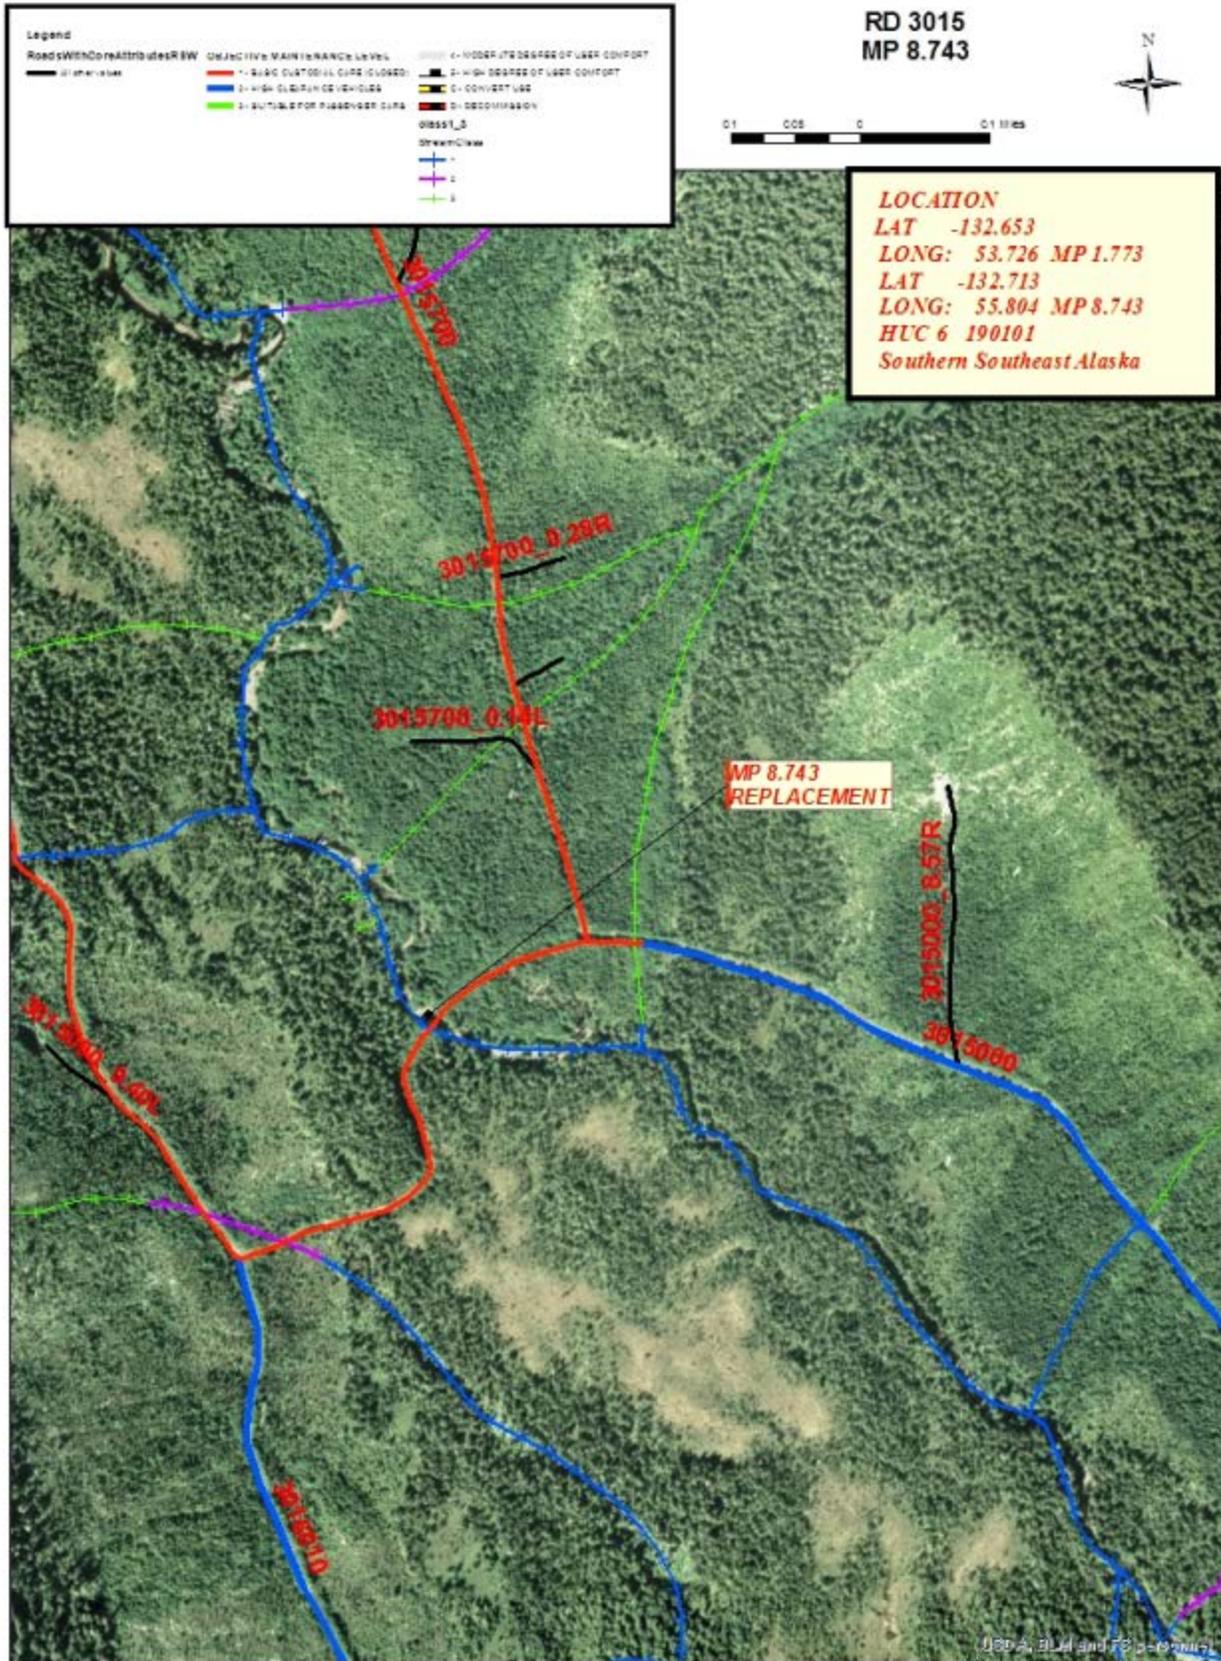
Road 3015 Figure 4. Milepost 8.743

**MP 8.743** – Reconstruction on this pipe was completed in July. Small fish were present at the pipe during this review. The length of the road segment evaluated is 532 feet. The length of the road segment near the AMZ is 280 feet. Silt fencing was used downslope of the culvert during installation.

**MP 8.743** – Stream armored at inlet to direct water into corrugated metal pipe (CMP). Also note that armoring adjacent to ditch directs water into the culvert.

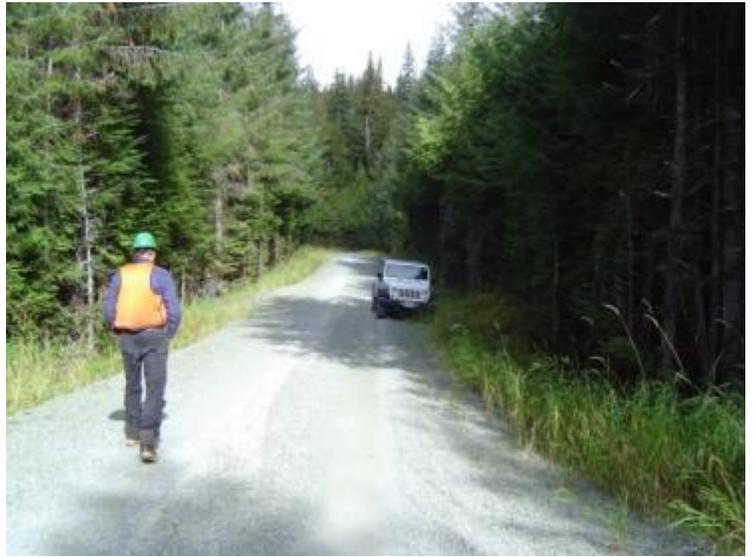
Road 3015 Photo 2. View of road surface
