**Steele Creek Roadhouse Rehabilitation, June-July 2009**

Robin O. Mills, Archaeologist  
Bureau of Land Management, Fairbanks District Office, Fairbanks, AK  
December 2009

Location: Steele Creek Roadhouse (49-EAG-00019), Fortymile river mile 22.8R

Date(s): June 25 – July 8, 2009

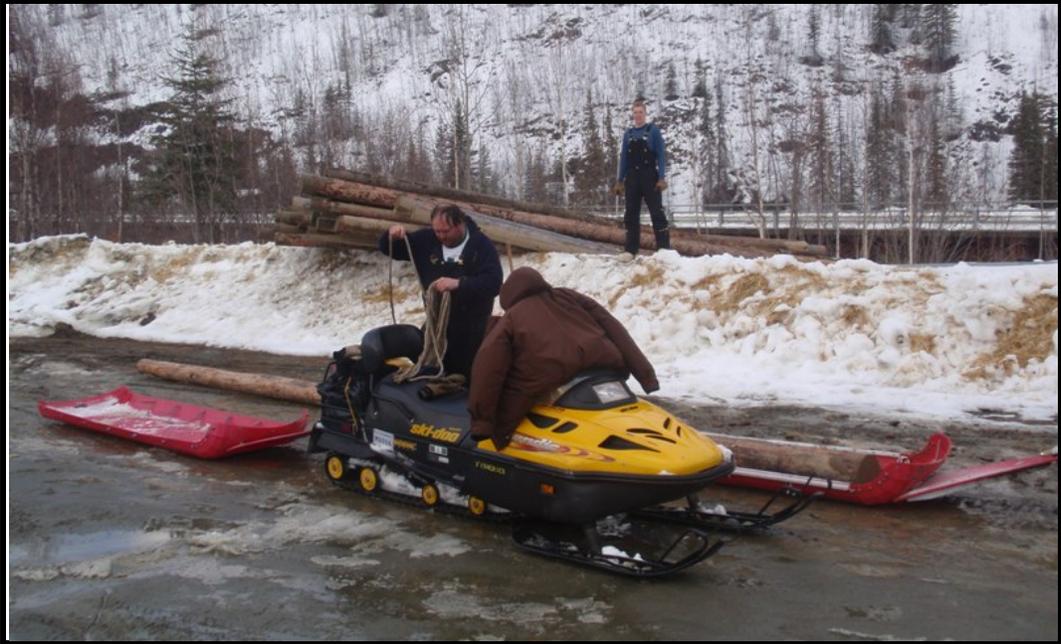
Figure 3. The logs for the summer's project were delivered in April 2009 by contract to the main bridge over the Fortymile River at Taylor Highway 112.4. BLM employees arrived and hooked the logs up on to sleds and transported them to the site, 6.6 miles downstream from the bridge.

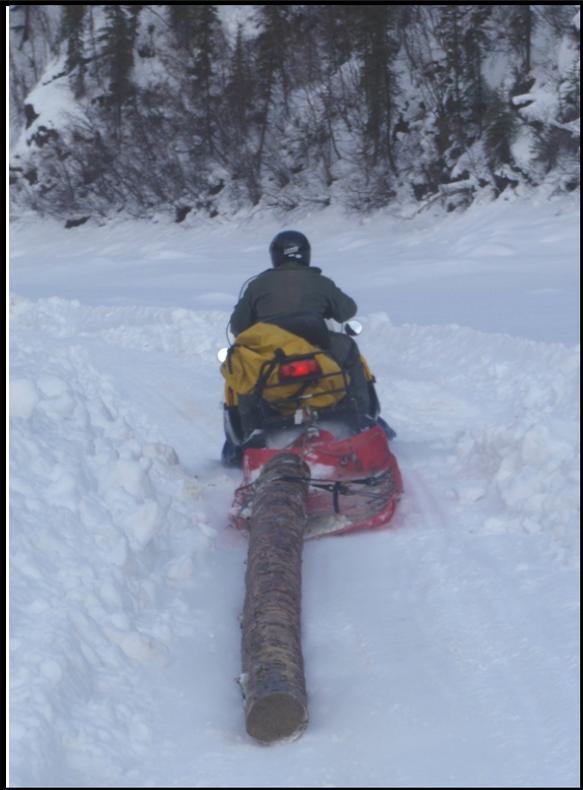
Figure 4. Transporting logs to the Steele Creek site via snowmachine over the frozen river.

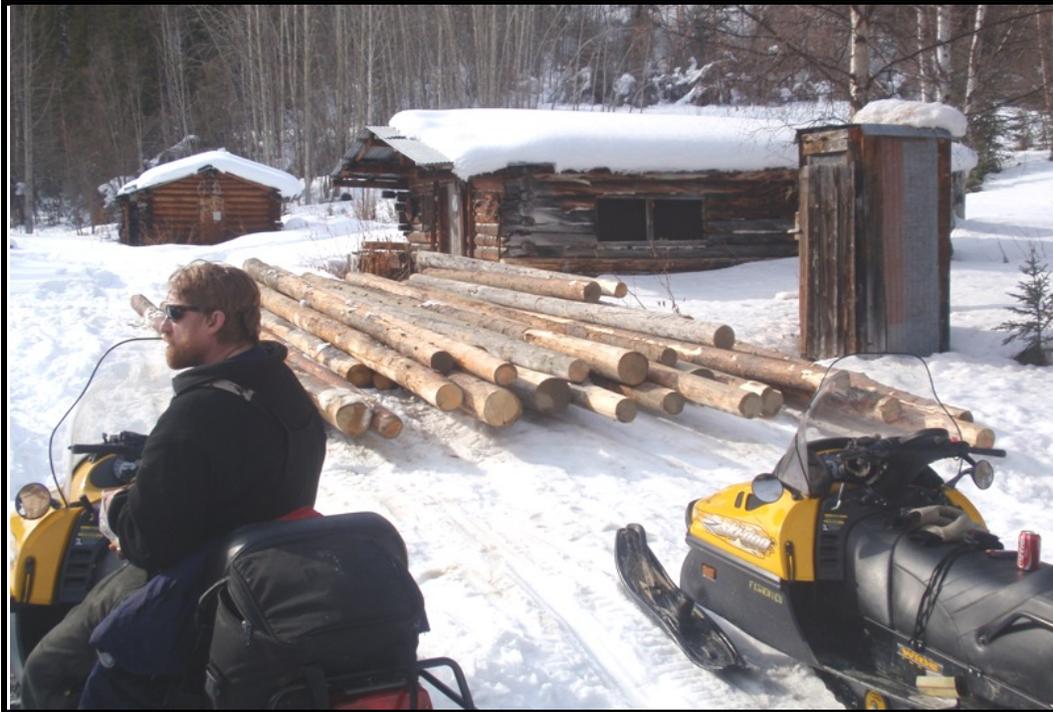
Figure 5. All logs transported to the Steele Creek site. Other single-story, single room log cabins at the site are seen in the background.

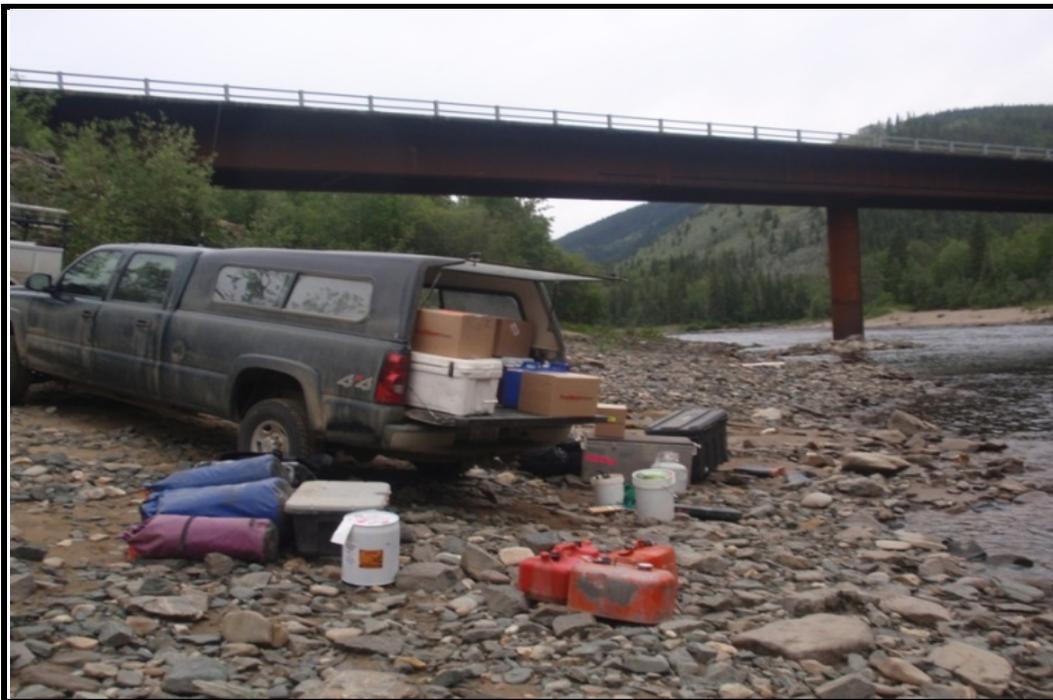
Figure 6. All gear, supplies and equipment for the summer project were delivered in June 2009 to the main Fortymile River bridge.

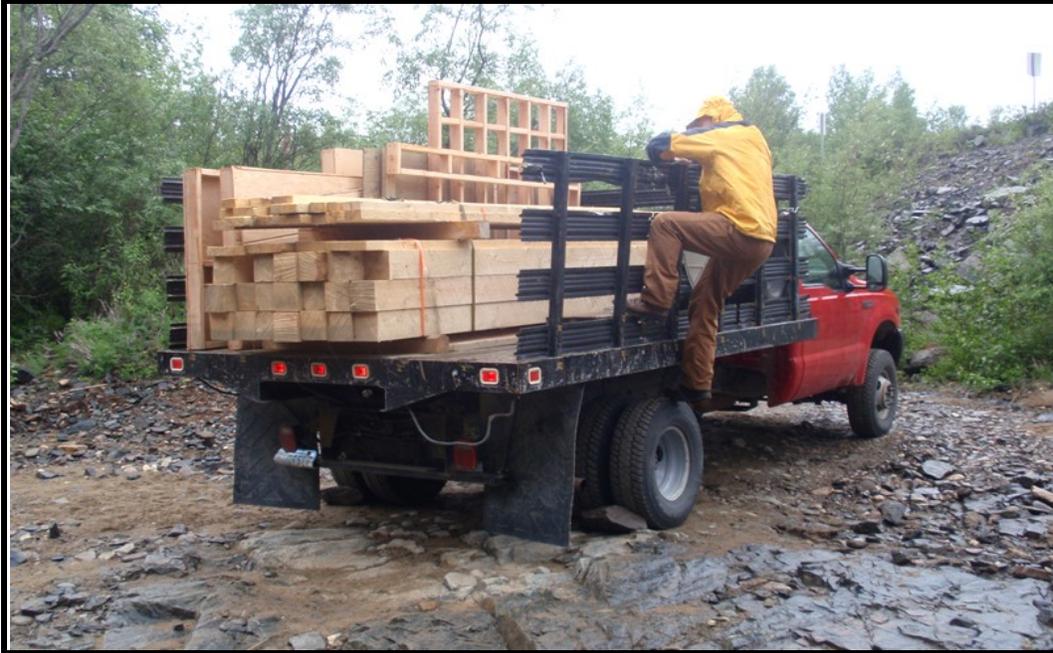
Figure 7. All gear, supplies and equipment for the summer project were delivered in June 2009 to the main Fortymile River bridge.

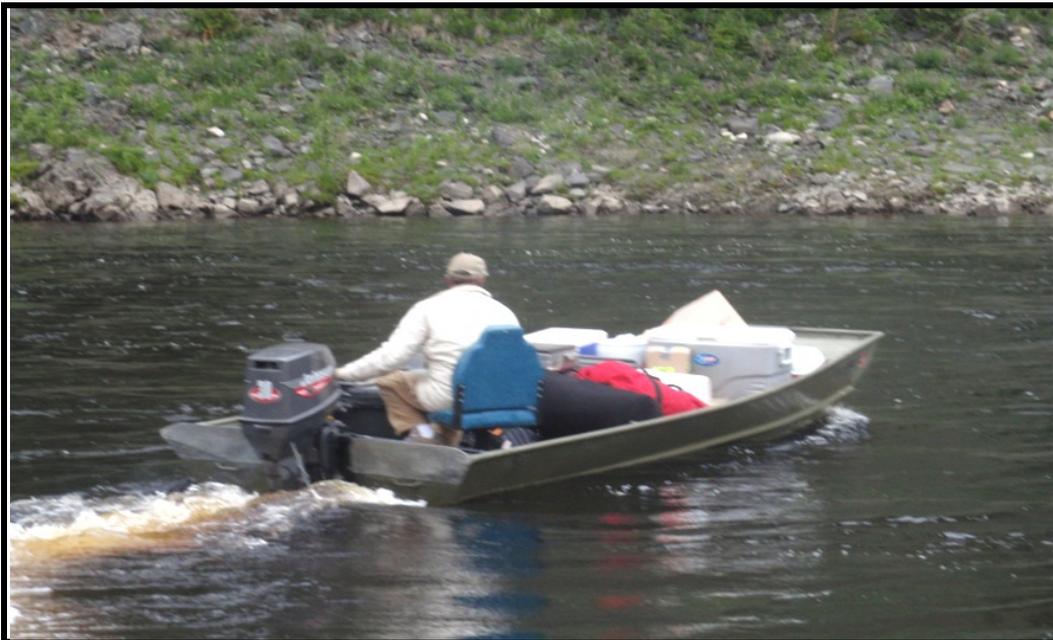
Figure 8. .... and transported to the site, 6.6 miles downstream, via river boat.
