PHOTOGRAPH LOG
Mingus Area

Project Name: USFS Preliminary Assessment/Site Inspection (PA/SI)	Site Location: Prescott National Forest, Yavapai County, Arizona	Project No. 12767.204.001
---	--	-------------------------------------

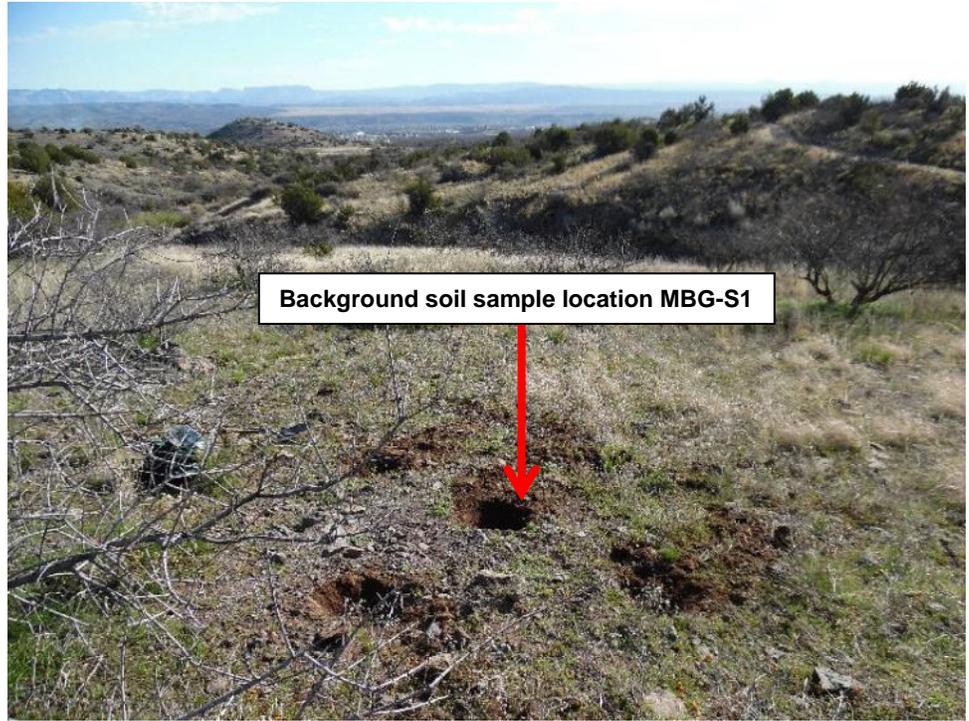
Photo No. 1	Date: 3/9/2015
------------------------------	--------------------------

Description: Background soil sample location MBG-S1.
--

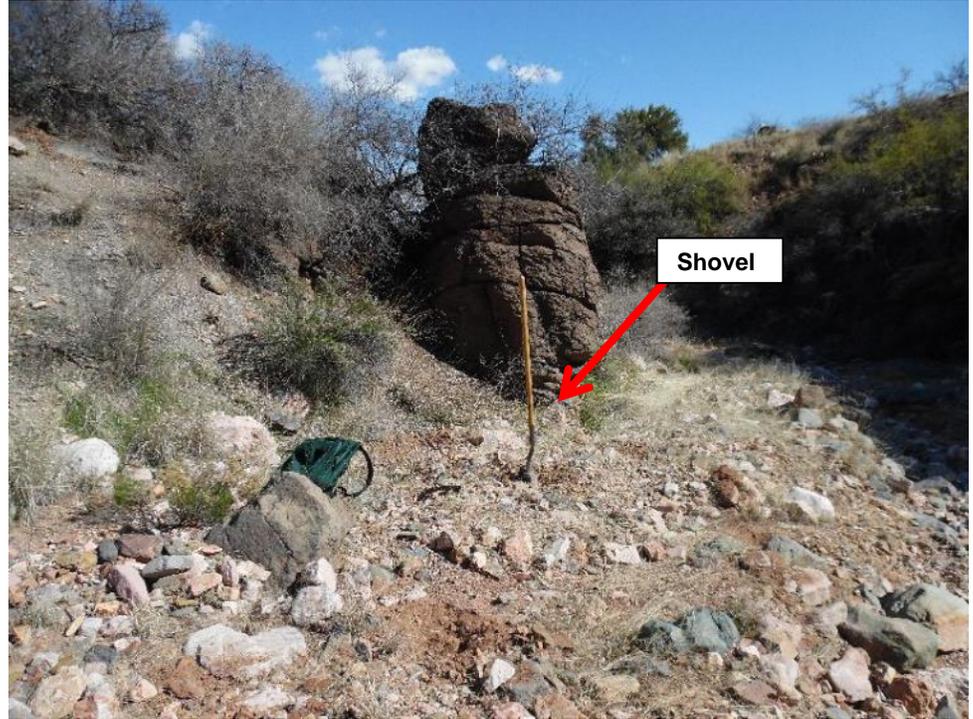
Photo No. 7	Date: 3/9/2015
Direction Photo Taken: Northeast

Description:
Background sediment sample location MBG-Sed1, marked by the shovel

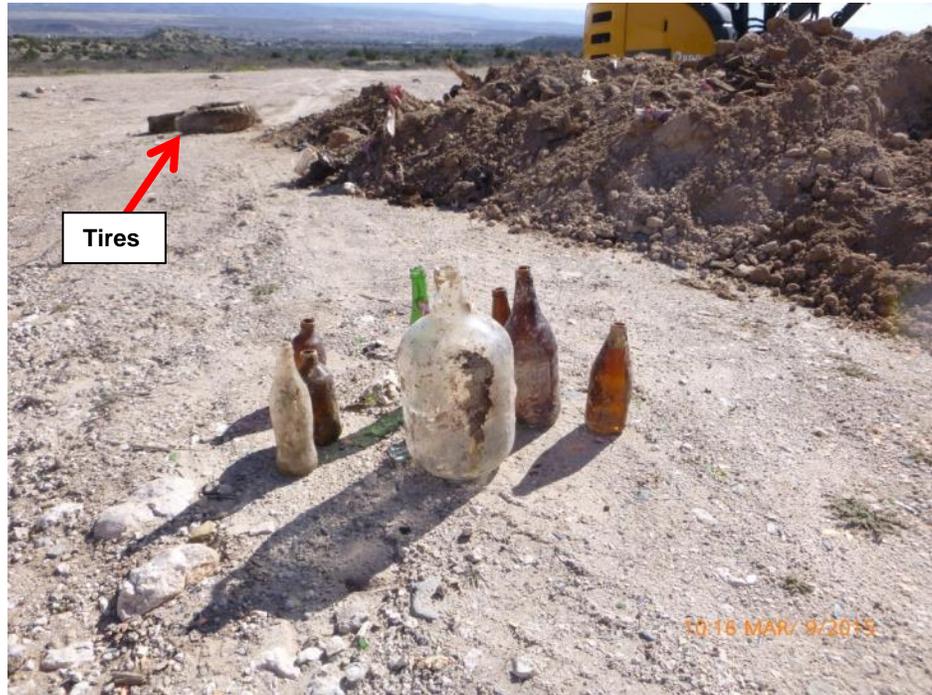
Photo No.
23

Bottles and tires excavated from MA1-ES3.

Tires were removed from the Site by the USFS and disposed at the local landfill.

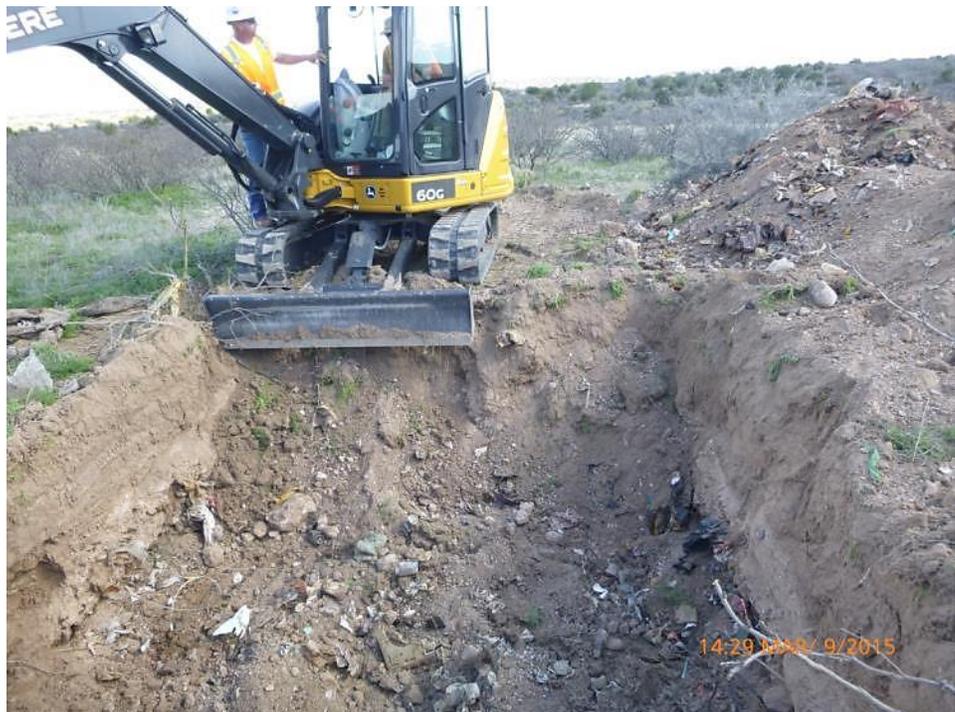
The east wall of MA1-ES5, Area 1. Heavy trash/debris is visible in the test pothole and to the right of the photo. Trash/debris included various glass and plastic bottles and plastic bags.

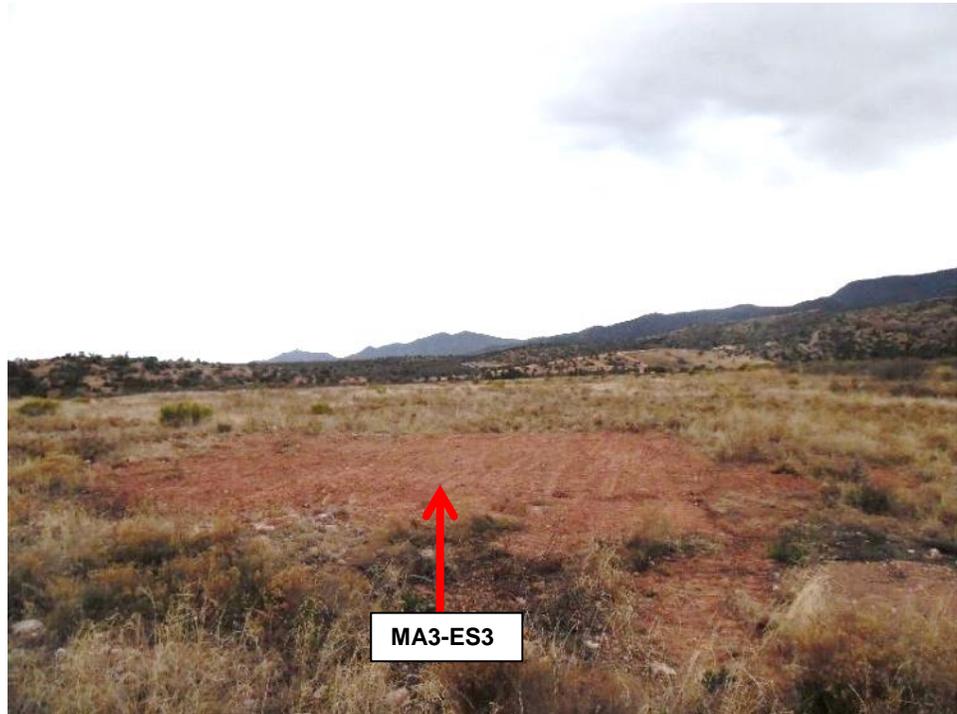
Area 3 overview, with MA3-ES3 pictured in the foreground post excavation and refill.

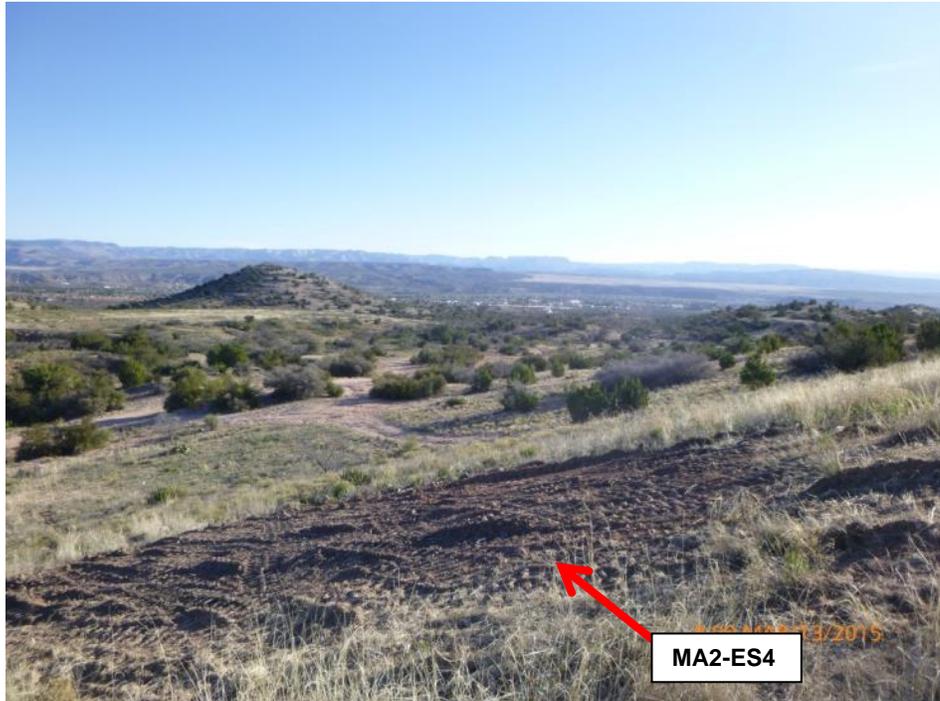
Area 2 overview, with MA2-ES4 pictured in the foreground post excavation and refill.
