CTWS/BPA Final Project Reporting Outline

2. **Camp Creek Headwaters Project 2016**

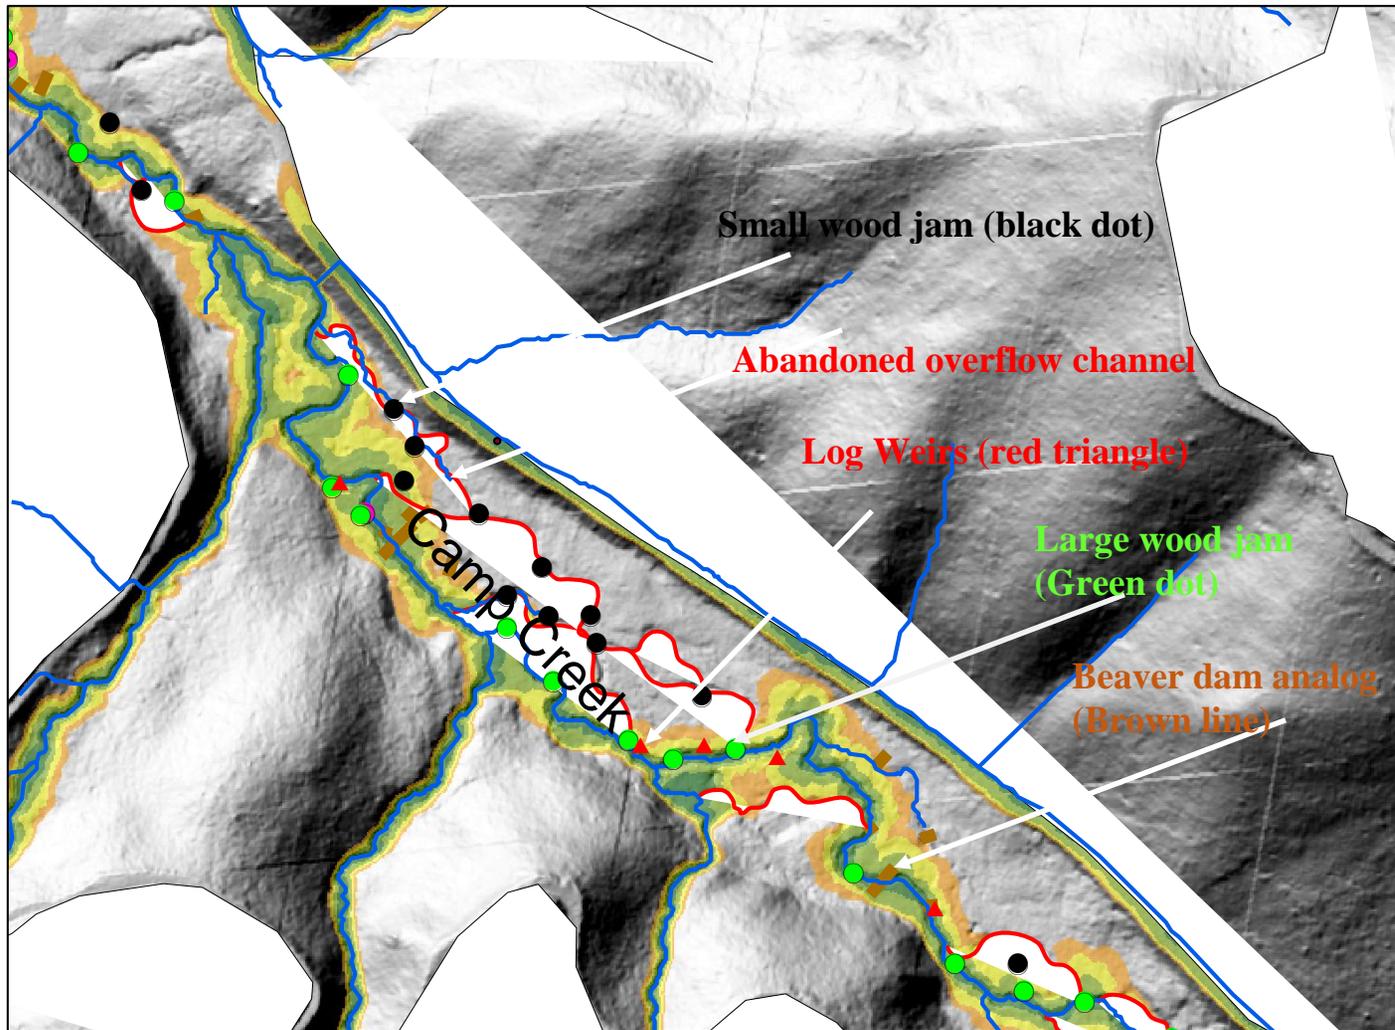
Figure 6 : Camp Creek within project area in 1970s.

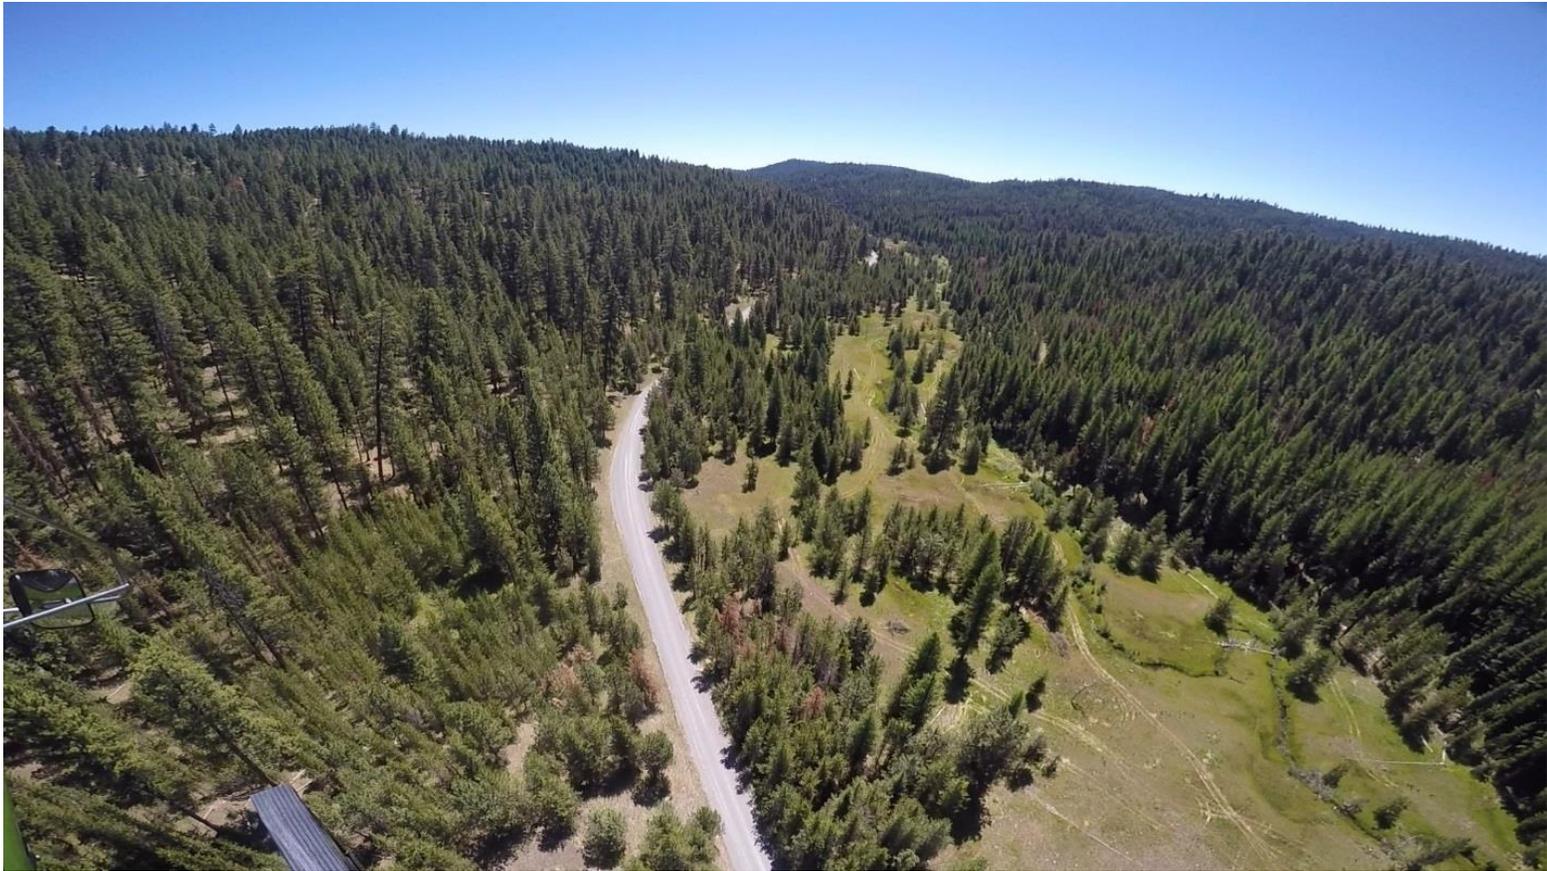
Figure 31 : Aerial overview of Camp Creel Headwaters 2016 project area. The entire project areas was flown by helicopter prior to beginning instream work and video taken with a Go Pro Camera of specific areas. Tracks visible in meadow are from moving/staging BDA posts with UTV. The entire project area will be re-flown during spring 2017 during high flows

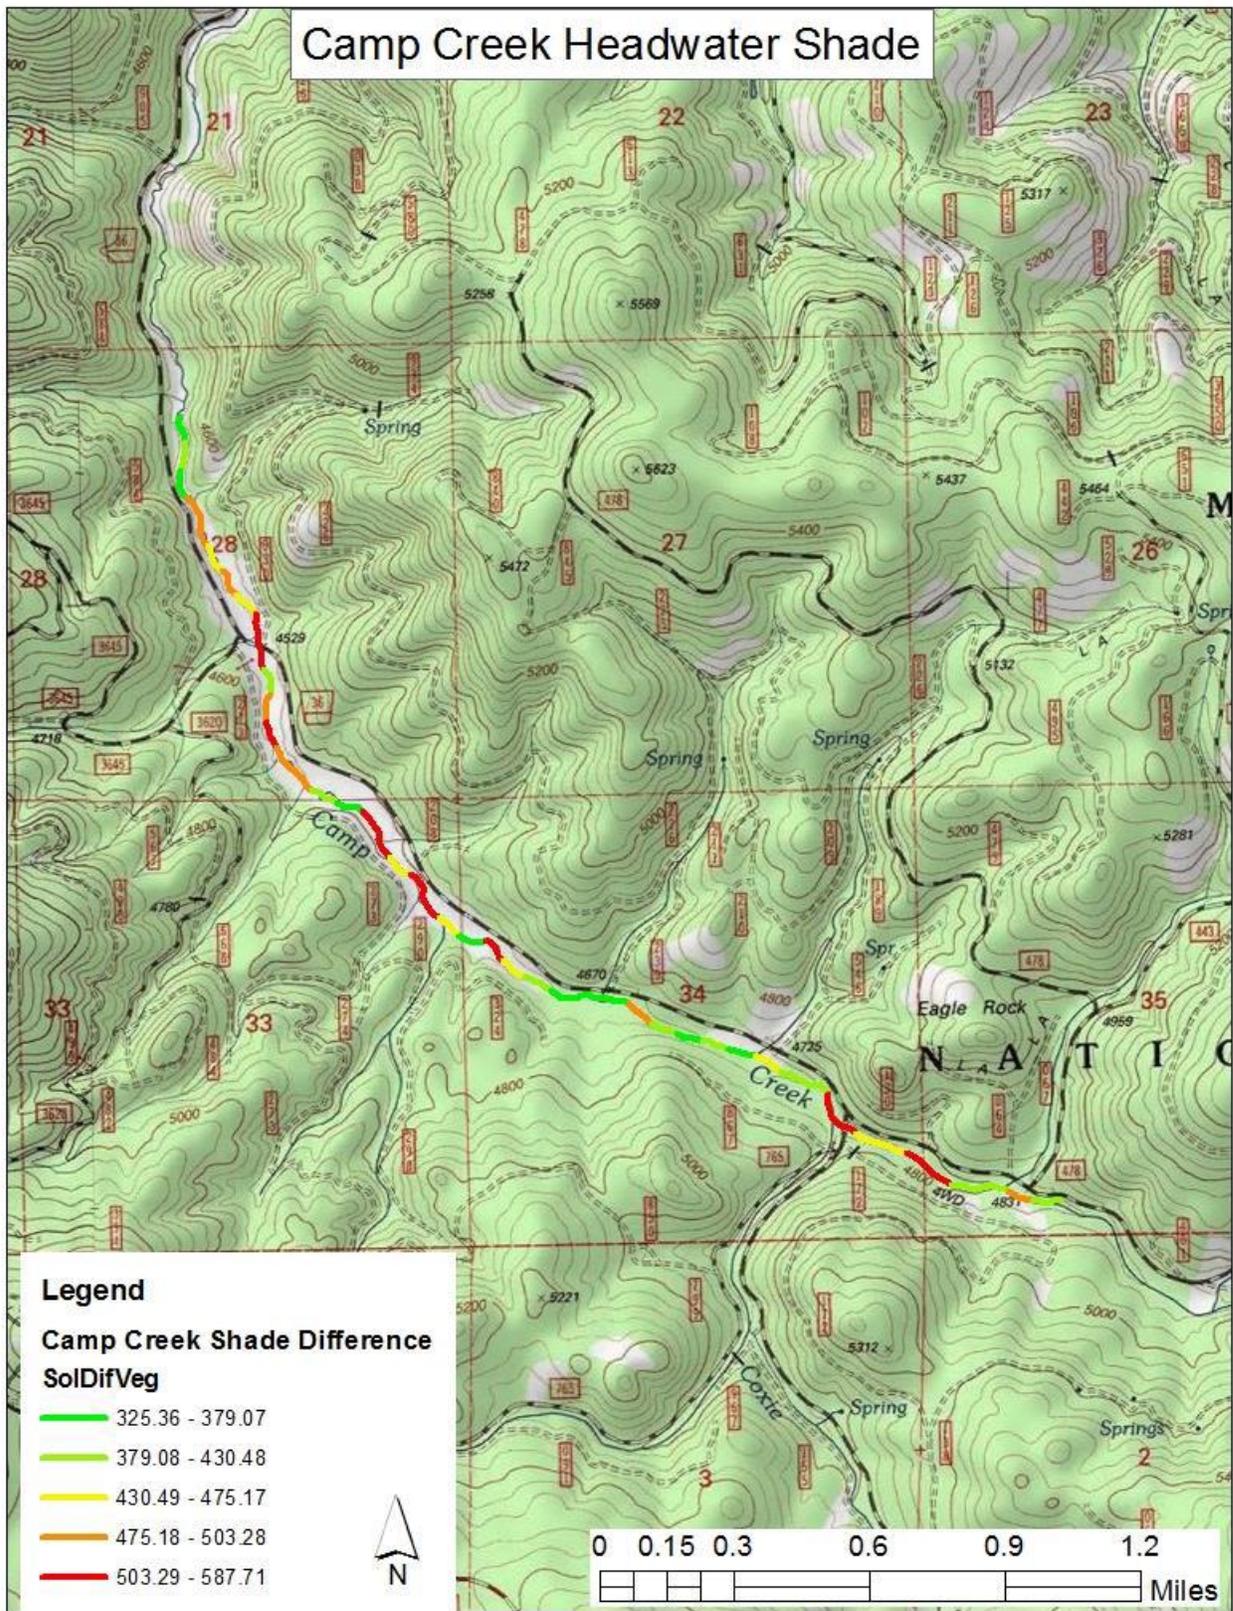
Willow planting involved the same procedure as cottonwood however in some patches we were able to use an auger instead of a bucket. Willow planting was not continuous but in specific “patches” identified within the most thermally sensitive areas (Figure 34) in the 4 mile project area where restoration of shade would provide the greatest effect. Structures placed adjacent to these patches specifically were designed to elevate the water table and facilitate deposition thus increasing the likelihood of expansion of the “patches”. The willow patches were fenced using hog panels to include multiple clusters of willows.

Figure 34: Solar radiation from a desired willow future condition minus topographical shade to illustrate areas where vegetative shade would have the most effect within Camp Creek Headwaters Project Area (red areas). These areas were focused on for hardwood planting/sediment deposition and riparian hardwood expansion.
