October 2017

# Still Creek Watershed Restoration Completion Report

**Mt. Hood National Forest  
Zigzag Ranger District**

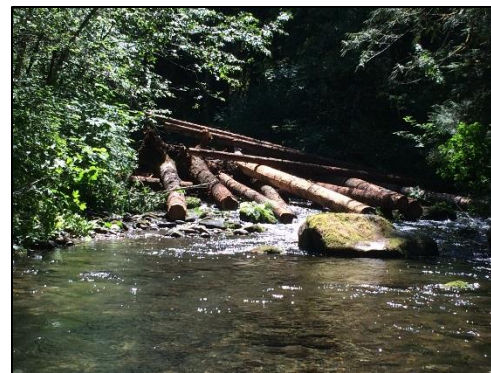
Restoration actions included the addition of an estimated 2,300 wood pieces throughout the project areas, including at least 300 key pieces of wood. Over 84% of these wood pieces were used to construct approximately 240 log jam structures (Figure 5), designed to promote the deposition and retention of spawning gravels, the formation of slack water and pool habitats, and the reactivation of historic side channels and floodplain habitats. Large wood pieces were sourced from hazard tree removal, debris clean up along highways, forest thinning operations, standing riparian trees, and from debris removal from reservoirs in the Bull Run watershed. Wood was added to the stream either by cabling over standing riparian zone trees directly into the river, flying in wood via helicopter (Figure 4), or dragging trees into the river via skidder through the creation of temporary skid roads.

**Figure 5.** An example of a channel spanning restoration log jam in the Cabins project area. Photo is facing upstream.

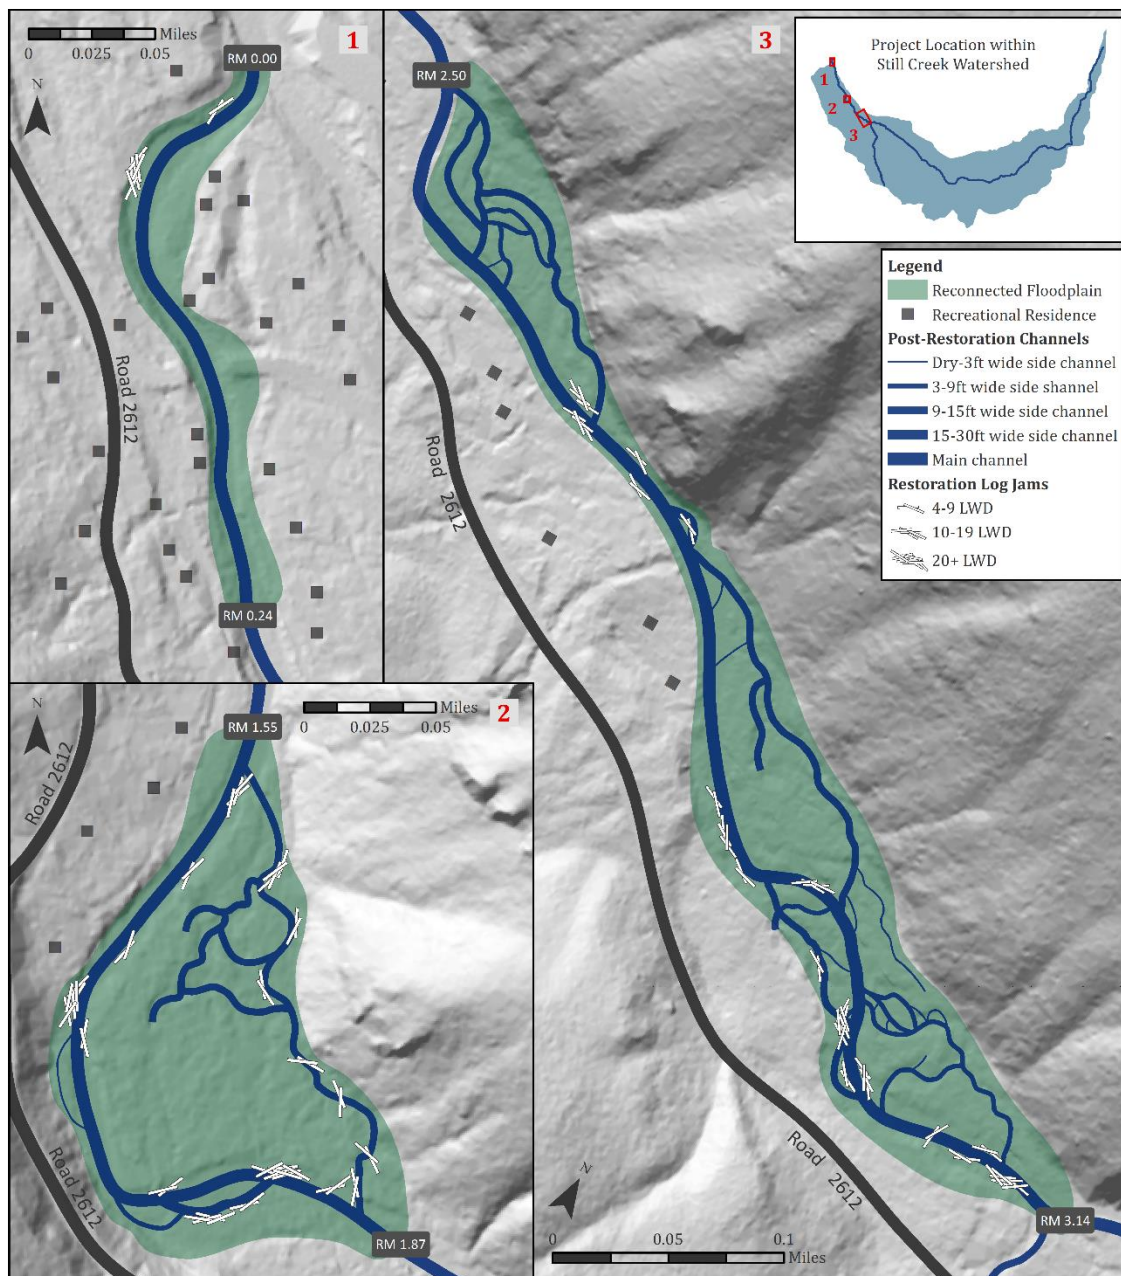
Key outcomes for this area were realized with the reactivation or improvement of nearly 1.7 miles of side channel habitat (Figure 15) and the creation of three new pools through LWD additions and excavation. The area now nearly meets (>75% of target), meets, or exceeds five out of ten objectives for which data were available (Box 1)<sup>2</sup>. It is expected that objectives not currently being met will continue to improve as natural river processes continue to create and deepen pools, increase channel sinuosity, and decrease thalweg gradient.

**Figure 15.** The lower (1), middle (2), and upper (3) Cabins project areas and their location within the Still Creek watershed, showing post restoration side channels, estimated active floodplain, and the location of major restoration logjams. Note: only log jams containing 4 or more pieces of LWD are represented on this map.

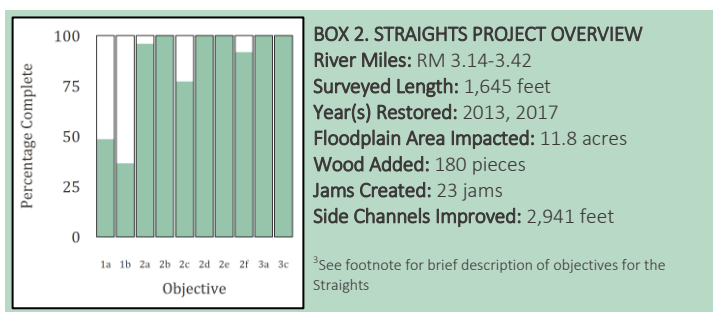
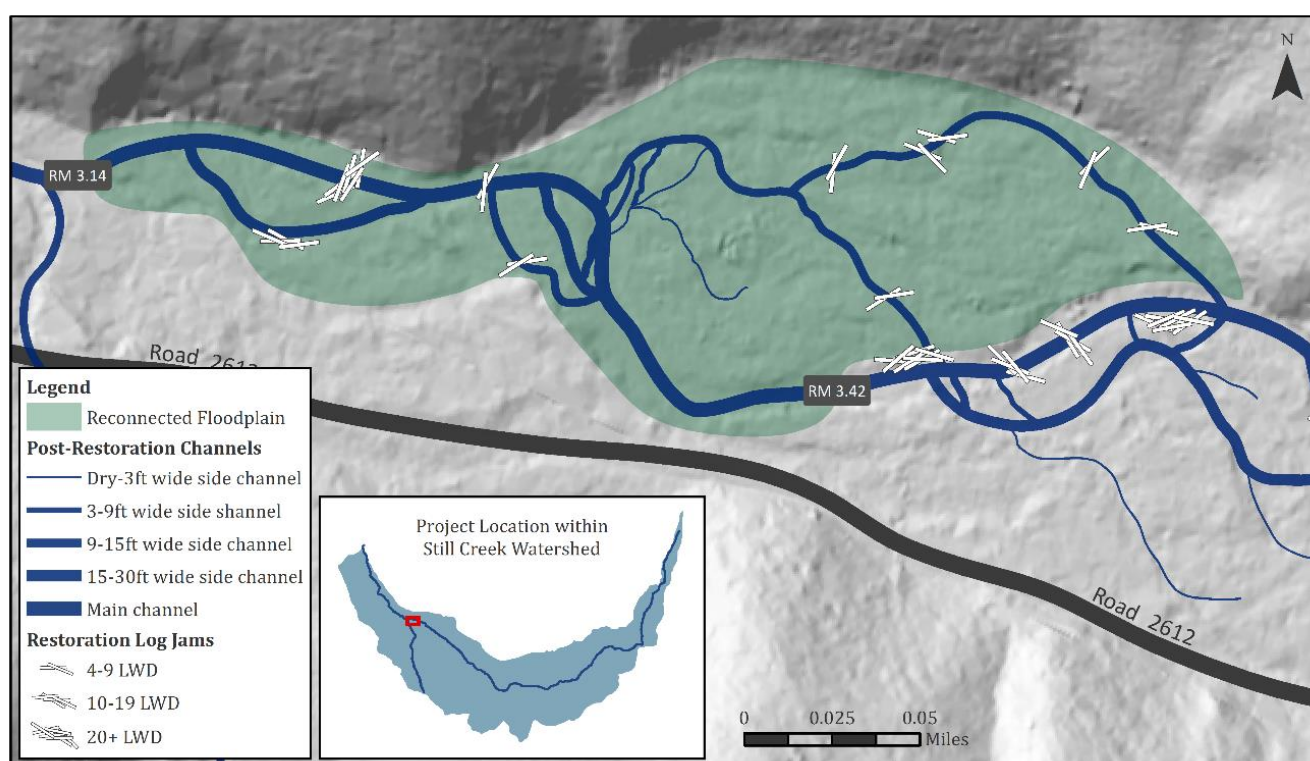
**Actions** | Restoration in the Straights project area occurred in the summers of 2013 and 2017. Approximately 180 pieces of large woody debris were placed in 23 jams both in the main channel and in the side channels of the Straights project area (Figure 16). Excavators removed a berm in the upper portion of the project area to reconnect a nearly 800 foot long historic side channel.

Key outcomes for the area were realized with a sinuosity increase to 1.39 and a reduced thalweg gradient to 3.6%. Floodplain roughness was increased through the addition of 127 pieces of large wood debris to the floodplain, and off channel habitat was increased through the re-activation or improvement of 2,941 feet of side channels. The Straights now has among the highest spawning gravel densities in the Still Creek watershed, with over 2,600 square yards of spawning gravels per river mile. Straights project area now nearly meets (>75% of target), meets, or exceeds eight out of ten objectives for which data are available (Box 2)<sup>3</sup>. The two objectives (1a and 1b) not met pertain to densities of key pieces of LWD; however, all other evidence indicates that current levels are promoting naturally dynamic river processes. In total, an estimated 11.8 acres of floodplain habitat were restored.

**Figure 16.** The Straights project area and its location within the Still Creek watershed, showing post restoration side channels, estimated active floodplain, and the location of major restoration log jams. Note, only log jams containing 4 or more pieces of LWD are represented on this map.

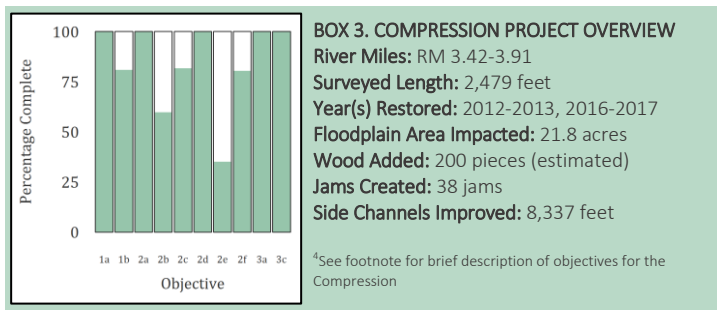
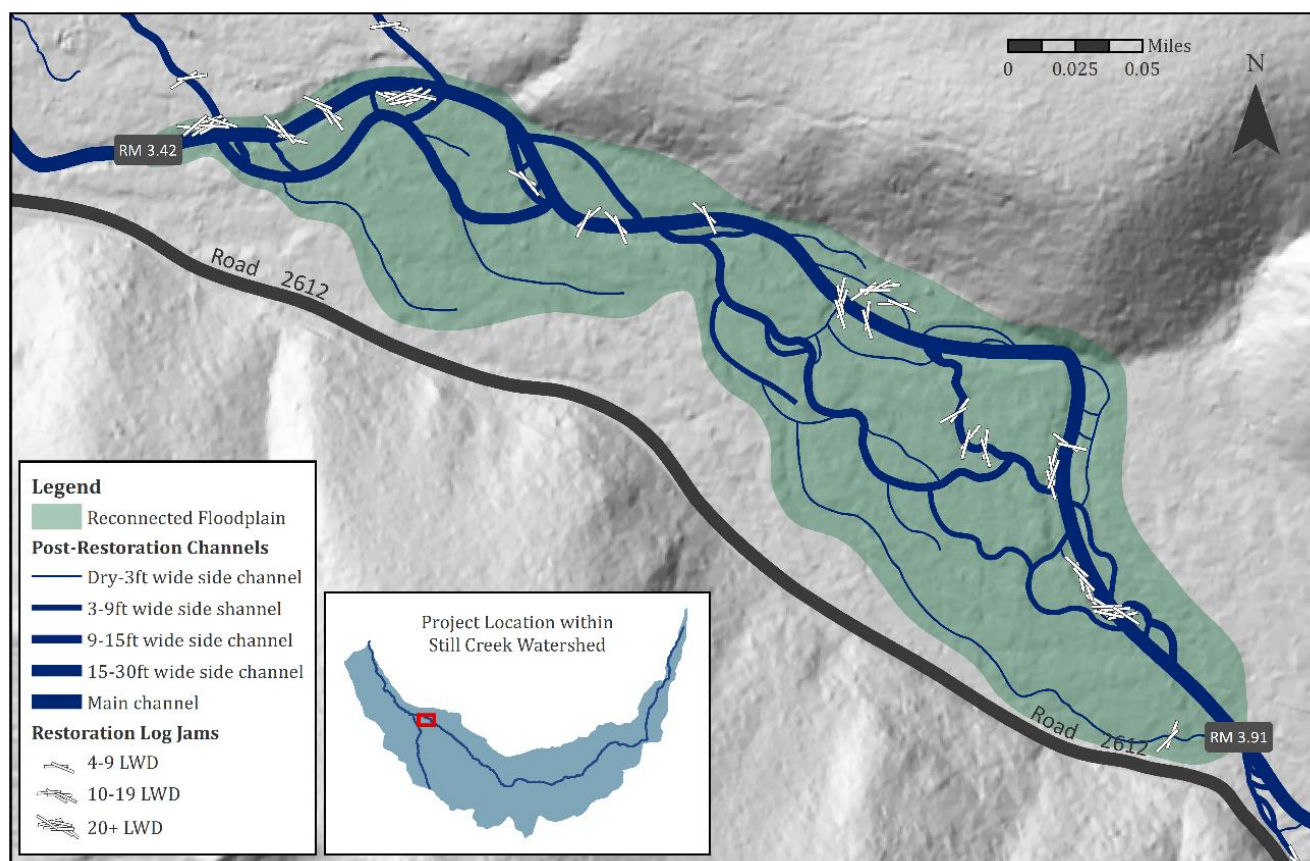
**Actions** | Restoration actions in the Compression project area occurred in the summers of 2012, 2013, 2016, and 2017. Approximately 200 pieces of LWD were placed in 38 jams both in the main channel and in the side channels. Excavators removed a riprap and berms in several locations on the river left floodplain to open an extensive side channel network. In total, an estimated 21.8 acres of floodplain habitat were restored.

**Figure 17.** The Compression project area and its location within the Still Creek watershed, showing post restoration side channels, estimated active floodplain, and the location of major restoration logjams. Note, only log jams containing 4 or more pieces of LWD are represented on this map. Side channels on the floodplain that do not connect to another channel on both ends represent groundwater side channels and their source on the floodplain.

Key outcomes for the area were realized with the creation or improvement of nearly 1.6 miles of side channel habitat. Several side channels were fed entirely by groundwater, indicating that groundwater tables have risen (Figure 17). Five new pools were recorded in the main channel, and numerous additional pools throughout side channels, indicating an increase in both pool density and volume. The addition of large wood and jam structures provide additional hiding

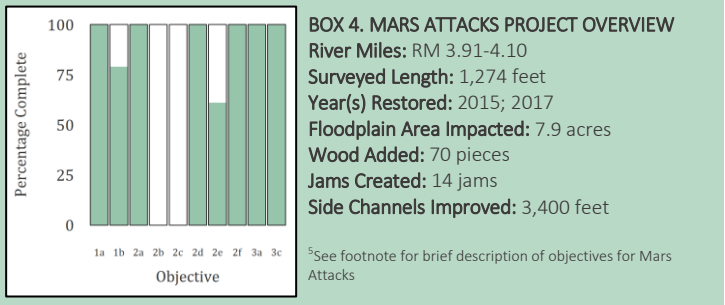
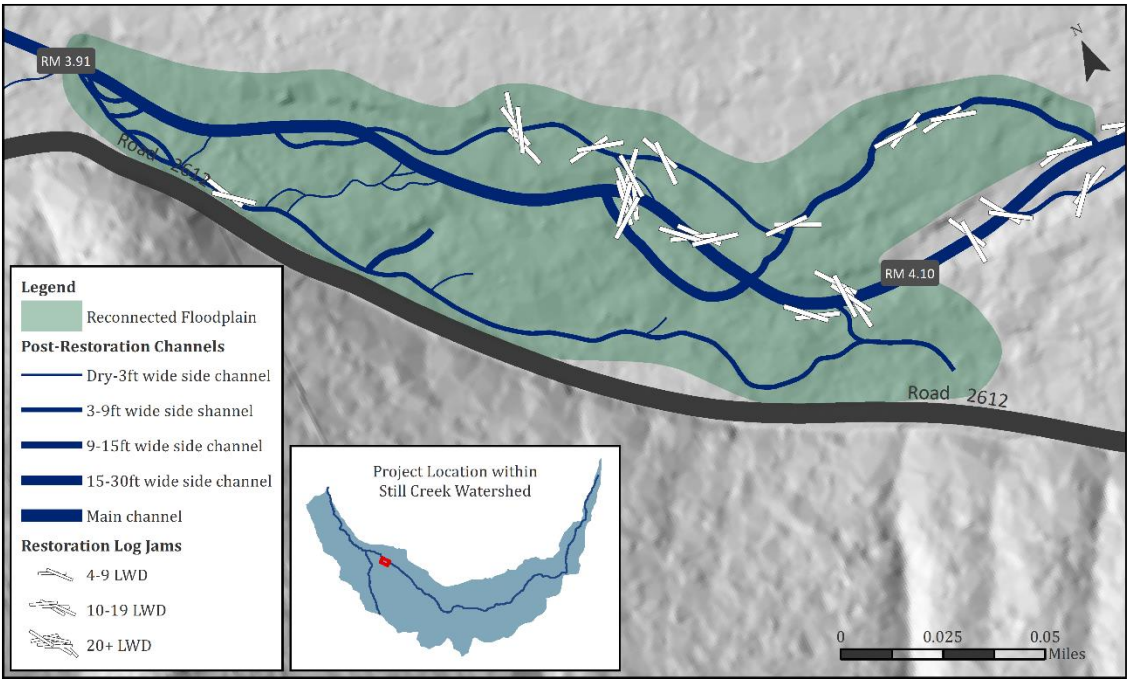
**Actions |** Restoration actions in the Mars Attacks project area occurred in the summers of 2015 and 2017. Approximately 70 pieces of large woody debris were placed in 14 jams both in the main channel and in the side channels (Figure 18). Several large pieces of wood were placed along the FS 2612 road to protect the road from erosion during winter flooding. In total, an estimated 7.9 acres of floodplain habitat were restored.

**Figure 18.** The Mars Attacks project area and its location within the Still Creek watershed, showing post restoration side channels, estimated active floodplain, and the location of major restoration logjams. Note, only log jams containing 4 or more pieces of LWD are represented on this map.

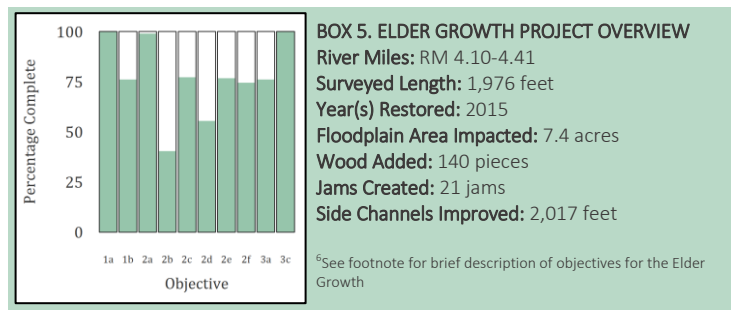
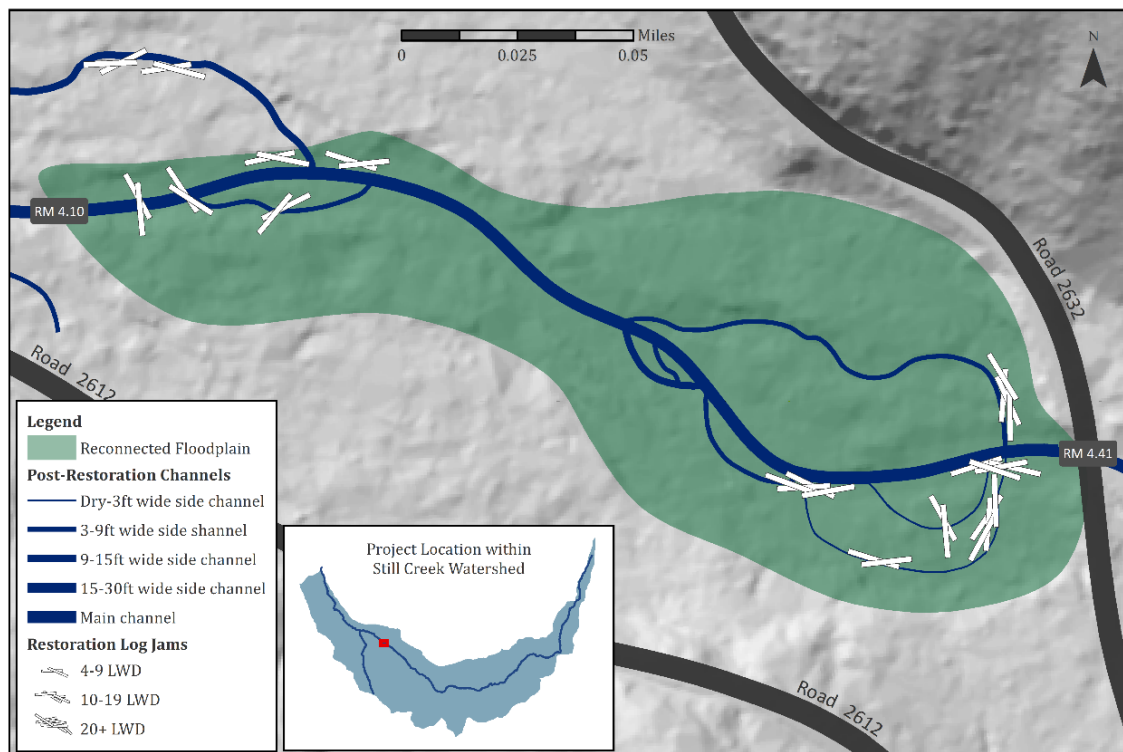
**Figure 19.** The Elder Growth project area and its location within the Still Creek watershed, showing post restoration side channels, estimated active floodplain, and the location of major logjams. Note, only log jams containing 4 or more pieces of LWD are represented on this map.

**Actions** | Restoration actions in the Elder Growth project area occurred in the summer of 2015. Approximately 140 pieces of large woody debris were placed in 21 jams both in the main channel and in the side channels (Figure 19).

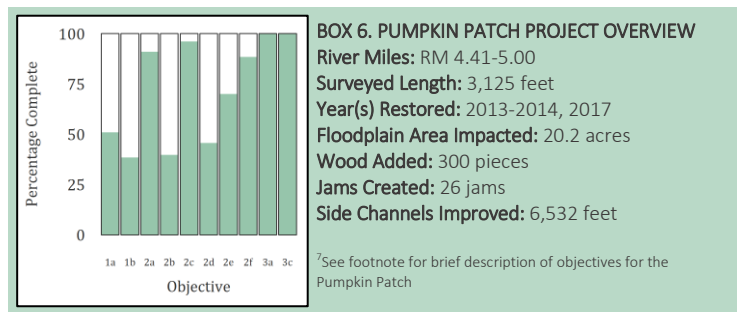
**Figure 20.** (A) A log structure slows winter high flows down the main channel, outlined in red box. Photo is facing downstream. (B) A log structure and removed riprap push water onto the floodplain, outlined in red box. Photo is facing downstream.

**Actions** | Restoration in the Pumpkin Patch project area occurred primarily in the summers of 2013, 2014 and 2017. Approximately 300 pieces of LWD were placed in 26 jams (Figure 21) both in the main channel and in the side channels (Figure 20). Berms were removed and log jams installed to guide water into a large 800 foot long side channel, which now contains approximately 20% of the river's flow. In total, an estimated 20.2 acres of floodplain habitat were restored.

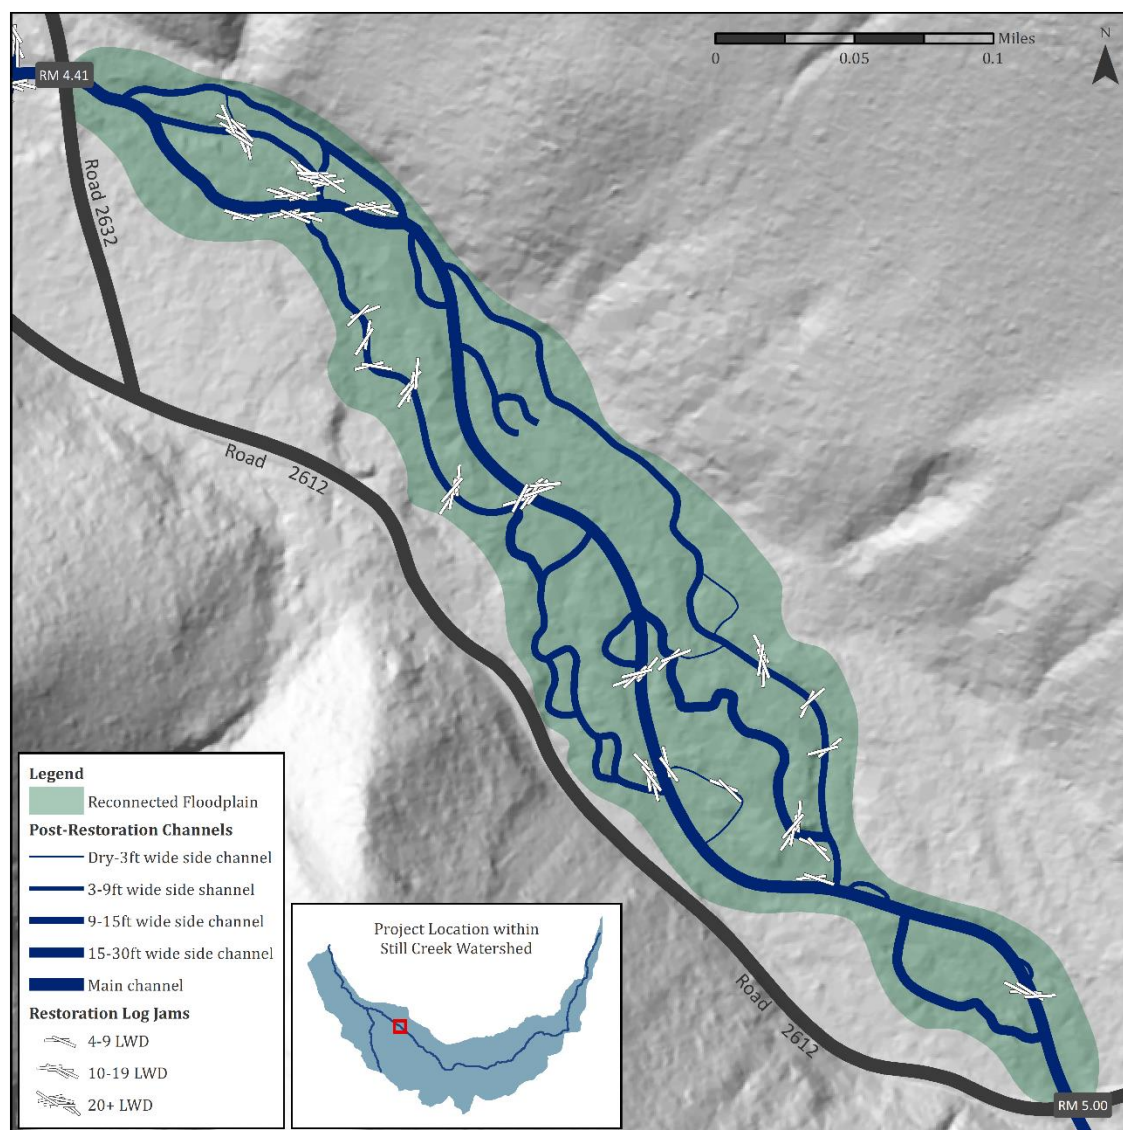
**Figure 21.** The Pumpkin Patch project area and its location within the Still Creek watershed, showing post restoration side channels, estimated active floodplain, and the location of major logjams. Note, only log jams containing 4 or more pieces of LWD are represented on this map.

Key outcomes for the area were realized through the reconnection or improvement of more than 1.2 miles of side channel habitat, which now provides substantial off-channel and over-wintering habitat for juvenile salmonids. Main channel pool density increased from 13.6 to 23.7 pools per river mile, and the reactivation of the floodplain now provides access to 9 pools counted throughout the floodplain. The Pumpkin Patch project area now nearly meets (>75% of target), meets, or exceeds five out of ten targets listed for the area (Box 6)<sup>7</sup>. Key piece LWD density (objectives 1a and 2a), primary pool density (objective 2b), and spawning gravel densities still remain below target values, but these are all expected to increase with time. Likewise, sinuosity (objective 2e) is still below the target of 1.2. The improvement in this reach are expected to enhance the existing production potential and restore high quality salmonid rearing habitat.

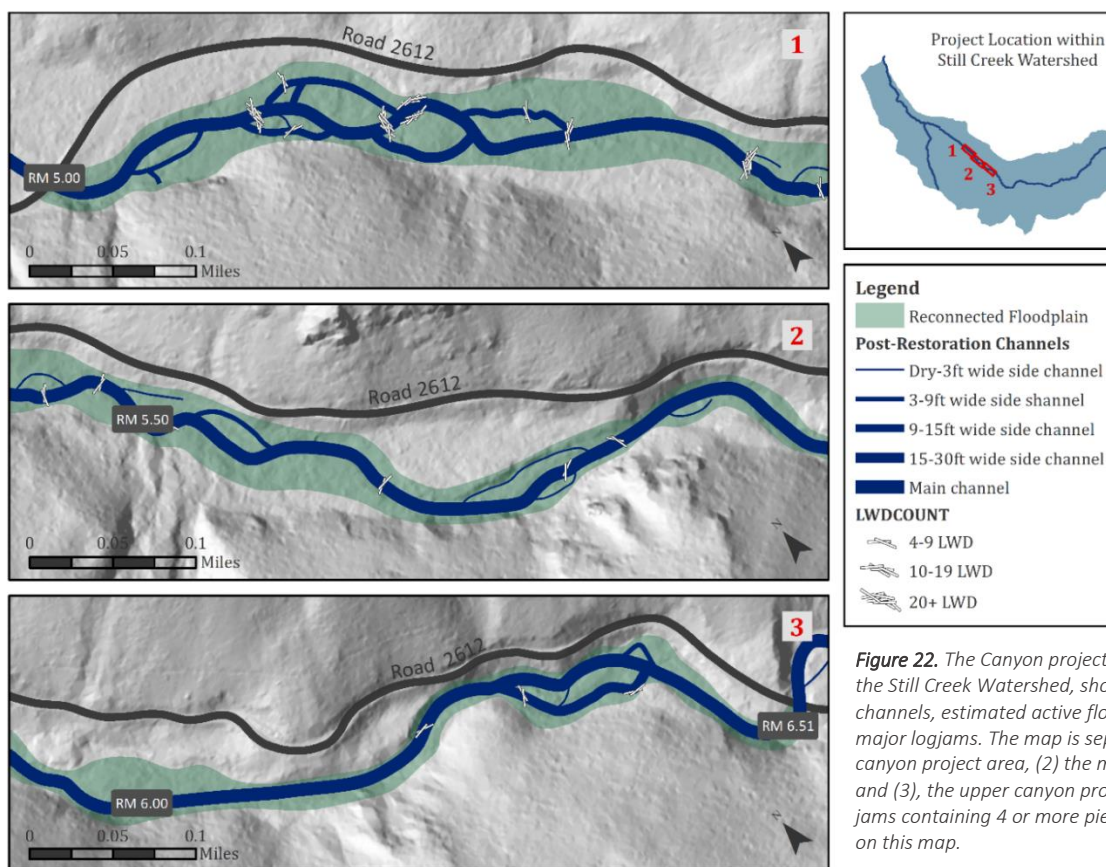
**Figure 22.** The Canyon project area and its location within the Still Creek Watershed, showing post-restoration side channels, estimated active floodplain, and the location of major logjams. The map is separated into (1) the lower canyon project area, (2) the middle canyon project area, and (3), the upper canyon project area. Note, only log jams containing 4 or more pieces of LWD are represented on this map.

**Actions** | Restoration actions in the Canyon project area occurred between 2016 and 2017. Approximately 50 riparian zone conifers were cabled over into the main channel and side channels, and an additional 265 pieces of LWD were transported by helicopter into the lower portion of the reach. These logs were used to construct a total of 26 jams throughout the project area (Figure 22). In the upper portion of the reach, log jams helped to raise groundwater levels and force water into the limited available floodplain habitat. In the lower portion of the reach, two large side channels 600 and 400 feet long were reactivated, and riprap was removed from an additional 350 foot long side channel. In total, an estimated 28.3 acres of floodplain habitat were impacted.

Key outcomes for this area were realized through the addition of substantial LWD to the main channel, increasing complexity and providing additional resting habitat. In total, 3,624 feet of side channels were created or enhanced due to restoration actions, providing much needed off channel habitat in this high gradient area. The Canyon project area now nearly meets (>75% of target), meets, or exceeds five out of nine targets applicable to the area (Box 7)<sup>8</sup>. Wood

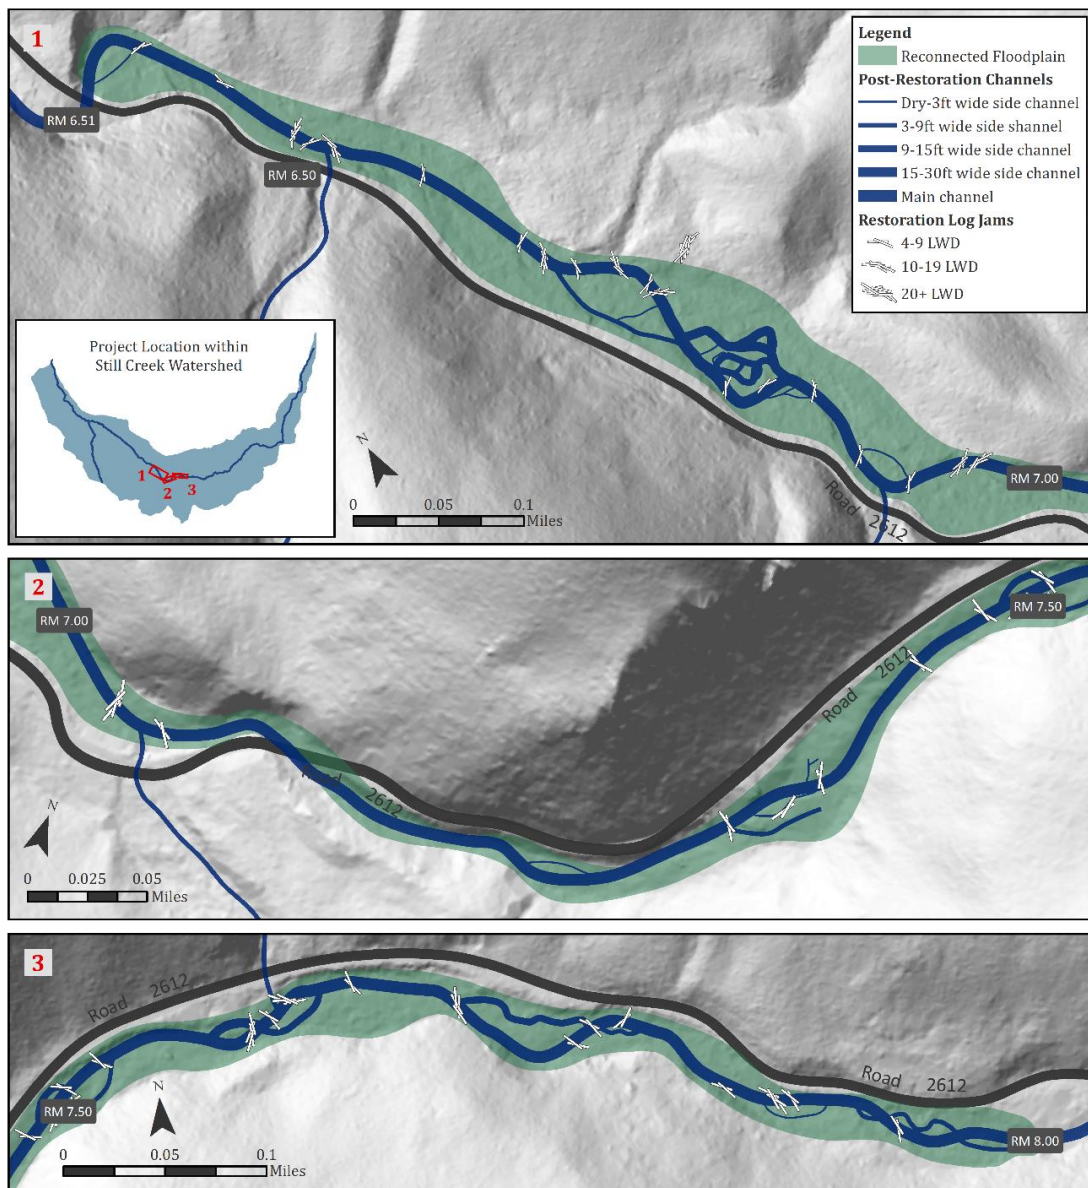
**Figure 23.** The lower (1), middle (2), and upper (3) portions of the headwaters Nirvana project area and their location within the Still Creek watershed, showing post restoration side channels, estimated active floodplain, and the location of major logjams. Note, only log jams containing 4 or more pieces of LWD are represented on this map.

**Actions** | Restoration actions in the Headwaters Nirvana project area occurred in 2014, 2015, and 2016. Approximately 220 riparian zone conifers were cabled over into the main channel and side channels with another 115 logs cabled in via a skidder winch line and blocks. The cabled over trees and logs created 47 log jams and helped to reactive the limited available side channel habitats (Figure 23). In total, an estimated 30.8 acres of floodplain habitat were impacted.

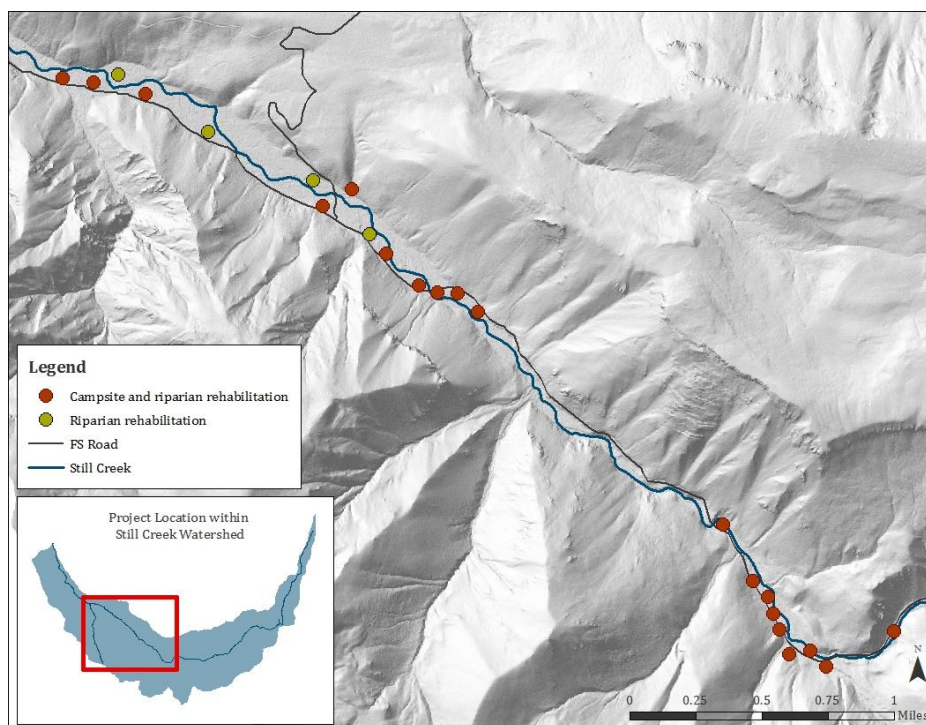
Figure 25. Map of riparian vegetation (essential project SC-9) and campsite rehabilitation (essential project SC-11) sites throughout the Still Creek Watershed.

**Actions** | Between 2012 and 2017, about 13 acres of riparian habitat was restored with native conifers and understory vegetation (Figure 25). Over 2,000 cedars trees were planted along the riparian areas of Still Creek. Approximately 2,000 sword ferns and salmon berries were transplanted into the riparian area. Native grass seed was spread throughout the entire 13 acres of revegetated areas.

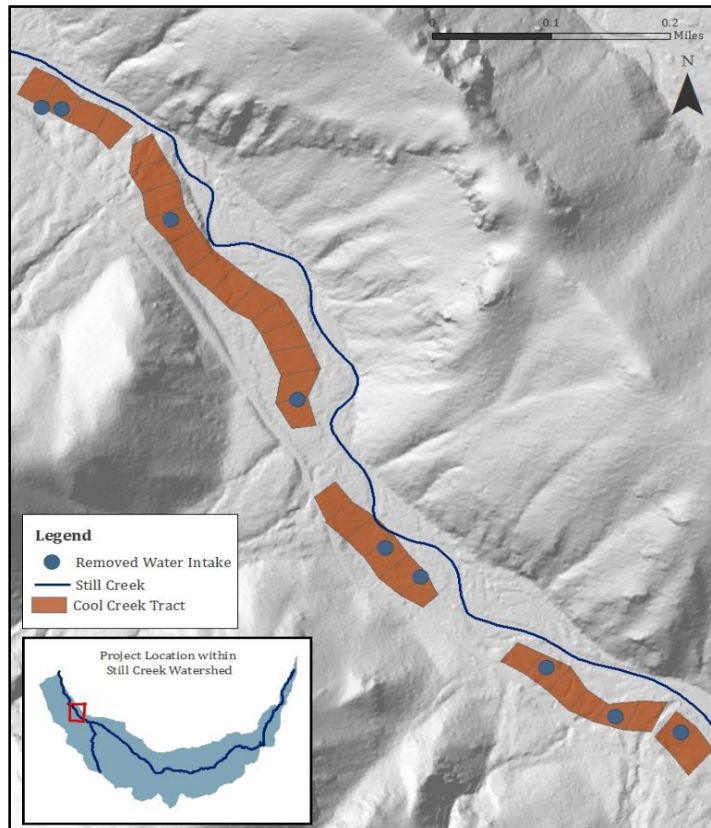
Figure 27. Map of wells drilled between 2011 and 2017 to replace direct water withdrawal intakes for recreational residences.

**Actions** | From 2012 to 2017, five wells were dug in place of using direct water intakes to provide water for the Cool Creek Tract residents (Figure 27). Nine direct water intakes were removed from Still Creek due to residences sharing wells with additional waterlines. Well drilling was recorded by the Zigzag Ranger District Permit Administrator and Oregon Water Resources Department. The Forest Service conducted all NEPA analyses, provided resource protection oversight during the construction of the wells, monitored post disturbance sites for erosion, and rehabilitated sites with native vegetation in cooperation with the cabin owner. The cabin owners ensured that private contractors complied with the best management practices that protect aquatic resources and control erosion. Cabin owners also worked with Clackamas County to ensure all permits were acquired and met Clackamas County standards. Although progress was made towards eliminating all water intake structures from Still Creek in the Cool Creek Tract to increase water quality and quantity, there remains five recreational residences currently withdrawing water that need to be addressed.

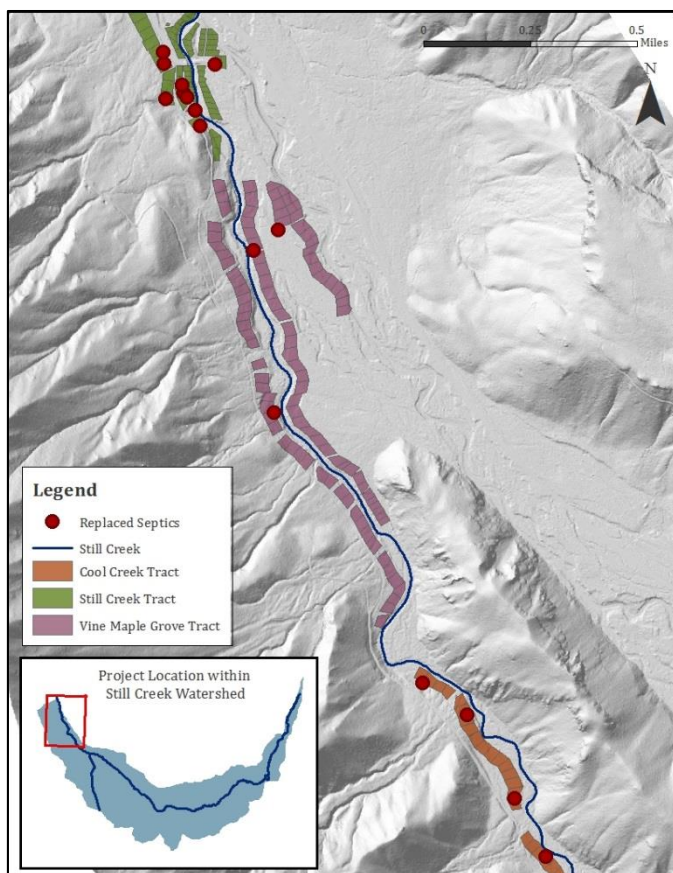
Figure 28. Map of septic systems installed or upgraded from 2012-2017.

**Actions** | Eighteen septic systems were replaced within the Still Creek, Vine Maple and Cool Creek Tracts between 2012 and 2017 (Figure 28) (Clackamas County 2017). This exceeded the project goals of constructing ten new systems. Replaced septic systems were recorded by the Zigzag Ranger District Permit Administrator and Clackamas County. The new septic systems all met Clackamas County regulations with a 100 foot minimum setback from all perennial streams and a fully contained system with no adverse effects to water quality. The Forest Service conducted all of the NEPA

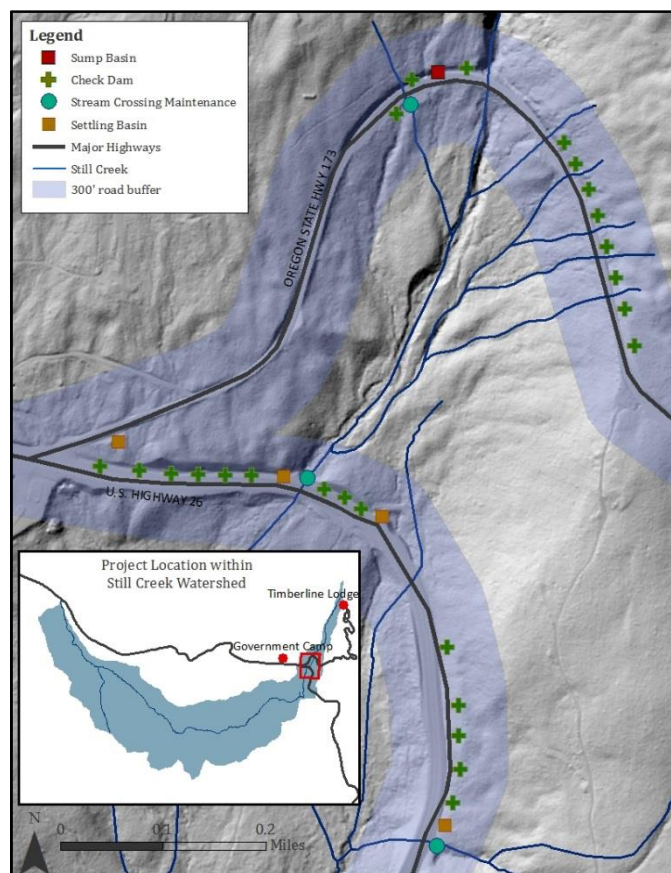
**Figure 30.** Map showing location of sediment retention or control structures constructed in 2017 by ODOT on U.S. Highway 26 and Oregon State Highway 173 to reduce road related sediment transport into Still Creek.

Sediment retention structures were constructed and road maintenance was completed by ODOT on July 20th, 2017 (Figure 31). Cumulatively, two miles of US Highway 26 and Oregon State Highway 173 now have 30 sediment retention barriers that are expected to significantly reduce road-related sediment transport to Still Creek and its tributaries (Figure 30). The following construction and maintenance was completed:

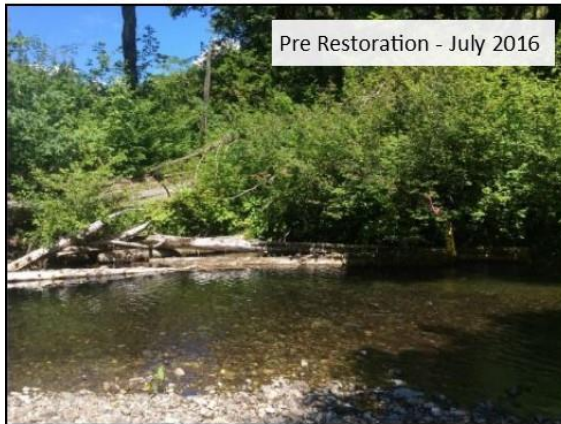
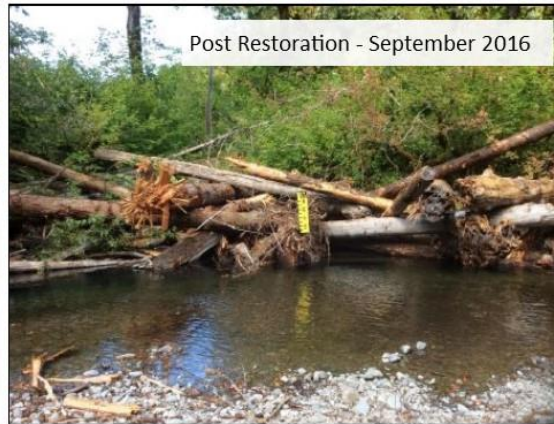
### Cabins Project Area

*Figure C1. Constructed jam on river right in the Cabins project area. The photos are taken looking across the main channel.*

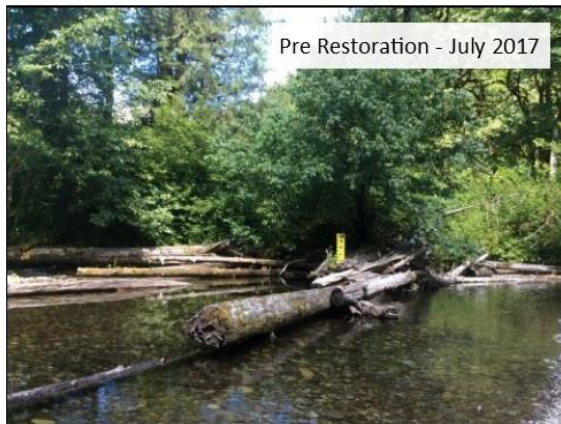
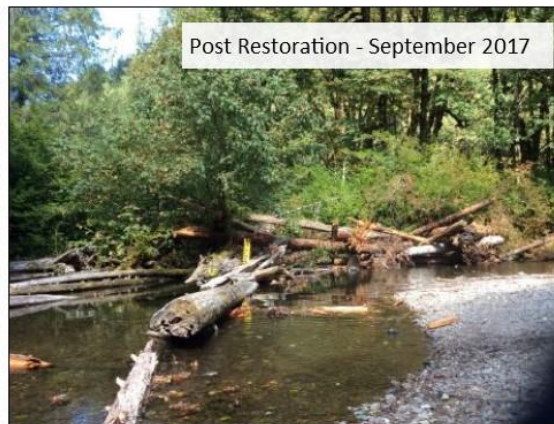
### Cabins Project Area

*Figure C2. Enhanced large wood structure in the Cabins project area. The photos are taken looking across the main channel.*

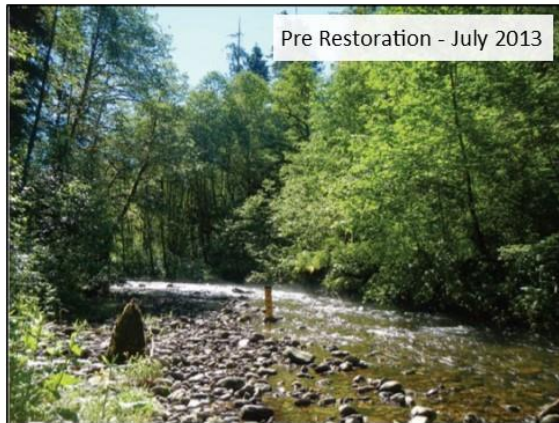
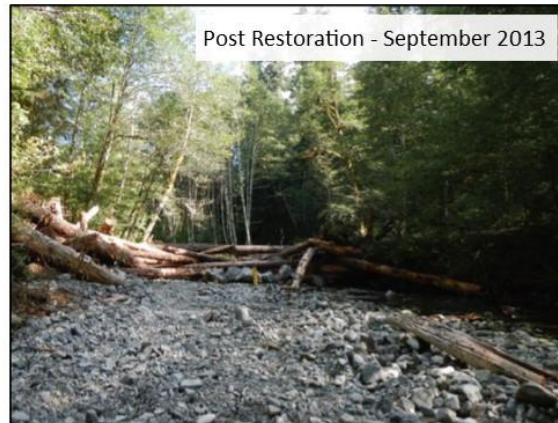
#### Cabins Project Area

*Figure C3. Newly excavated side channel inlet re-activating a large floodplain area in the Middle Cabins project area. The photos are taken facing downstream.*

Pre Restoration - July 2013

Post Restoration - September 2013

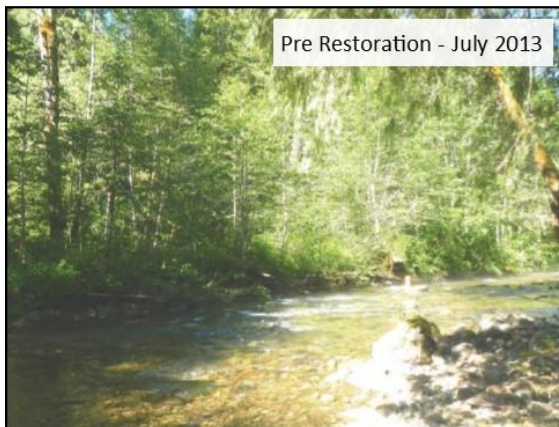
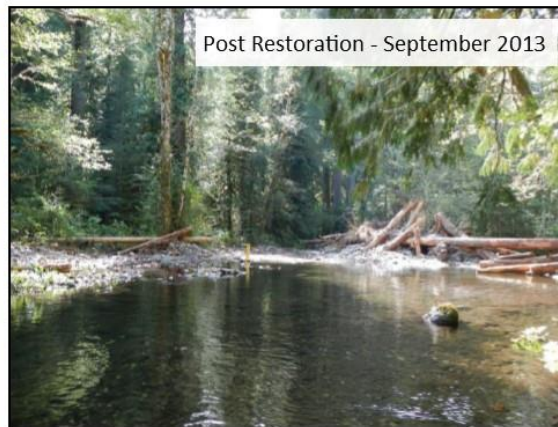
#### Straights Project Area

*Figure C4. Channel spanning jam restoration structure in the Straights project area, before and after restoration. The photos are facing upstream.*

Pre Restoration - July 2013

Post Restoration - September 2013

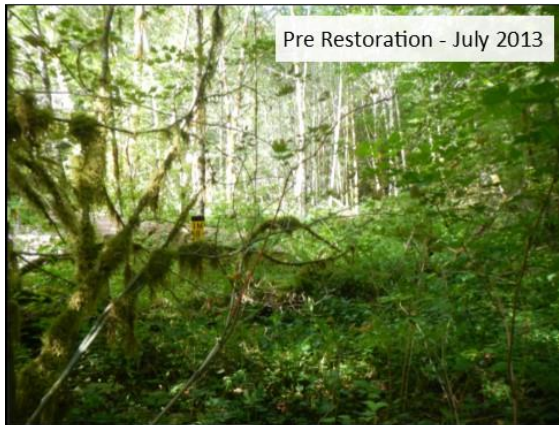
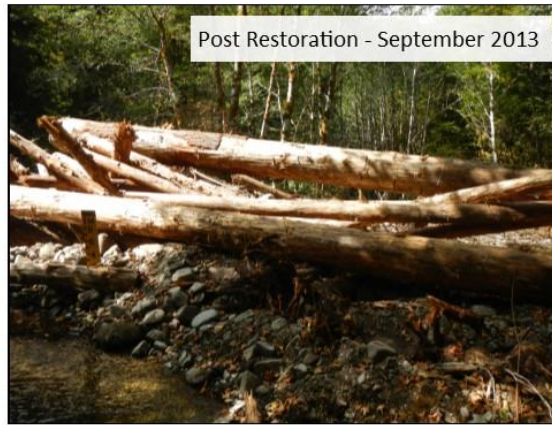
#### Straights Project Area

*Figure C5. Channel spanning jam restoration structure in the Straights project area, before and after restoration. The photos are facing downstream.*

Pre Restoration - July 2013

Post Restoration - September 2013

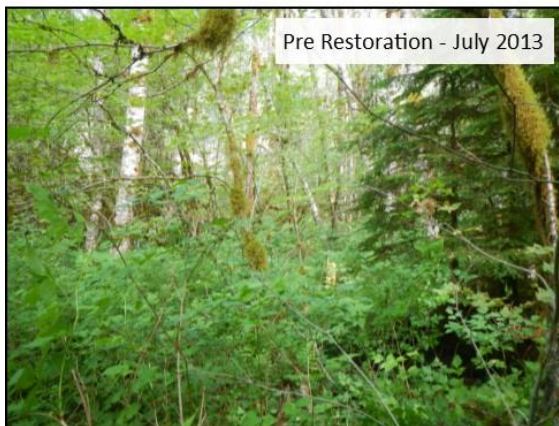
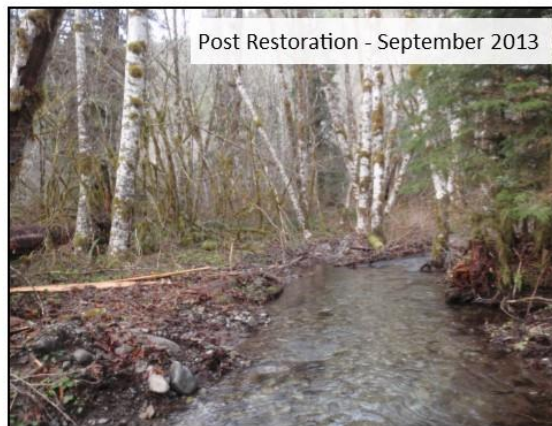
#### Compression Project Area

*Figure C6. Restoration jam created in the Compression project area constructed in 2015. The photos are taken looking up-stream.*

Pre Restoration - July 2013

Post Restoration - September 2013

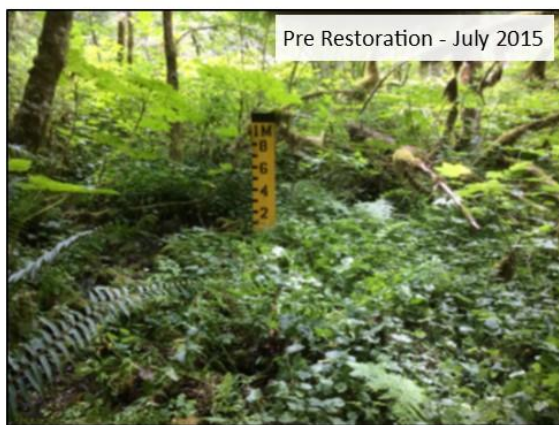
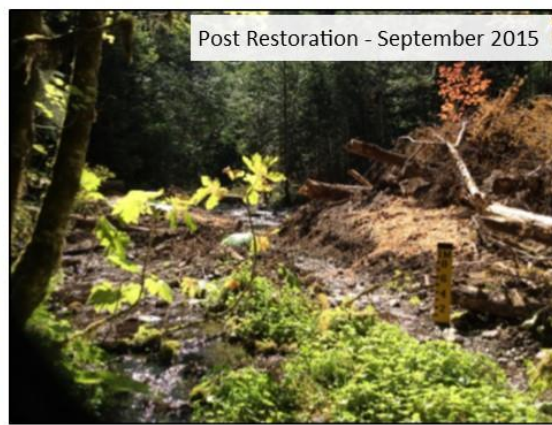
#### Compression Project Area

*Figure C7. Reactivated side channel in the Compression project area. The photos are taken looking downstream.*

Pre Restoration - July 2015

Post Restoration - September 2015

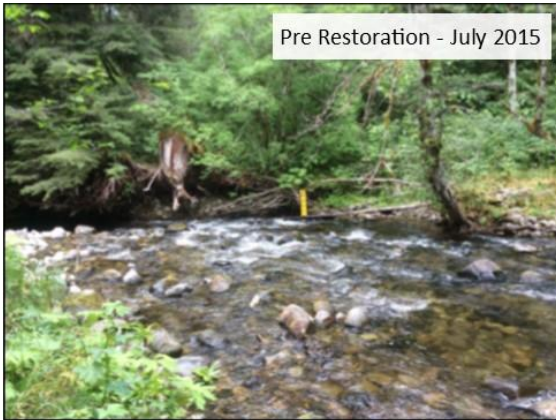
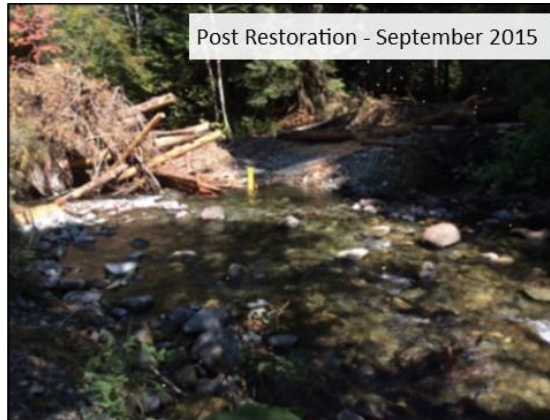
#### Mars Attacks Project Area

*Figure C8. Restoration jam and excavated side channel created in the Mars Attacks project area constructed in 2015. The photos are taken looking upstream.*

Pre Restoration - July 2015

Post Restoration - September 2015

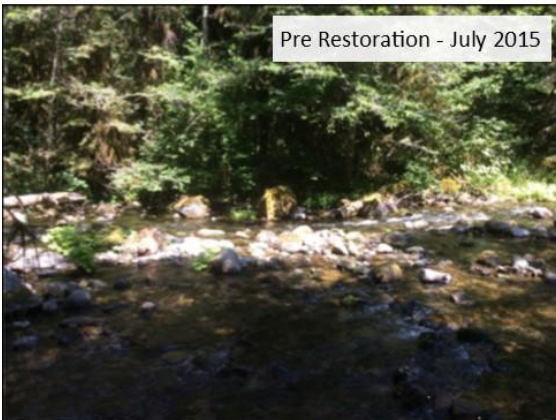
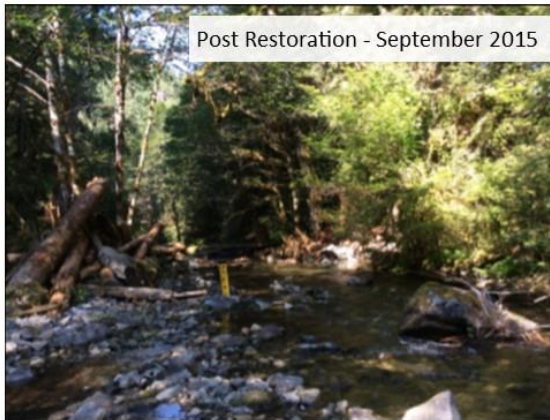
#### Mars Attacks Project Area

*Figure C9. Restoration jam and excavated side channel created in the Mars Attacks project area constructed in 2015. The photos are taken looking downstream.*

Pre Restoration - July 2015

Post Restoration - September 2015

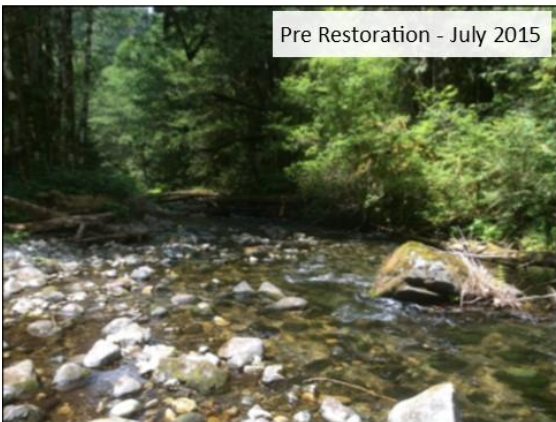
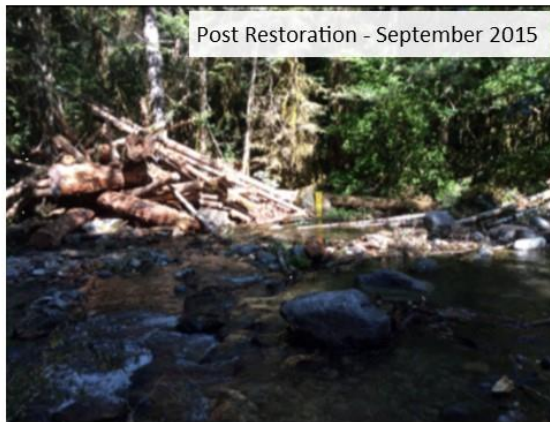
#### Elder Growth Project Area

*Figure C10. Restoration jam created in the Elder Growth project area constructed in 2015. The photos are taken looking downstream.*

Pre Restoration - July 2015

Post Restoration - September 2015

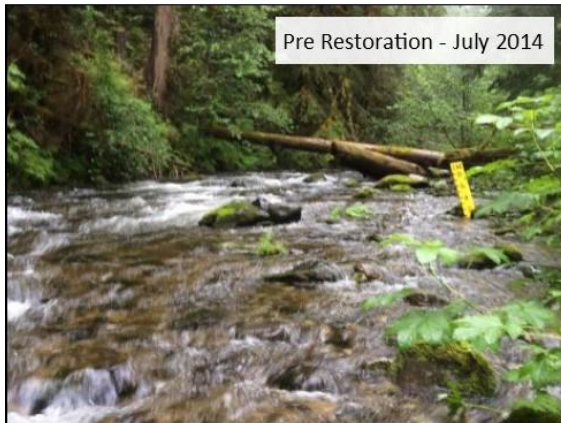
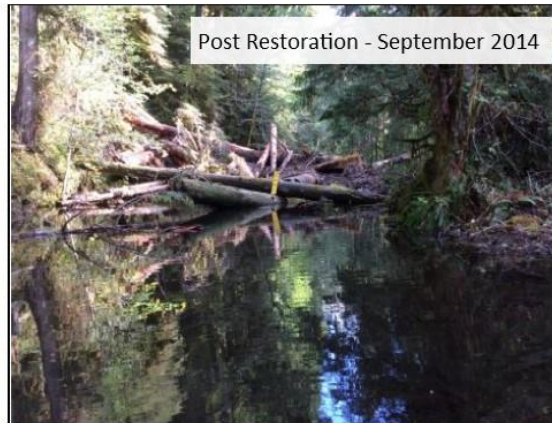
#### Elder Growth Project Area

*Figure C11. Restoration jam created in the Elder Growth project area constructed in 2015. The photos are taken looking downstream.*

Pre Restoration - July 2014

Post Restoration - September 2014

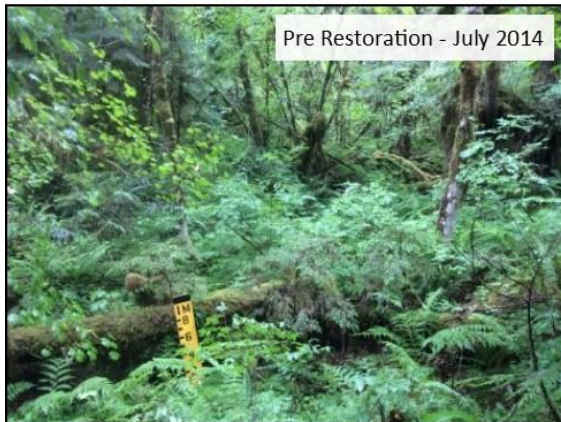
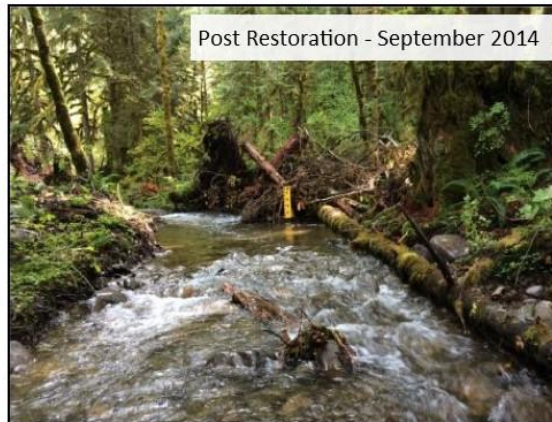
#### Pumpkin Patch Project Area

*Figure C12. Enhanced log jam in the Pumpkin Patch project area. The photos are taken looking upstream.*

Pre Restoration - July 2014

Post Restoration - September 2014
