October 2017

# Still Creek Watershed Restoration Completion Report

**Mt. Hood National Forest  
Zigzag Ranger District**

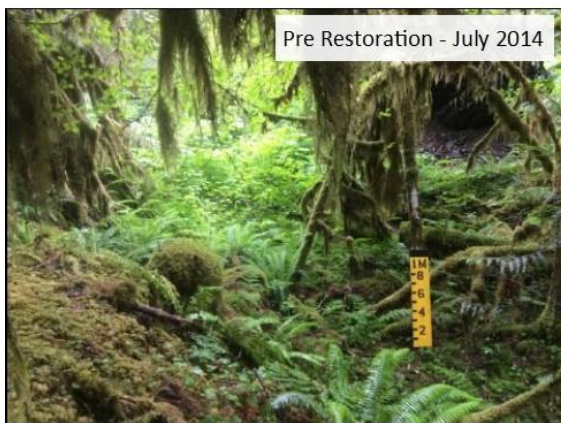
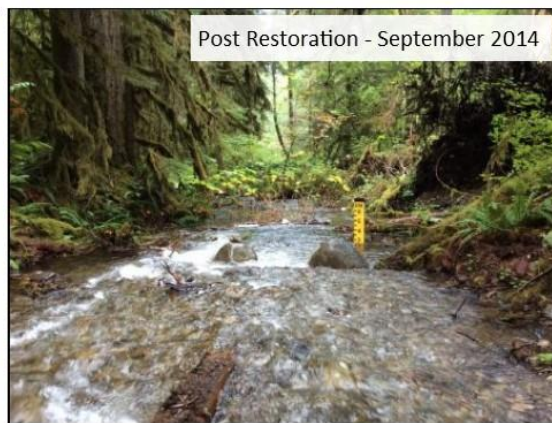
#### Pumpkin Patch Project Area

*Figure C13. Reactivated side channel in the Pumpkin Patch project area. The photos are taken looking upstream.*

Pre Restoration - July 2014

Post Restoration - September 2014

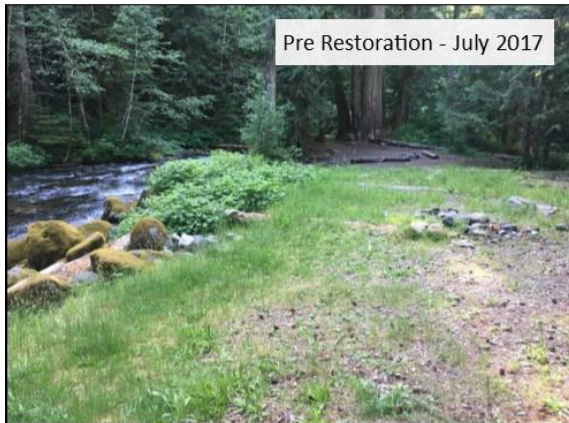
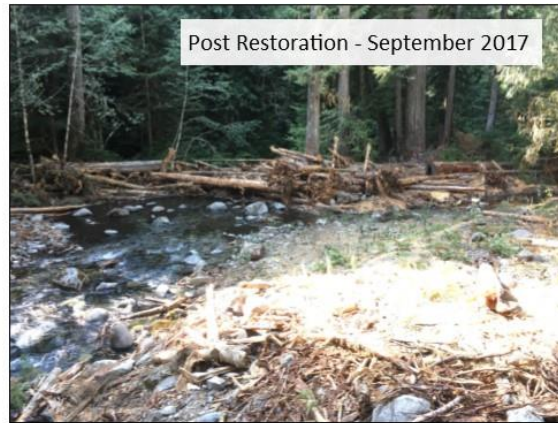
#### Pumpkin Patch Project Area

*Figure C14. Reactivated side channel in the Pumpkin Patch project area. The photos are taken looking downstream.*

Pre Restoration - July 2017

Post Restoration - September 2017

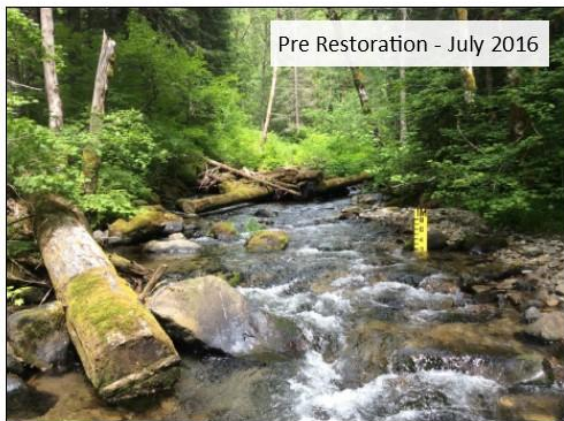
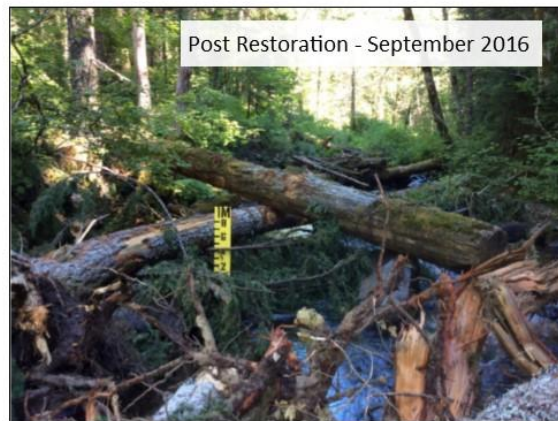
#### Canyon Project Area

*Figure C15* Reactivated side channel, island jam, and rehabilitated dispersed camping site in the Canyons project area. The photos are taken looking downstream.

Pre Restoration - July 2016

Post Restoration - September 2016

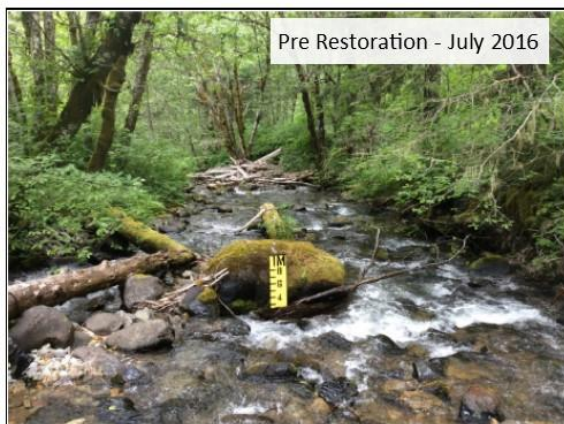
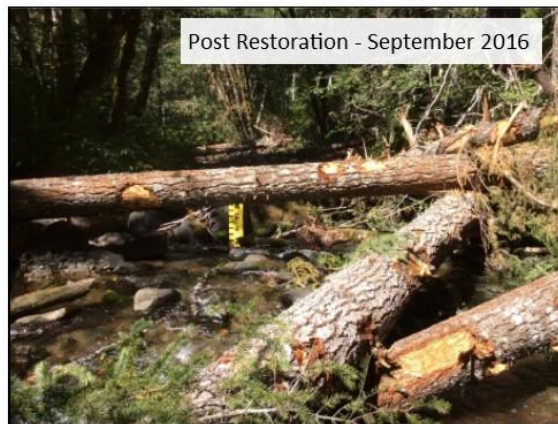
#### Headwaters Nirvana Project Area

*Figure C16.* Trees cabled over in the Headwaters Nirvana project area. The photos are taken looking upstream.

Pre Restoration - July 2016

Post Restoration - September 2016
