Idaho Panhandle National Forest, USDA Forest Service

Mallard Peak Restoration Project

FY 2010 Project Description

Mallard Peak Lookout (10SE65) Project Description

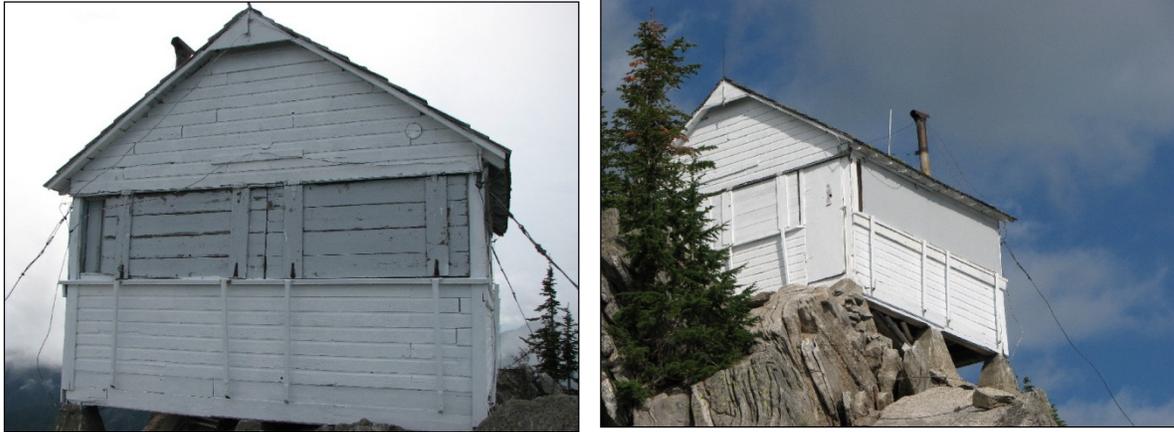
Figure 1. North side of lookout at end of project (left) and south and east sides at end of project (right).

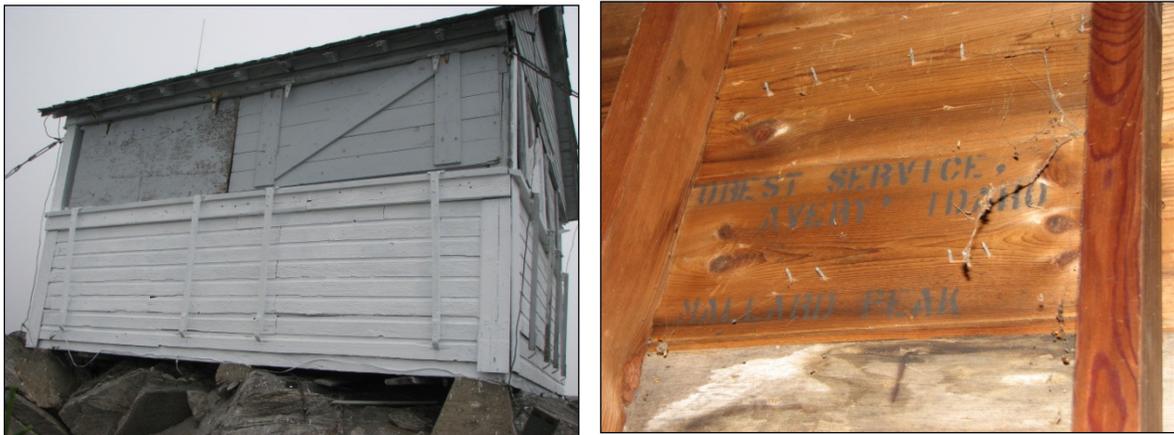
Figure 2. West side of lookout at end of project (right) and stencil "FOREST SERVICE, AVERY IDAHO, MALLARD PEAK" on interior roof sheathing suggesting the lookout was from a pre-cut kit (left).

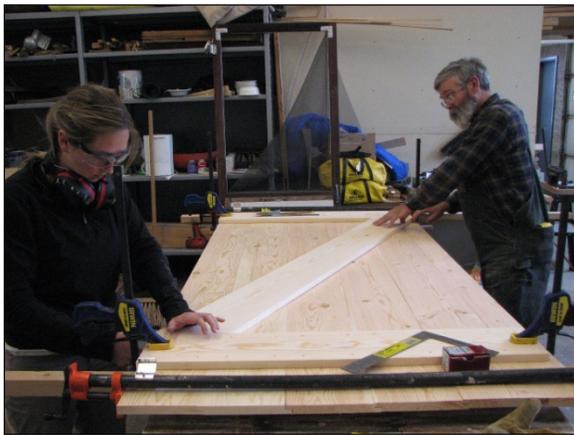
Figure 5. Fred and Sarah putting a shutter together. The vertical battens were moved closer to the edge than the original plan and the 1940s period cross batten was added for additional strength (left). Sarah using a Yankee screw driver to attach the battens (right).

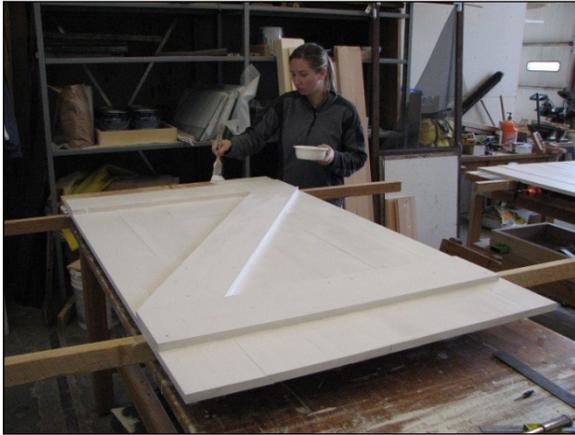
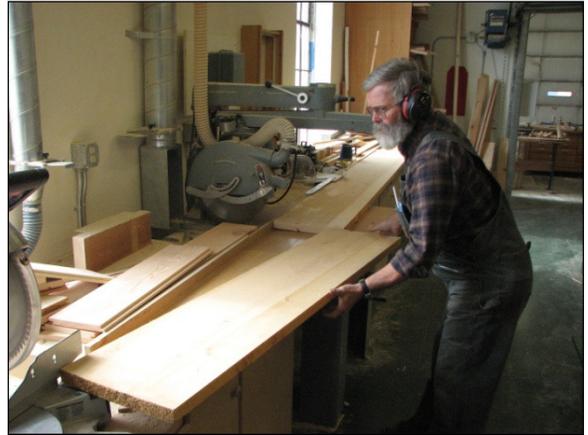
Figure 6. Sarah priming the shutter (left). The final color will be white on the outside and chrome green on the inside to reduce glare. Fred cutting 20 foot plus long white pine boards for window parts (right).

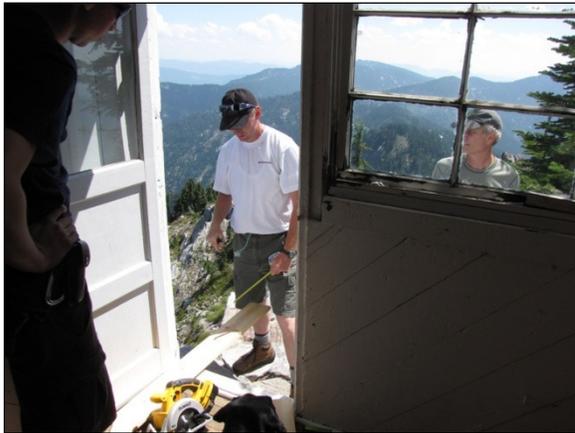
Figure 11. Tim cuts blocks for shutter hinge installation (left) and Tim and Richard hang door shutter (right).

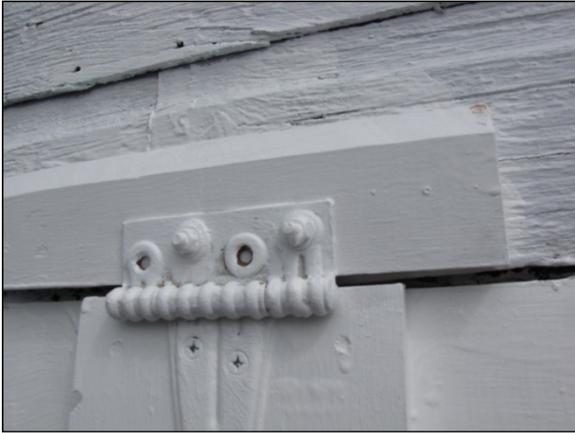
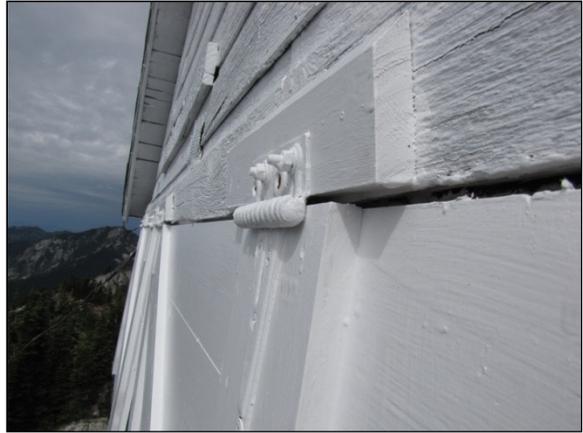
Figure 13. Shutter hinge installation from straight on (left) and hinge installation from edge (right).

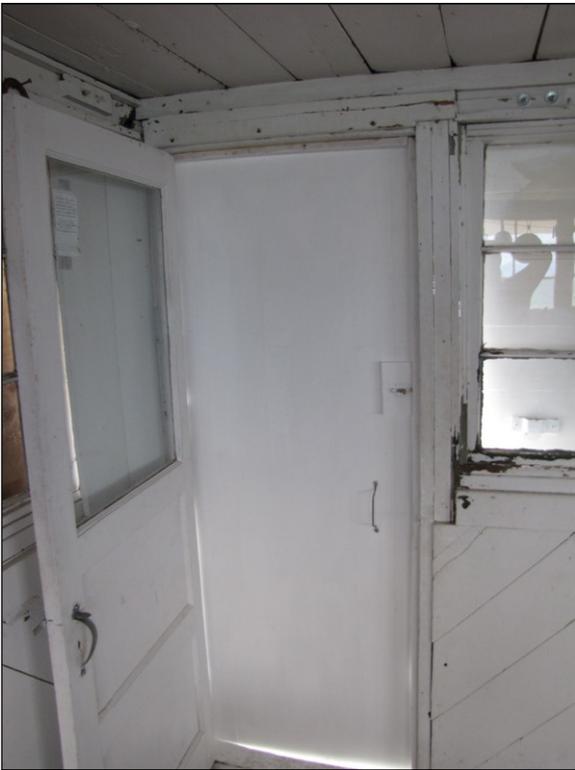
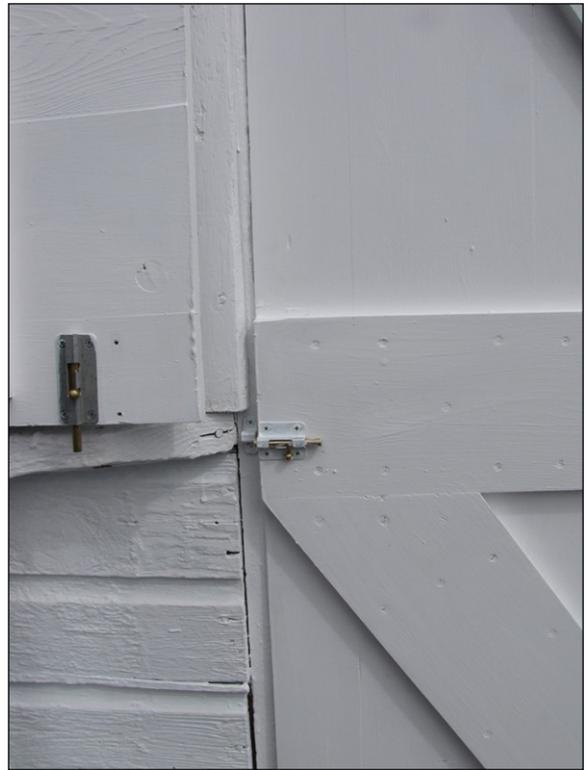
Figure 14. Interior view of door shutter installation (left) and exterior door and window shutters with barrel bolt installation (right).

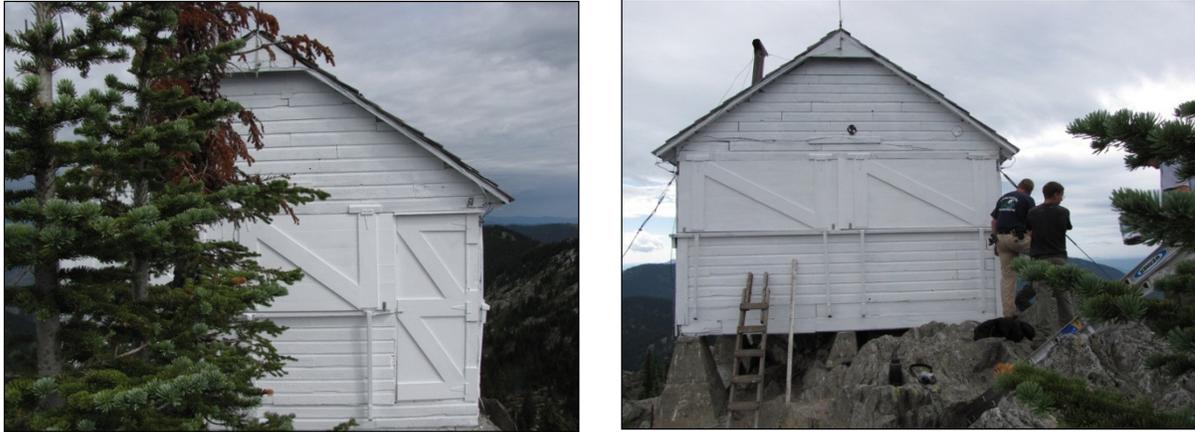
Figure 15. South (left) and north (right) sides completed.

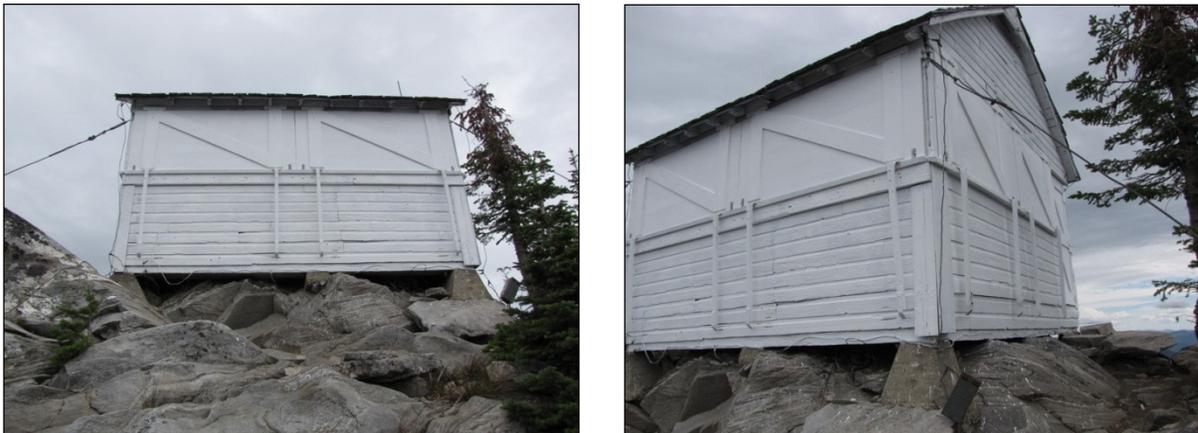
Figure 16. West side completed (left) and southwest corner completed (right).

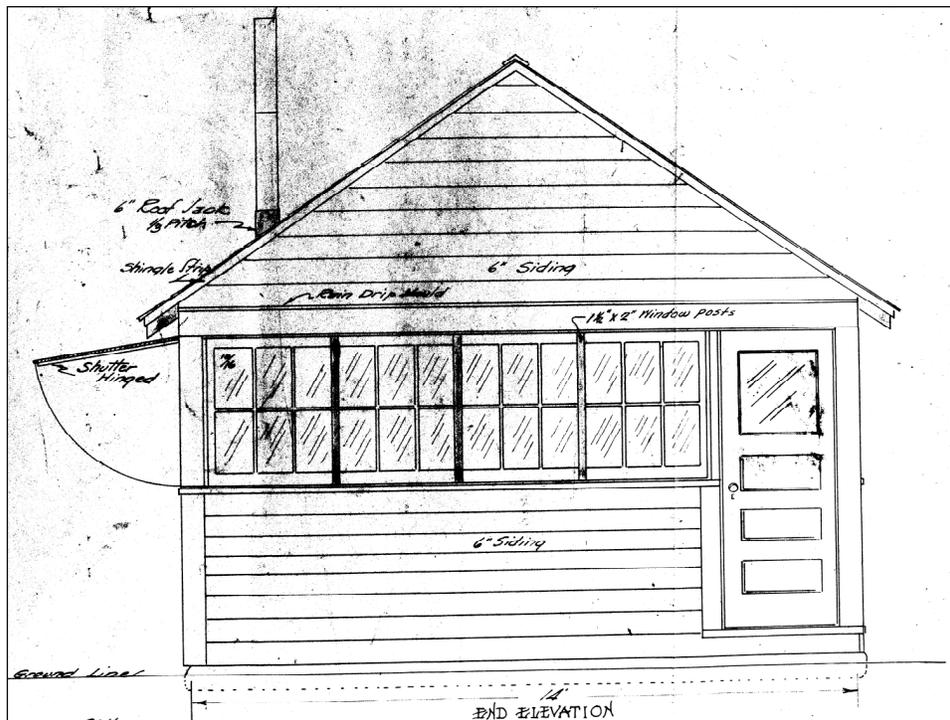
Figure 21. Front window detail. Front window opening dimensions are approximately 10' 8".

- ✓ Install original 3-over-2 configuration windows with two of five panes on west, north and east side and two of four panes on south side so that they slide open for ventilation.
- ✓ Inspect and replace window headers with either single header or spliced header as per original plans to remove bow in north side of lookout.
- ✓ Install window posts as per plan detail.

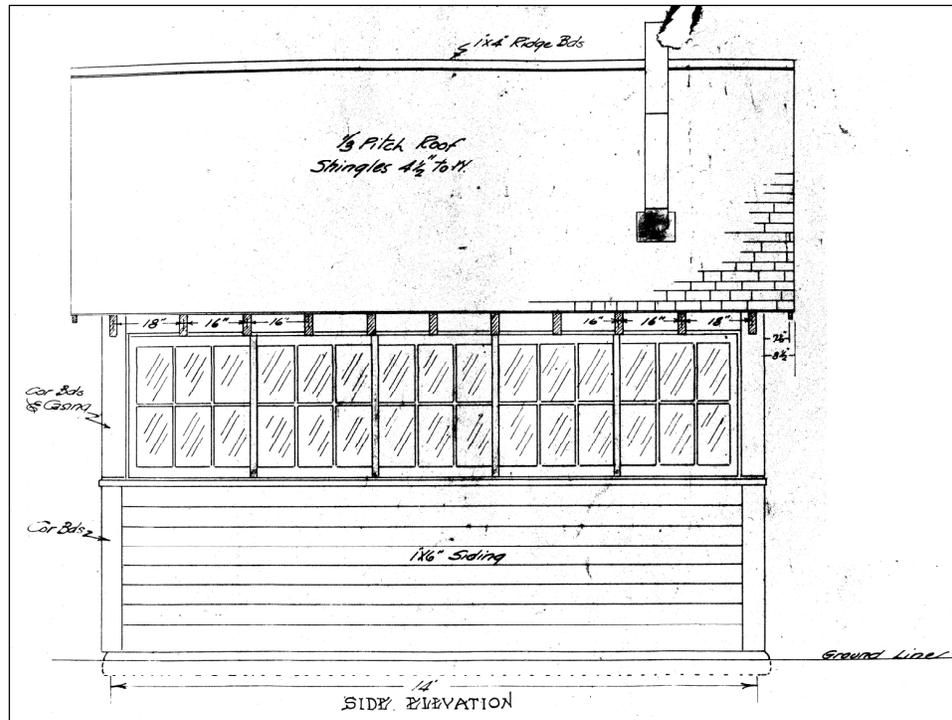
Figure 22. Side window detail. Side and rear window opening dimensions are approximately 13' 4".
