Management by Closure to Use, BMP 11.09

Site Description

Narrative

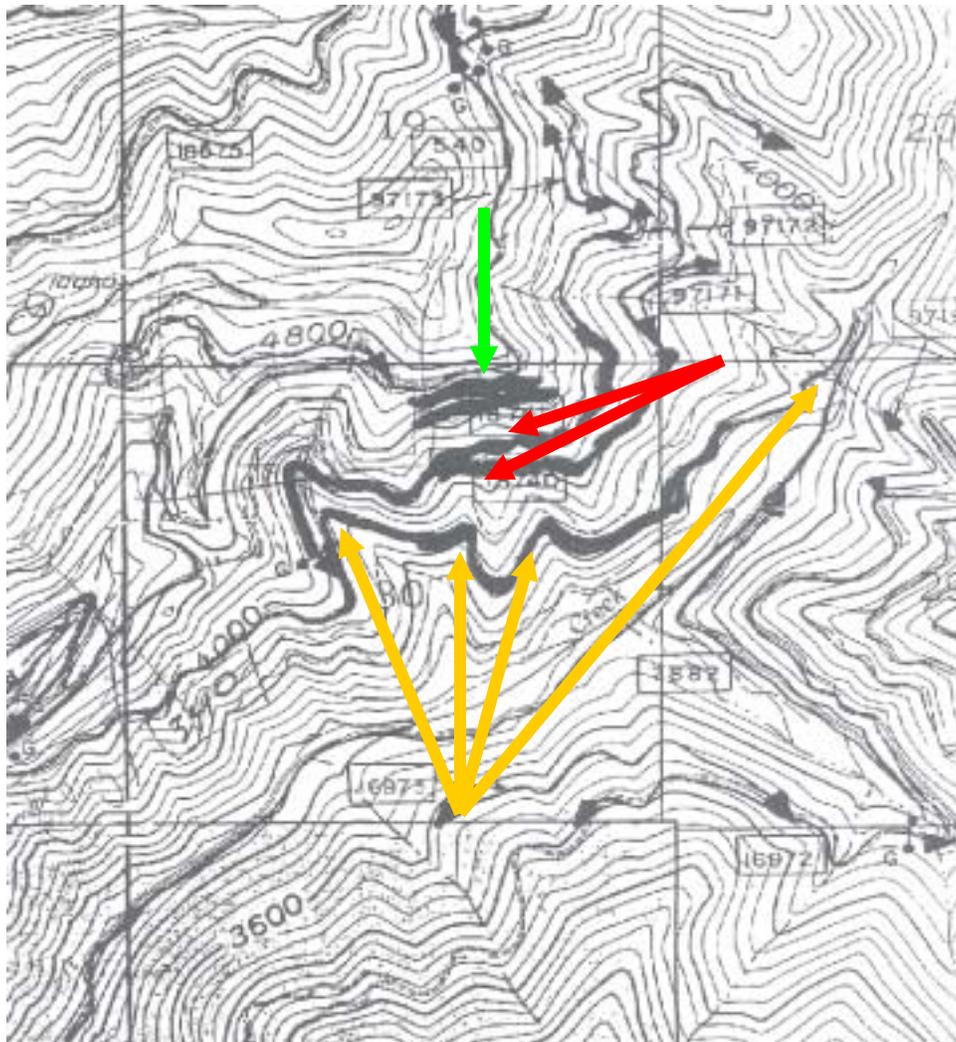
Map 1

After the September rain event in the Johnson Creek drainage, overland flow concentration and soil erosion quickly accelerated on the historic jammer road systems located above and below Road 540 (Map 1). Runoff concentration caused gullies to form and with increased sediment became mudflows (photos 1-3). Water velocity increased and accumulated sediment as it scoured down the drainages.
