Log Landing Erosion Prevention and Control, BMP 14.11

Erosion Prevention and Control Measures during Timber Sale Operations, BMP 14.12

Erosion Prevention and Control Measures during Timber Sale Harvest, BMP 14.12 Erosion Control on Skid Trails, BMP 14.15

Stream Channel Protection, BMP 14.17

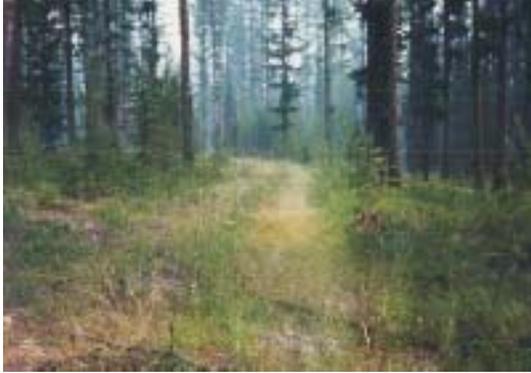
Photo 2

Two log landings were located within Unit 23. At the second landing, where two main skid trails branched off, was an open area. The open area allowed easy access and tractor mobility. In addition, only a few trees were removed for the landing (photo 1). After use, both landings and the road connecting them were scarified and seeded (photos 1, 2 & 3). Froelich and others (1985, p 1017) recommend scarifying skid trails because of the long-term erosion potential.

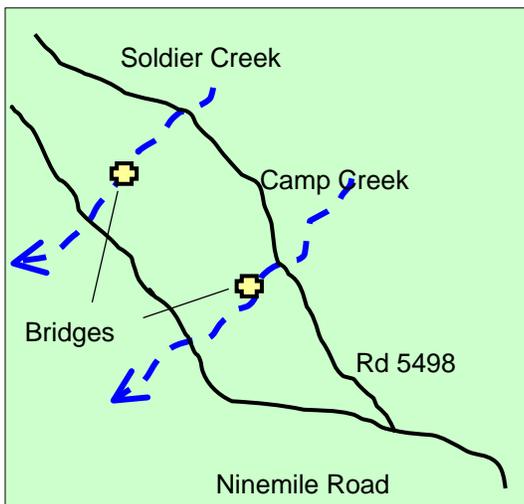
The Camp Creek and Soldier Creek bridge removal sites are located between Road 5498 (Foothills Road) and Road 412 (Ninemile Road), on Camp and Soldier Creeks. They are found within the Ninemile Ranger District of the Lolo NF, in Sections 24 and 26, Township 17N, Range 23W. LSI classification is 15JB.
