Obliteration of Temporary Roads, BMP 15.25

Stabilization of Fire-Suppression Related Watershed Damage, BMP 18.05

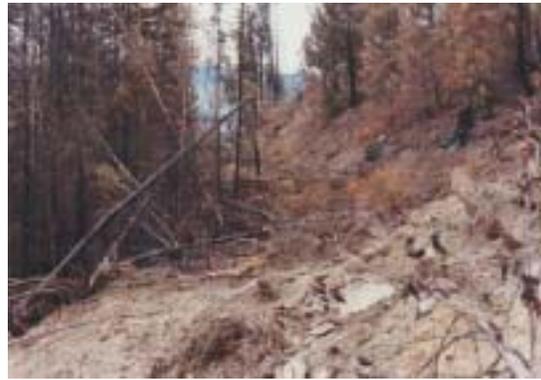
Photo 3

The re-contoured crossing closely matches the natural slope of the draw. The road was ripped 8 to 12 inches deep, creating a surface which water can infiltrate. Slash diameters varied widely, with a 2-inch average. The slash will add nutrients to the soil and provide shade for vegetation. Through a combination of slash and vegetation, the jammer roads will stabilize. Because the fills have been removed from the draw, sedimentation will be minimized and the natural drainage system restored.

This practice to date has proved to be effective at reducing the amount of sediment yielded from the jammer roads.
