Bear Creek Watershed – 2014 Rapid Trail Condition Assessment

Assessment prepared by:
Amber Shanklin, RMFI Program Director

July 1, 2014

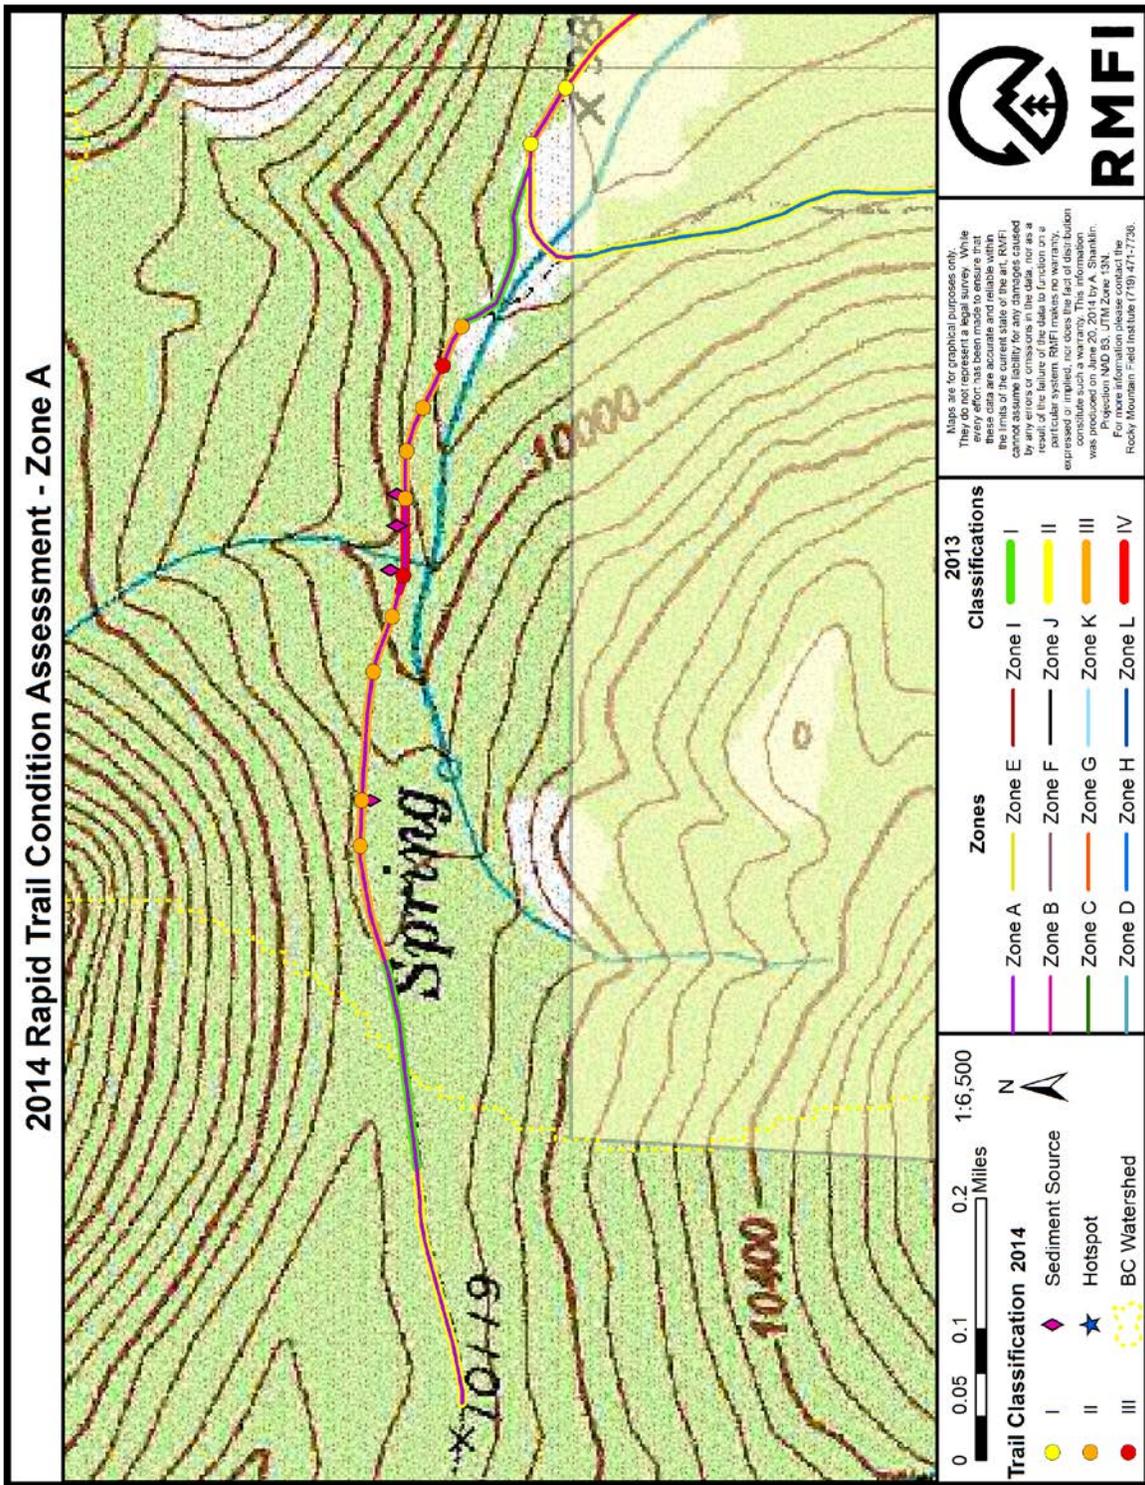
Figure 4. Bear Creek Watershed; Zone A with 2014 Classification Ratings displayed.

This zone lies within the Pike National Forest and currently dead ends at the Colorado Springs Utilities South Slope watershed. There are approximately 6,099 feet of trail in this zone. Of the 16 sections originally identified for the 2013 assessment, 6 were re-assessed for the purpose of this assessment. Data was collected from 12 individual locations along the trail within these 6 sections: 2 locations were classified as Class I, 8 were Class II, and 2 were Class III. There are 4 locations along the trail in Zone A where sediment is currently entering the stream or may enter the stream in the near future. Three locations along the trail are currently depositing sediment into the stream and 1 will deposit sediment soon if the sediment detention structure designed to keep sediment out of the stream is not maintained.

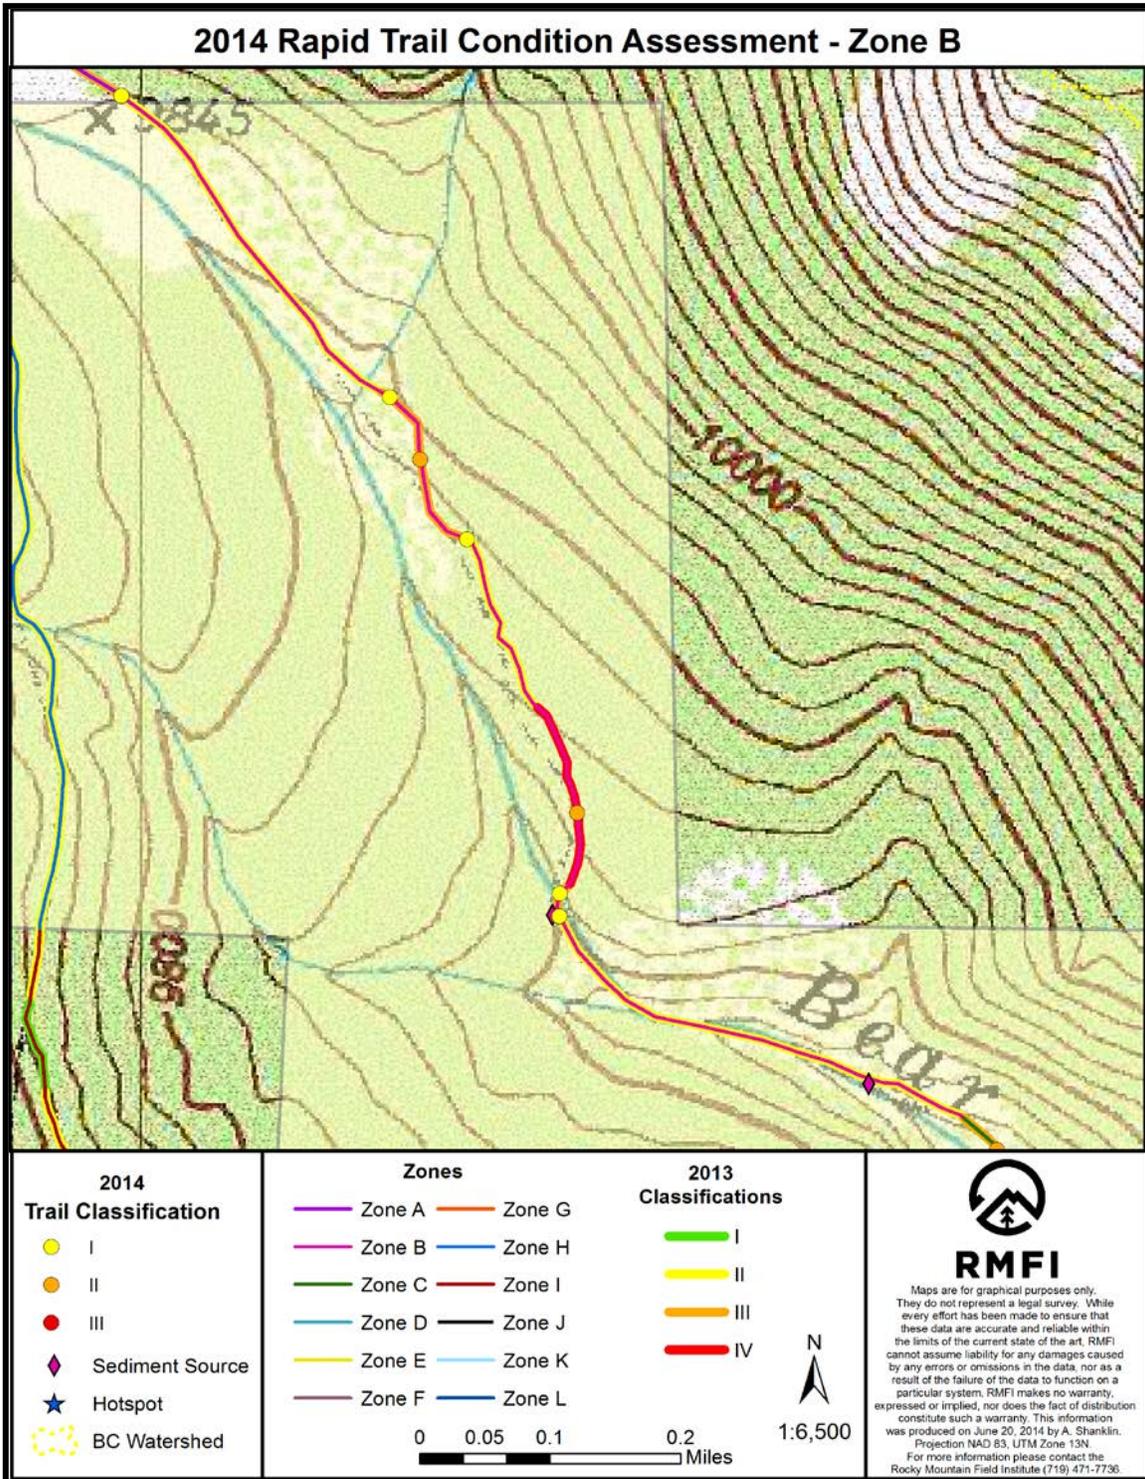
Figure 5. Bear Creek Watershed; Zone B with 2014 Classification Ratings displayed.

Zone B lies exclusively on Colorado Springs Utilities land. There are approximately 5,907 feet of trail within this zone. Of the 16 sections originally identified for the 2013 assessment, 4 were re-assessed for the purpose of this assessment. Data was collected from 6 individual locations along the trail within these 4 sections: 4 locations were classified as Class I, 2 were Class II, and no locations were Class III. There are 2 locations along the trail in Zone B where sediment is currently entering the stream or may enter the stream in the near future. One of these areas is currently depositing sediment into the stream and one will deposit sediment soon if a sediment detention structure is not constructed.

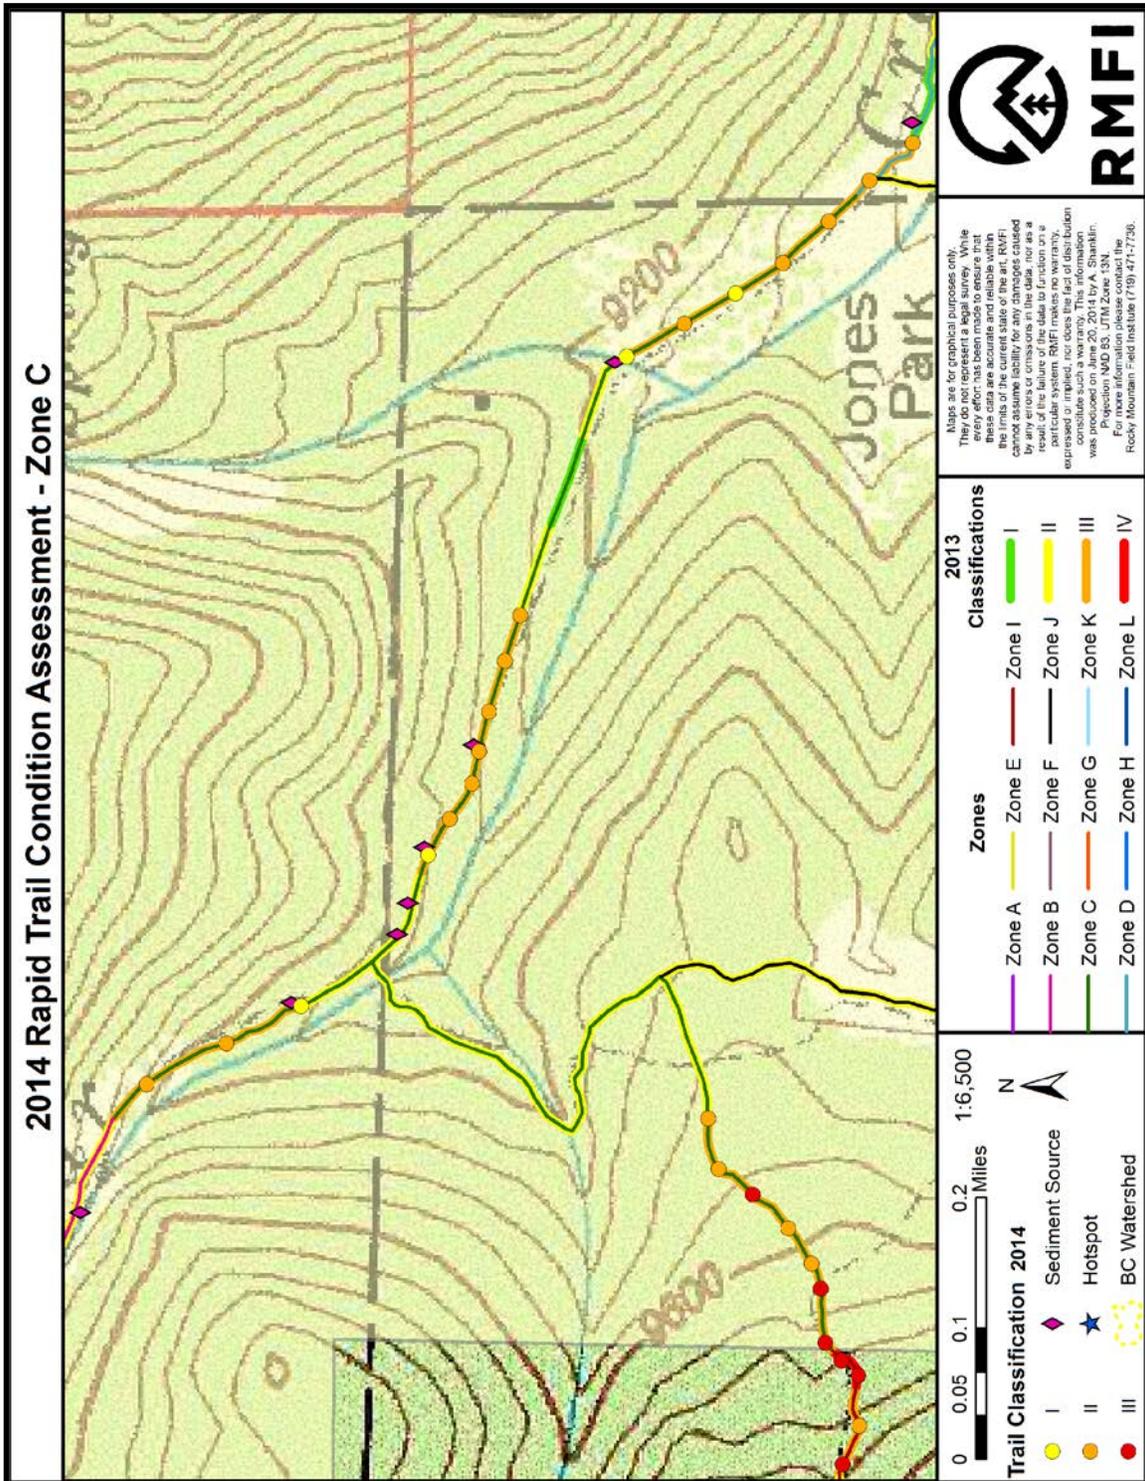
Figure 6. Bear Creek Watershed; Zone C with 2014 Classification Ratings displayed.

Zone C covers approximately 8,753 feet of trail on CSU property. Of the 24 sections originally identified for the 2013 assessment, 13 were re-assessed for the purpose of this assessment. Data was collected from 22 individual locations along the trail within these 24 sections: 4 locations were classified as Class I, 15 were Class II, and 3 were Class III. There are 6 locations along the trail in Zone C where sediment is currently entering the stream or may enter the stream in the near future. Four of these areas are currently depositing sediment into the stream and 2 will deposit sediment soon if sediment detention structures are not constructed.

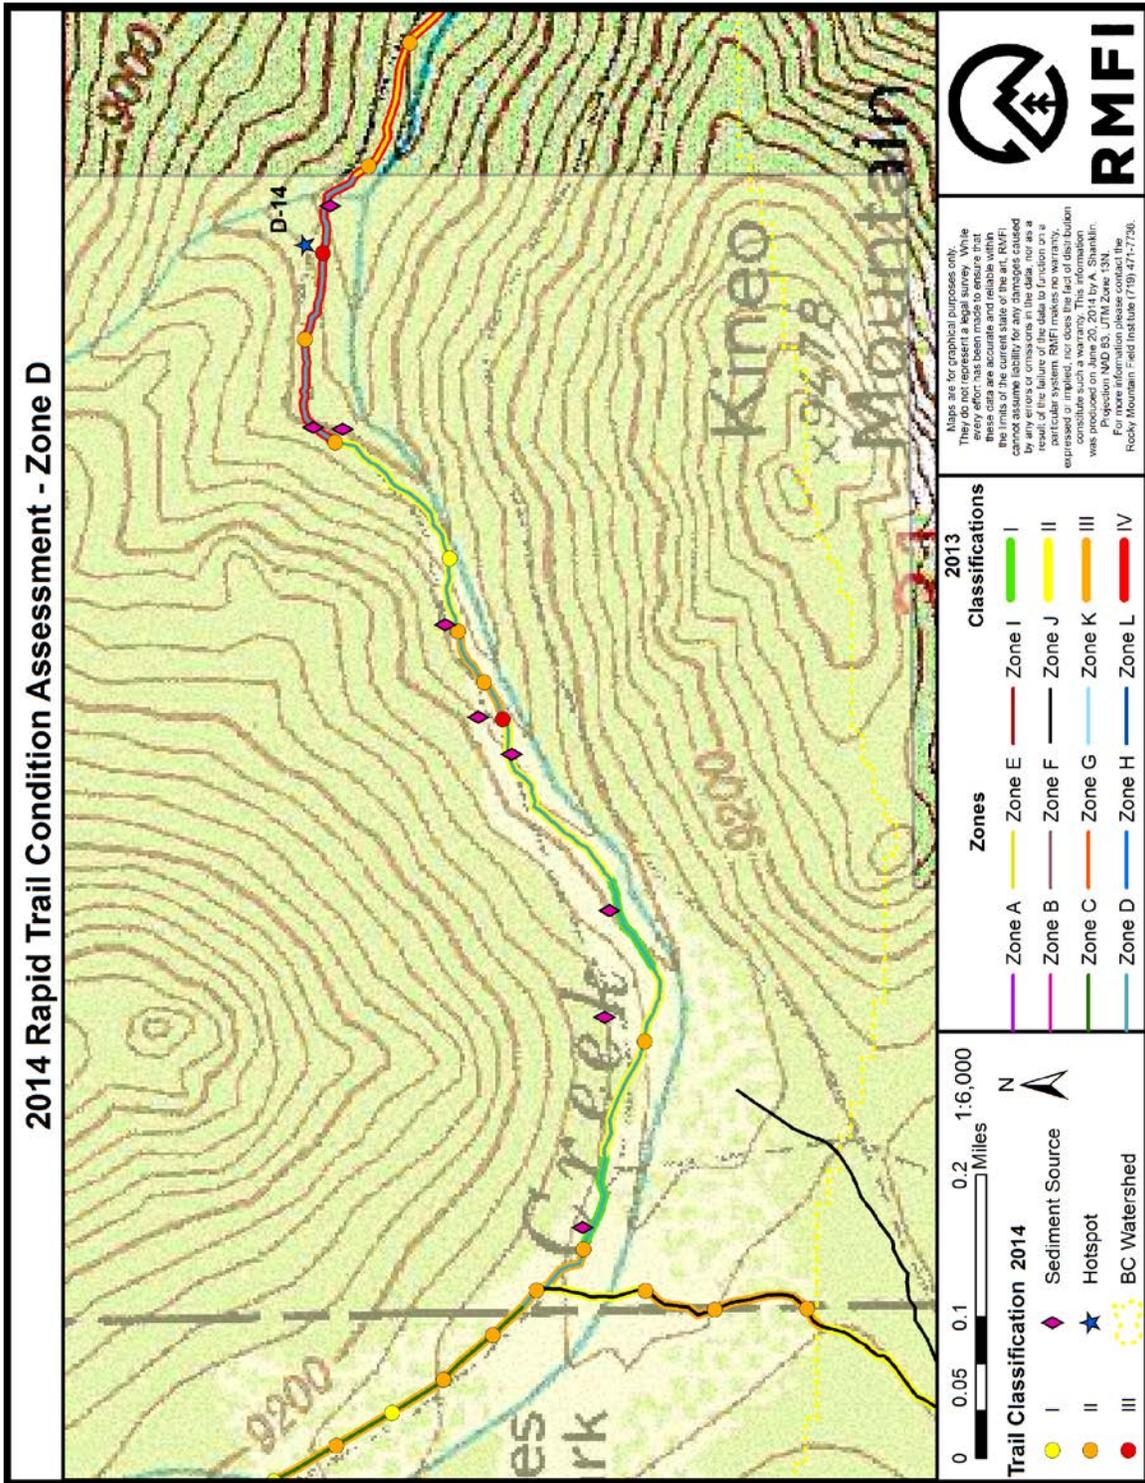
Figure 7. Bear Creek Watershed; Zone D with 2014 Classification Ratings displayed.

This Zone encompasses the last section of Trail #667 on CSU land. The trail in Zone D stretches approximately 5,057 feet adjacent to Bear Creek. Of the 14 sections originally identified for the 2013 assessment, 9 were re-assessed for the purpose of this assessment. Data was collected from 10 individual locations along the trail within these 9 sections: 1 location was classified as Class I, 7 were Class II, and 2 were Class III. There are 9 locations along the trail in Zone D where sediment is currently entering the stream or may enter the stream in the near future. Six of these areas are currently depositing sediment into the stream and two will deposit sediment in the stream soon if a sediment detention structure is not constructed soon. Within Section D-14 an extremely incised portion of trail that is approximately 10 feet wide was discovered, this was not captured within the assessment framework and was individually identified as a 'hot spot' for the purposes of this assessment.

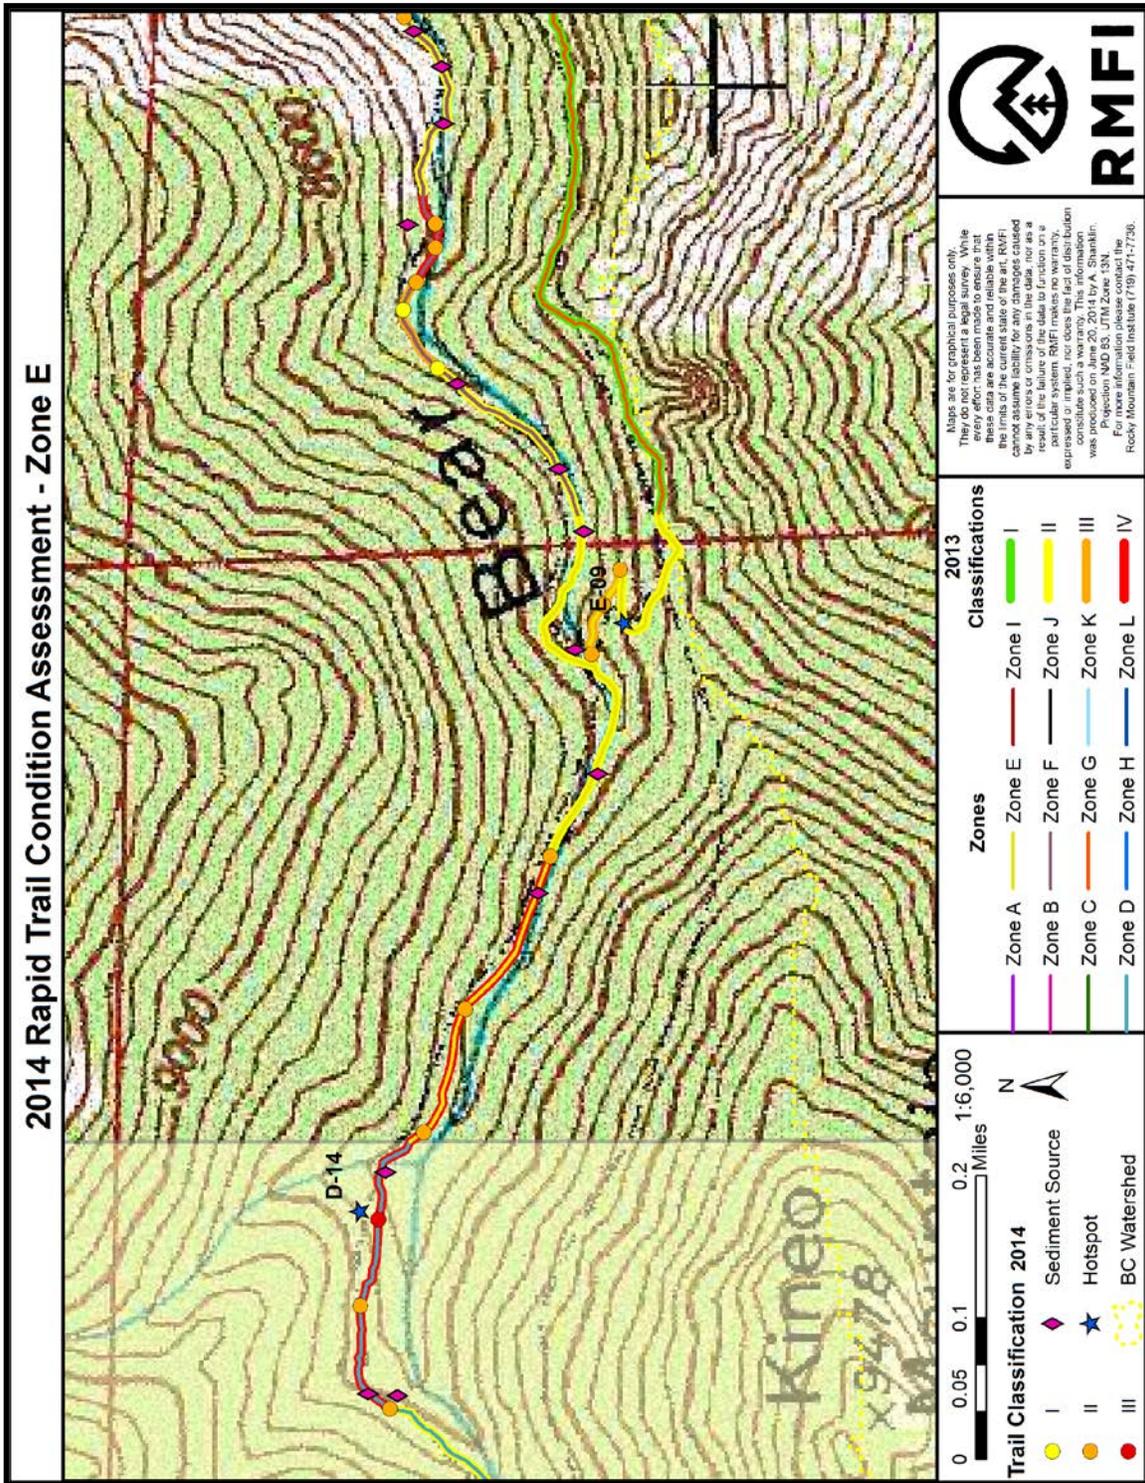
Figure 8. Bear Creek Watershed; Zone E with 2014 Classification Ratings displayed.

Zone E contains portions of trail from both Trail #666 and Trail #667. Approximately 3,909 feet of total trail is found within this zone. Of the 10 sections originally identified for the 2013 assessment, 4 were re-assessed for the purpose of this assessment. Data was collected from 6 individual locations along the trail within these 4 sections: 0 locations were classified as Class I, 6 were Class II, and 0 were Class III. There are 4 locations along the trail in Zone E where sediment is currently entering the stream. Within Section E-09 a portion of trail was discovered that was incised approximately 5 feet deep. This was not captured within the assessment framework and was individually identified as a 'hot spot' for the purposes of this assessment.

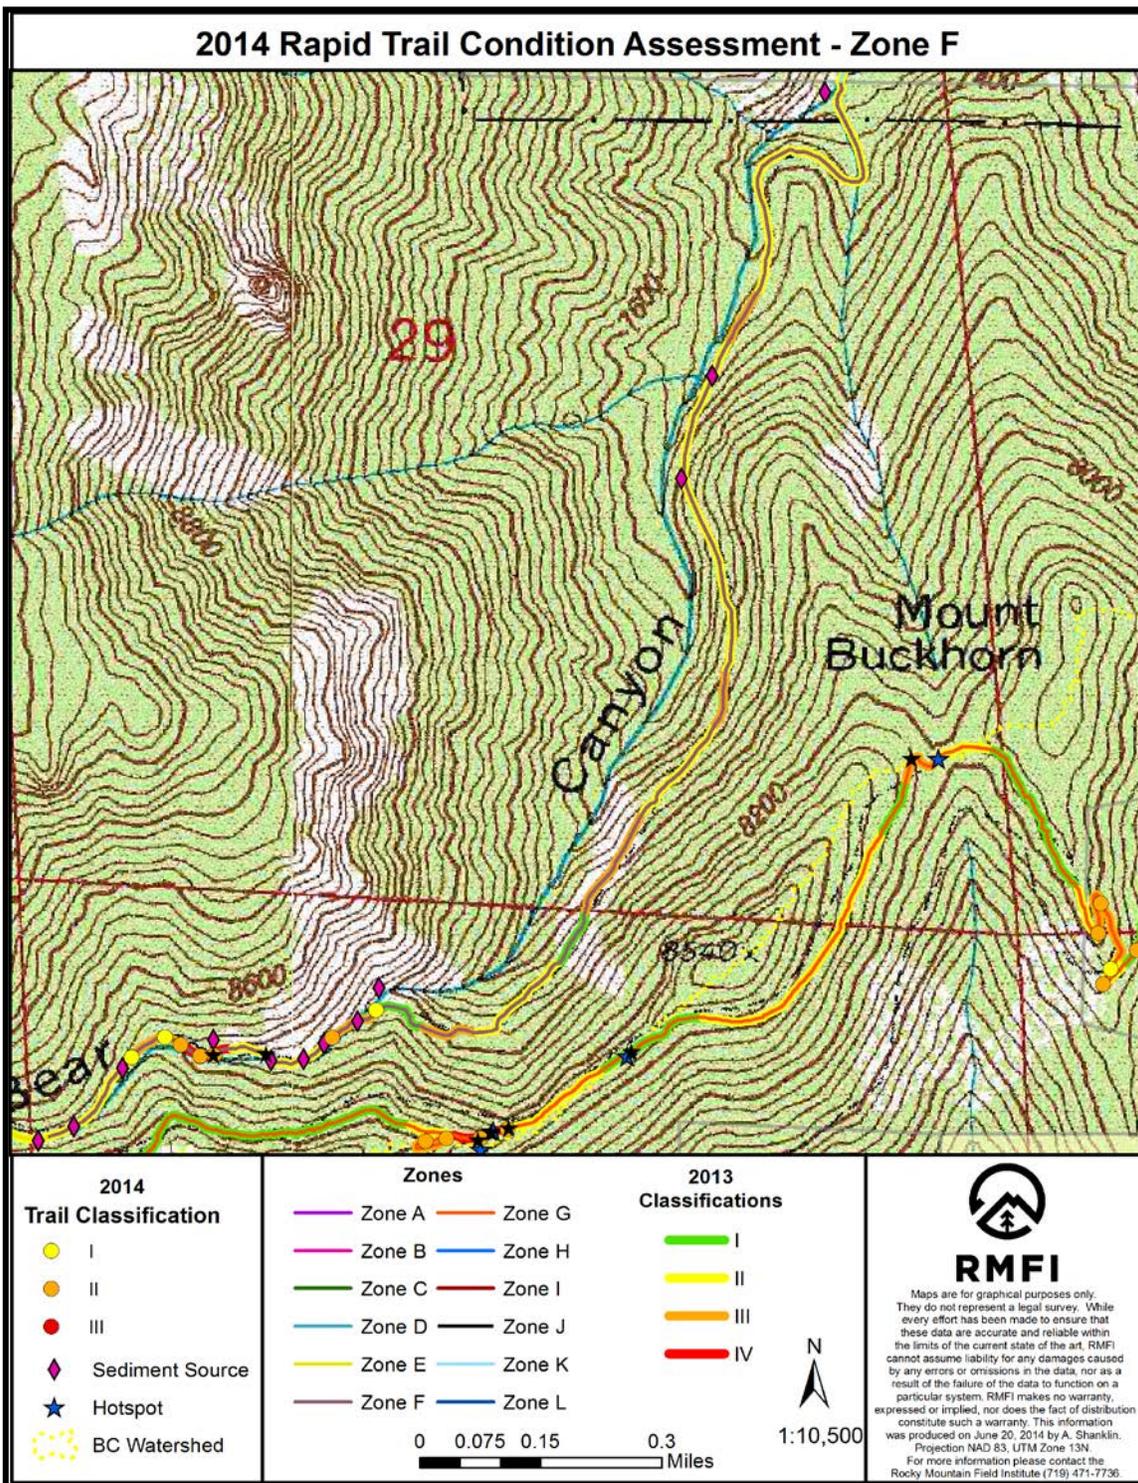
Figure 9. Bear Creek Watershed; Zone F with 2014 Classification Ratings displayed.

The trail in Zone F is on Forest Service land and includes Trail #666. The eastern section of this trail runs into City of Colorado Springs property. This is one of 2 Zones within this assessment that are designated fully non-motorized. There were 11,424 feet of trail within Zone F. Of the 30 sections originally identified for the 2013 assessment, 4 were re-assessed for the purpose of this assessment. Data was collected from 7 individual locations along the trail within these 4 sections: 3 locations were classified as Class I, 4 were Class II, and 0 were Class III. There are 11 locations along the trail in Zone F where sediment is currently entering the stream. New waterbars were recently installed by an unknown party within this zone. These structures are diverting water and sediment directly into the stream. Without proper maintenance these structures could become large sources of sediment into Bear Creek.

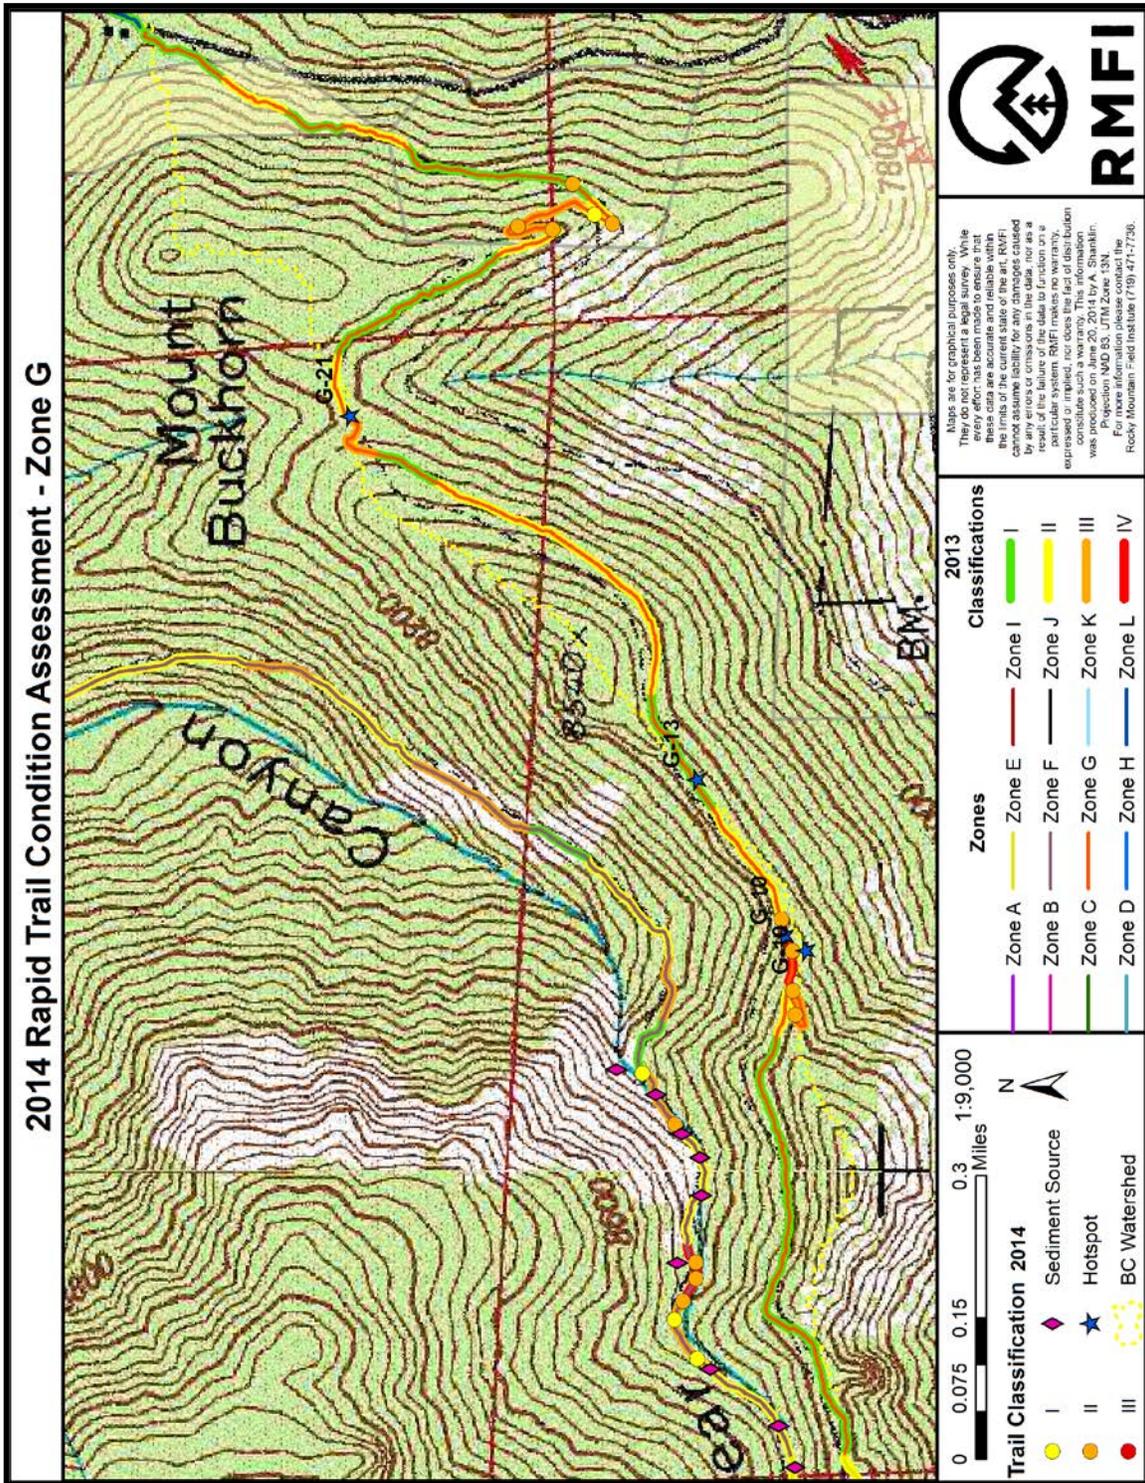
Figure 10. Bear Creek Watershed; Zone G with 2014 Classification Ratings displayed.

The section of trail in Zone G includes Trail #667, starting at High Drive and ending just before the trail meets Trail #666. The 13,876 foot section of trail in Zone G follows a contour line closely. Of the 37 sections originally identified for the 2013 assessment, 5 were re-assessed for the purpose of this assessment. Data was collected from 9 individual locations along the trail within these 5 sections: 1 location was classified as Class I, 8 were Class II, and 0 were Class III. Zone G is not adjacent to Bear Creek and therefore, there are no locations along the trail where sediment is entering the stream. Within Section G-10 there are 3 areas that have been incised to bedrock and have extreme incision and downcutting occurring. Section G-13 contains newly created dips that are causing water to pool and the trail to widen. A portion of trail within Section G-24 is extremely incised. This information was not captured within the assessment framework and was individually identified as a 'hot spot' for the purposes of this assessment.

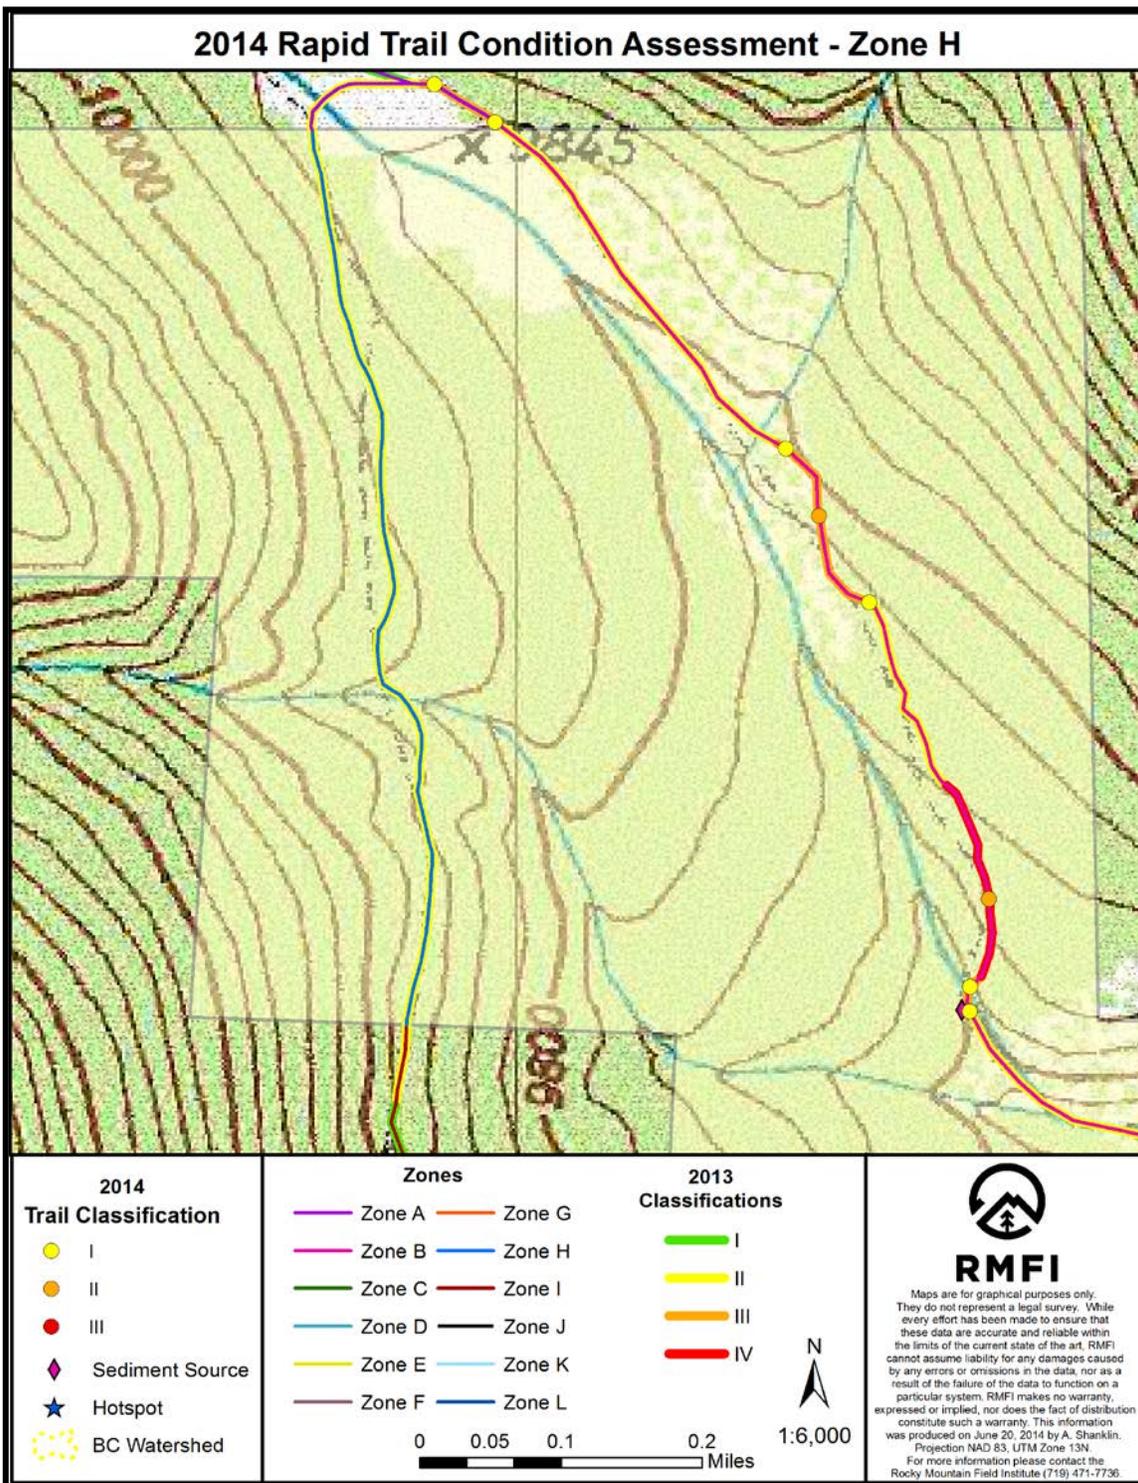
Figure 11. Bear Creek Watershed; Zone H with 2014 Classification Ratings displayed.

This trail is located on CSU land and is designated for multi-use, including motorized vehicles. Zone H encompasses Trail #701, which runs south from Trail #667 near the western extent of the Bear Creek Watershed to the edge of one of the southern borders of CSU property. There are approximately 3,478 feet of trail within this zone. Of the 10 sections originally identified for the 2013 assessment, 0 were re-assessed for the purpose of this assessment. Zone H is not adjacent to the stream and therefore, there are no locations along the trail where sediment is entering the stream.

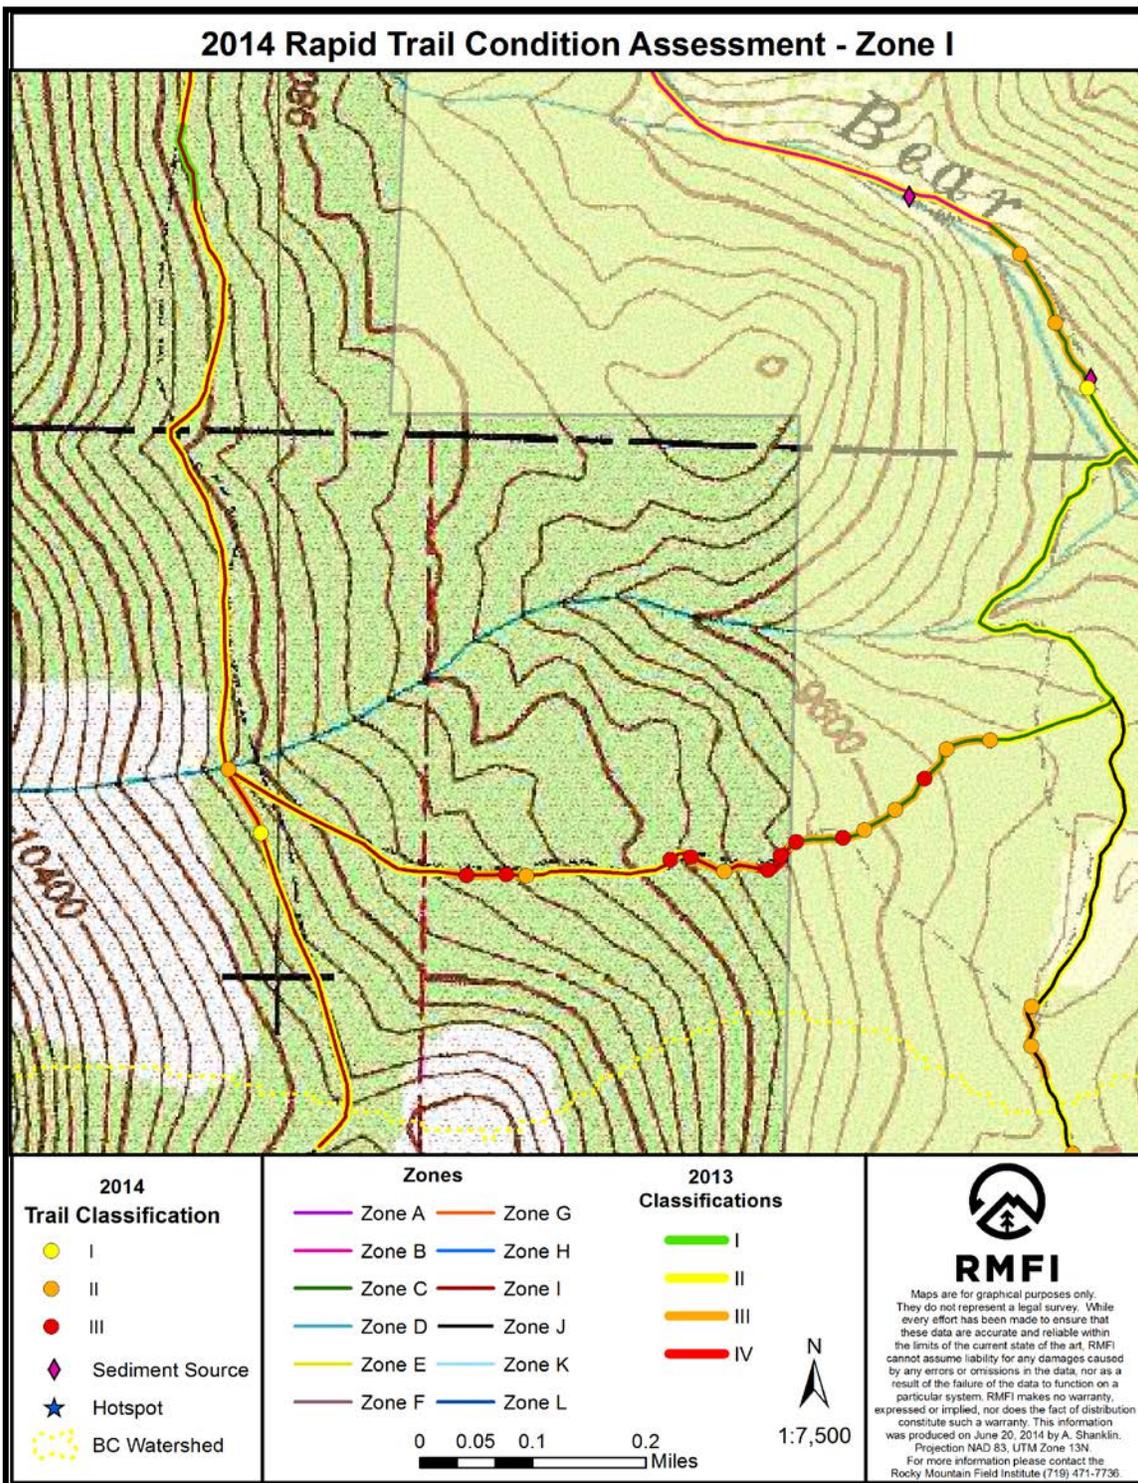
Figure 12. Bear Creek Watershed; Zone I with 2014 Classification Ratings displayed.

Zone I falls entirely on Forest Service land, encompassing both Trail #701 and a portion of Trail #720 where it connects with Zone C. Approximately 8,278 feet of trail is found within Zone I. Of the 22 sections originally identified for the 2013 assessment, 7 were re-assessed for the purpose of this assessment. Data was collected from 10 individual locations along the trail within these 7 sections: 1 location was classified as Class I, 3 were Class II, and 6 were Class III. Zone I is not adjacent to the stream and therefore, there are no locations along the trail where sediment is entering the stream.

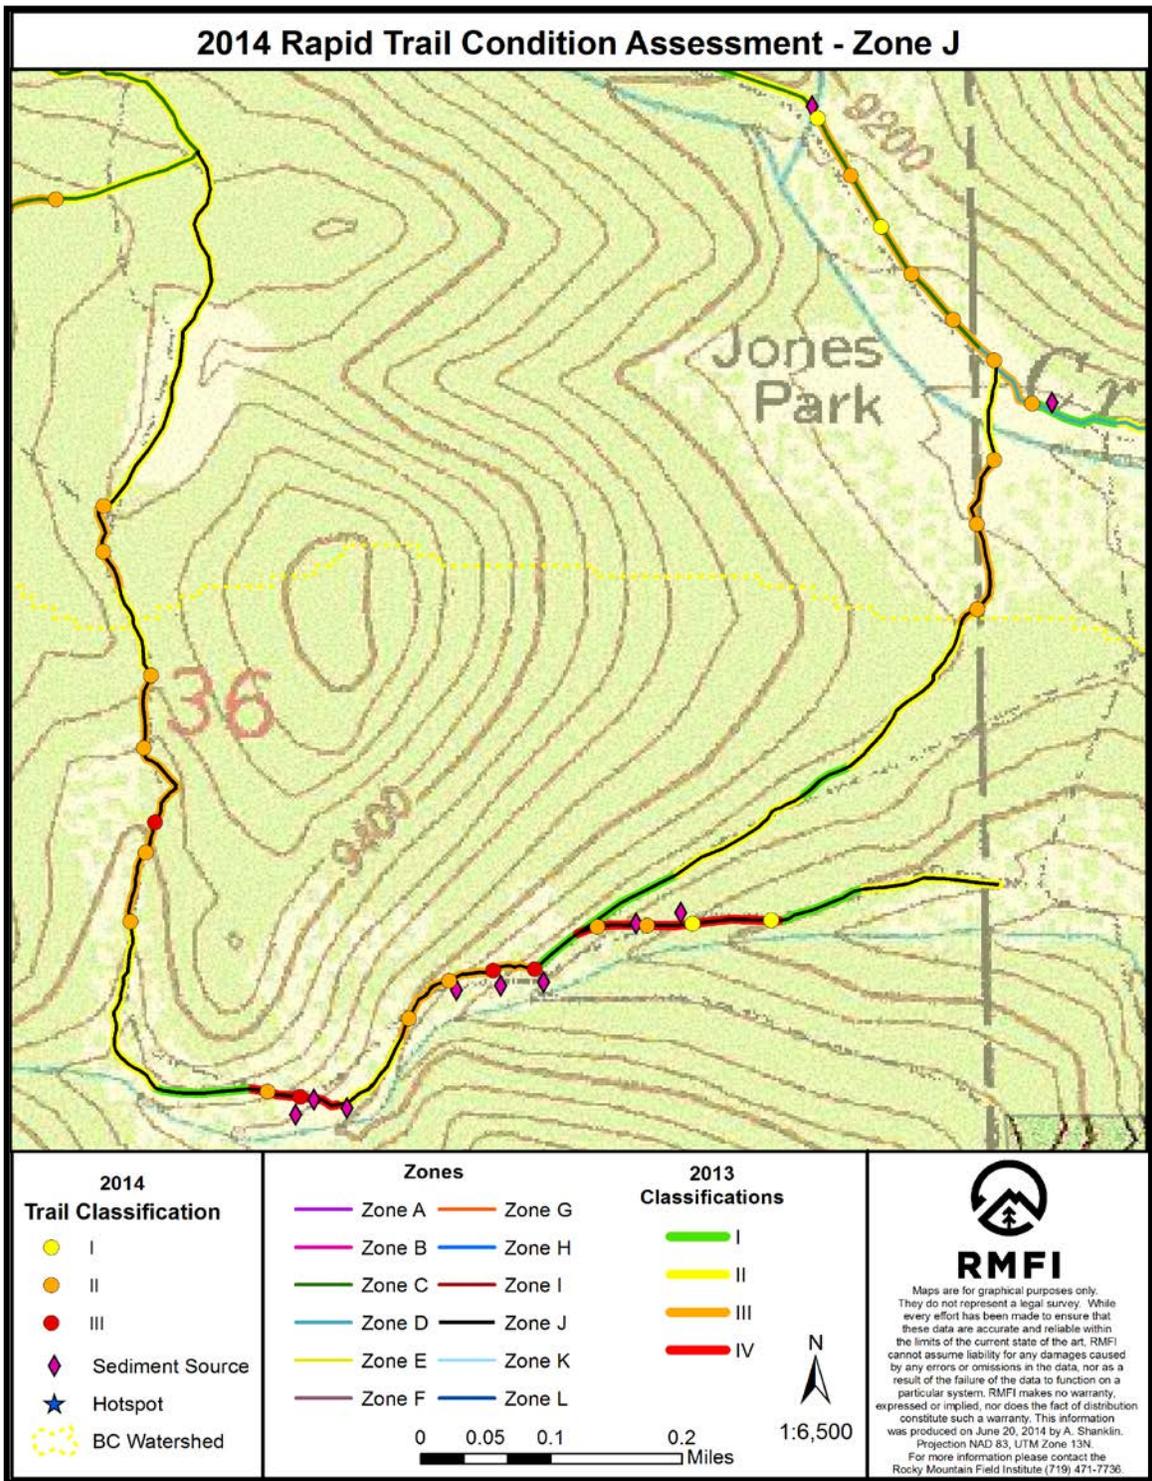
Figure 13. Bear Creek Watershed; Zone J with 2014 Classification Ratings displayed.

The section of trail in Zone J includes portions of Trail #720A, #720, and #668. This zone contains the lower loop around Jones Park. There are approximately 11,286 feet of trail within this Zone. Portions of this zone are not within the Bear Creek Watershed (the lower portion of Trail #720 and #668) but were analyzed in this assessment. Of the 29 sections originally identified for the 2013 assessment, 10 were re-assessed for the purpose of this assessment. Data was collected from 20 individual locations along the trail within these 10 sections: 2 locations were classified as Class I, 14 were Class II, and 4 were Class III. Zone J is not adjacent to Bear Creek; however, there are 8 locations along the trail where sediment is currently entering North Cheyenne Creek.

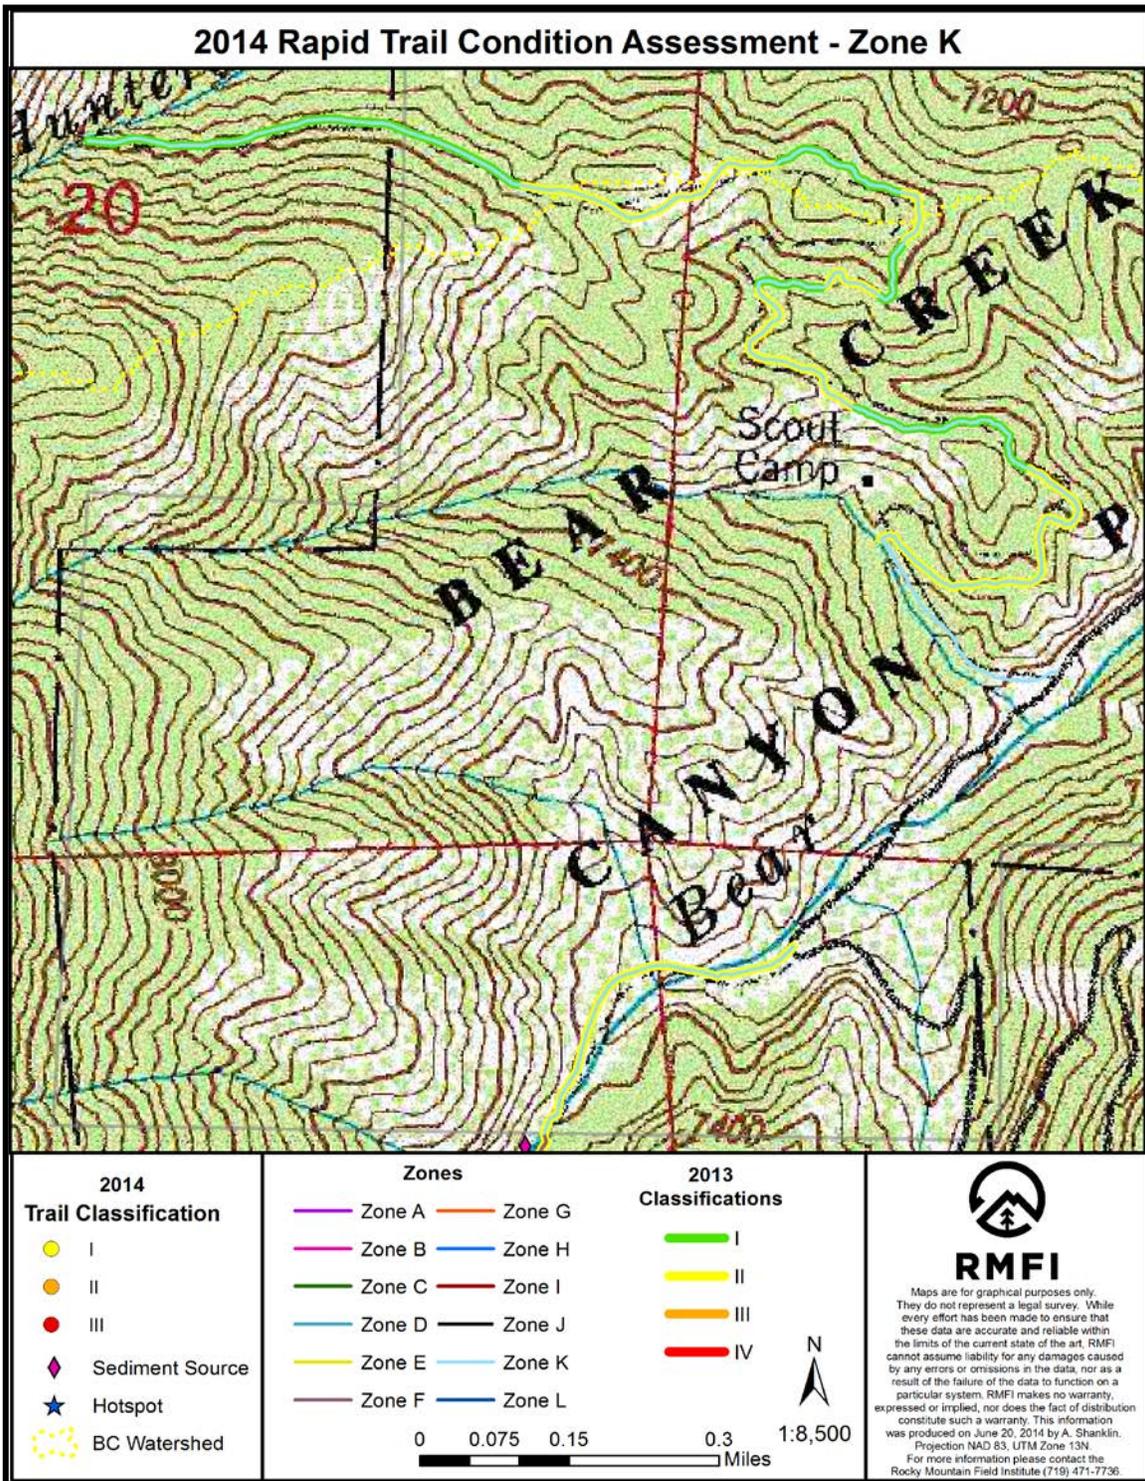
Figure 14. Bear Creek Watershed; Zone K with 2014 Classification Ratings displayed.

There are two system trails in Zone K (City of Colorado Springs land), one along a portion of Trail #666 and one along a portion of the Palmer Loop Trail. The eastern section of the first trail connects to High Drive and the western section meets Trail #666 where it enters US Forest Service land. This is the only other fully non-motorized designated section in this assessment (with Zone F). There are a total of 12,301 feet of trail in Zone K. Of the 32 sections originally identified for the 2013 assessment, 0 were re-assessed for the purpose of this assessment. Zone K is not adjacent to Bear Creek and therefore, there are no locations along the trail where sediment is entering the stream.
