Bear Creek Watershed – 2014 Rapid Trail Condition Assessment

Assessment prepared by:
Amber Shanklin, RMFI Program Director

July 1, 2014

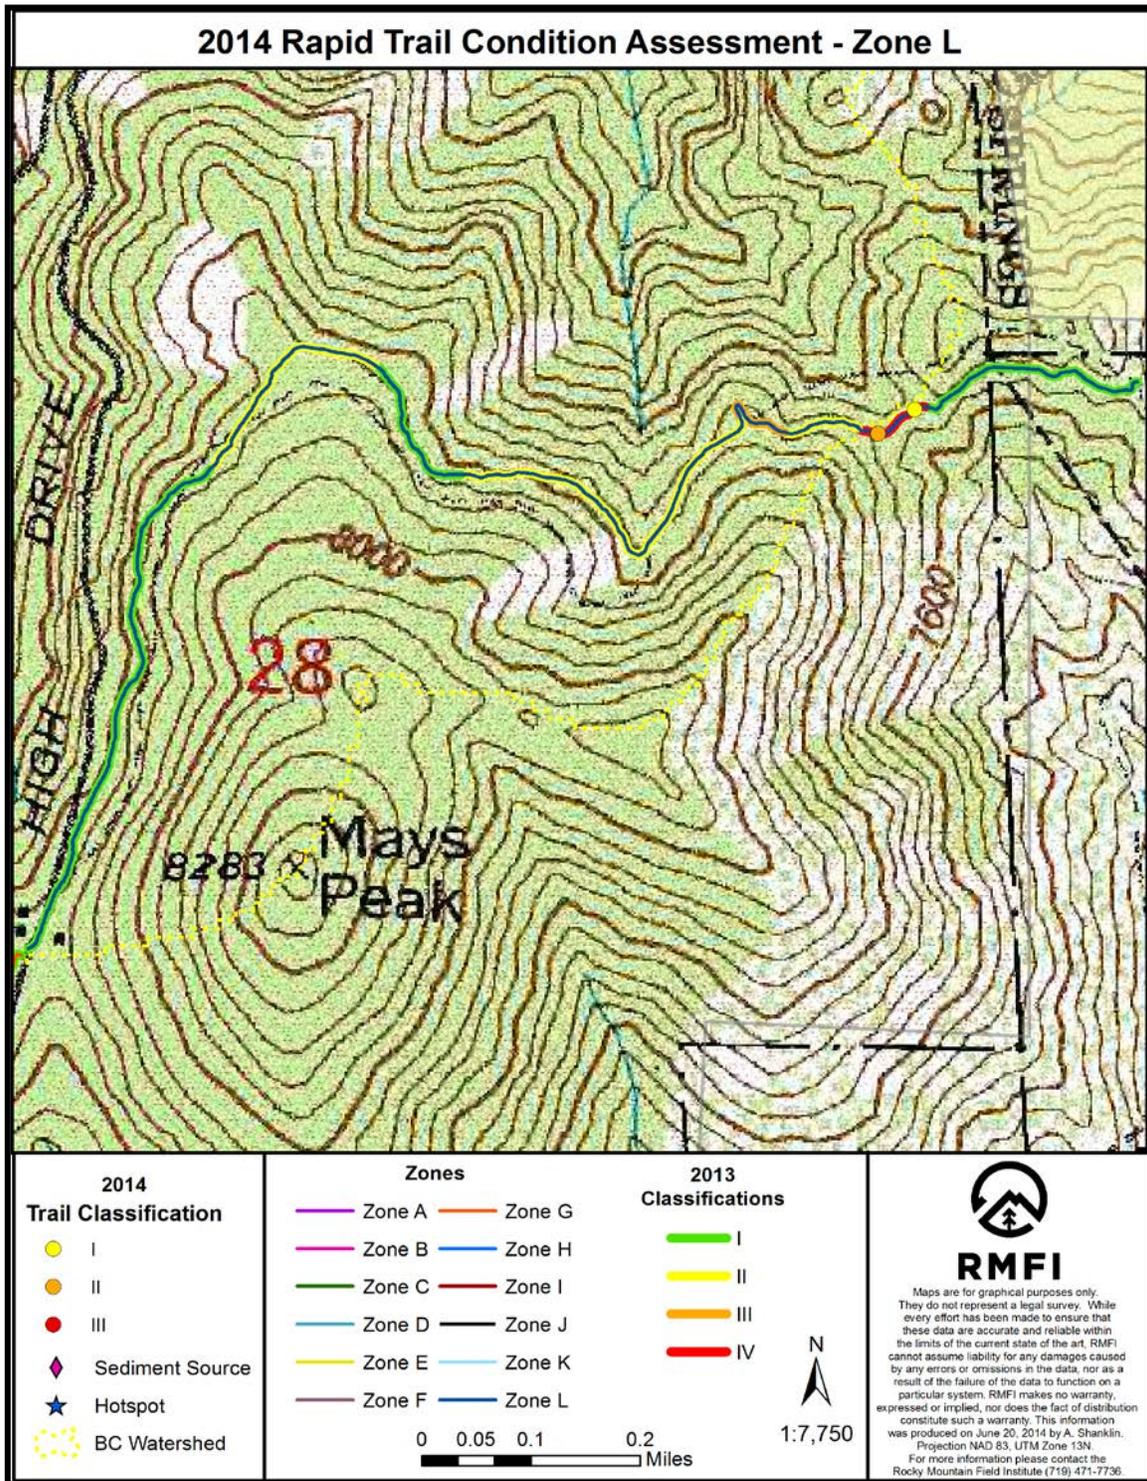
Figure 15. Bear Creek Watershed; Zone L with 2014 Classification Ratings displayed.

There is one system trail (#665) east of High Drive within Zone L. Trail #665 travels northeast from High Drive (near Trail #667), with approximately 8,762 feet of trail within the Bear Creek Watershed. Of the 23 sections originally identified for the 2013 assessment, 1 was re-assessed for the purpose of this assessment. Data was collected from 2 individual locations along the trail within this 1 section: 1 location was classified as Class I, 1 was Class II, and 0 were Class III. Zone L is not adjacent to Bear Creek and therefore, there are no locations along the trail where sediment is entering the stream.
