April 18, 2014

Ref.: 2010-084

Technical Memorandum
April 2014 Site Inspection Report
Blue Ledge Mine
Rogue River-Siskiyou National Forest

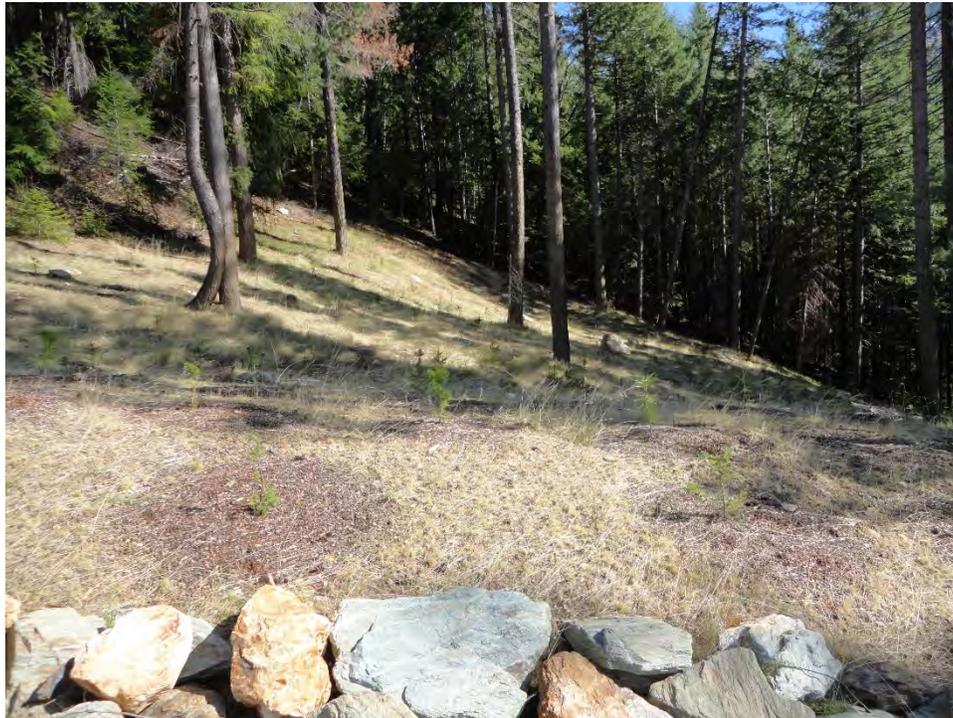
Photograph 5: Repository Stockpile Area with hydroseed and reclamation planting.
Blue Ledge Mine, Rogue River - Siskiyou National Forest, CA
Photographed by: Annica Nord (ERRG) Date: April 9, 2014

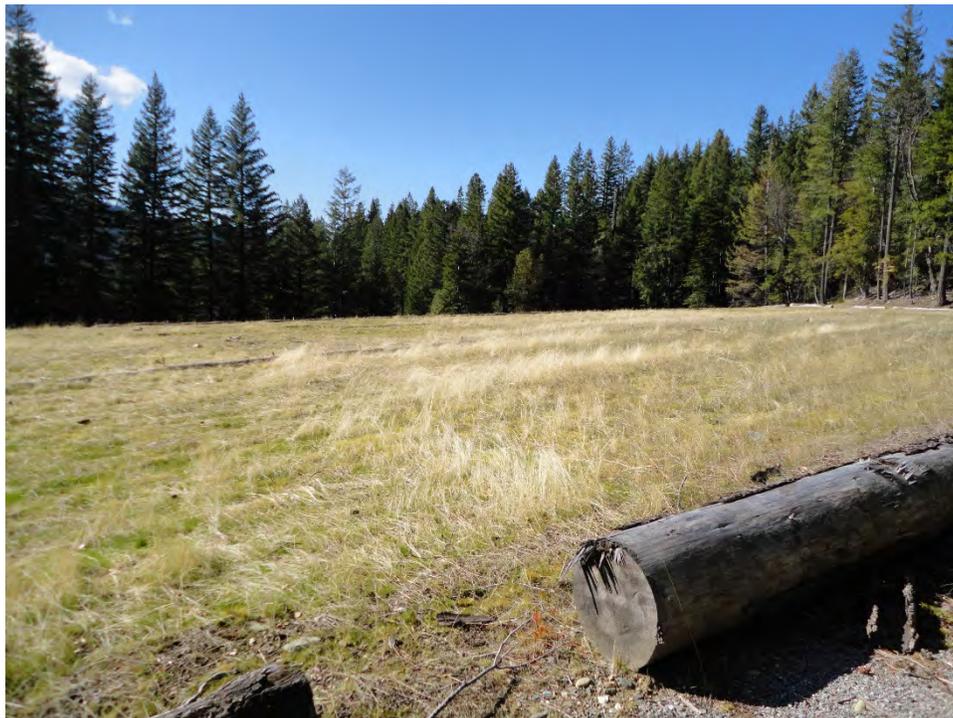
Photograph 6: Hydroseeded top of repository looking northwest.
Blue Ledge Mine, Rogue River - Siskiyou National Forest, CA
Photographed by: Annica Nord (ERRG) Date: April 9, 2014

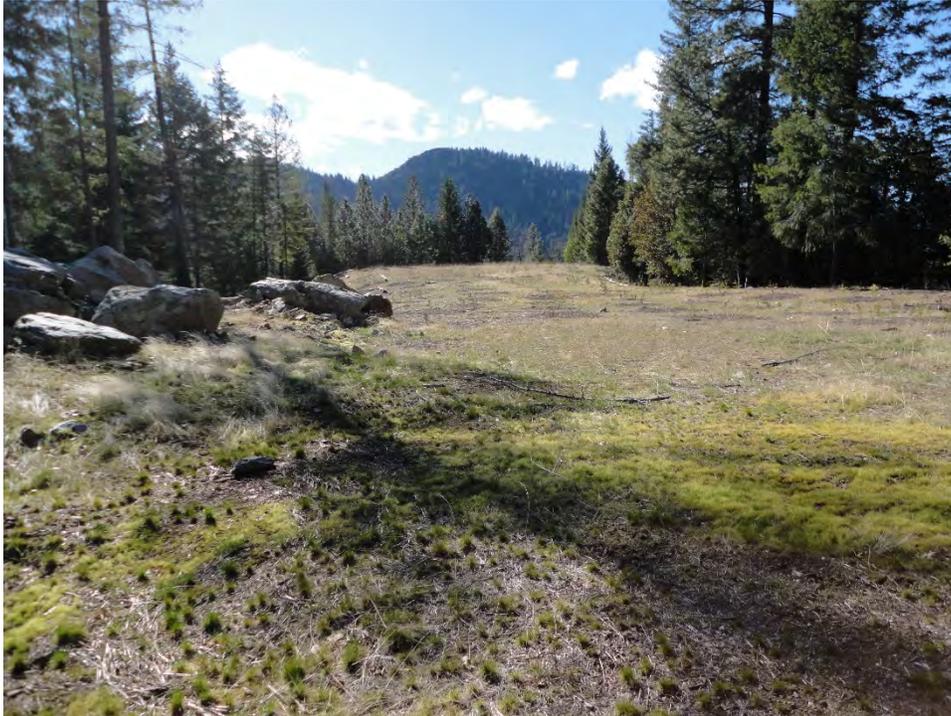
Photograph 7: North Storage area looking west.
Blue Ledge Mine, Rogue River - Siskiyou National Forest, CA
Photographed by: Annica Nord (ERRG)

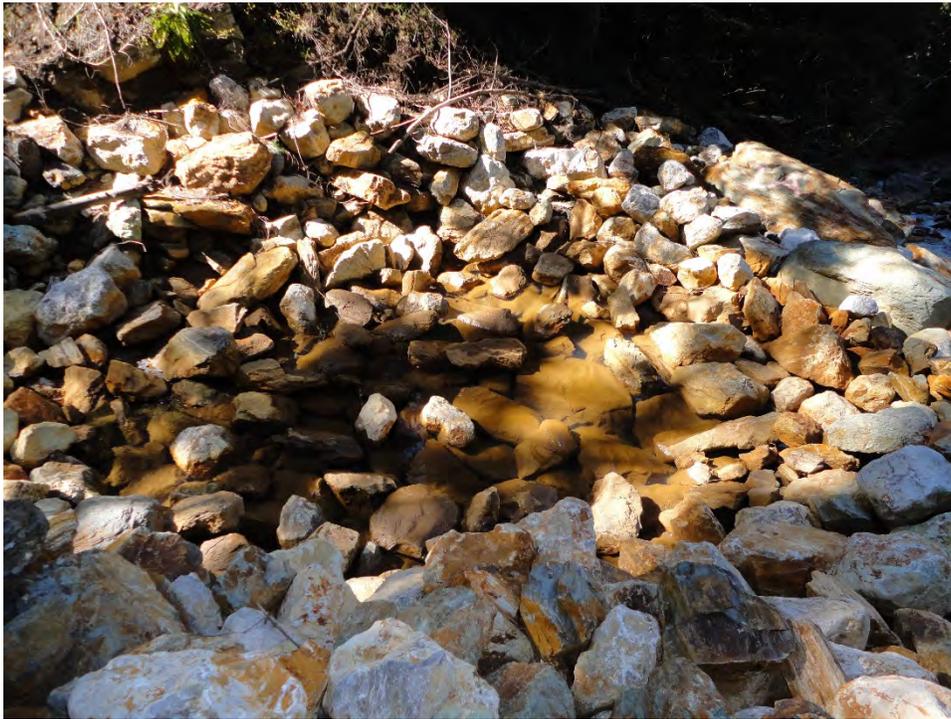
Photograph 10: Sediment/pH Treatment Basin 1A.
Blue Ledge Mine, Rogue River - Siskiyou National Forest, CA
Photographed by: Annica Nord (ERRG) Date: April 9, 2014

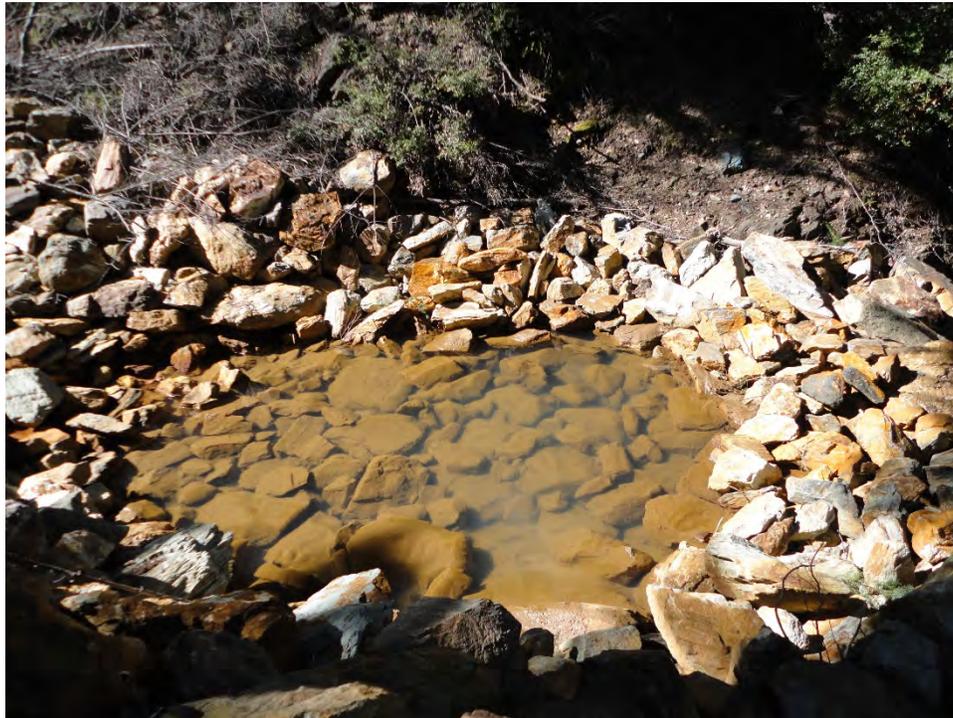
Photograph 11: Sediment/pH Treatment Basin 1B.
Blue Ledge Mine, Rogue River - Siskiyou National Forest, CA
Photographed by: Annica Nord (ERRG)

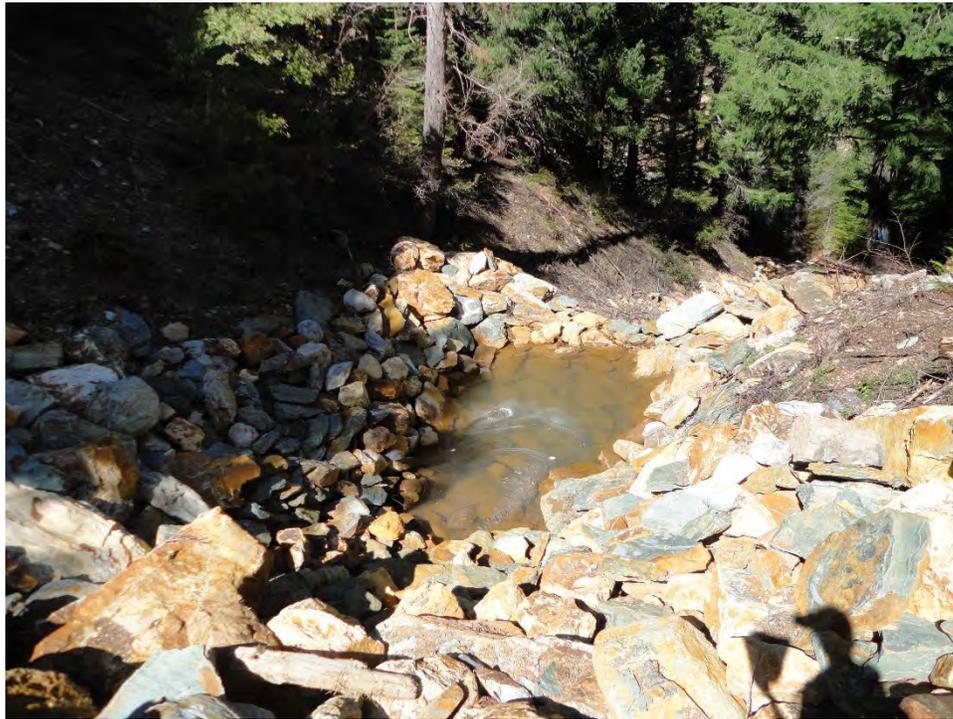
Photograph 12: Sediment/pH Treatment Basin 1C.
Blue Ledge Mine, Rogue River - Siskiyou National Forest, CA
Photographed by: Annica Nord (ERRG)

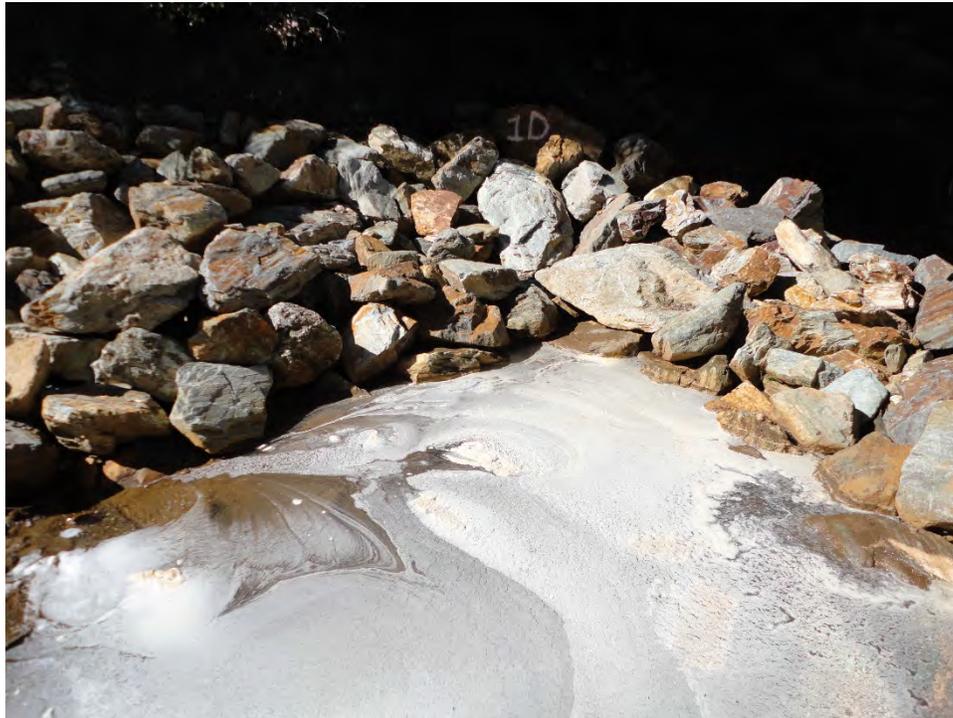
Photograph 13: Sediment/pH Treatment Basin 1D.
Blue Ledge Mine, Rogue River - Siskiyou National Forest, CA
Photographed by: Annica Nord (ERRG)

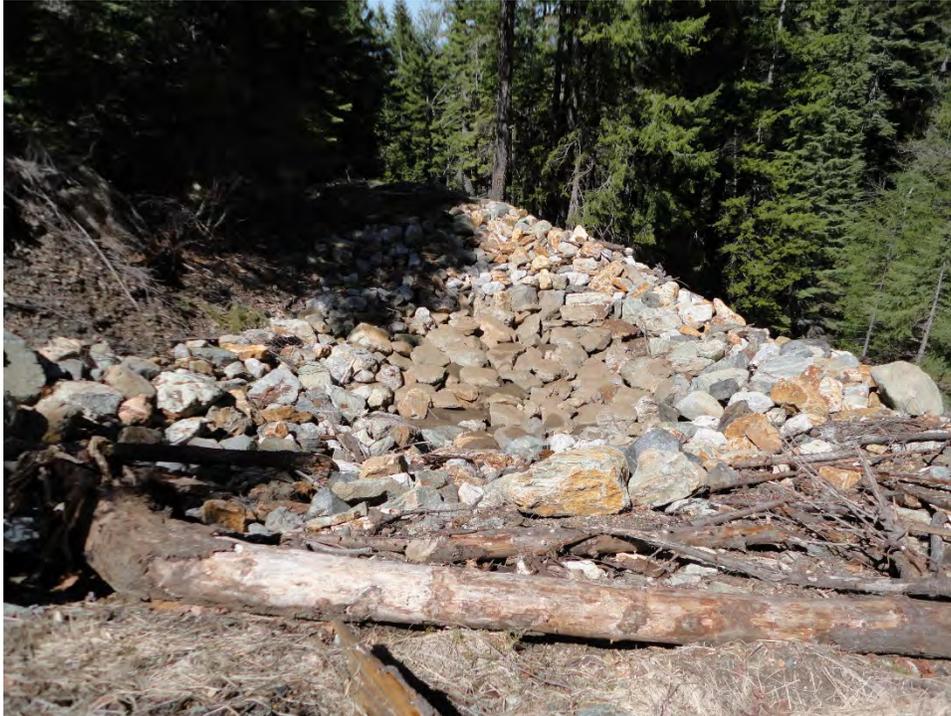
Photograph 17: Sediment/pH Treatment Basin 2A.
Blue Ledge Mine, Rogue River - Siskiyou National Forest, CA
Photographed by: Annica Nord (ERRG)

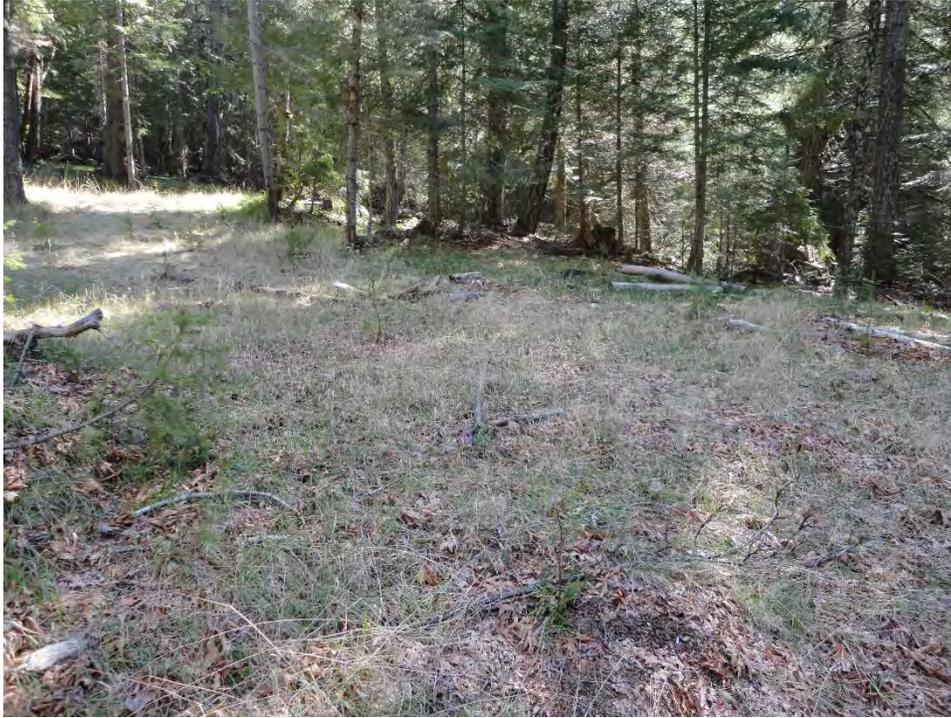
Photograph 19: Rock Stockpile reclamation plants and grass looking west.
Blue Ledge Mine, Rogue River - Siskiyou National Forest, CA
Photographed by: Annica Nord (ERRG)

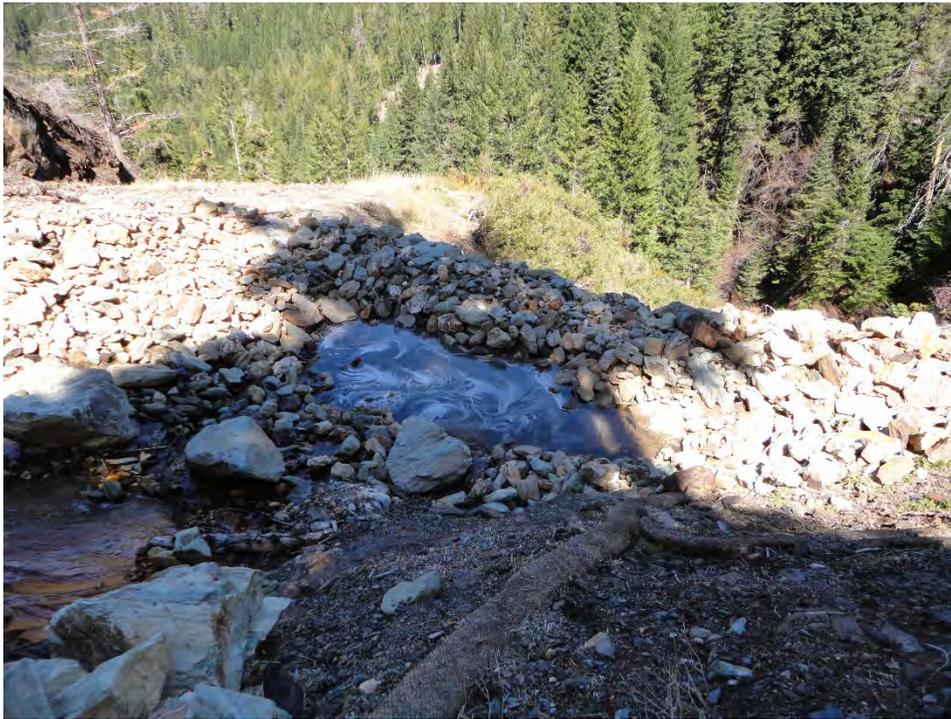
Photograph 20: Sediment/pH Treatment Basin 3.
Blue Ledge Mine, Rogue River - Siskiyou National Forest, CA
Photographed by: Annica Nord (ERRG)

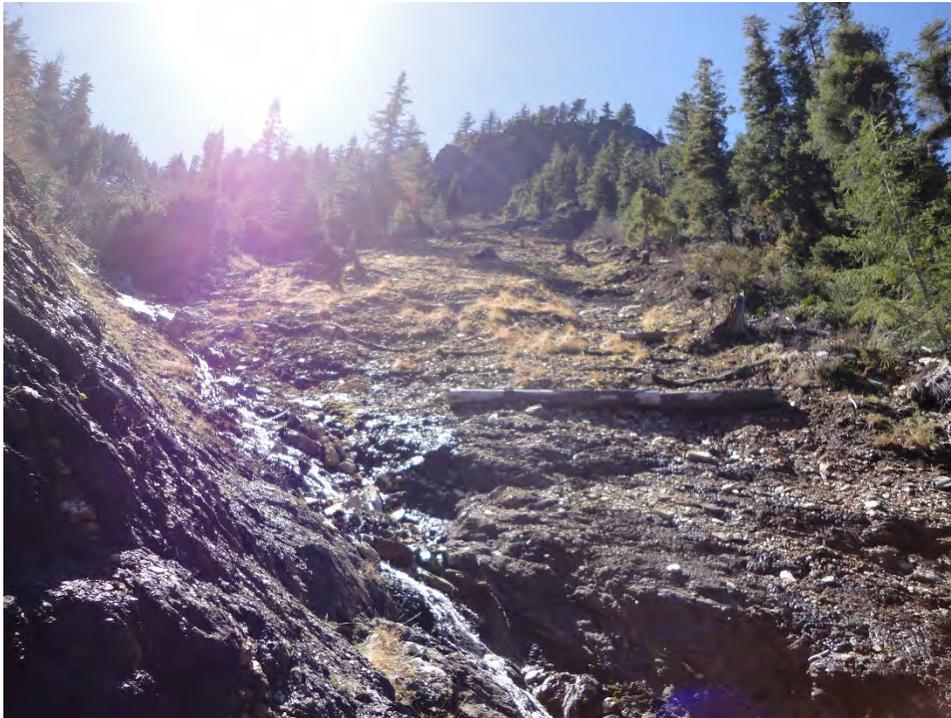
Photograph 21: WRP-3 reclamation plants and grass.
Blue Ledge Mine, Rogue River - Siskiyou National Forest, CA
Photographed by: Annica Nord (ERRG)
