## **APPENDIX M: Supplemental Hydrology Report**

### **Objectives**

### **Observation and Findings from On-The-Ground Surveys**

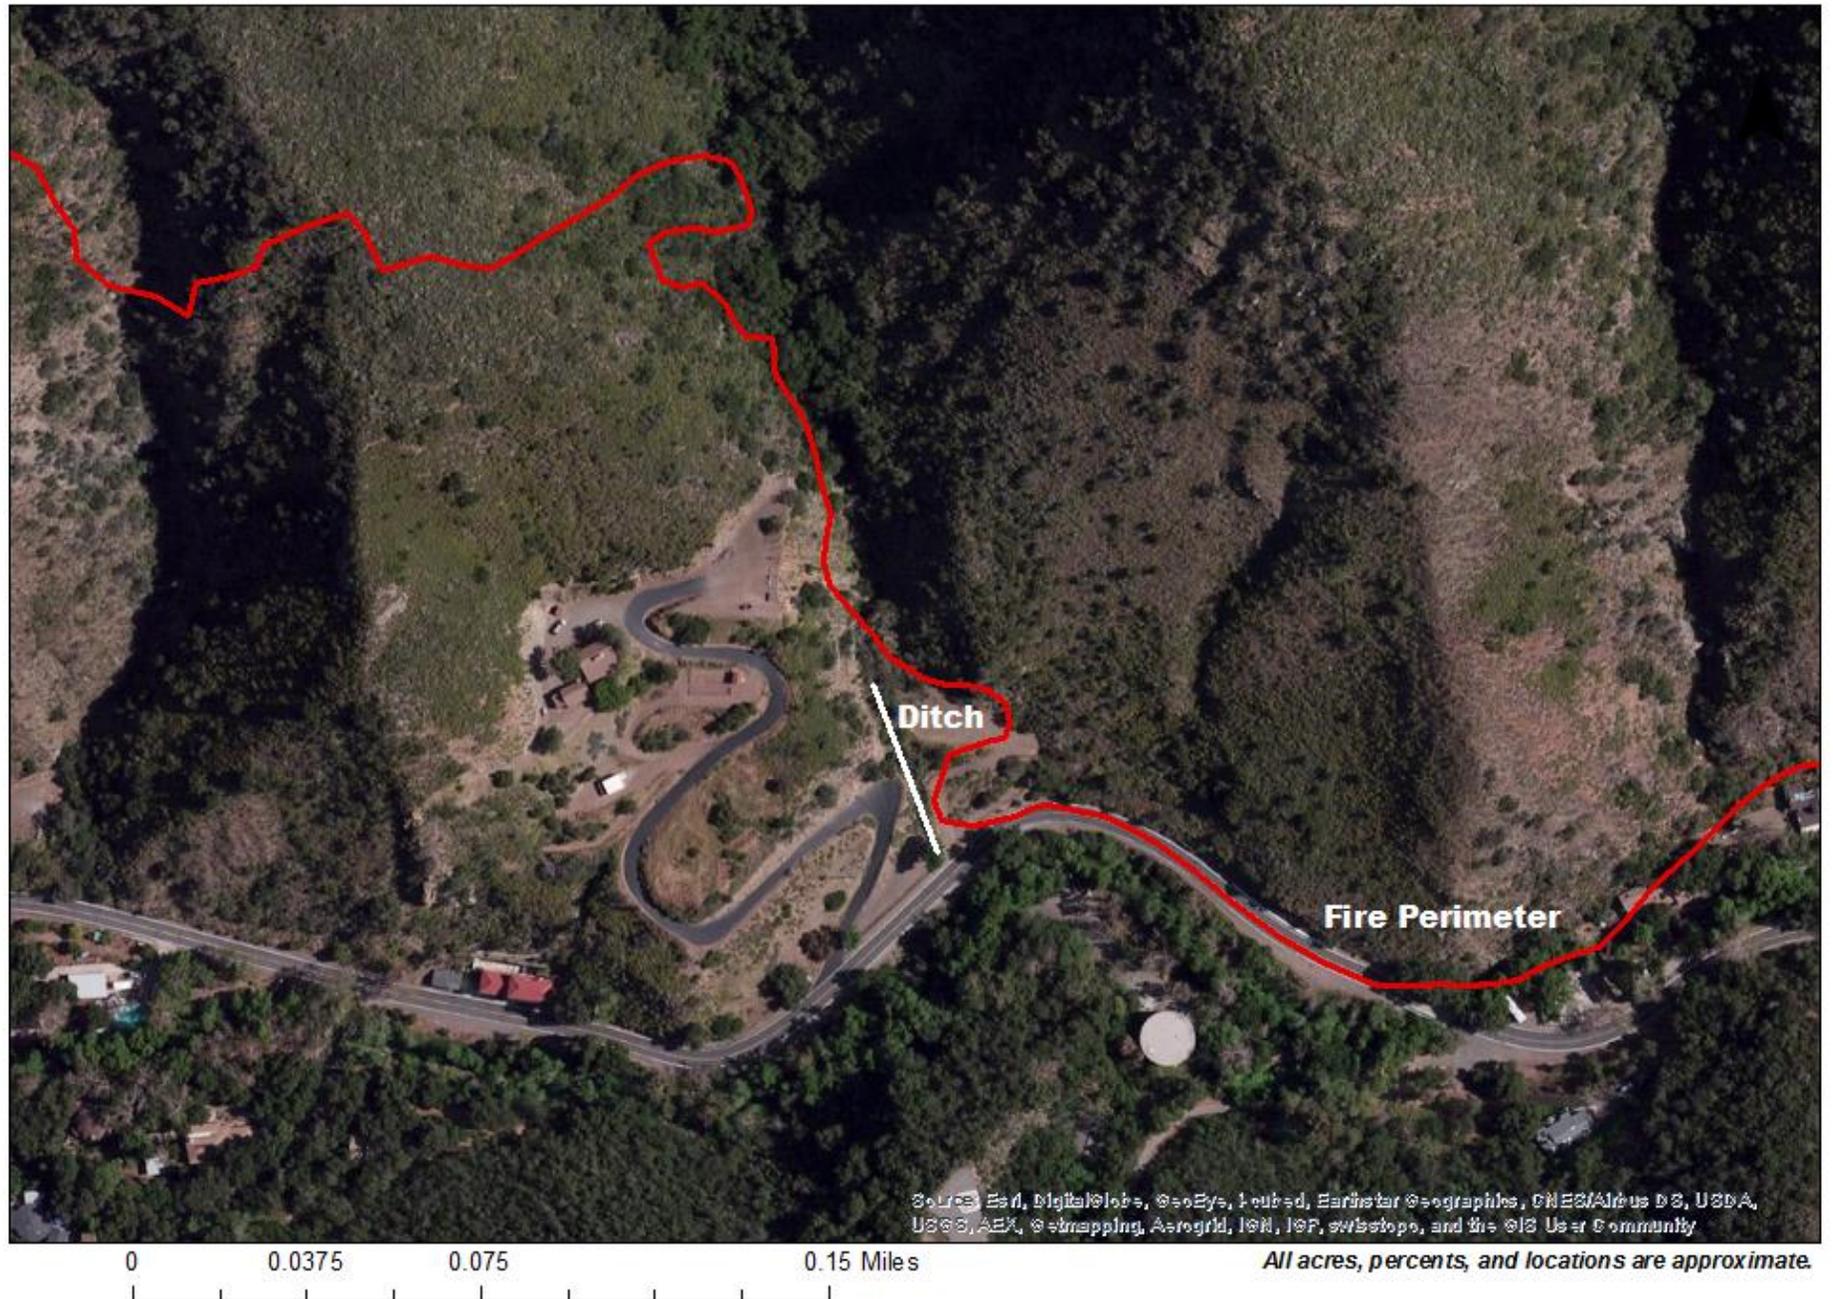
## Silverado Fire 2014 Map: Analysis of VARs--Ranch Access Road

Private road, Silverado Cyn	Contact residents about need for maintenance between storms to prevent failure. Evacuation plan for residents.	<b>Intermediate to Low Risk.</b>  <b>Emergency exists</b>
Ranch access road, Silverado Cyn	Contact NRCS/County to determine erosion control needs. Potentially add k-rails and/or sandbags to channel edge to prevent flooding onto main road. Post-storm patrol and maintenance. Evacuation plan for residents.	<b>High to Intermediate Risk.</b>  <b>Emergency exists</b>
