**SHU-LIGHTNING COMPLEX BURNED-AREA REPORT**  
(Reference FSH 2509.13)

- A. Fire Name: SHU Lightning Complex                      B. Fire Number: CASHU004727  
 C. State: CA    D. County: Tehama, Trinity, Shasta  
 E. Region: 5    F. Forest: Shasta-Trinity National Forest  
 G. Districts: NRA and SFMU                                      H. Fire Incident Job Code: P5D29H  
 I. Date Fire Started: 6/21/08                                      J. Date Fire Contained: 7/20/08  
 K. Suppression Cost: 35 million  
 L. Fire Suppression Damages Repaired with Suppression Funds  
     1. Fireline waterbarred (miles):  
     2. Fireline seeded (miles):  
     3. Other (identify):

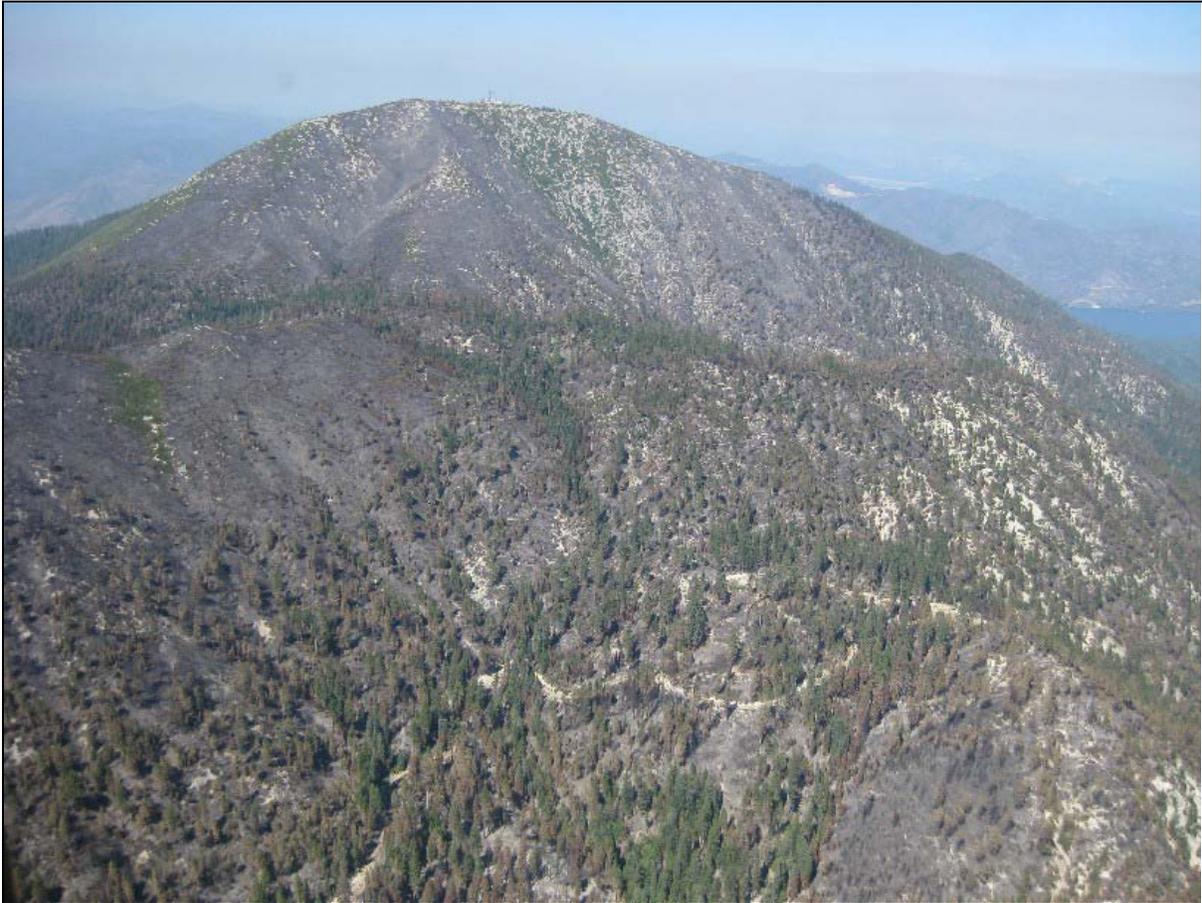
Moon Fire looking at Shasta Bally portion of the SHU-Lightning Complex

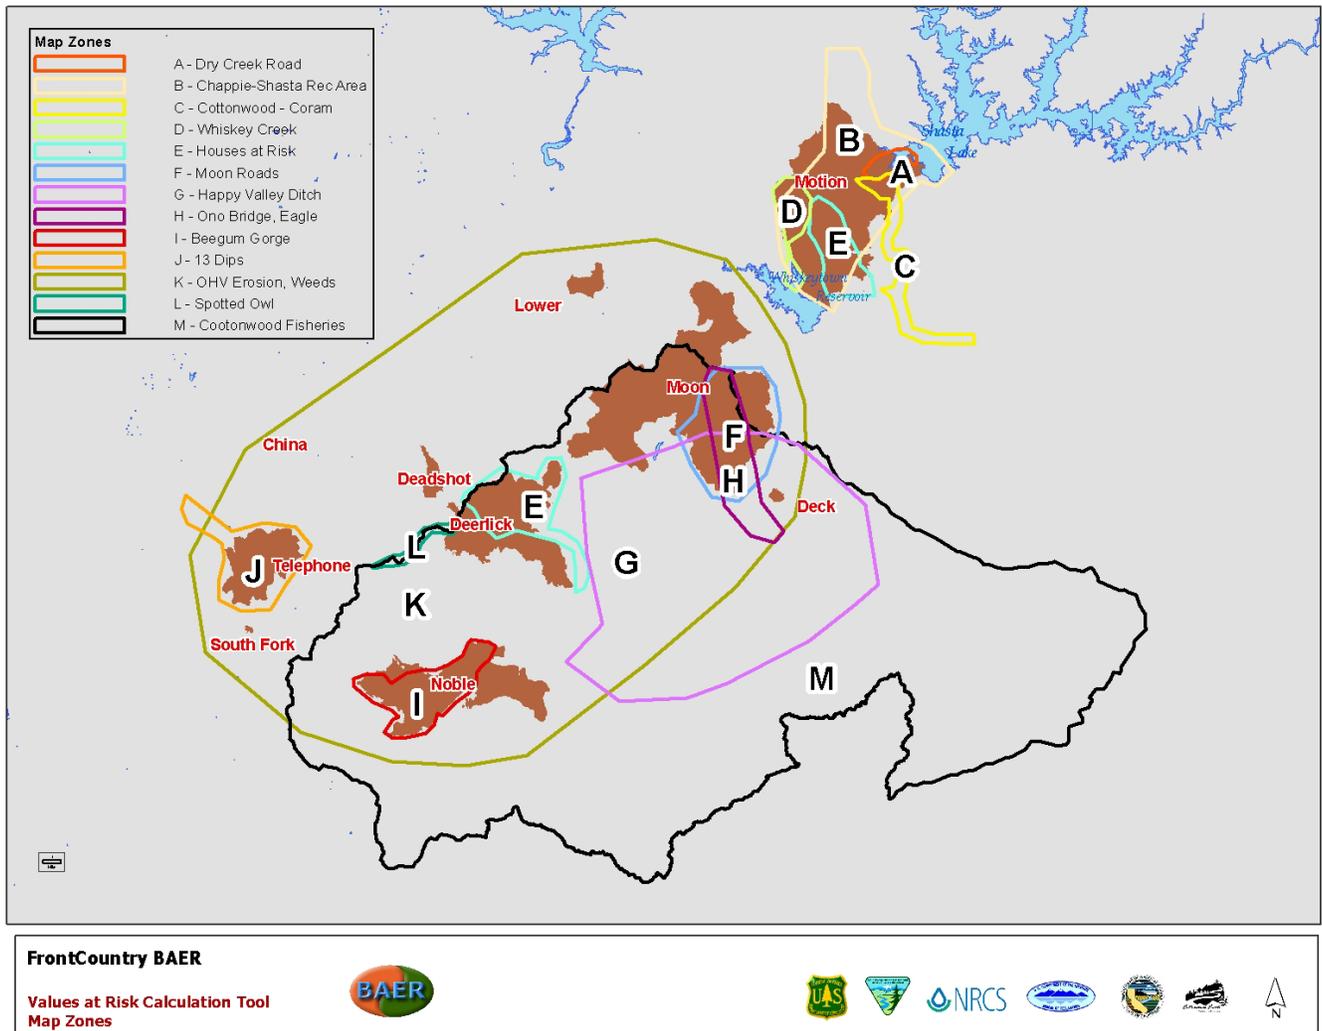
collected, critical value map zones were created to locate their influence on watersheds of concern (see map below).

This map identifies areas that have threats to life, property, and safety (Facility structures, homes, roads and trails). This map also identifies areas that have threats to water quality, fisheries, ecosystem stability, soil productivity, recreation, cultural, and wildlife resources.

**Threats to Life, Property and Safety:** Threats include facility structures and homes: The SHU-Lightning Fires burned on mixed ownership that has many facilities and homes that are now at risk from erosion and flooding. Roads and Trails: Many roads are now at risk due to increased flows from moderate to high soil burn severity, undersized culverts and stream crossing.

**Threats to Water Quality and Fish Habitat:** With Moderate to high soil burn severity water quality and fish habitat could be compromised due to steep burned erosive soils that have sandy loam surfaces.
