Photos of Three Years Monitoring of Winged Subsoiler Treatment Areas

Rio Grande National Forest, Colorado

July 3, 2006

Million Fire Subsoiler Monitoring Project

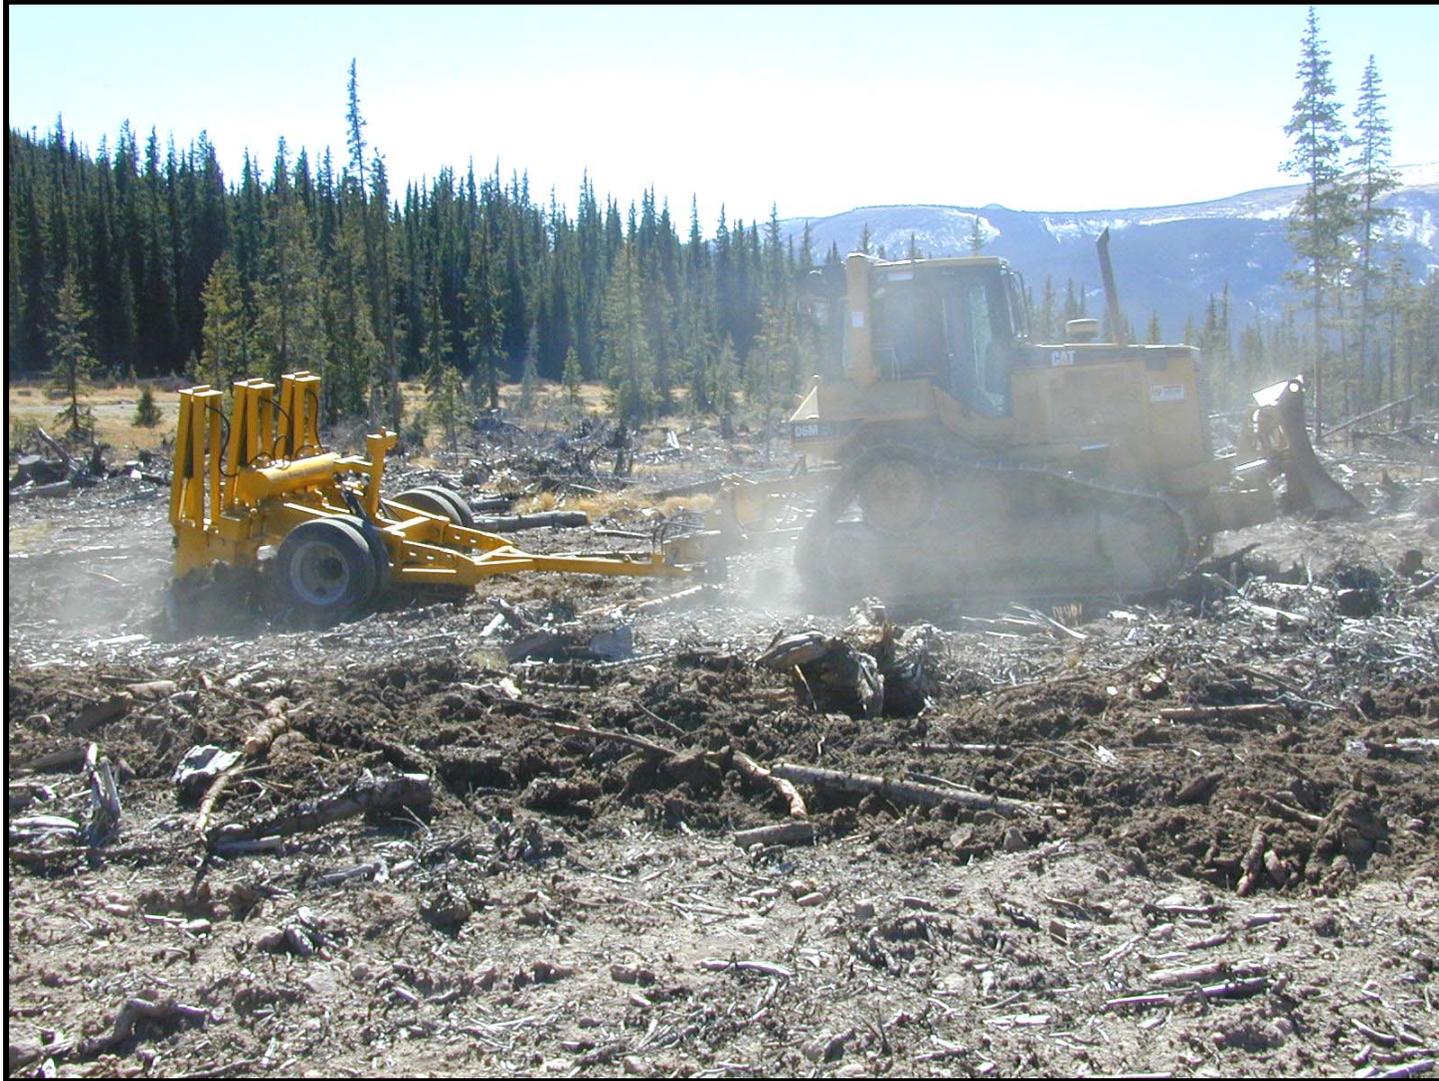
The left side photo is taken on a skid trail after harvest in 1999. This area was subsoiled in 2003. Ideally, we would have subsoiled immediately after logging, but it took a few years to obtain the subsoiler and get it operational. The photo on the right was taken June 28, 2006. The planted stock seems to have good survival in the subsoiled areas.
