**Snodgrass Mountain Geologic Hazards
and Assessment of Potential Effects of
Ski Area Development on Slope Stability**

TECHNICAL REPORT

October 12, 2006

**by
United States Forest Service
Grand Mesa, Uncompahgre and Gunnison (GMUG)
and San Juan National Forests**

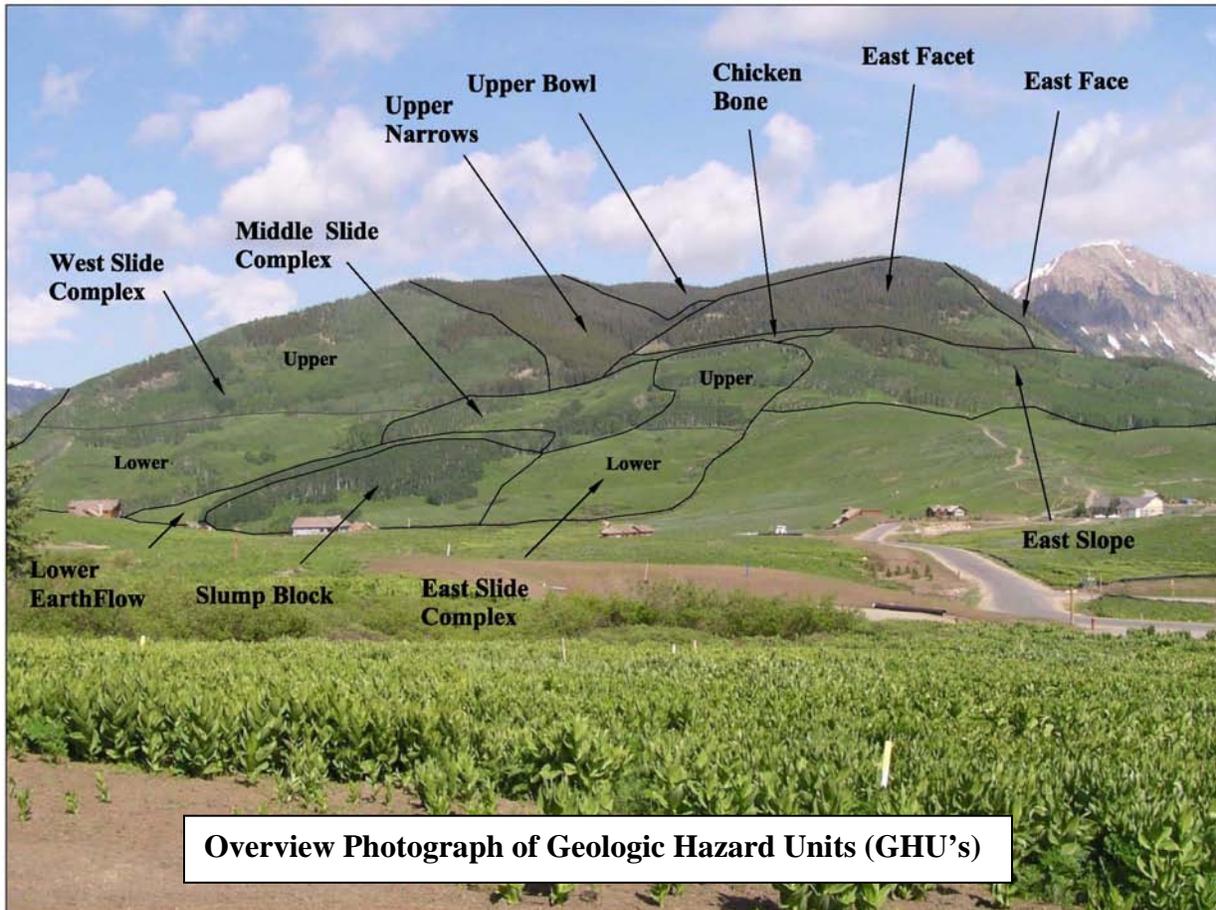
The following photograph, taken of the southeastern slopes of Snodgrass Mountain, shows most of the Geologic Hazard Units discussed in this report. There are additional ground photographs presented under each GHU (discussed after Table 1) and in Appendix C (with 130 photos). Map 5 (Appendix A) shows the locations and orientations of the ground photographs.

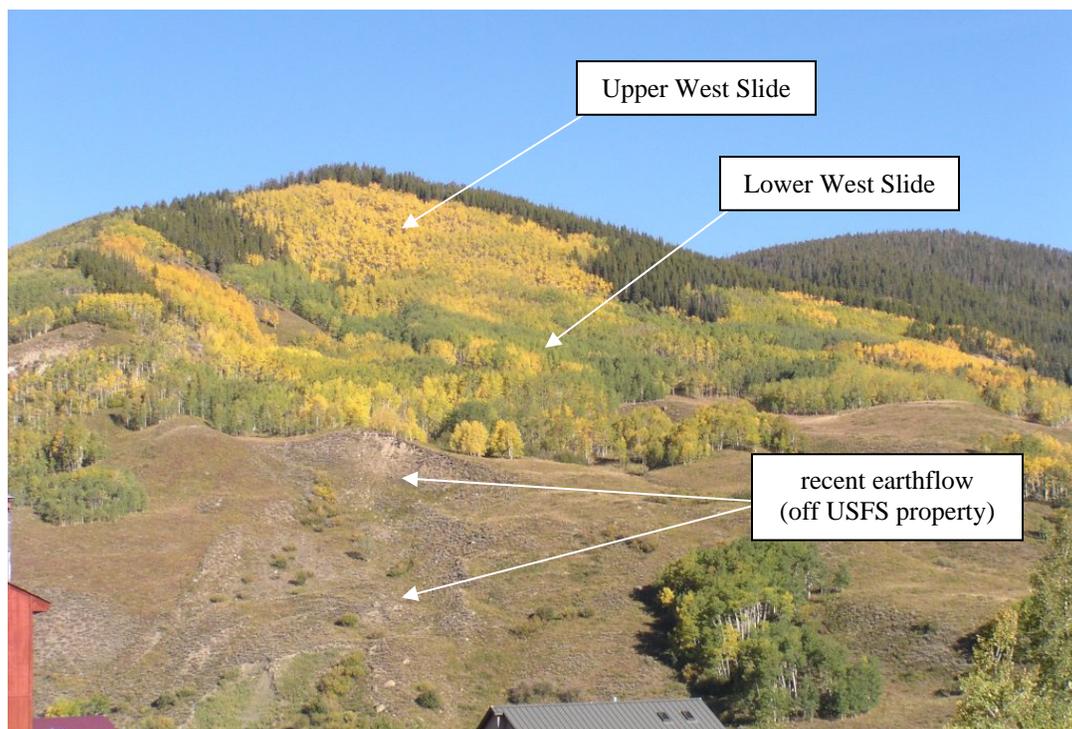
The West Slide Complex extends from just below the false summit on that ridge to the valley bottom between the Crested Butte ski area and the proposed Snodgrass Mountain development. The West Slide Complex consists of two components: the Upper West Slide (also known as the West Facet for its triangular-shaped cut face) and the Lower West Slide. The upper and lower components of this slide are shown in the following photograph. The recent (within past 40 years) earthflow discussed in the Baum (1996) report can be seen in the lower left quadrant of this photograph, but it is outside of the USFS boundary.

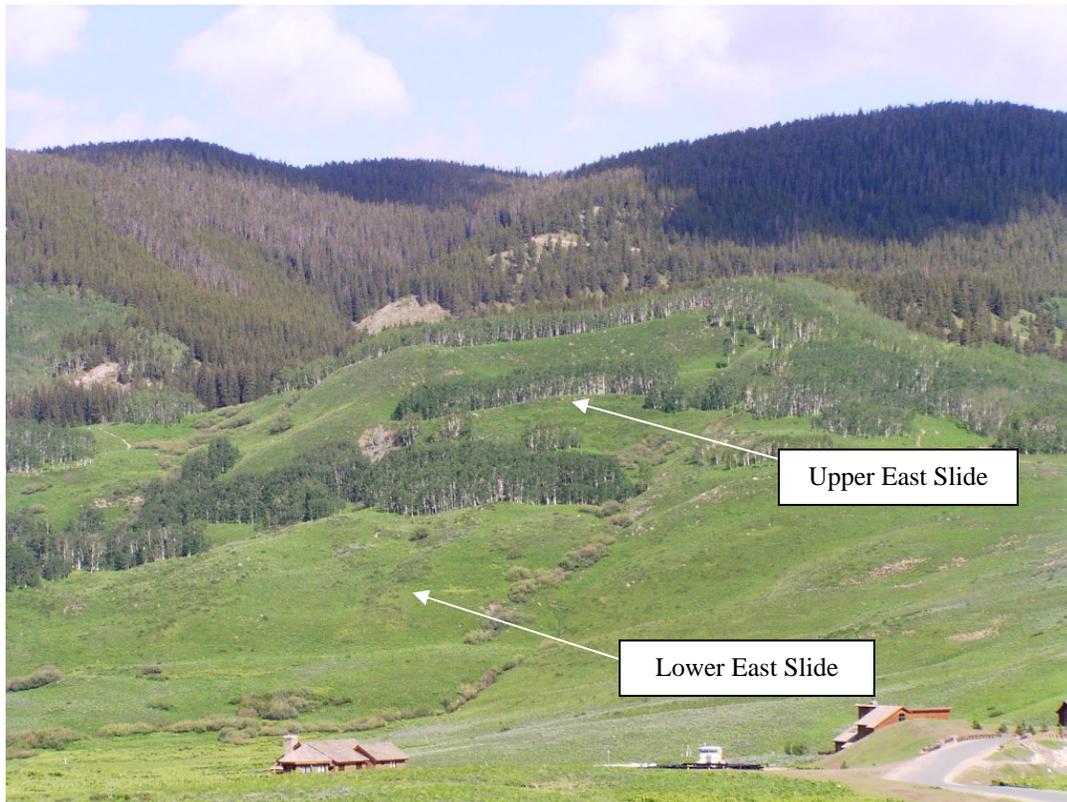
The East Slide Complex is northeast of the Middle Slide Complex, Lower Earthflow, and Slump Block and southwest of East Face. Previous investigators (RCE, 1995; Irish, 1996; Baum, 1996) have considered it to be the least stable part of the proposed development and all have recommended avoidance of this area, if possible. Due to its complexity and varying landslide features, the East Slide Complex has been further divided in this study into the Upper East Slide and Lower East Slide. The Upper East Slide consists of a sequence of aligned scarps and slump blocks starting at an elevation of 10,185 feet and descending down the slope. The landslide transitions into an earthflow at 9,810 feet, just below the bottom of a clump of aspen, and it extends to the valley bottom at 9,525 feet. This earthflow portion of the East Slide Complex is the Lower East Slide. The entire East Slide Complex is shown in the following photograph, taken looking northwest from a residential area in Mount Crested Butte.

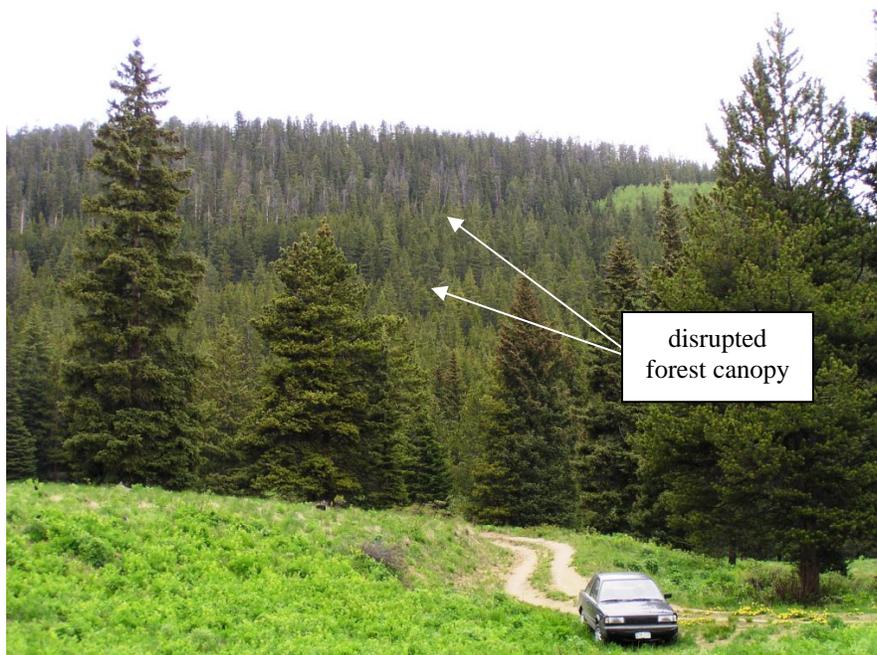
The conifer tree cover on the upper slopes is older than on the lower slopes and contains numerous dead standing snags. The contact between the forest canopy's textures, when observed from below, is a series of gentle arcs that are concave upslope, as seen in the following photograph. This suggests possible movement of the slopes, which would displace whole clusters of trees, but this has not been verified on the ground.

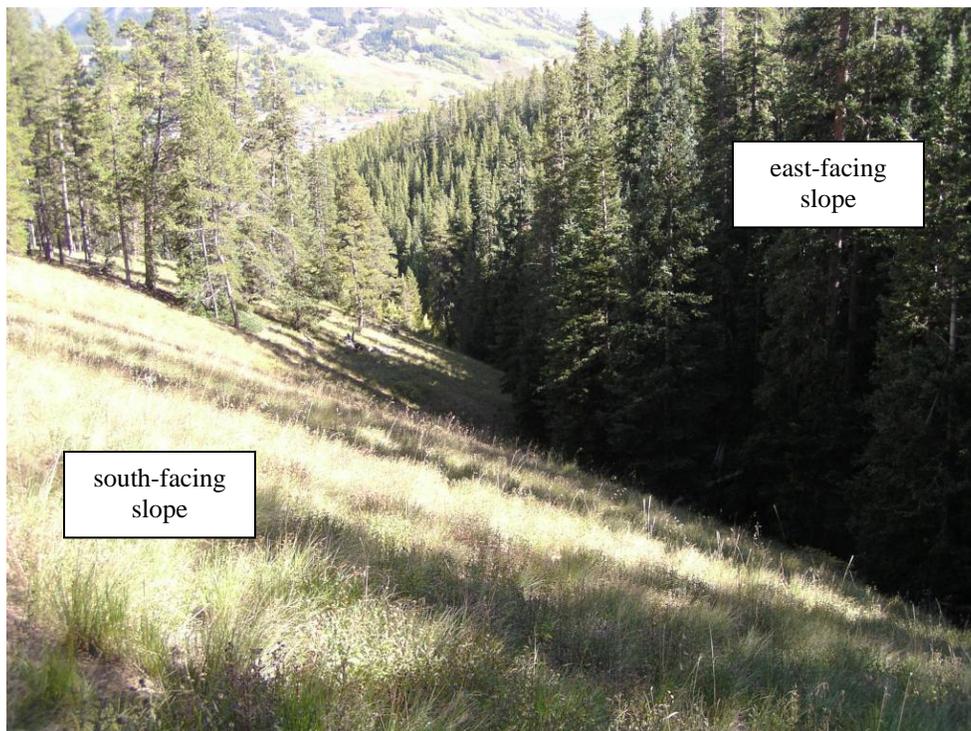
The dirt access road that accesses the top of Snodgrass Mountain crosses the upper, northern portion of the Upper Narrows. On the northeast side of the Unnamed Drainage, the slope faces south and varies from 35 to 45%. This south-facing slope is heavily wooded with conifers above the road and patchy stands of conifers amongst sloping meadows below the road. On the southwest side of the Unnamed Drainage, the slope faces east to northeast, is densely wooded with conifers, and slopes generally varies from 35 to 60%. The following photograph, taken looking down the Unnamed Drainage, shows the densely wooded east-facing slope on the right and the more open south-facing slope (below the road) on the left.

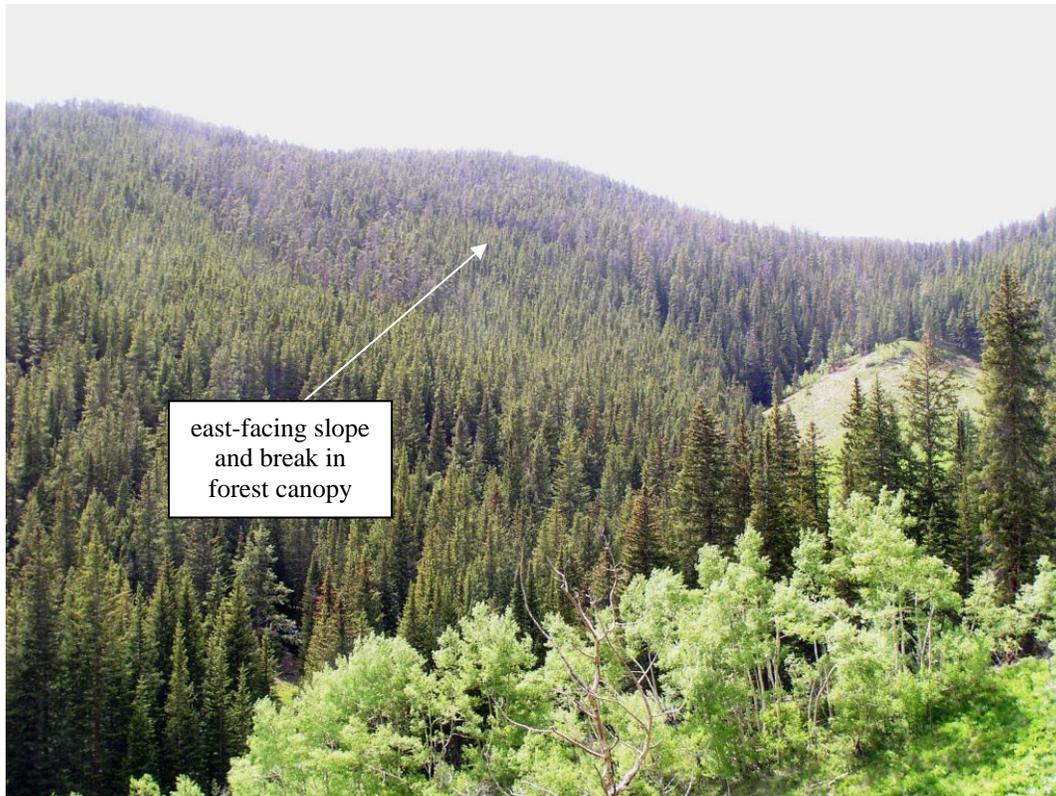
As with the East Facet (GHU #7), there are some locations with a change in the texture of the tree canopy that can be seen as arcs that are concave upslope. The forest below the arcs appears to be younger and there are fewer dead and leaning trees compared to above the arcs. Further ground investigation is suggested to observe whether scarps or topographic breaks exist in this area to determine whether this forest change indicates previous slope movement. The following photograph, taken looking up the Unnamed Drainage, shows the texture of the dense forest on the east-facing slope of the Upper Narrows.

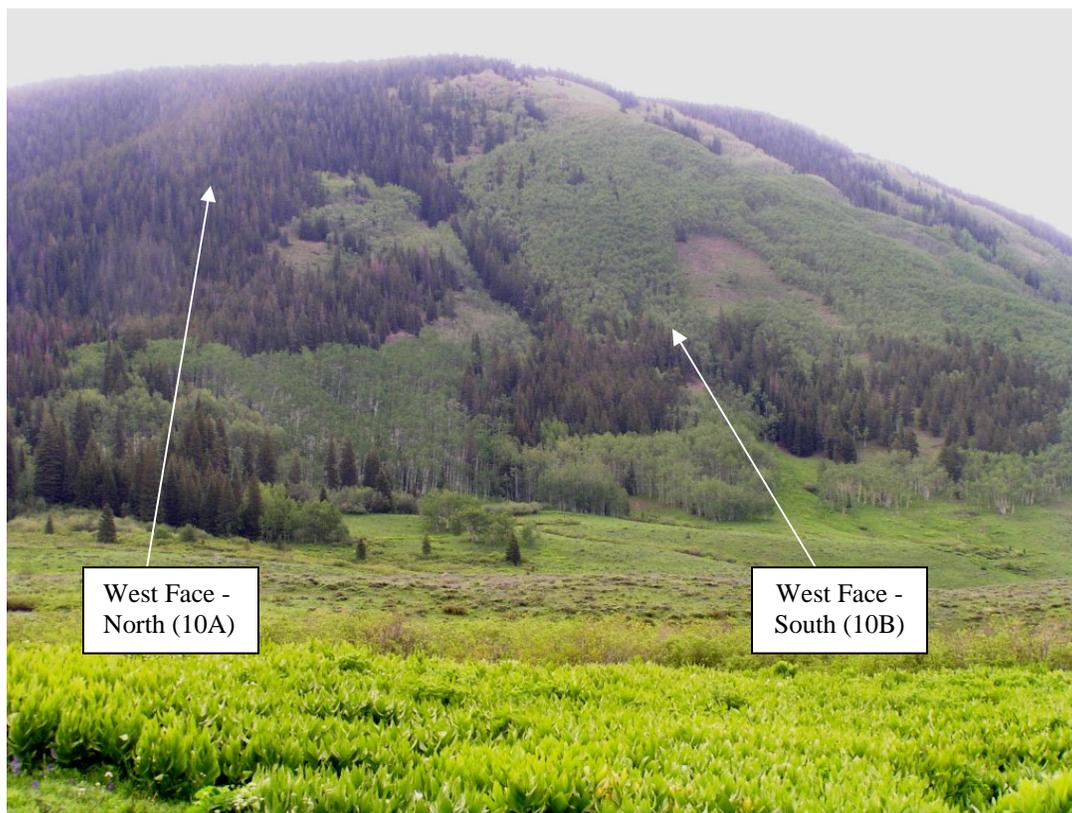
The slopes of the West Face are generally moderately steep to steep throughout this unit. The vegetation consists of predominately conifers on most of the West Face – North unit, with mixed aspen and conifers on the lower slopes. The West Face – South unit is vegetated with aspen in the upper portion and a mixture of aspen and conifers in the lower half. Some areas have only grasses and shrubs. The following photograph, taken looking roughly southeast at the western side of Snodgrass Mountain, shows the character of the West Face. A portion of the North Face (GHU #11) is seen on the left side of the following photograph as the steep slope with a dense cover of conifers.

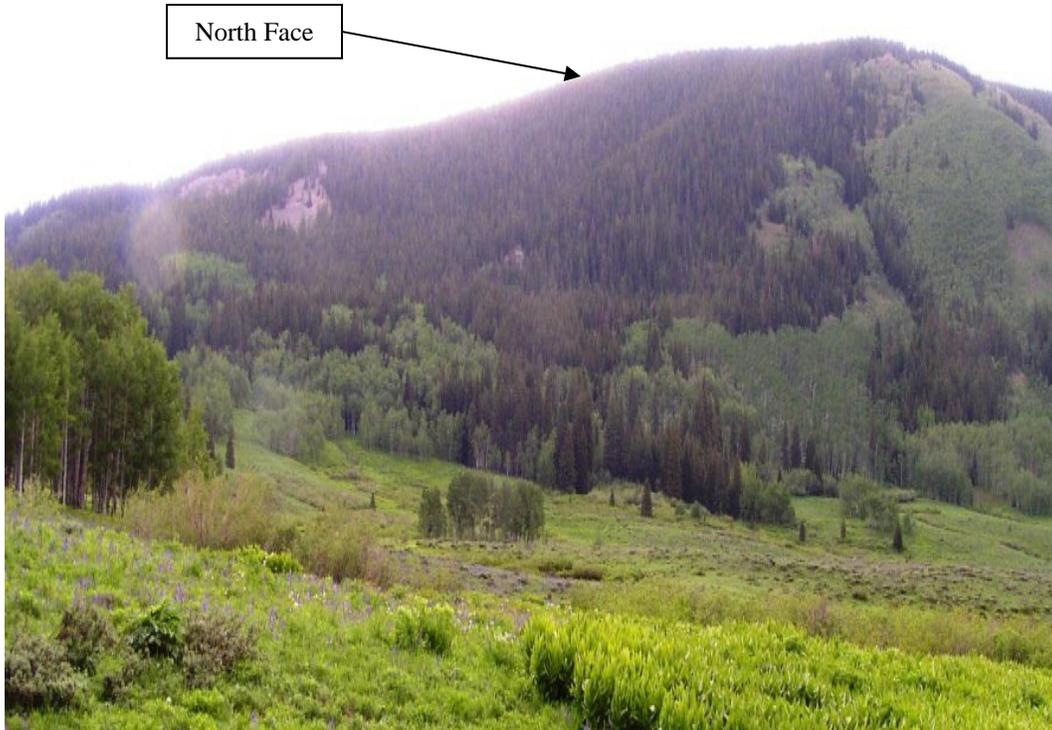
The following photograph, taken from near the valley floor of Washington Gulch looking east-southeast, shows the ridge between the West Face – North and the North Face. The North Face is actually beyond the ridge to the east and it has a northeast aspect. Some areas of the North Face are heavily wooded, while other areas have patchy tree cover, grassy meadows, and bare rock chutes.
