EXISTING CONDITIONS REPORT

Beal Mountain Mine

*Beaverhead-Deerlodge National Forest
Silver Bow County, Montana*

Maxim Technologies, Inc.
851 Bridger Drive
P.O. Box 1413
Bozeman, Montana 59715

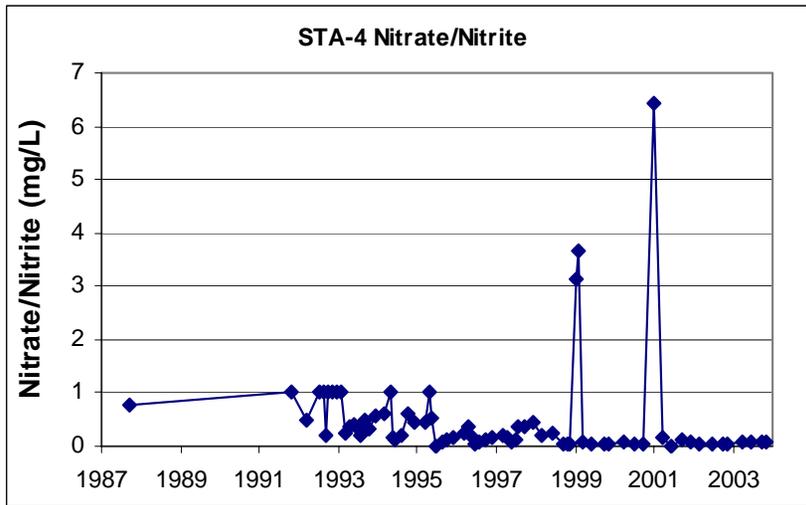
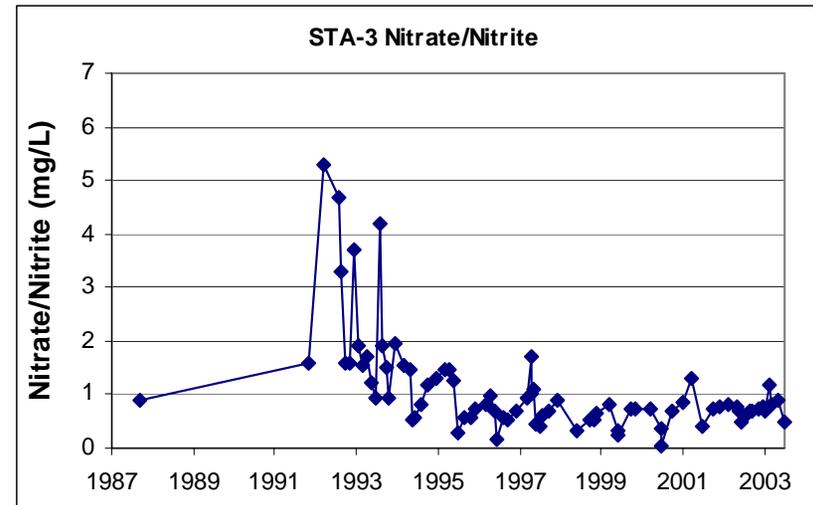
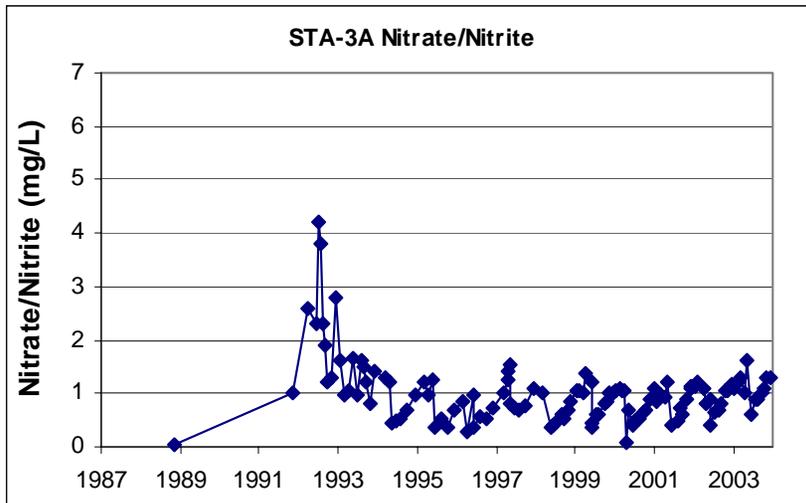
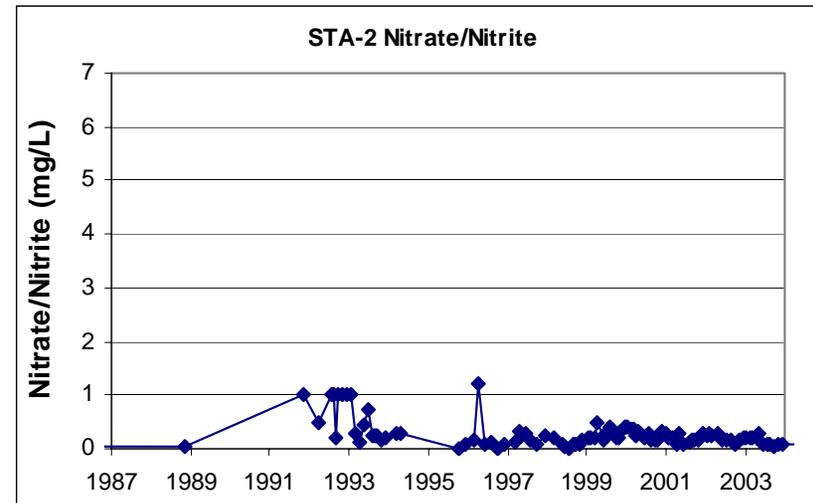
Figure 8. Nitrate Trends at select German Gulch Surface Water Stations (concentrations in milligrams per liter)

mg/L to 2.0 mg/L. Nitrate concentrations at STA-3 and STA-3A were highest in 1992 and then declined until 1995 (**Figure 8**). Since that time, nitrate concentrations at these two stations have exhibited a seasonal trend with the lowest nitrate concentrations being measured during spring runoff, with concentrations increasing as stream flows decrease. Nitrate concentrations have been generally low (less than 0.100 mg/L) at STA-4 with the exception of three samples collected since 1999 then have contained greater than 3.0 mg/L nitrate. Concentrations of nitrate from STA-2 downstream have remained low since 1987.

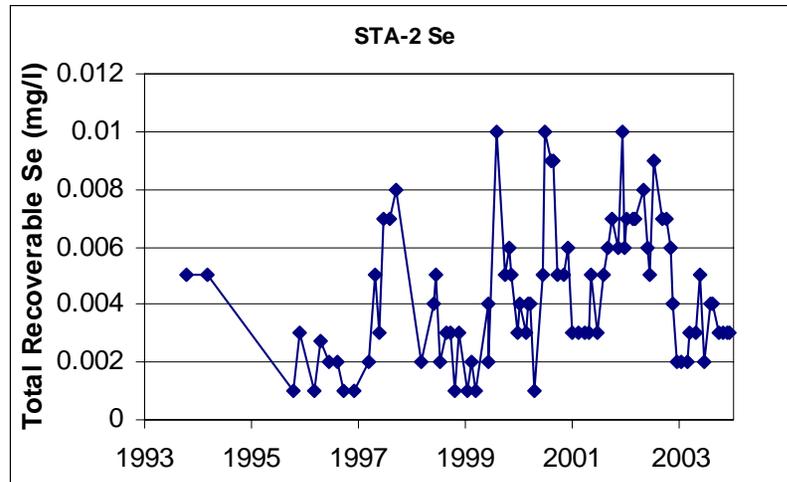
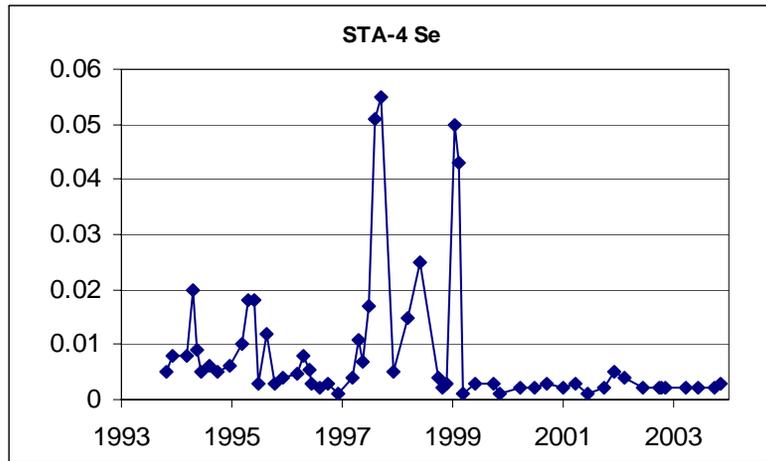
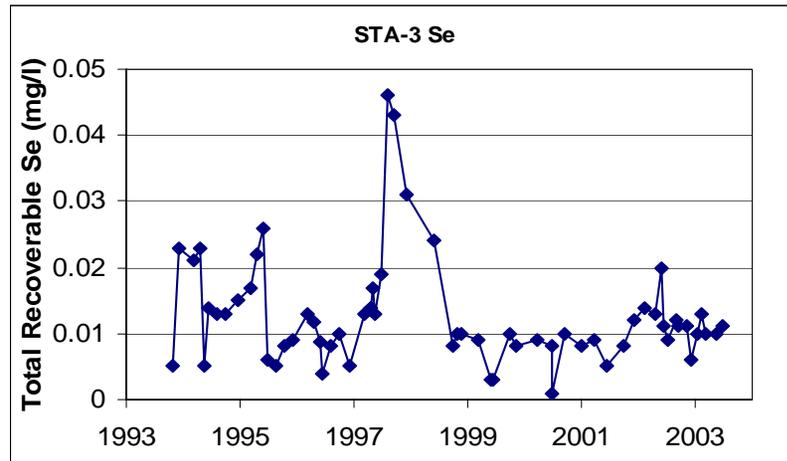
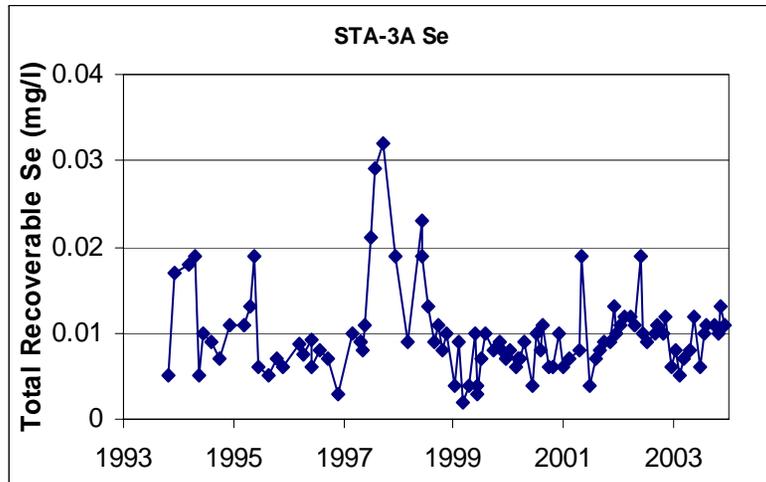
Figure 12. Total Recoverable Selenium Concentrations in German Gulch (milligrams per liter)

Total recoverable selenium concentrations measured in 2003 samples of surface water from German Gulch stations downstream from STA-3A are well below the chronic aquatic life selenium standard of 0.005 mg/L with the exception of a sample collected from STA-2 in May 2003 (0.005 mg/L). Concentrations of selenium measured in all but one of the surface water samples collected between January and July 2003 from STA-3 and STA-3A exceeded the chronic aquatic life standard (**Figure 12**). Five out of 10 samples collected from STA-4 between July 1997 and February 1999 contained selenium concentrations ranging from 0.025 to 0.055 mg/L, which exceed the acute aquatic life standard of 0.020 mg/L. Selenium concentrations measured in surface water samples from stations STA-4, STA-3, and STA-3A reached the highest levels between 1997 and 1999 and have generally declined since (**Figure 12**). This decline is related to the capturing and redirecting of water from spring 10A (SPR-10A). Concentrations of selenium in samples from station STA-2 continued to increase until 2002, but have generally declined since.

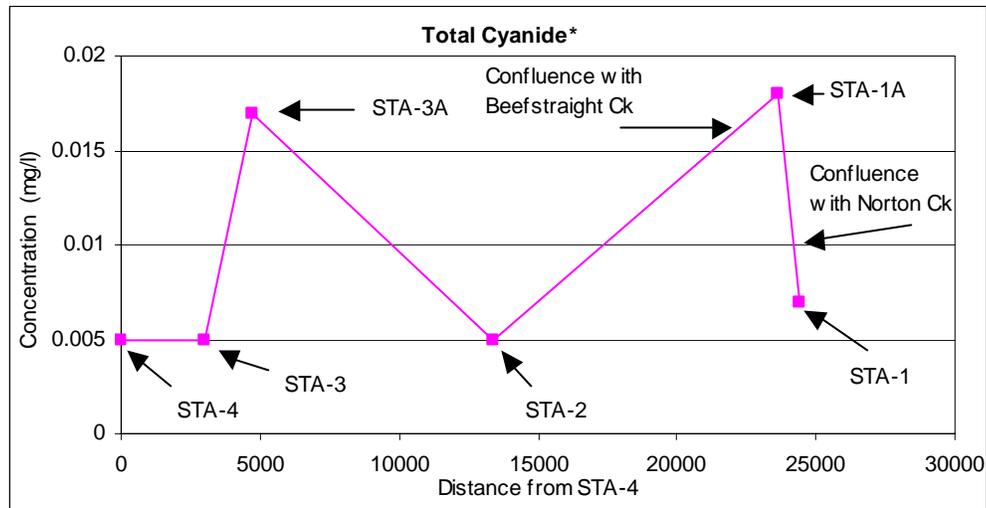
Figure 13. Total Cyanide Concentrations in German Gulch (June 18, 2003 data reported for STA-4, all other data collected on May 13, 2003)

Concentrations of cyanide exceed the chronic standard (0.005 mg/L) and occasionally the acute standard (0.022 mg/L) for some sampling events in 2003 in both American Gulch and in Lower Minnesota Gulch. All samples in Beefstraight Gulch exceeded the cyanide chronic standard and occasionally the cyanide acute standard for in 2003 surface water samples (**Table 6**). These three tributaries are located to the north of the German Gulch divide and drain the areas that were used for LAD application north of the leach pad. Surface water from samples at STA-3A in upper German Gulch was also occasionally elevated in cyanide (above the chronic but below the acute level) also probably from contamination by LAD solutions (**Figure 13**). Surface water Station 2 (STA-2) showed only one exceedance of the cyanide standard, although STA-1 and STA-1A, located below the confluence of Beefstraight Gulch (the tributary creek that drains the LAD area) and German Gulch, frequently exceeded the chronic standard for cyanide. LAD applications were discontinued in November 2003 and it is thought that cyanide concentrations should decline in surface water and groundwater over time.

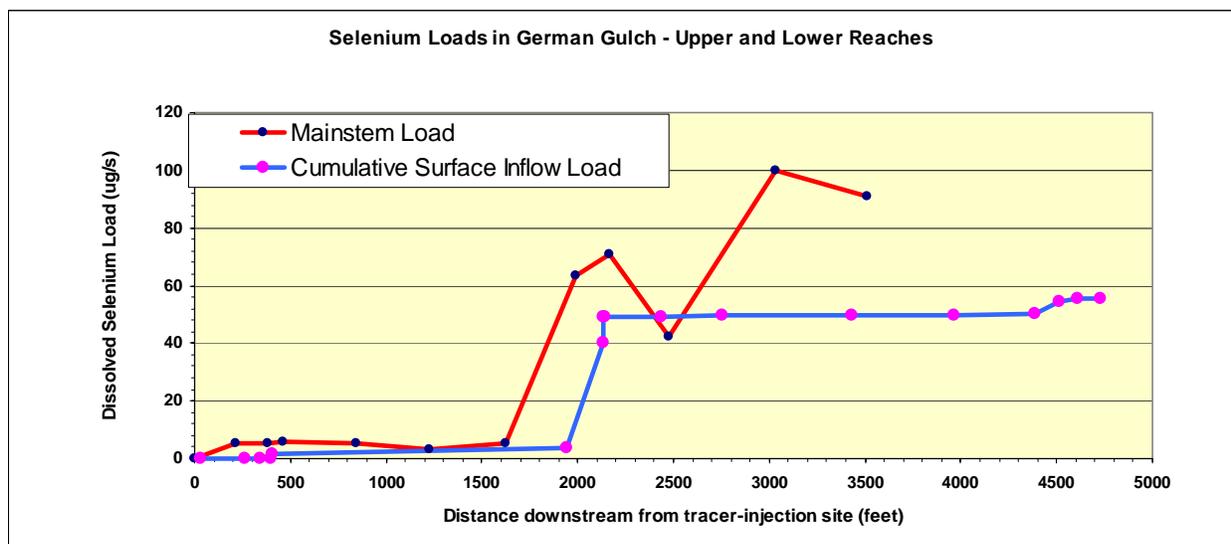
Figure 16. Selenium Loading in German Gulch (micrograms per second) (after Gurrieri, 2003)

Results of the study indicated that all main stem-sampling sites above station 2100 had selenium concentrations below the chronic aquatic life criteria of 0.005 mg/L. Selenium, sulfate, and nitrate concentrations increase appreciably between station 1627 and 2165 (there are no sample sites between these two stations), suggesting there is major source of water containing these constituents somewhere in this reach (**Figure 15**). Sources included right-bank and left-bank (looking downstream) surface inflows and sub-surface inflow. The highest level of selenium (0.0370 mg/L) was measured at station 2100. A right-bank inflow at 2132 had selenium concentrations of 0.0112 mg/L with a main stem concentration in this area of 0.0150 mg/L. Below station 2165, selenium increased slightly at station 3032 to 0.0160 mg/L and then decreased downstream to 0.0094 at the end of the study reach (station 4964) (Gurrieri, 2003).

Station 2131 is a large flow-volume right bank tributary that discharges just below a culvert that brings the flow of German Gulch from beneath a road fill area. This right-bank tributary contributes as much as 44 micrograms per second ($\mu\text{g/s}$) or about 65 percent of the total load encountered in the entire study reach (**Figure 16**). The subsurface inflow at this point of the stream is considerable and was calculated to contribute as much as 27 percent (18 $\mu\text{g/s}$) of the measured load. (These observations are consistent with the relative amount of loading seen at STA-3, as indicated by the MDEQ study described above.) Therefore, most of this subsurface selenium loading occurred in the reach of German Gulch within and downstream of a very short (approximately 300 foot reach between stations 1825 to 2132) road-fill area (Gurrieri, 2003). Mine waste from the main Beal Mountain pit was apparently used for road fill from about station 2100 upstream. Main Beal pit rock was not used to construct or surface roads below site 2100 (personal communication, Bruce Parker, BMMI, 12/31/03).

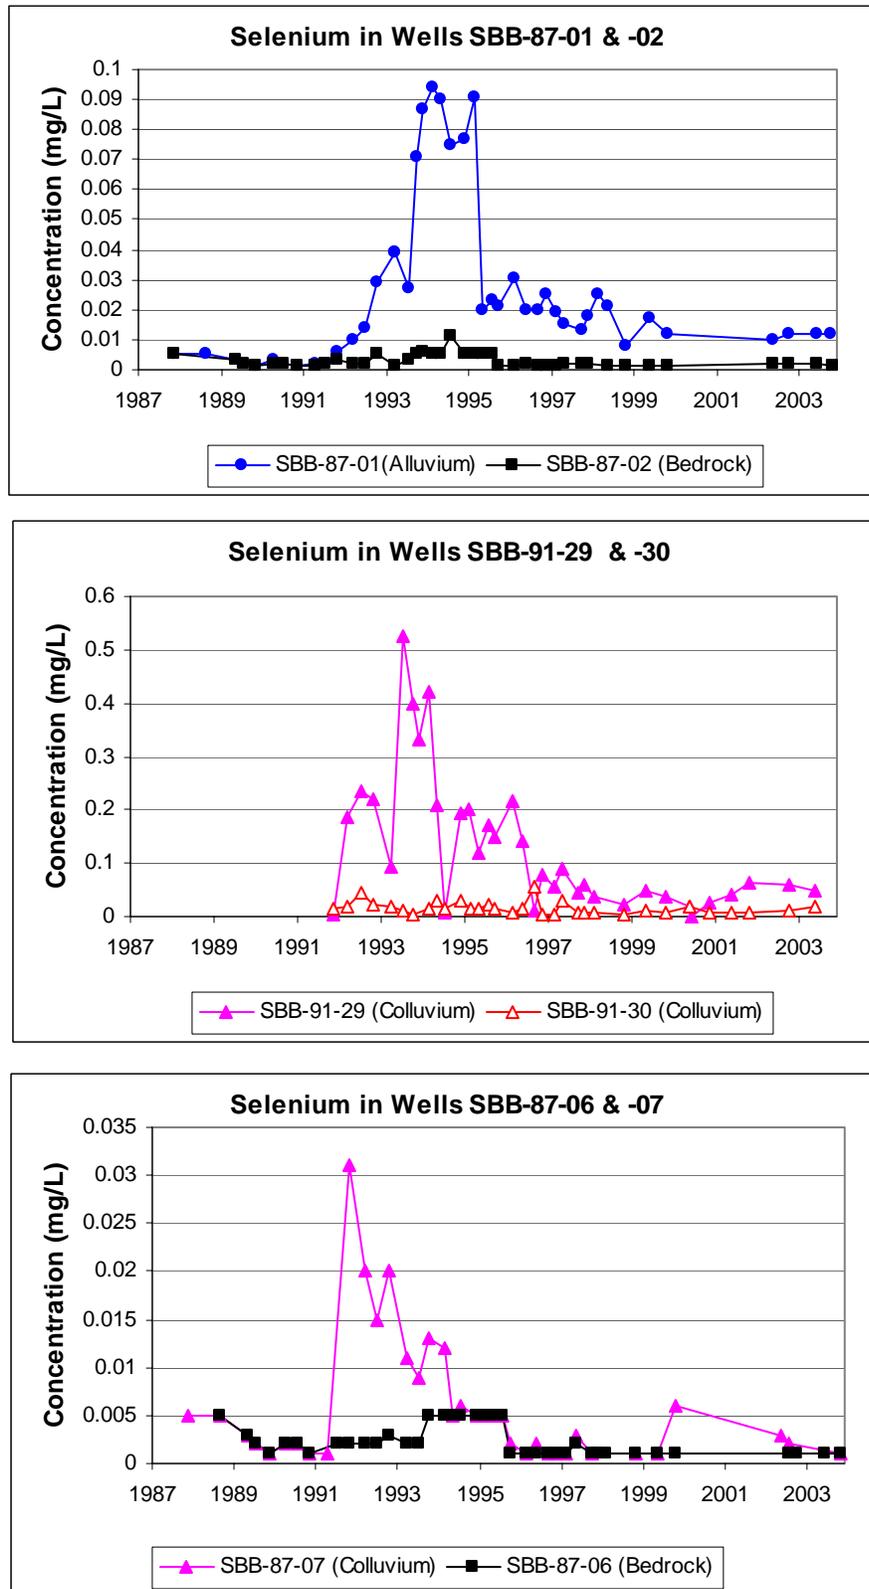
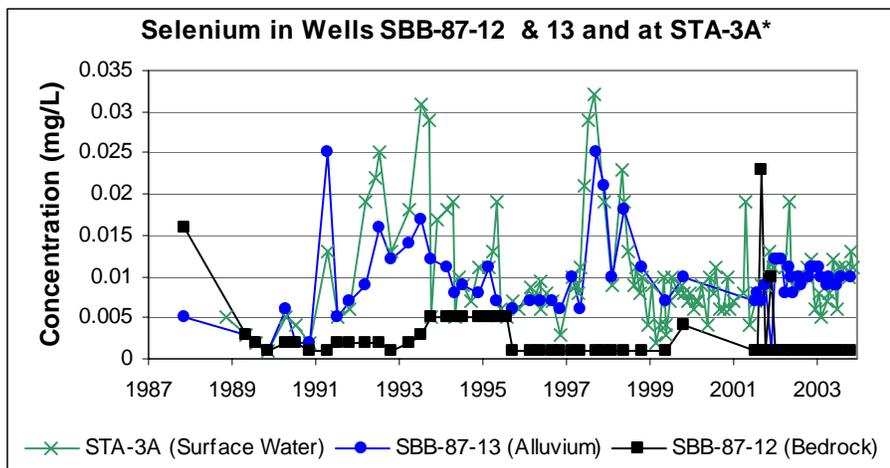
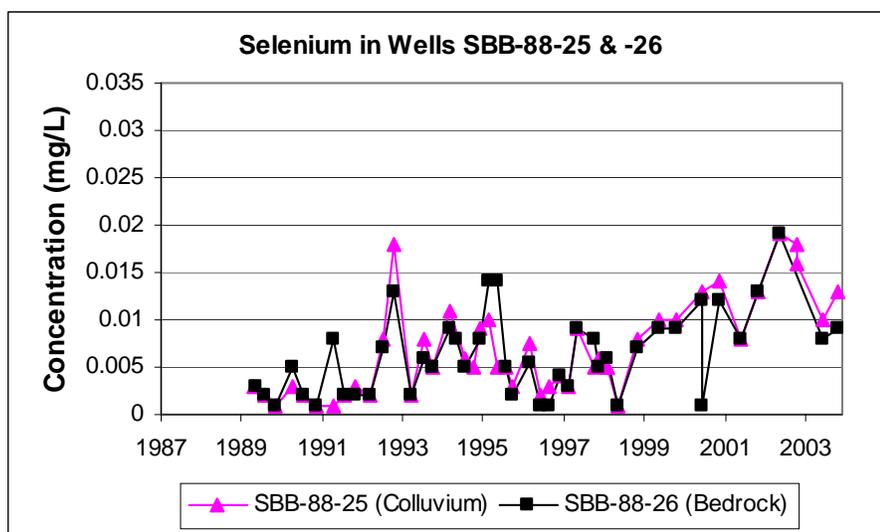
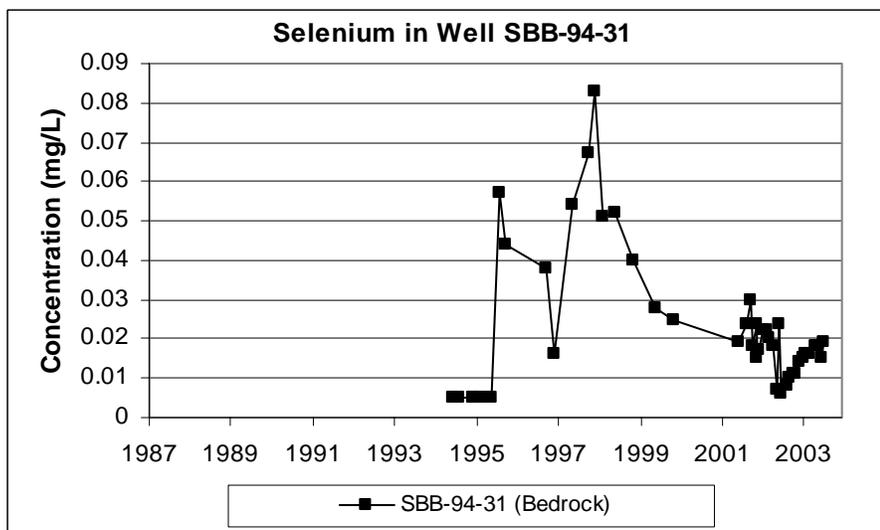
Figure 19. Selenium Trends in Select Monitoring Wells (milligrams per liter)

Selenium and sulfate concentrations increased in colluvial wells located north of the northern portion of the leach pad dike, which was constructed with unoxidized waste rock from the Beal Mountain pit. This may have resulted from the flushing of soluble selenium from this rock that infiltrated into shallow groundwater in this area.

Groundwater samples from wells adjacent to German Gulch downstream of the Beal Mountain pit exceeded the MCL for iron and contained relatively high concentrations of total dissolved solids and sulfate. Selenium concentrations increased slightly in alluvial and bedrock groundwater in these wells from 1993 to 1995, with another increase in selenium concentrations noted in bedrock groundwater in 2001. Changes in selenium concentrations in surface water in German Gulch at STA-3 parallel changes in the bedrock well near this station, suggesting good communication between surface and groundwater at this location.

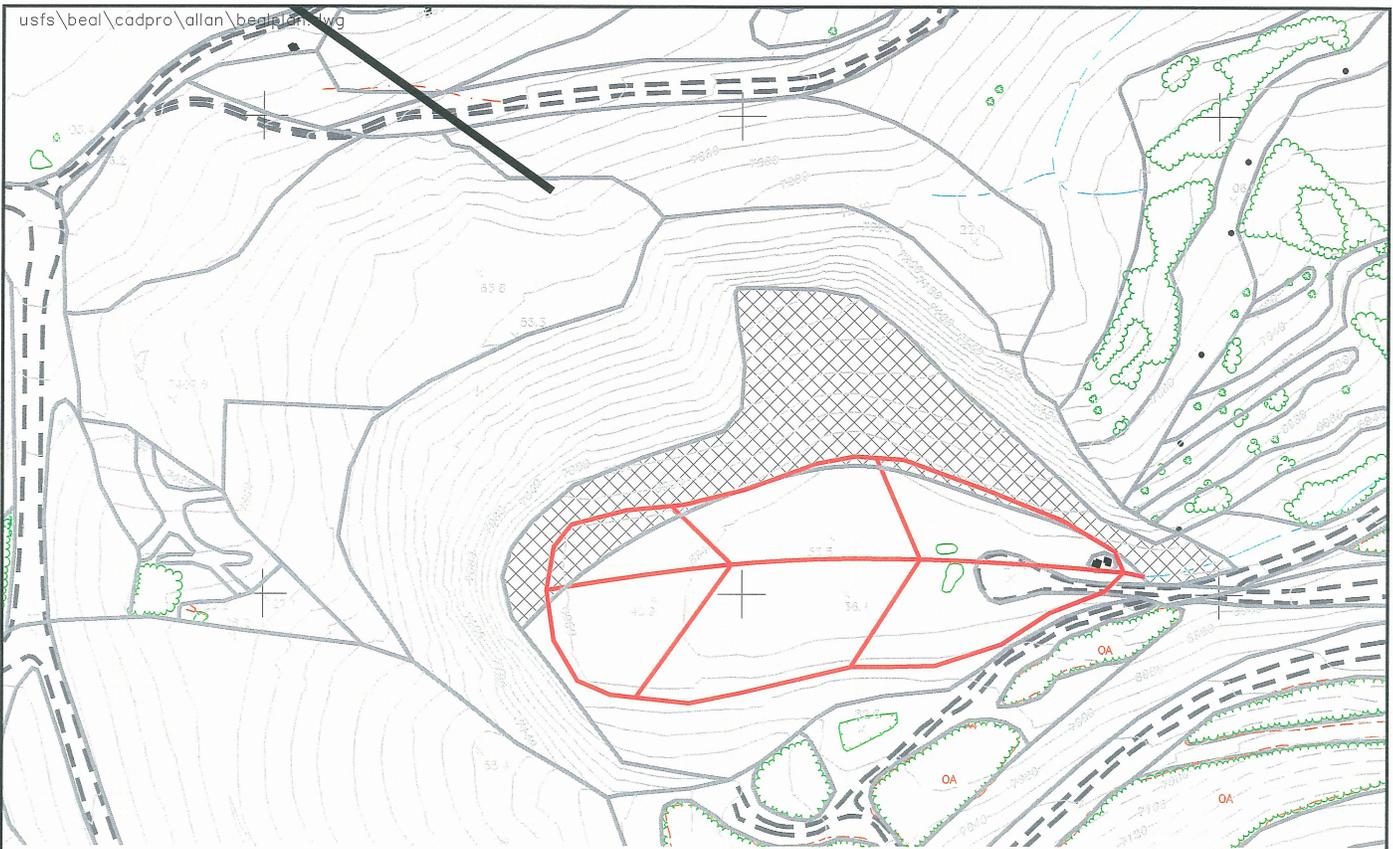
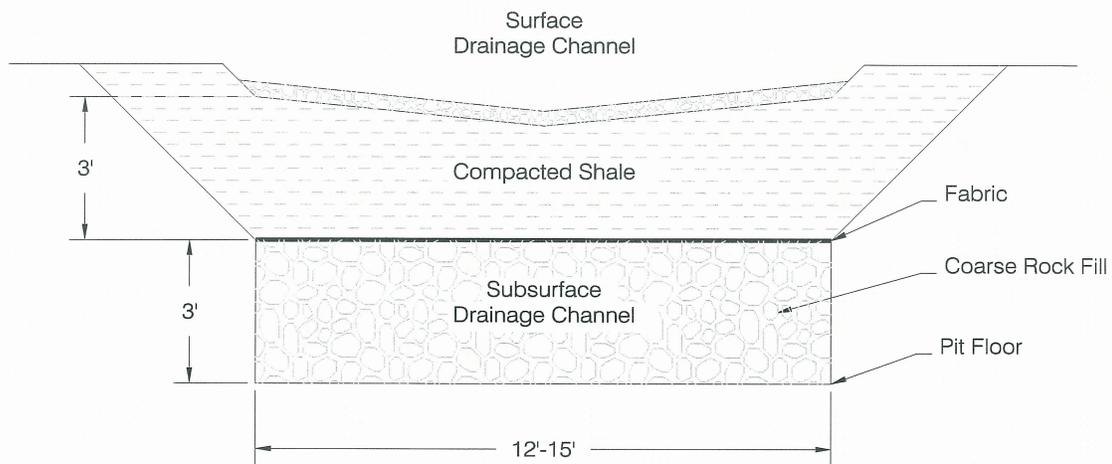
Main Beal Pit Slides
 Beal Mountain Mine
 Silver Bow County, Montana
FIGURE 25

During the course of mining, several slope stability problems were identified in the Beal Mountain pit. There are currently two active slides, the west wall slide and the clay/sill slide (**Figure 25**). These slides are wedge-shaped blocks of metasediments that move along clay layers which dip at a low angle (approximately 20°) to the northeast (Sitka, 1996). The orientations of the clay layers are apparently not parallel to, but occur at a low angle to metasediments bedding planes and are likely thrust fault planes parallel to the regional thrusts. Near vertical northwest trending joints and shears border the blocks along their northeast and southwest boundaries.

The west wall slide (**Figure 25**) has moved across and into the Beal Mountain pit in an eastward direction at high rates of speed and covered large distances. During the years when the main Beal Pit was actively being mined, movement of this slide was reported in the range of 10 to as much as 100 feet per year. A large portion of this movement resulted from undercutting the toe of the slide during Beal Mountain pit mining operations. The toe of the slide is exposed in the north pit wall. Numerous surface cracks occur on a flat bench in the central portion of the slide area, and a fault-scarp with two to four feet of displacement has developed in response to movement along the westernmost portion of the south flank of the slide. A spring at the toe of this slide was producing approximately 0.5 gpm in September 2003. Efforts to mitigate the slide's movement were implemented during mining operations by changes in the pit development plan that left ore reserves in the northwest corner of the pit to buttress the slide and over time curtail its movement. Current rates of movement are discussed in the following section on pit wall stability monitoring (Section 4.1.3).

The clay/sill slide is a relatively small slide located immediately south of the southern corner of the heap leach pad (**Figure 25**) and to the immediate north of the west wall slide. The slide moves along a clay layer that is oriented similar to the west wall slide (dips 20 degrees to the northeast) and the clay layers may represent weathering along small thrusts that are parallel to the main regional thrust faults. The vertical Gully Fault bounds the slide to the northeast and apparently cuts off the clay layers to the northeast of the fault towards the heap leach pad and dike. Some of the movement on the clay/sill slide is directly related to movement of the west wall slide, which through its eastward movement leaves the southern edge of the clay/sill slide unsupported and allowed it to move to the south and east toward the pit (**Figure 25**). During the period of active mining, movement of this slide propagated slump-like features and cracks or fractures upward into the unconsolidated fill of the southern corner of the heap leach pad. These features led to geotechnical stability studies of the leach pad dike in the southern corner of the pad (Section 4.1.3).

There were several responses implemented to mitigate the clay/sill slide's movement during mining and closure activities. These included, the construction of surface water diversion ditches; unloading of material above the slide; excavation of an area to the southwest of the southern corner of the leach pad embankment and the installation of a rock buttress; and the installation of dewatering wells (1995 and later) to reduce pore pressure on the slide plane. A large volume of material was excavated and a

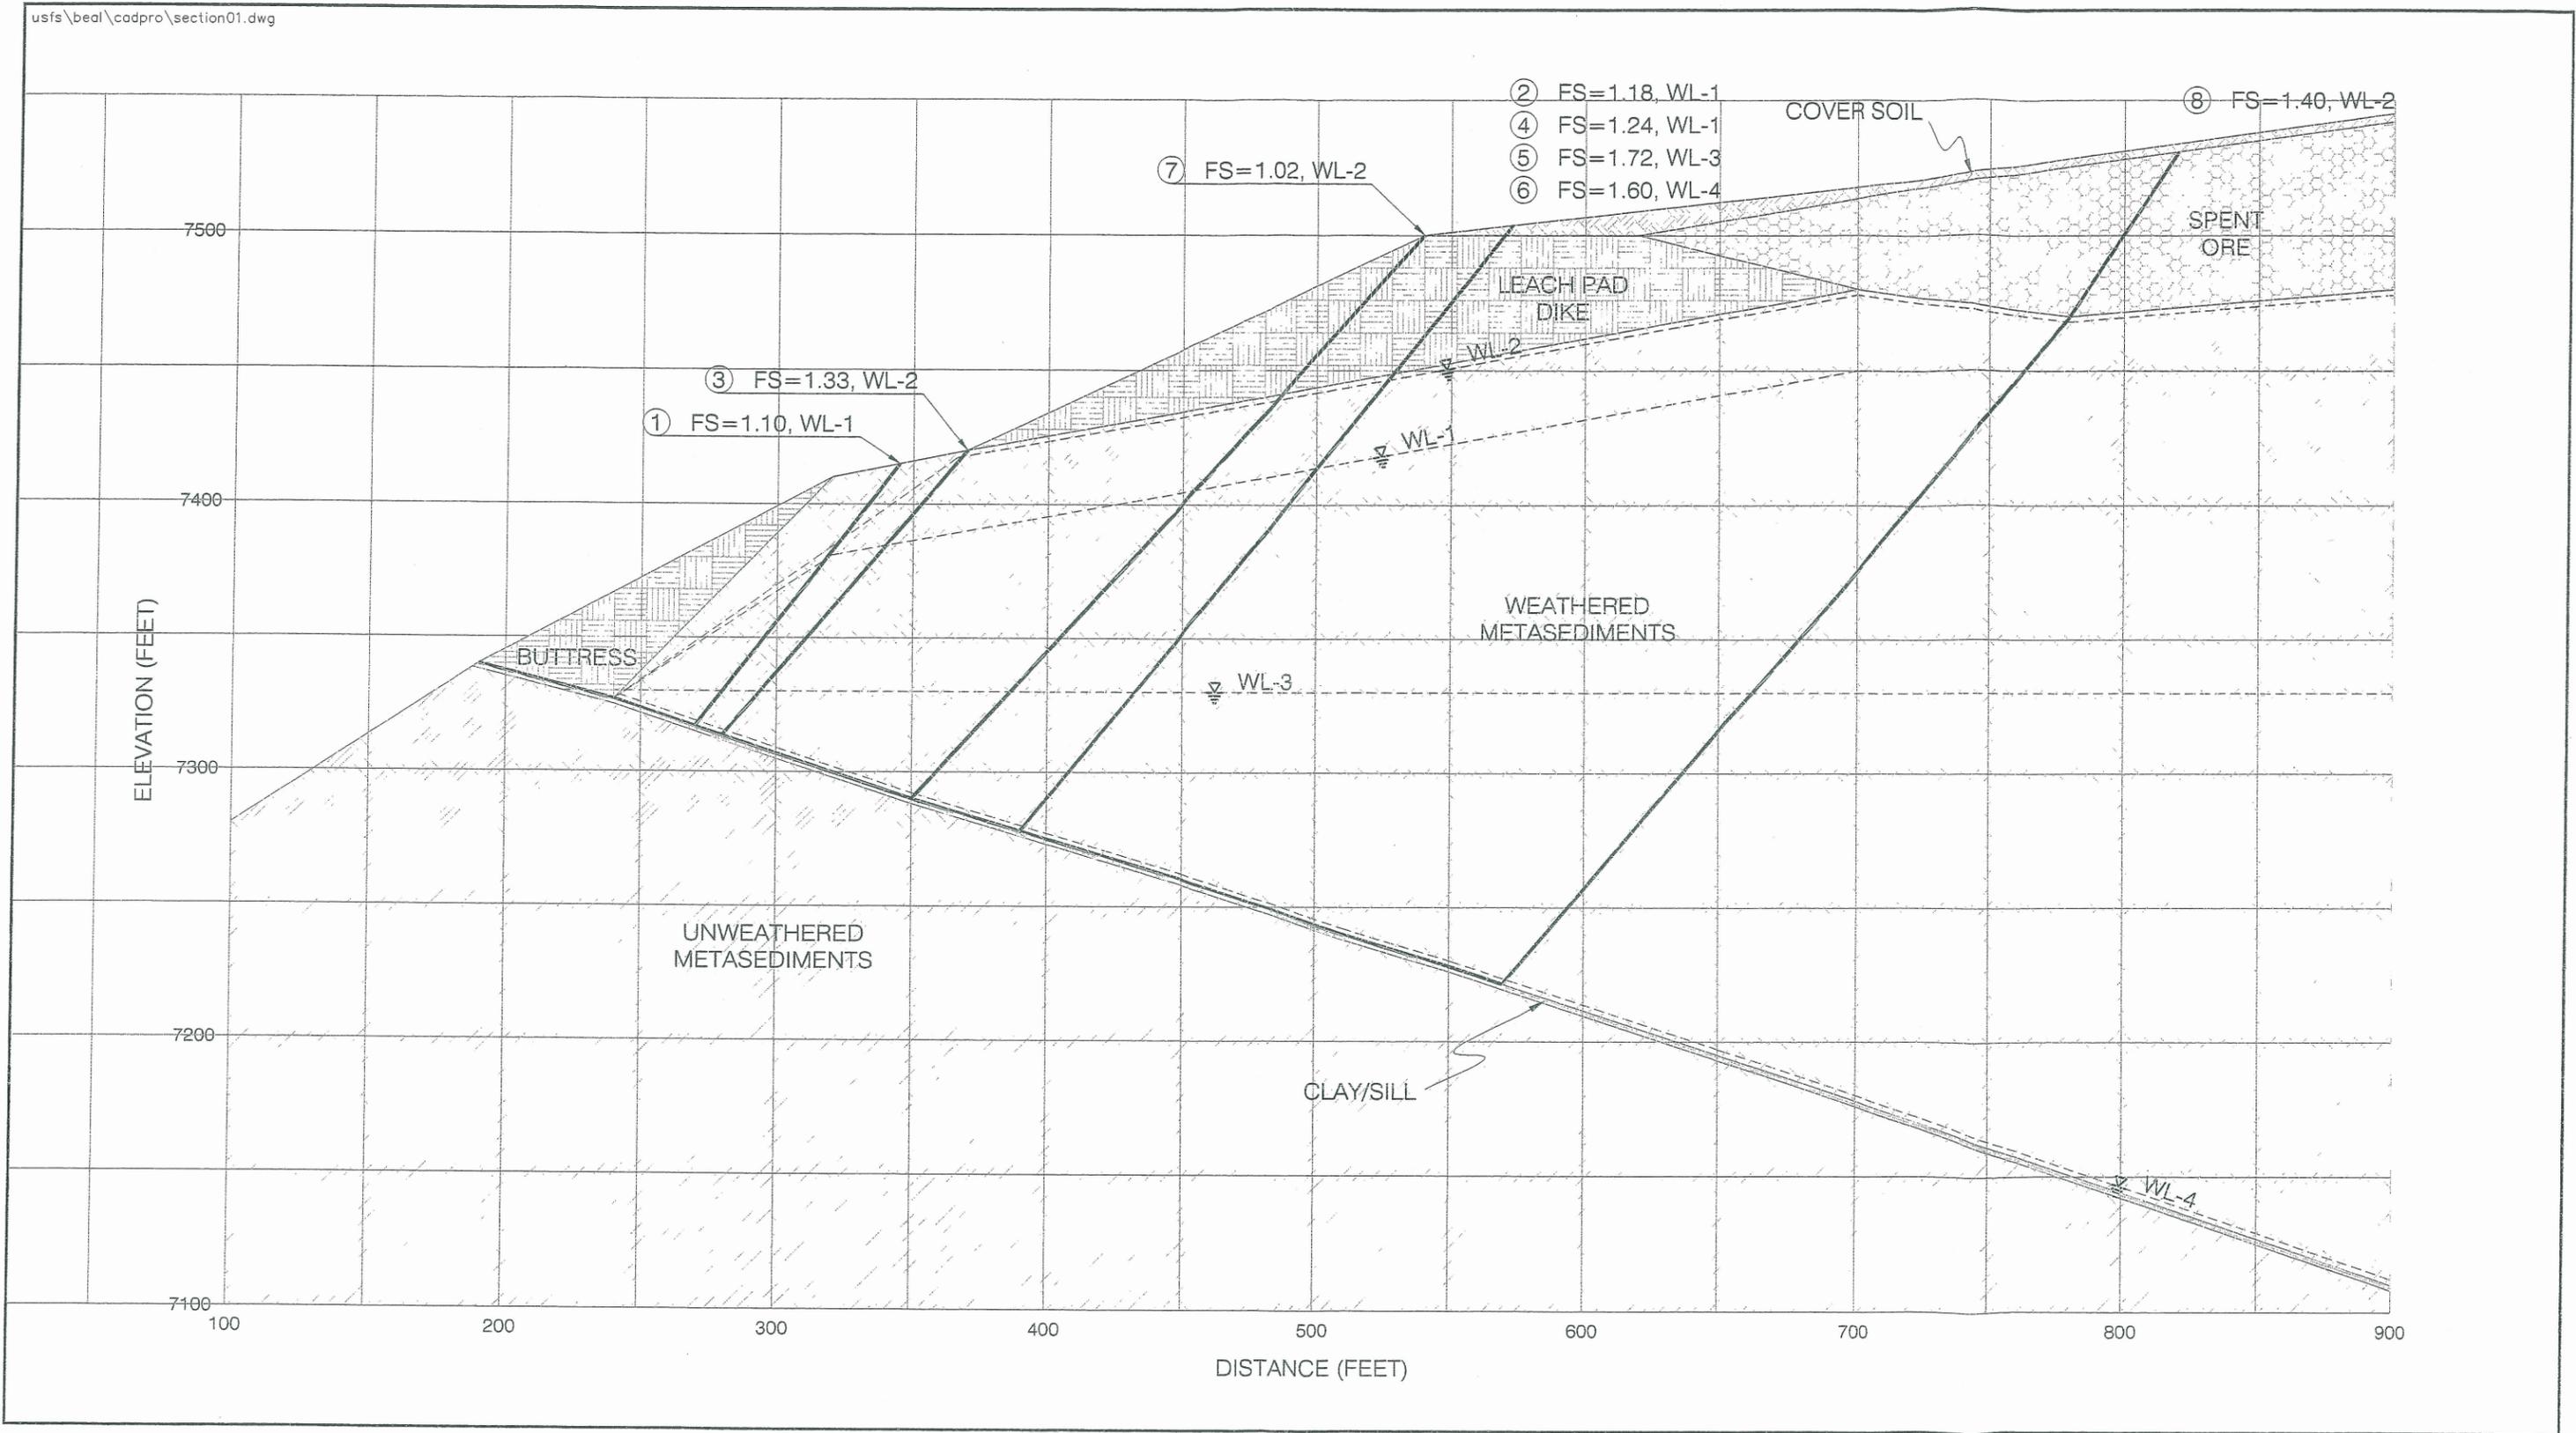
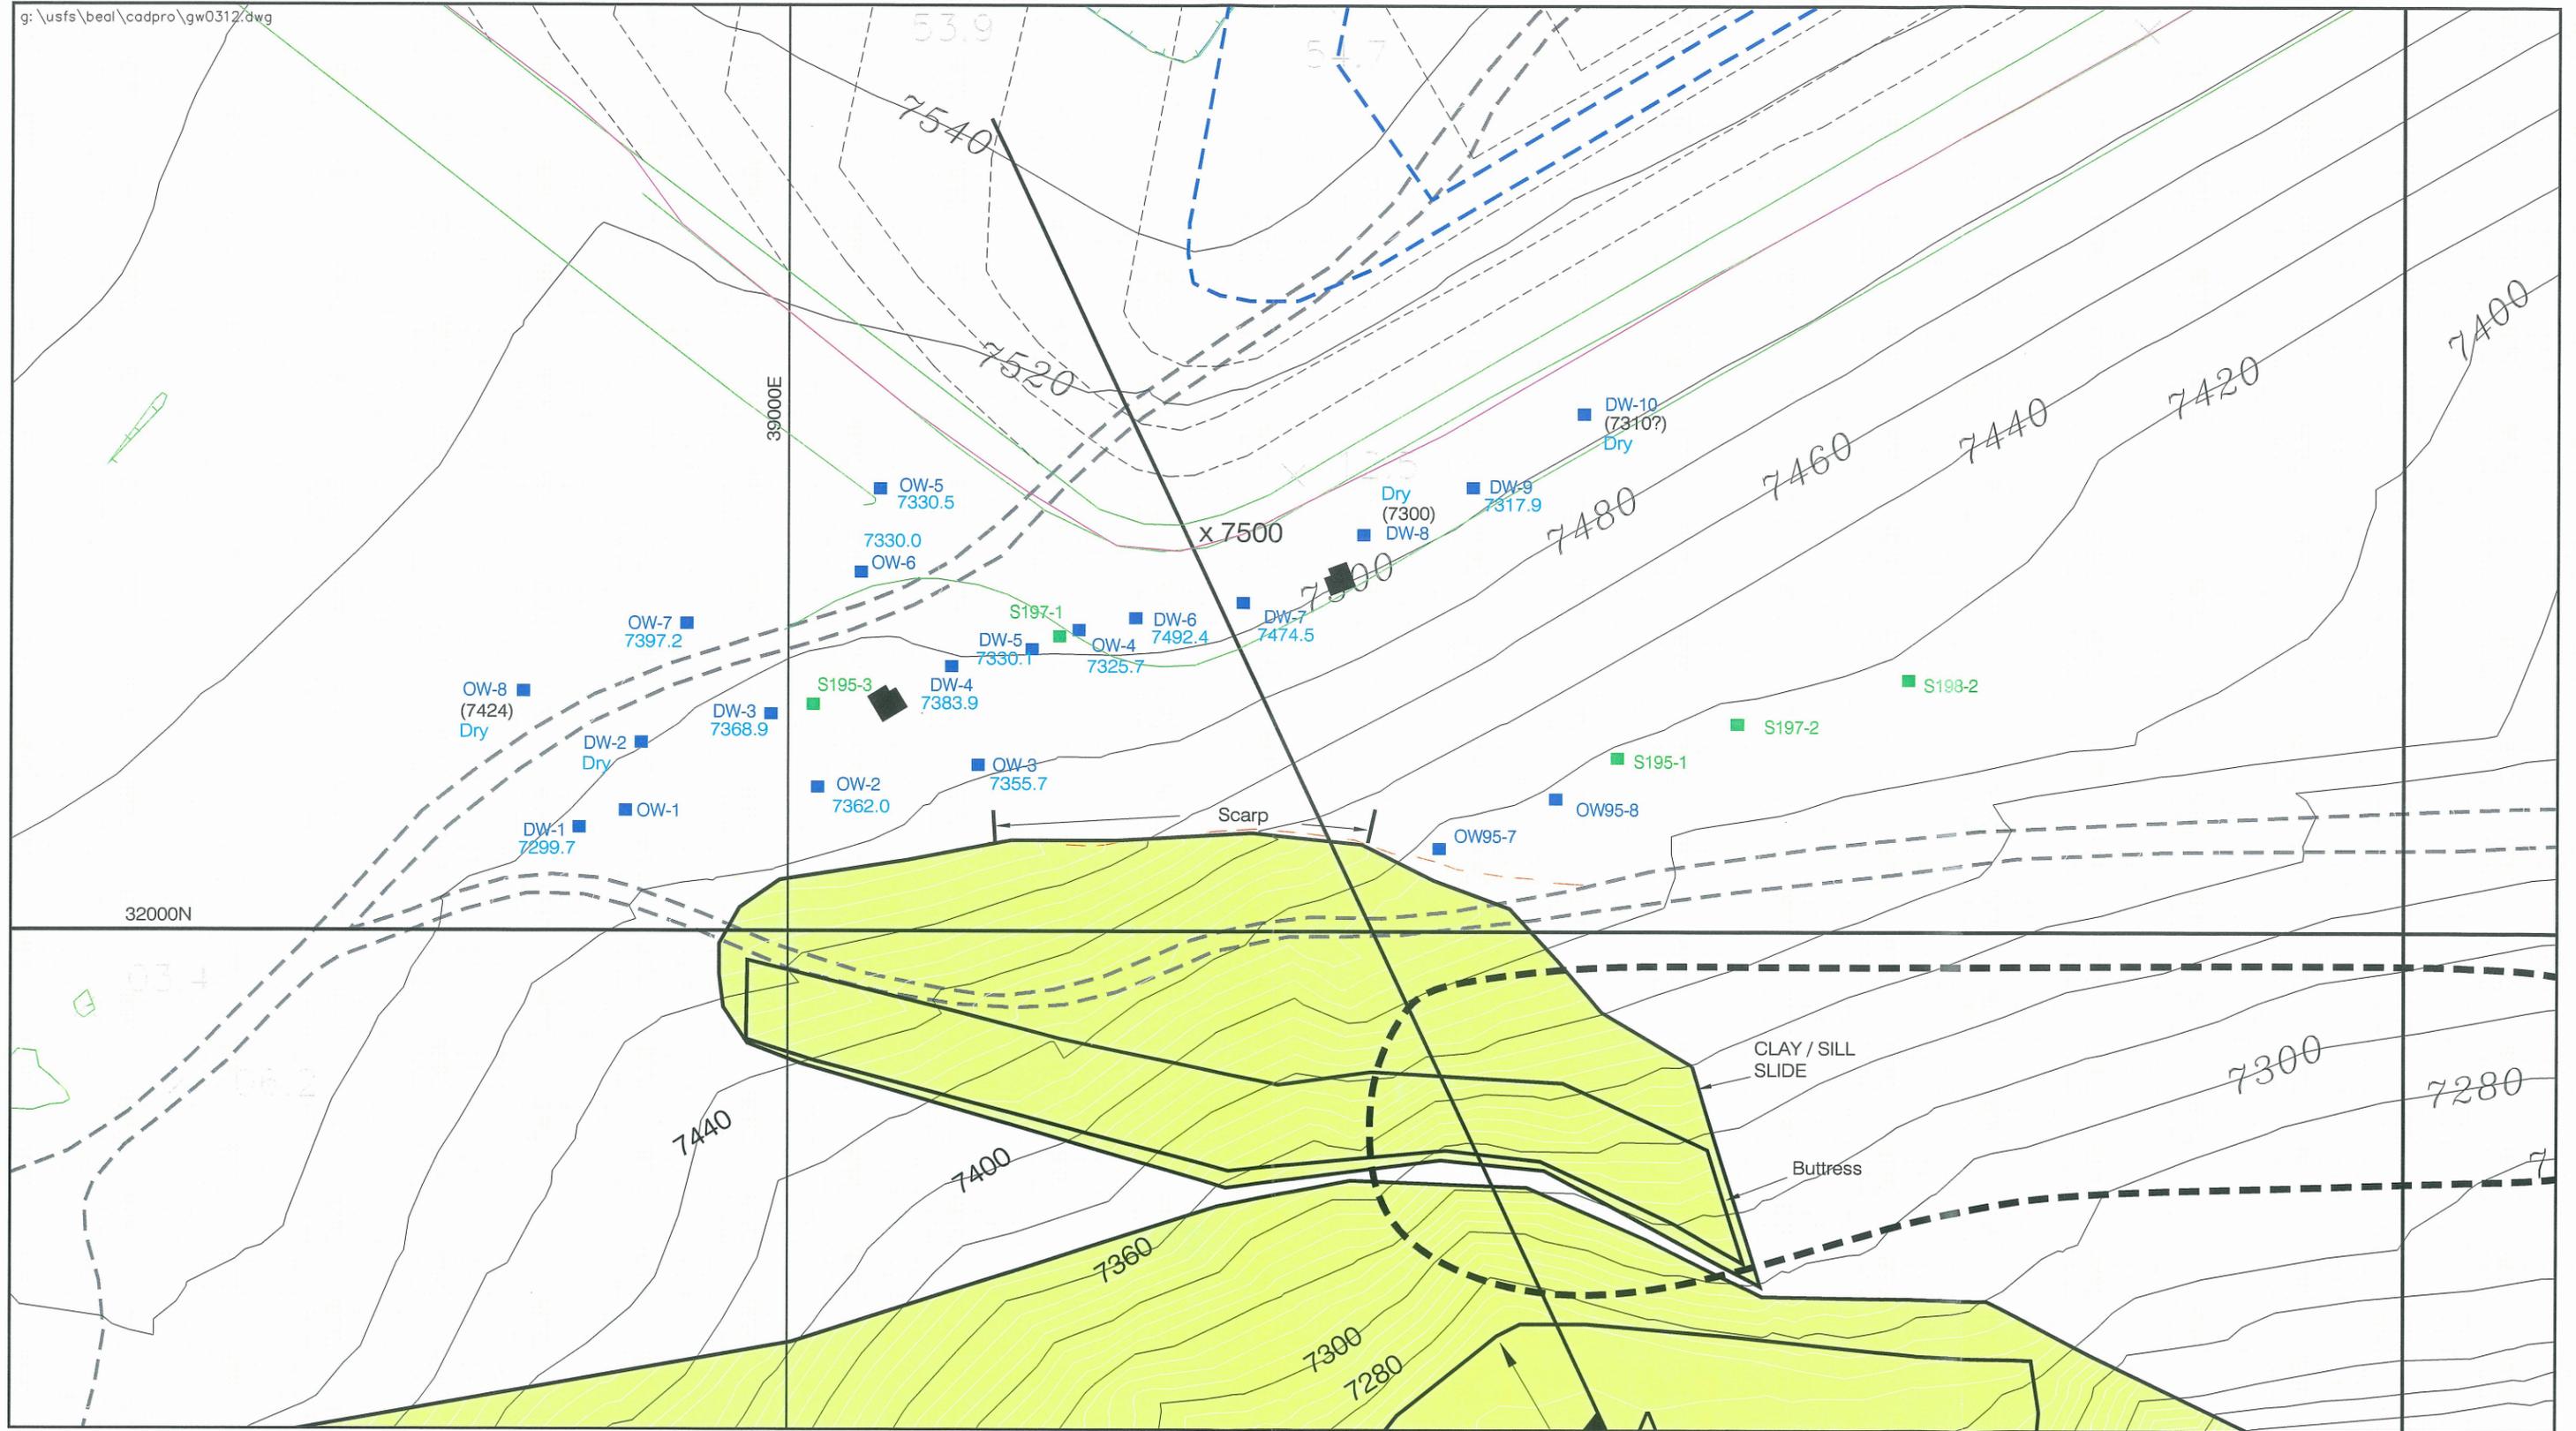
Groundwater Elevations in Clay/Sill Slide Area
Beal Mountain Mine
Silver Bow County, Montana
FIGURE 27

Dewatering wells (**Figure 27**) were in operation from 1995 through July 2003, when dewatering was discontinued. Currently, the clay/sill slide is being monitored for possible recurrent movement. The most obvious signs of slope movement on the clay/sill slide are presumed to be several years old and not an indication of recent movement. These include, three small slump blocks located near well OW-95-7 and a scarp that has developed from this point upslope in a northwest direction (**Figure 27**). In addition, there may be another crack on the slope of the constructed buttress that supports the leach pad embankment, but these features could not be observed directly as this area was too steep for safe access. Evidence of widespread cracking similar to the west wall slide is not apparent. A pit slope stability model was completed by Maxim in September/October 2003 with the specific intent of examining potential risks to the leach pad dike (**Appendix B**). Results of this modeling are presented in greater detail in the discussion of the heap leach facility and the leach pad dike (Section 4.4.3).

Figure 27 shows the location of existing dewatering wells installed for controlling movement of the clay/sill slide. The first dewatering wells were installed in 1995 and a couple of additional wells were installed in subsequent years to expand the volume of material dewatered. The dewatering system included submersible pumps, pump controllers, and portable power transformers. Discharge water from the dewatering well system was routed via pipelines and discharged. Dewatering of the slide was discontinued in July 2003; water levels have been monitored on a regular basis since then.

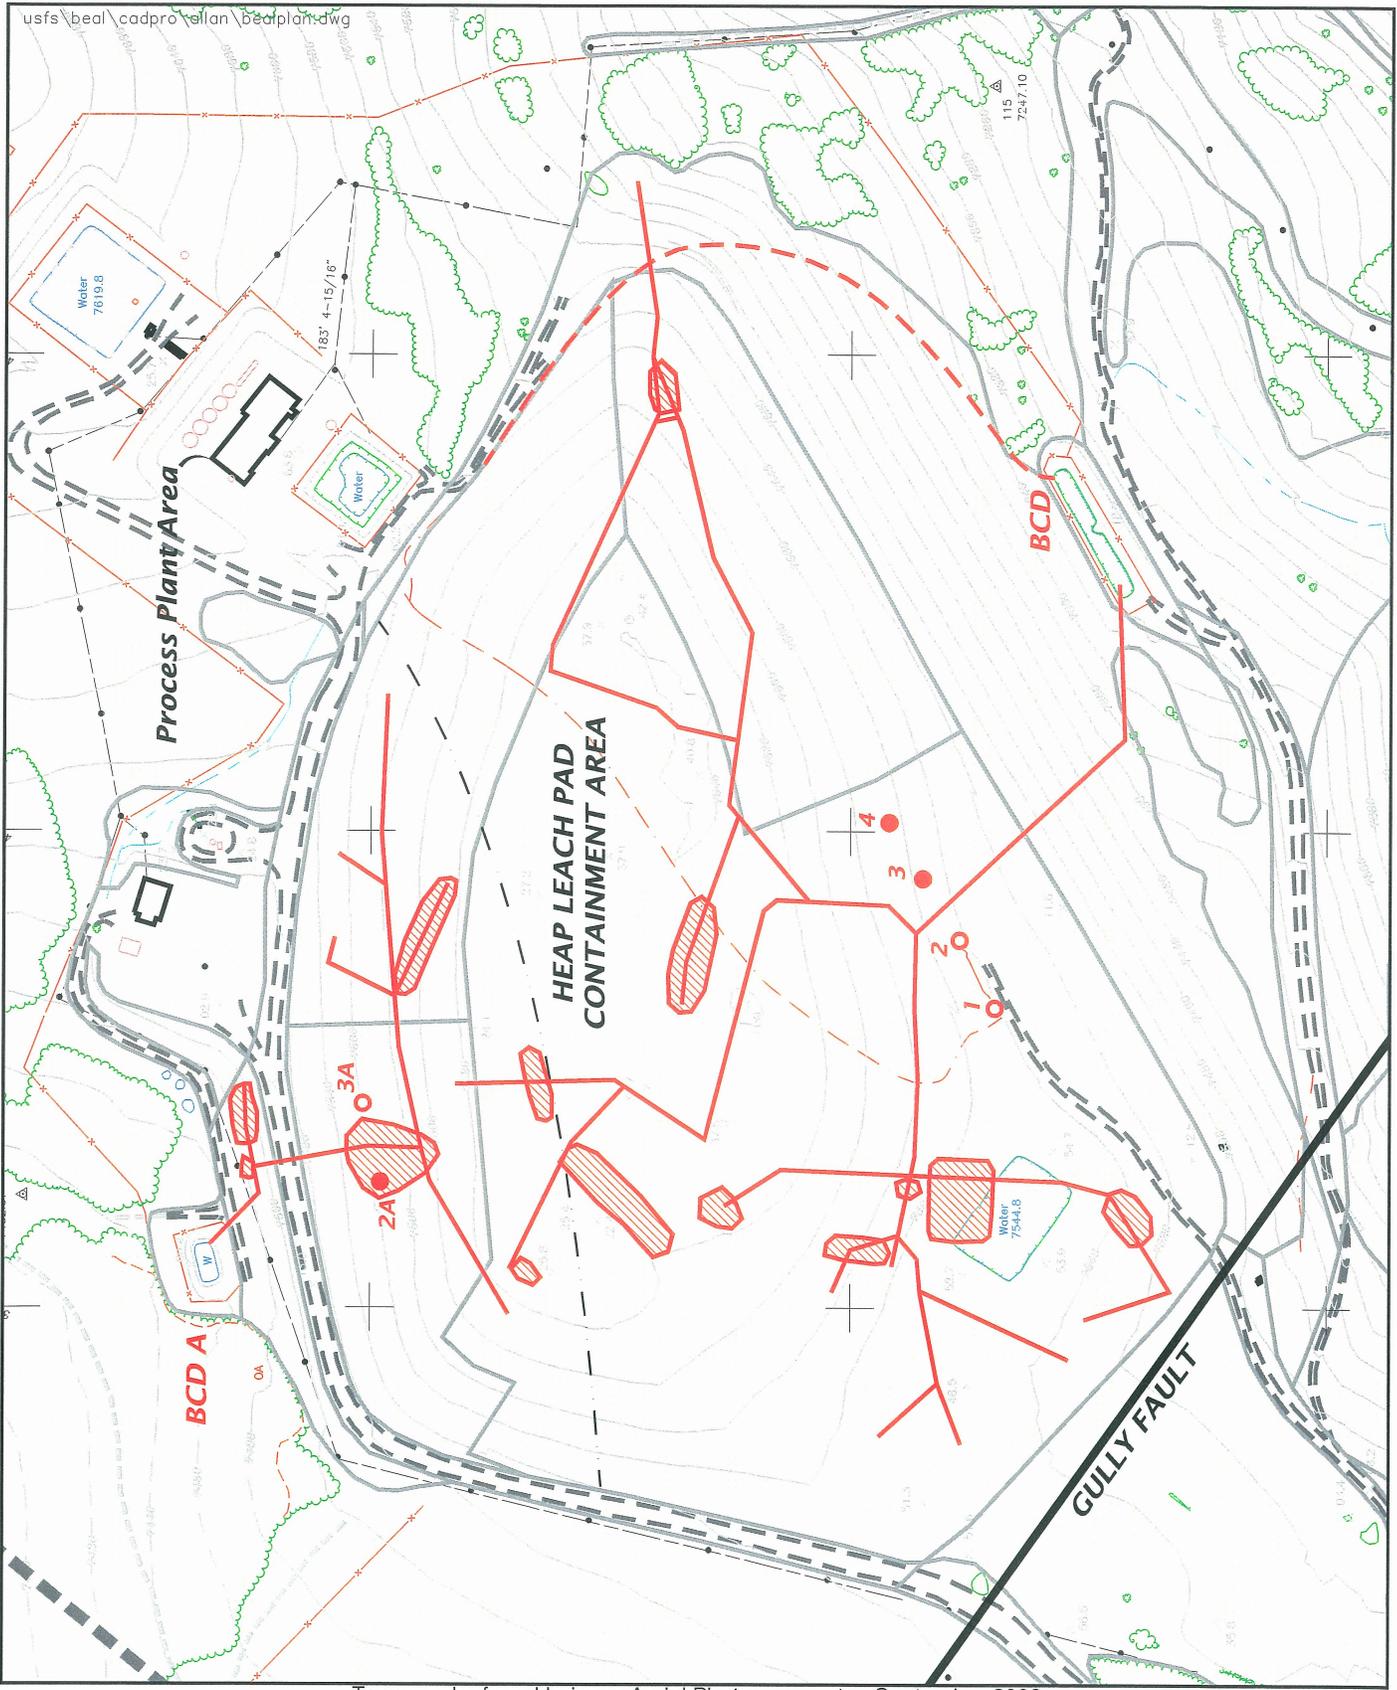
Schematic of Heap Leach
 Underdrain System
 Beal Mountain Mine
 Silver Bow County, Montana
FIGURE 35

On top of the foundation materials and beneath the base liner, a series of under drains were installed to remove shallow groundwater (**Figure 35**). The underdrain system drains to both the north and south as the topographic divide between German and Minnesota gulches occurs beneath the pad. The under drains were built beginning at the southern edge of the pad and were extended northward as new lifts were added to the containment dike and the footprint of the leach pad expanded. The under drains are a dendritic system of pipes called a blanket collection drain (BCD), that began with perforated pipe at the southern end of the pad that drains in the subsurface to the BCD pond (**Figure 35**). The dendritic pattern was extended using solid HDPE pipes that were excavated into surficial materials toward low and or wet areas on the construction surface. Pipes were terminated in rock-filled collection basins. As the leach pad expanded the solid branch pipes were brought together in a manifold to a main pipe, which exits through the south central portion of the leach pad dike. A smaller but similar under drain system was constructed on the northern portion of the leach pad foundation that drains to the north into pond BCDA (**Figure 35**).

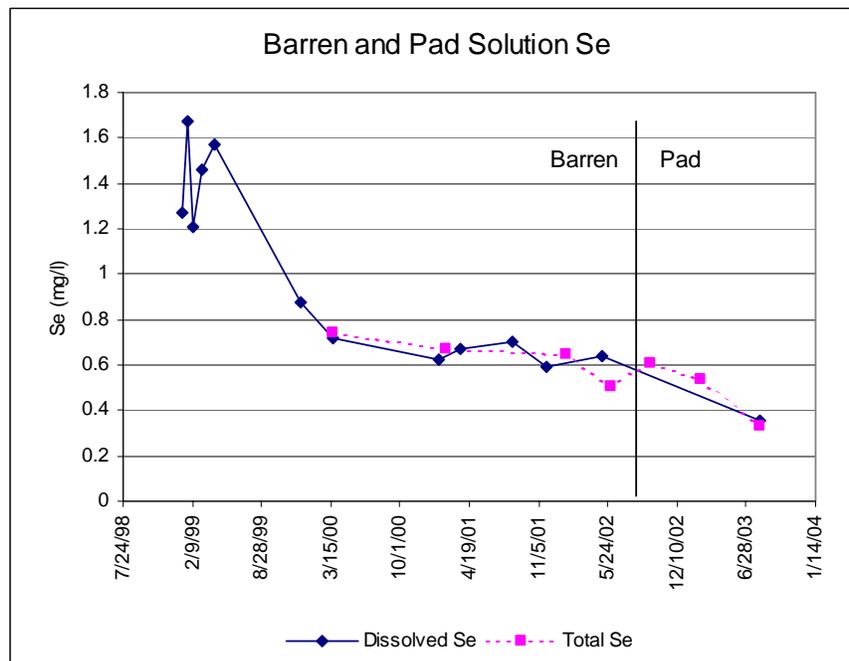
Figure 39. Beal Mountain Barren and Pad solution selenium (milligrams/liter)

After declining from a high of approximately 1.7 mg/L in January 1999, dissolved selenium concentrations in pad solution decreased to (and fluctuated around) 0.6 mg/L from January 2001 to May 2002 (**Figure 39**). Total concentration data reported from March 2000 until August 2003 show that the concentration of selenium decreased from 0.6 mg/L to 0.35 mg/L, indicating that selenium concentrations are decreasing within the heap leach facility.
