EXISTING CONDITIONS REPORT

Beal Mountain Mine

*Beaverhead-Deerlodge National Forest
Silver Bow County, Montana*

Maxim Technologies, Inc.
851 Bridger Drive
P.O. Box 1413
Bozeman, Montana 59715

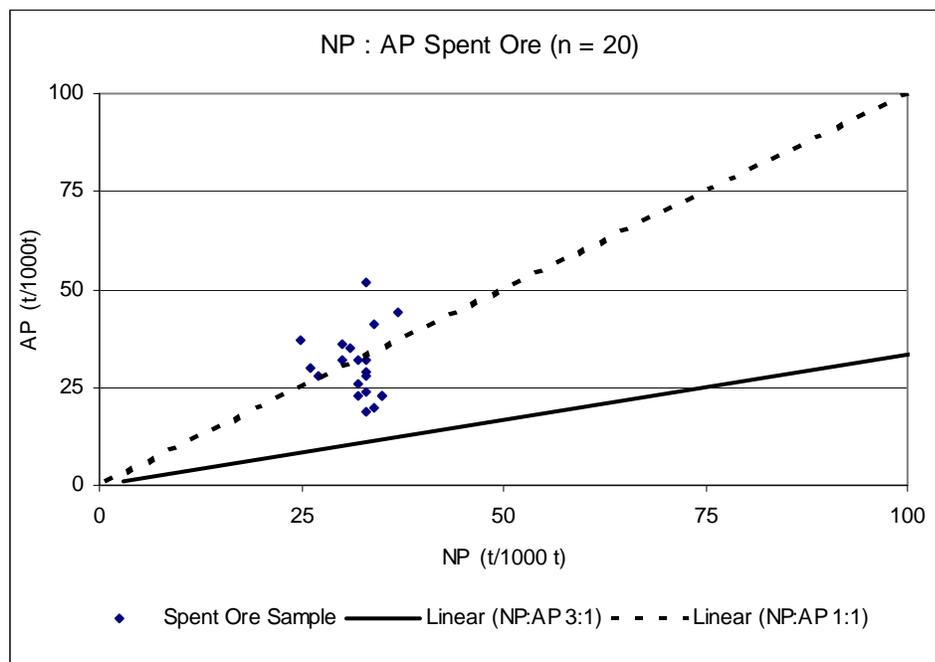
Figure 44. Spent ore static test results (tons/1000 tons)

Data for use in evaluating the acid generating potential of spent ore located in the leach pad include static test data for 20 spent ore samples reported by Gallagher (1994) (**Figure 44**). These data conservatively indicate that spent ore may present a risk of acid generation with no sample having NP:AP ratio greater than 3. Forty-five percent of the samples had NP:AP ratio less than 1 and the remaining 55 % had NP:AP ratio between 1 and 3.

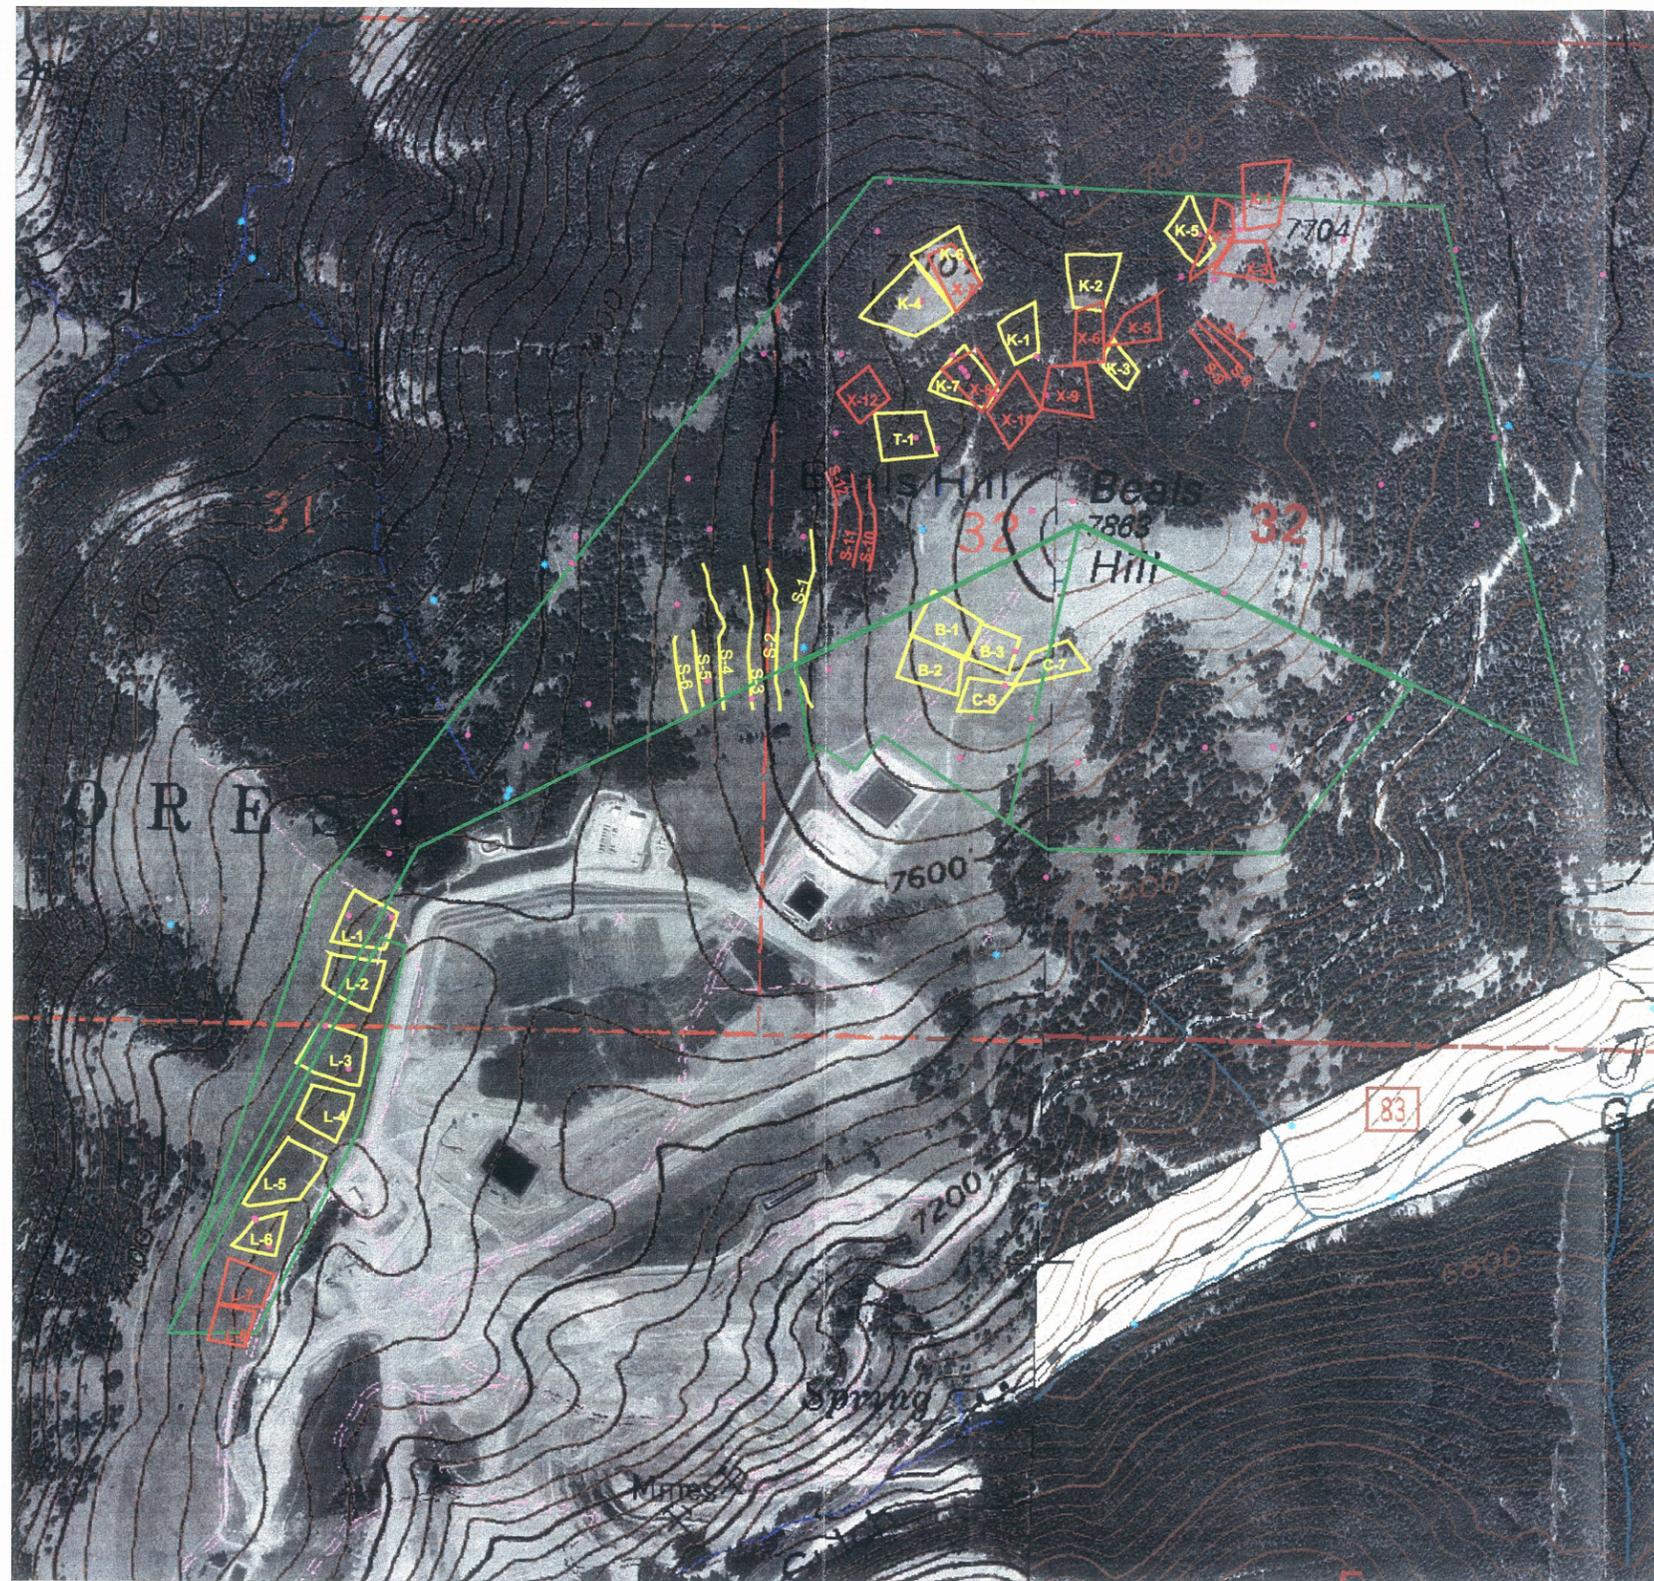
Figure 45 – Back page

Land application at Beal Mountain Mine was first undertaken in July 1995 in order to decrease leach pad solution volume. The 1995 area of land application area was located on approximately 3.5 acres in a grass/forb meadow on a 4H:1V west-facing slope slightly northeast of another land application cell C-7 on Beal's Hill (**Figure 45**). A detailed chronology of LAD operations is provided in **Appendix D-1**.

In 2001, as part of final mine closure operations, a biological treatment plant was constructed at the mine to treat leach pad solution prior to its disposal in land application areas. Treated solution was applied via drip lines and sprinklers on several small land application cells ranging between approximately 0.5 and 2.5 acres and comprising a total of approximately 31 acres within the overall permitted land application area (**Figure 45**). Not all cells referenced in the table cited below are illustrated on this figure.
