USDA Forest Service
Shasta-Trinity National Forest

August 2010

Chalk-Goose Fires Road & Hillside Monitoring Report 2009

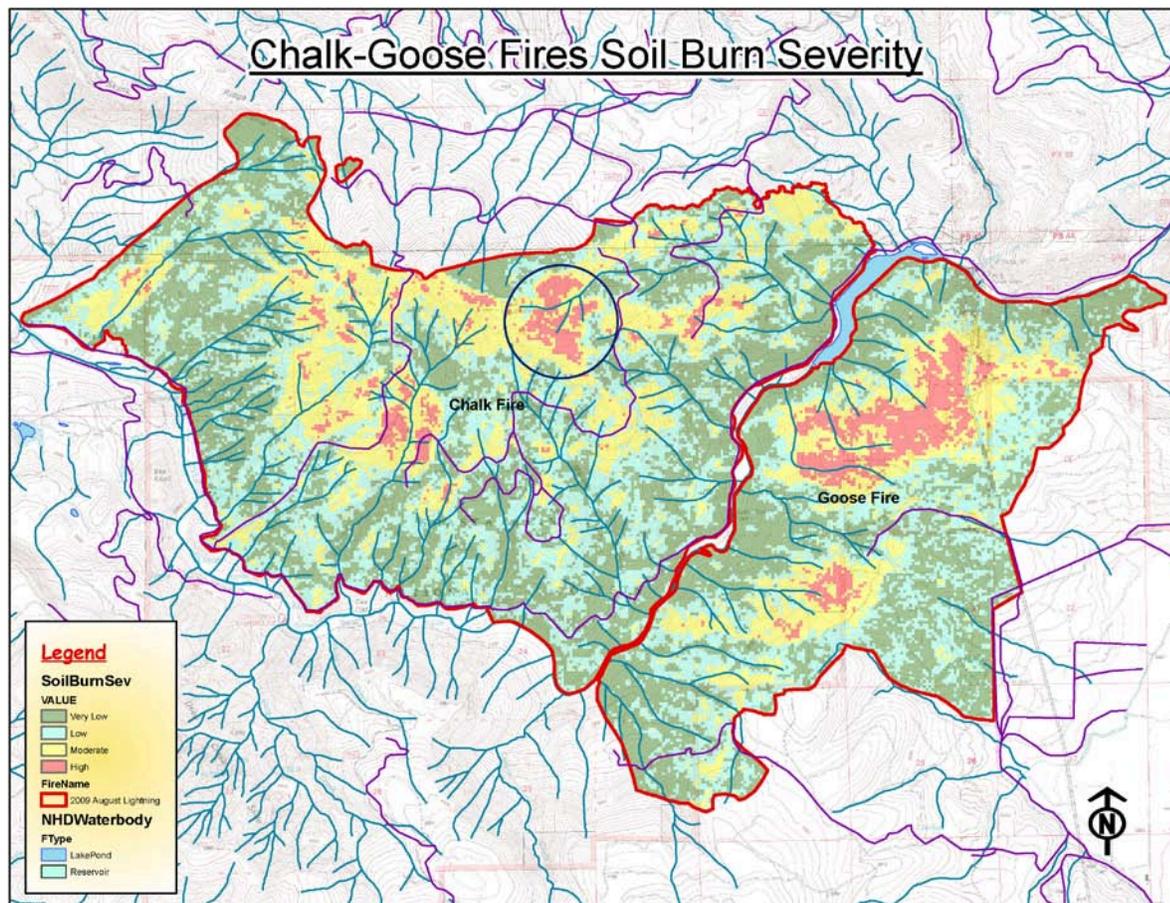
Figure 2: Calk-Goose Fire of 2009 Location and Burn Severity with Circled Watershed

Methods: Road were driven and pictures were taken of before and after one year along with walking hillslopes to collect terrain data (hillslope cover, aspect, slope, soil type, soil map unit, and dominate overstory vegetation) to evaluate hillslope recovery along with road treatment effectiveness (see circled area in Figure 2 below).
