**South Beaver Allotment
SOUTH CREEK #1 (SC1)
Riparian Browse Assessment
(1) June 1, 2008
(2) October 17, 2010
(3) September 8, 2011**

<p>South Creek #1 (SC1) Approximately one mile from end of road</p>	<p>June 1, 2008 Landrigan/Hoskisson October 17, 2010 Hoskisson/Wheeler September 8, 2011 Hoskisson/Ratcliffe/Young</p>
<p>Fishlake NF/Beaver RD</p>	<p>Allotment: South Beaver Pasture: Big Twist</p>
<p>Stake: 12 S E 0369646 N4225978</p>	<p>Elevation: 7667'</p>

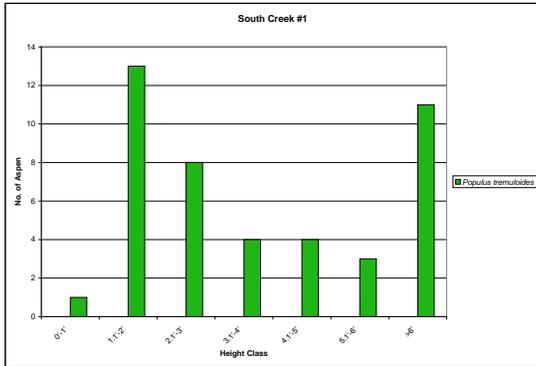
June 1, 2008

(6/1/2008): We found few aspen ramets below 3' tall. The leaders of aspen between three feet and six feet the leaders were mostly dead or browsed. Many or all of those we categorized as dead were likely browsed. The leaders were dead for the last one to three inches. We saw only one instance of insect damage and that was a gall at the end of a browsed leader. Most of the aspen taller than 6' (as shown in photographs) were one to two inches DBH. The appearance is that something permitted a pulse of generation some time in the last five to 12 years. **Question: Did management change during 1998-2001 take place that would have allowed for this pulse in regeneration?** There is a huge gap in the size of aspens in the area of the transect. The only very young ramets grew only under the protection of the spruce and juniper (as photographed). **What grazing management changes have taken place since 2003?**

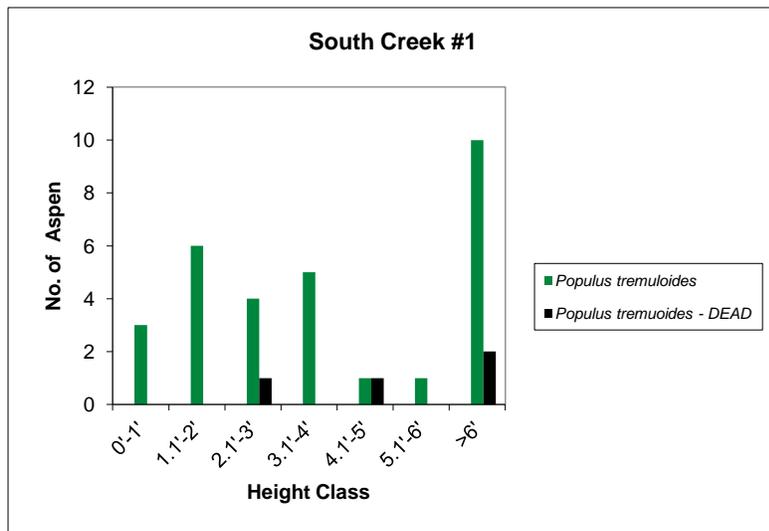
September 8, 2011

In 2011, tall leaders showed 27% browse (55% in 2010). Subleader browse was 53% in 2011 (79% in 2010). The reduced # of leaders (except in 5.1-6' height class) since 2010 would indicate that the cottonwood are being able to send an (unbrowsed) leader up. Height distribution has changed little, with continuing lack of recruitment.

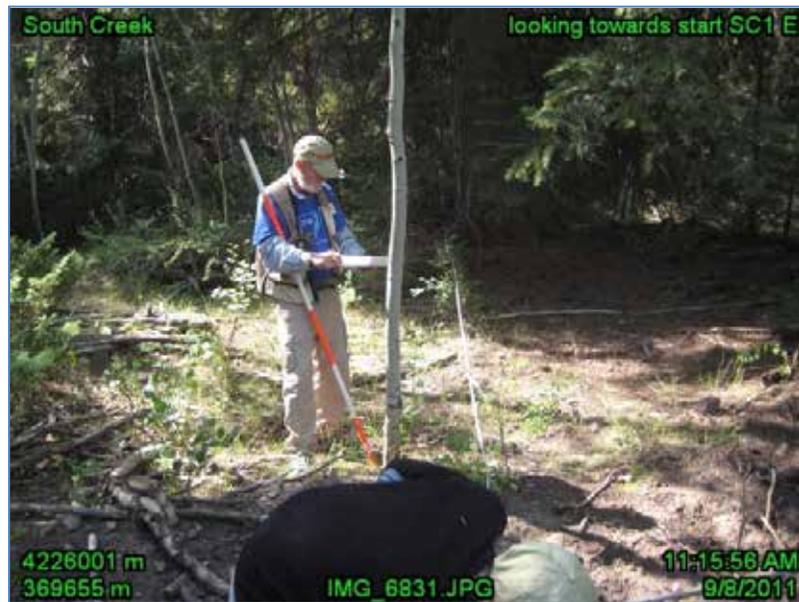
The streambank within South Creek #1 has excessive bare ground (Figs. 10 and 12) and the meadow below South Creek still appeared to be heavily used (Fig 13) and the ORV route next to the stream continues to erode and generate sediment into the stream.

Fig 10 (9/8/2011) South Creek 1 main transect
