USDA-FOREST SERVICE

FS-2500-8 (7/08)
Date of Report: 9/25/12

BAGLEY FIRE BURNED-AREA REPORT
(Reference FSH 2509.13)

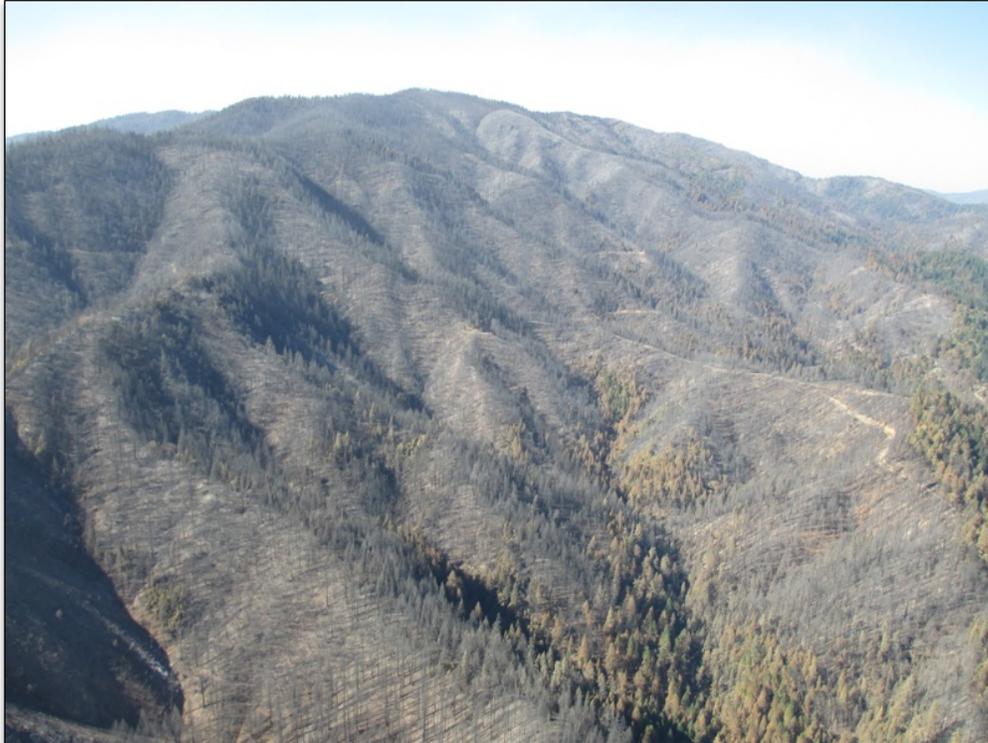
Bagley Fire burned hillslopes looking at Happy Hunting Grounds with Shoeinhorse Mtn. in the background.

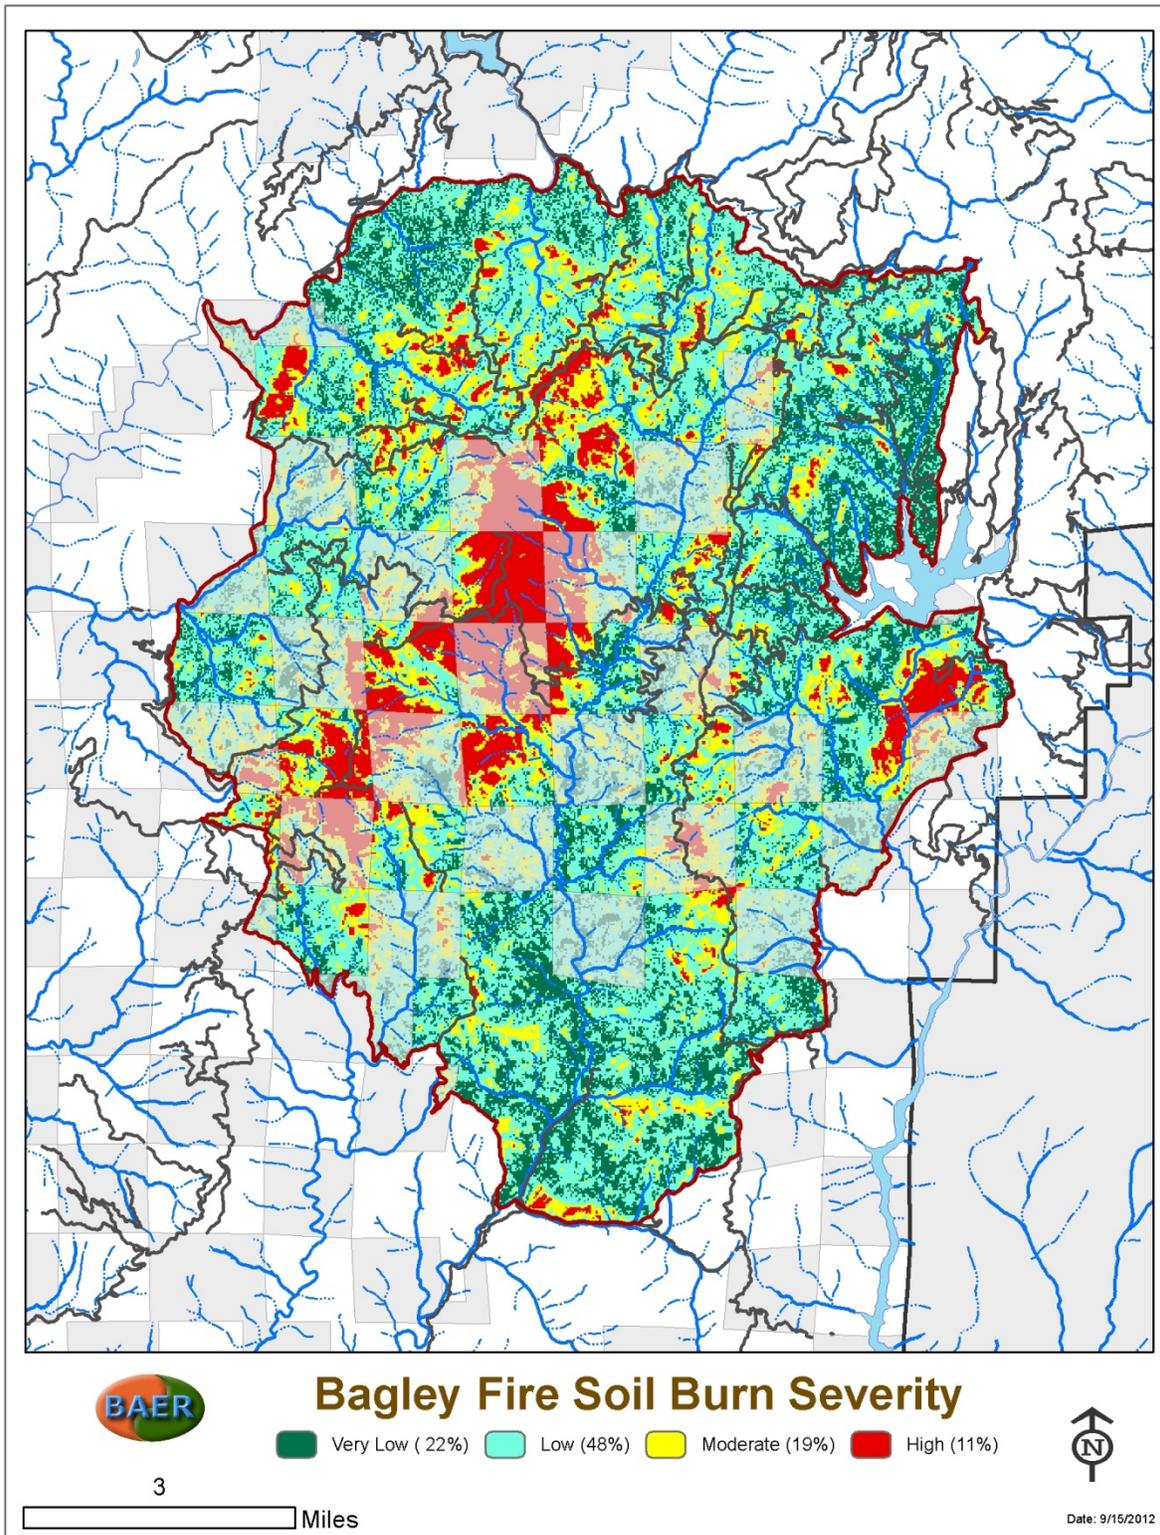
Bagley Fire Soil Burn Severity Map:

Looking at the soil burn severity map below shows multiple areas that have the majority of moderate and high soil burn severity. The main areas are along Squaw Creek and Iron Canyon Creek being at high risk due to flooding and sedimentation affecting water quality, fish habitat, roads, and private residents below.
