BAGLEY COMPLEX AREA EMERGENCY RESPONSE

GEOLOGY REPORT

SHASTA TRINITY NATIONAL FOREST

September 21, 2012

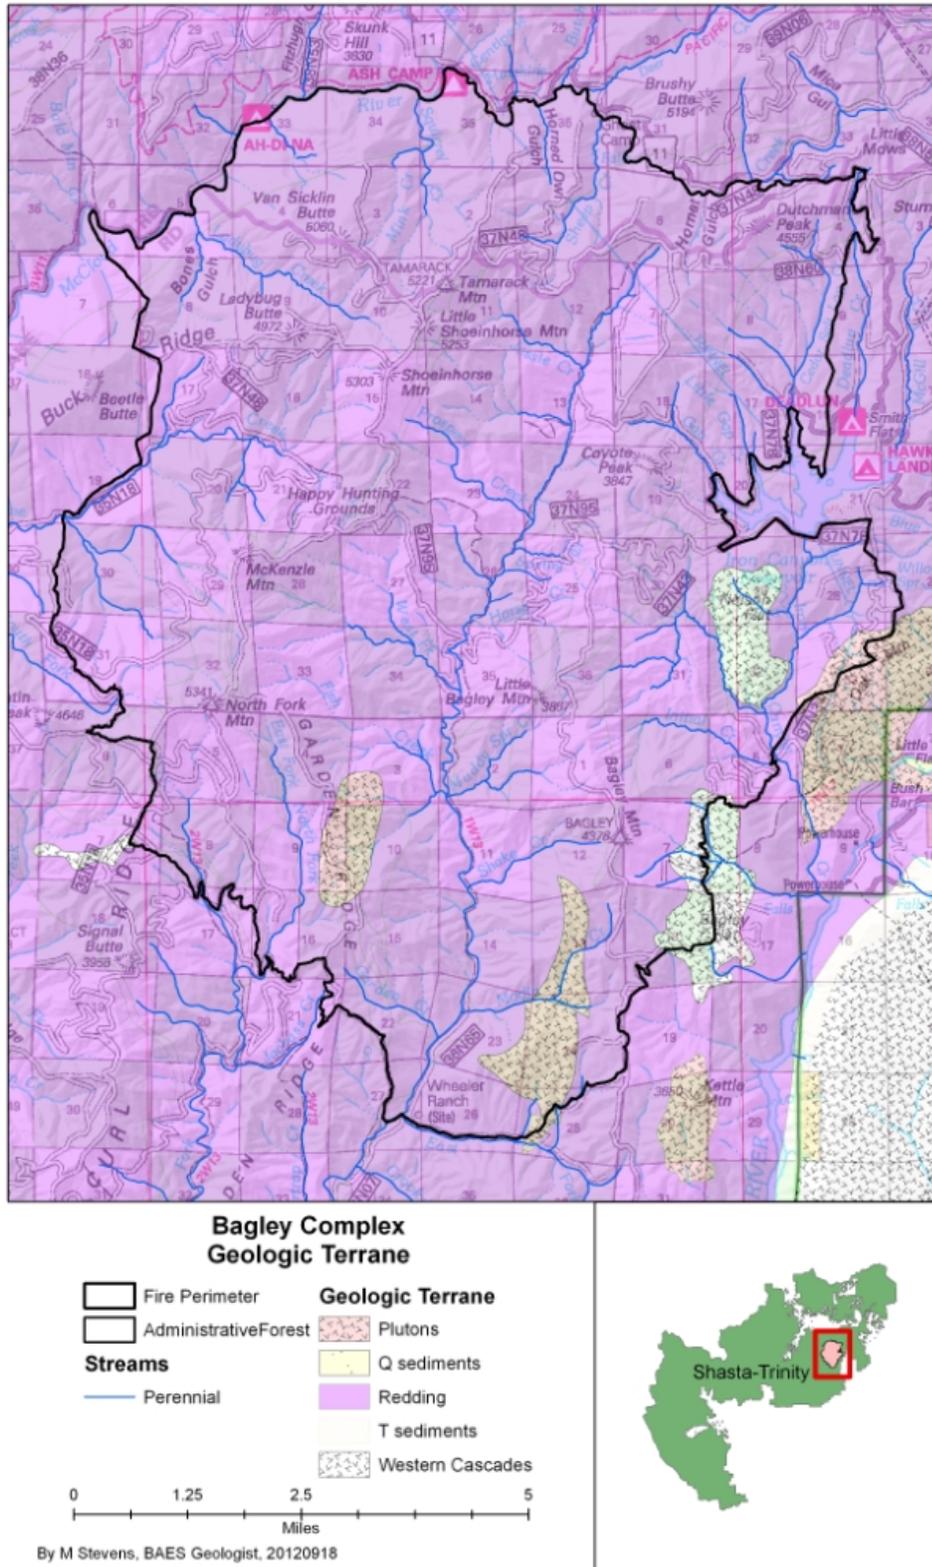
Figure 1: Geologic terrane of the Bagley Complex

The Bagley Complex is almost completely underlain by the Redding terrane which consists of, from east to west, the Potem unit (limestone and argillite), Arvison unit (volcaniclastics), Hosselkus unit (limestone), Modin unit (metasediments and volcaniclastic), Pit unit (metasediments and metavolcanics), and Dekkas Andesite unit (metavolcanics). There are two small units of the Western Cascades terrane on the eastern portion of the fire consisting of basalt and three plutons located in the southern portion of the fire consisting of quartz diorite and granodiorite (Figures 1 and 2).

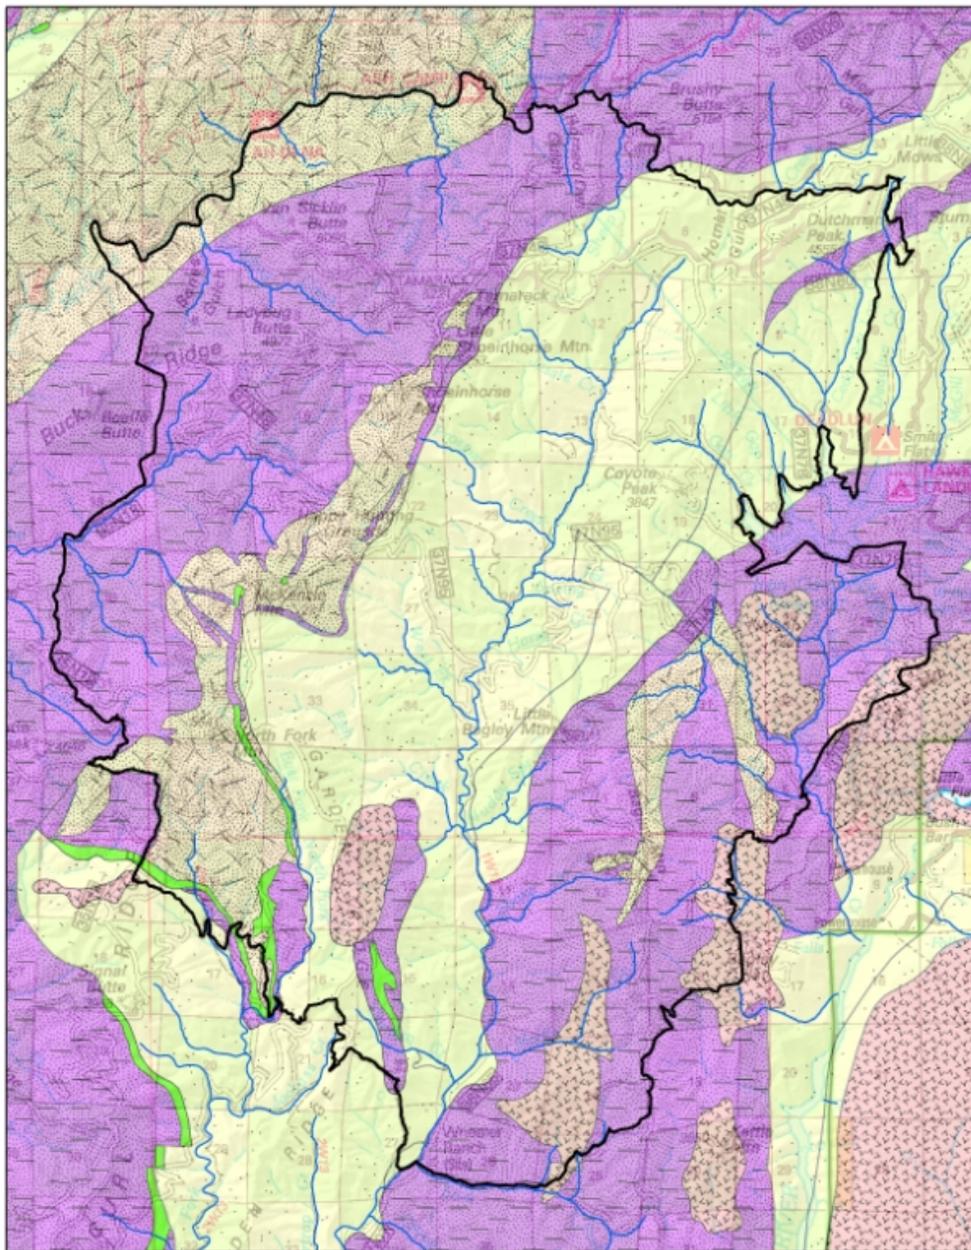
Figure 2: Lithology for the Bagley Complex

Geologic resources in the fire area include marble caves which are known to exist in some of the marble outcrops. Some of these burned at high or moderate severity. In keeping with the Federal Cave resource Protection Act, cave locations are kept confidential, similar to cultural sites. The Lithology Map (Figure 2) shows where marble bodies are located. Lastly, mollusk fossils (pelecypods) are known to exist in some of the metasedimentary rock.
