November 9, 2012

Technical Memorandum
November 2012 Planting and Site Inspection Report
Blue Ledge Mine
Rogue River-Siskiyou National Forest

**Blue Ledge Mine Removal Project
Siskiyou County, California
Operation, Maintenance, and Monitoring Period**

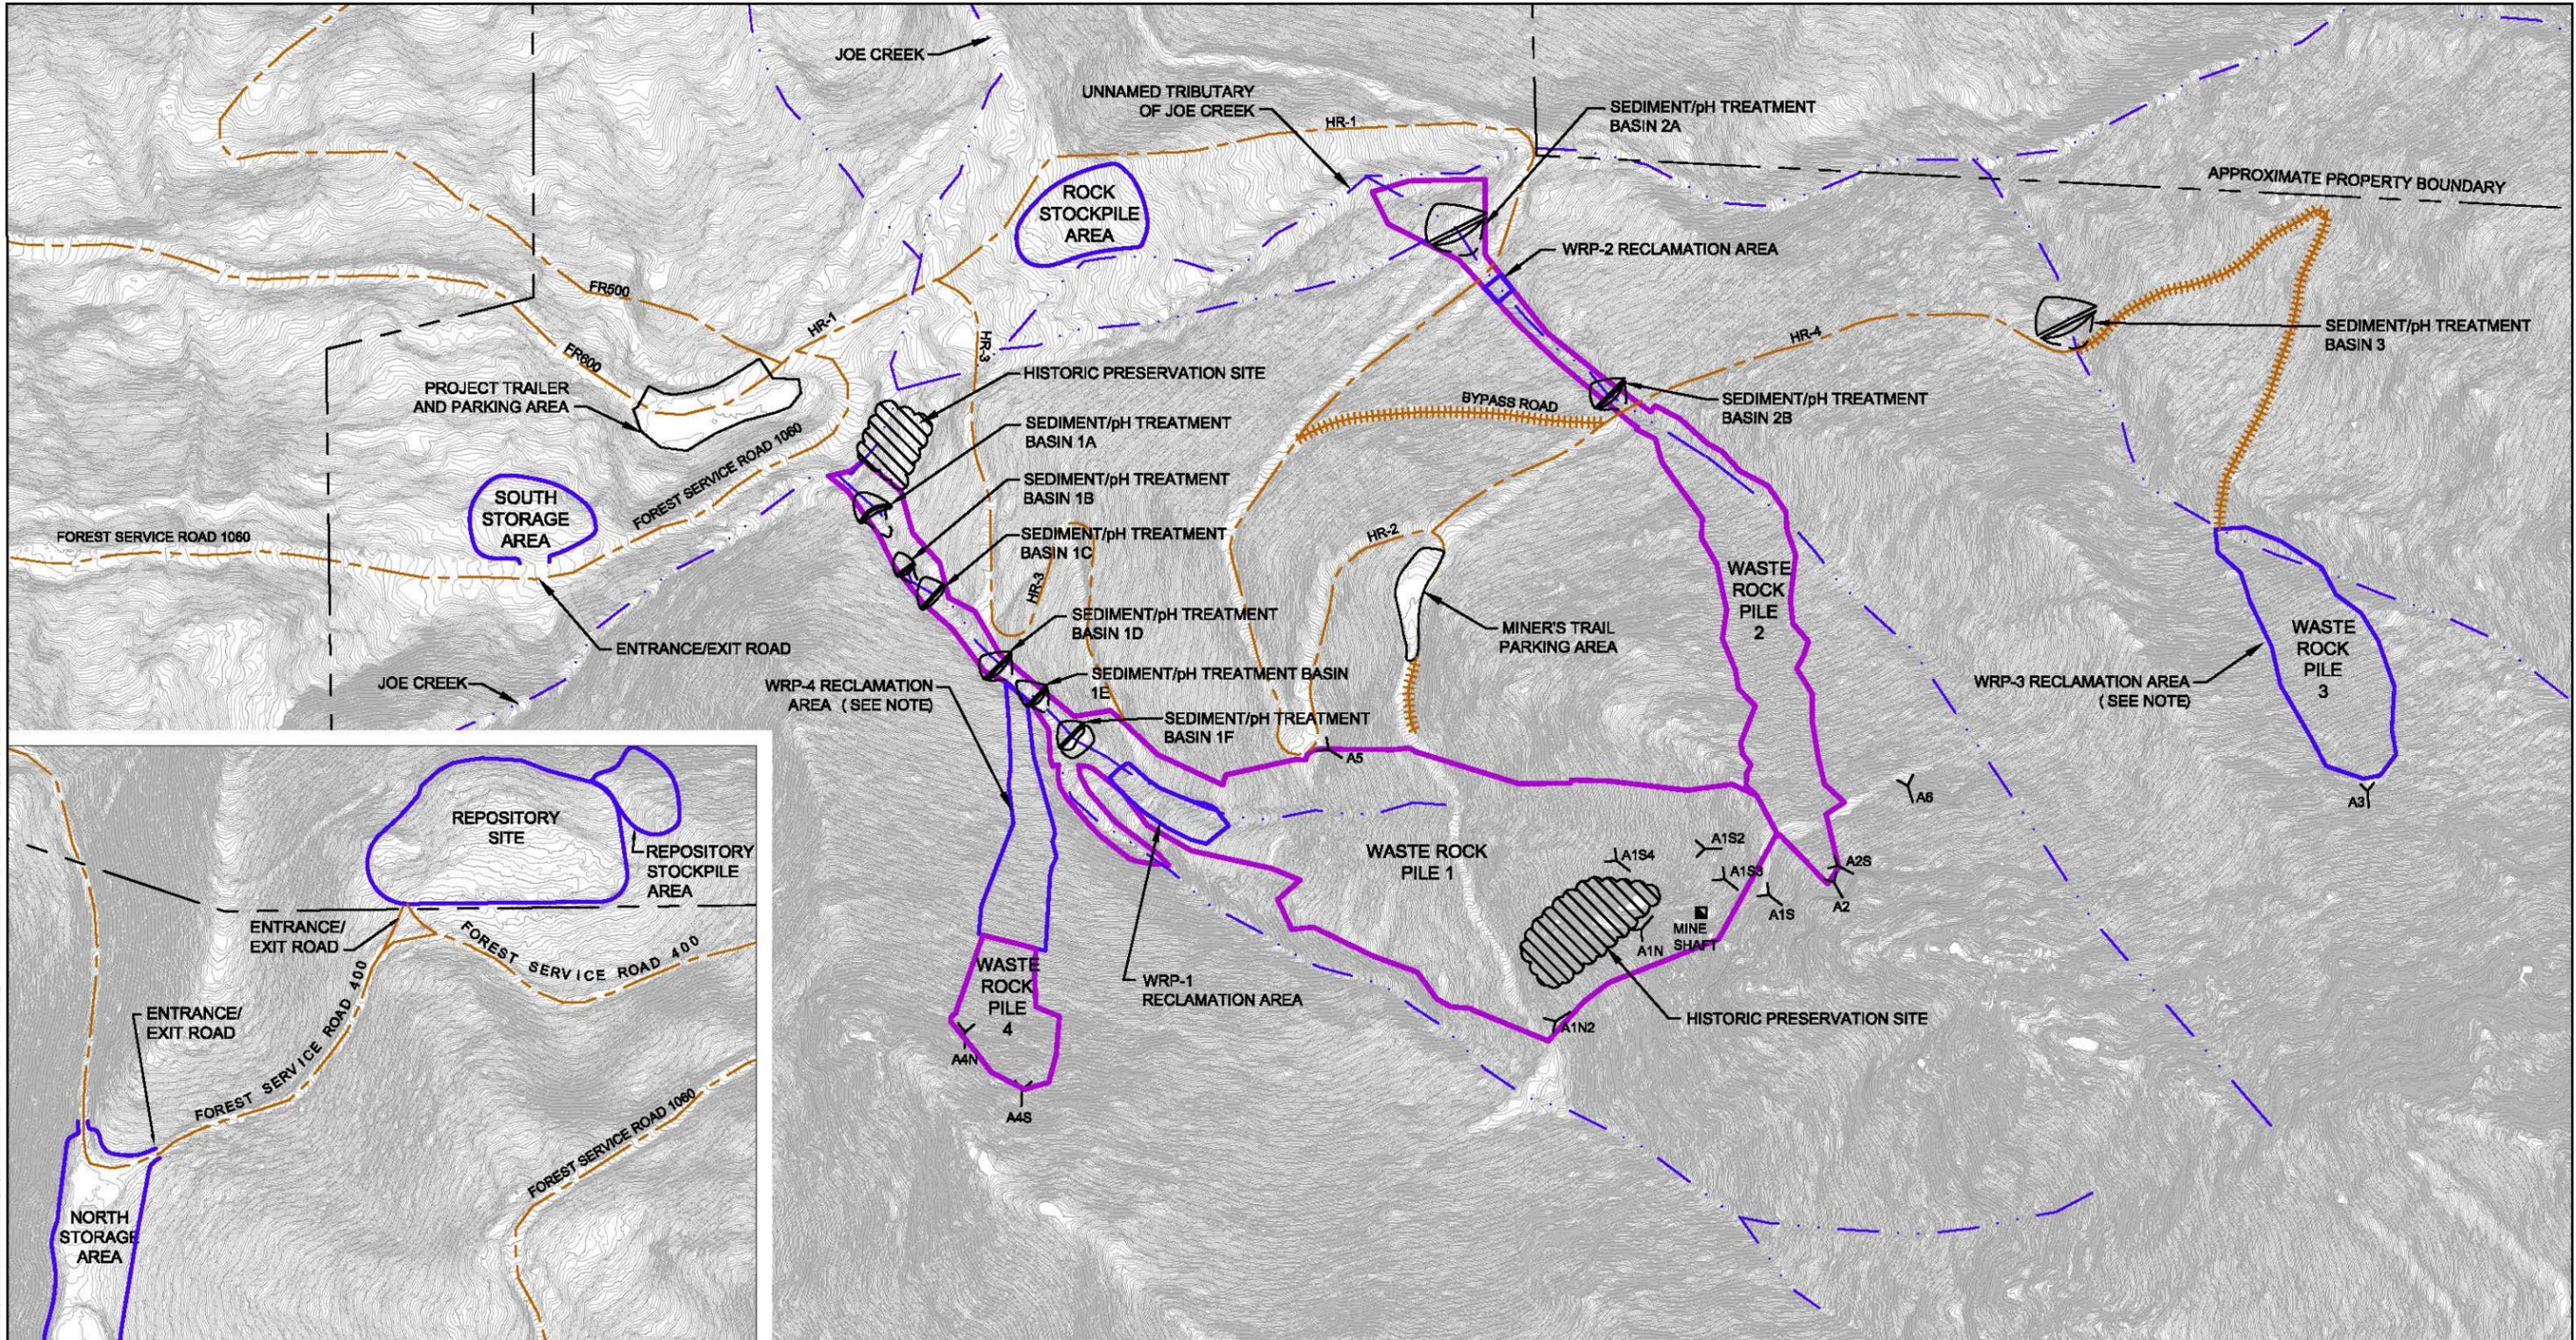
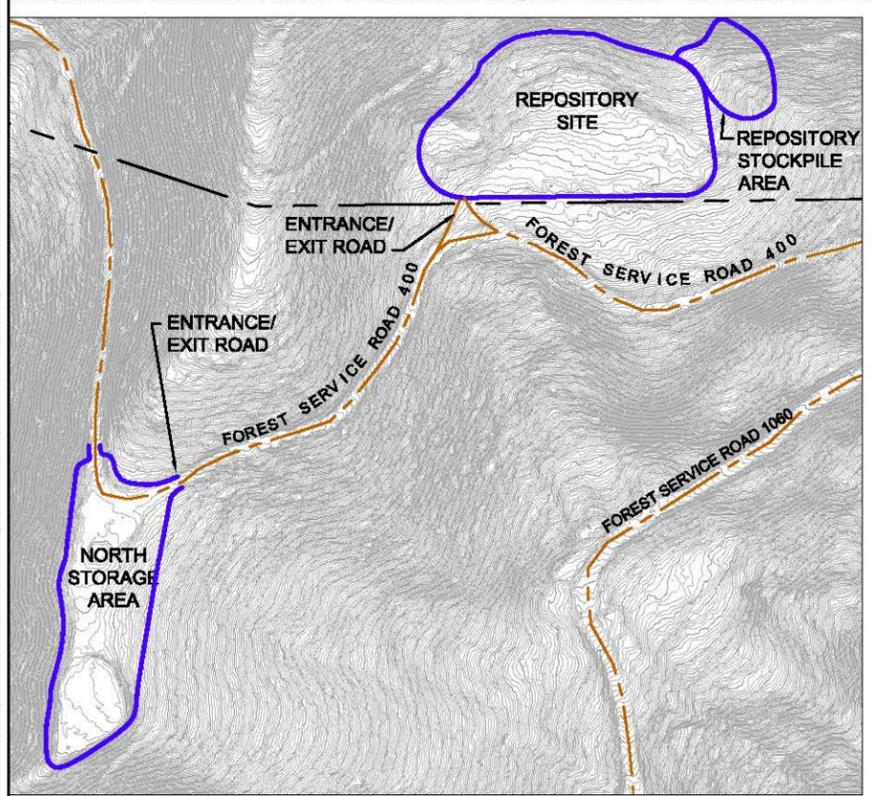
Enclosure 2. Overall Site Plan

4. Inspect BMPs along Haul Roads 1, 2, 3, and 4; the miner's trail parking area; and the decommissioned Haul Roads 2 and 4 (see Enclosure 2). Are BMPs in good condition? Yes No*

1. Inspect log wattles, straw wattles, and other BMPs at the reclamation areas on WRP-1 (See Enclosure 2). Are all BMPs in good condition? Yes No*

2. Inspect Flexterra and grass seeded areas at the reclamation areas on WRP-1 (see Enclosure 2). Are any repairs needed or any invasive species present? Yes* No

1. Inspect wattles, silt fence, and other BMPs at the reclamation areas on WRP-2 (see Enclosure 2). Are all BMPs in good condition? Yes No*

1. Inspect log wattles, straw wattles, and other BMPs at the reclamation areas on WRP-3 (see Enclosure 2). Are all BMPs in good condition? Yes No*

5. Inspect the reinforced slope stability fabric area at WRP-4 (see Enclosure 2). Is the fabric in good condition? Yes No*
