TECHNICAL MEMORANDUM

SUBJECT: Existing Monte Cristo Road Evaluation Summary

Cascade Earth Sciences (CES) has prepared the following Condition Assessment of the Monte Cristo Road between the confluence of Weden Creek with the South Fork Sauk River and the Monte Cristo Townsite. The purpose of this assessment is to identify required repairs and priorities associated with needed equipment access to the Townsite. On June 20, 2009, approximately three miles of road was surveyed and assessed by Mr. Timothy Otis, P.E. and Ryan Tobias of CES. Survey categories include:

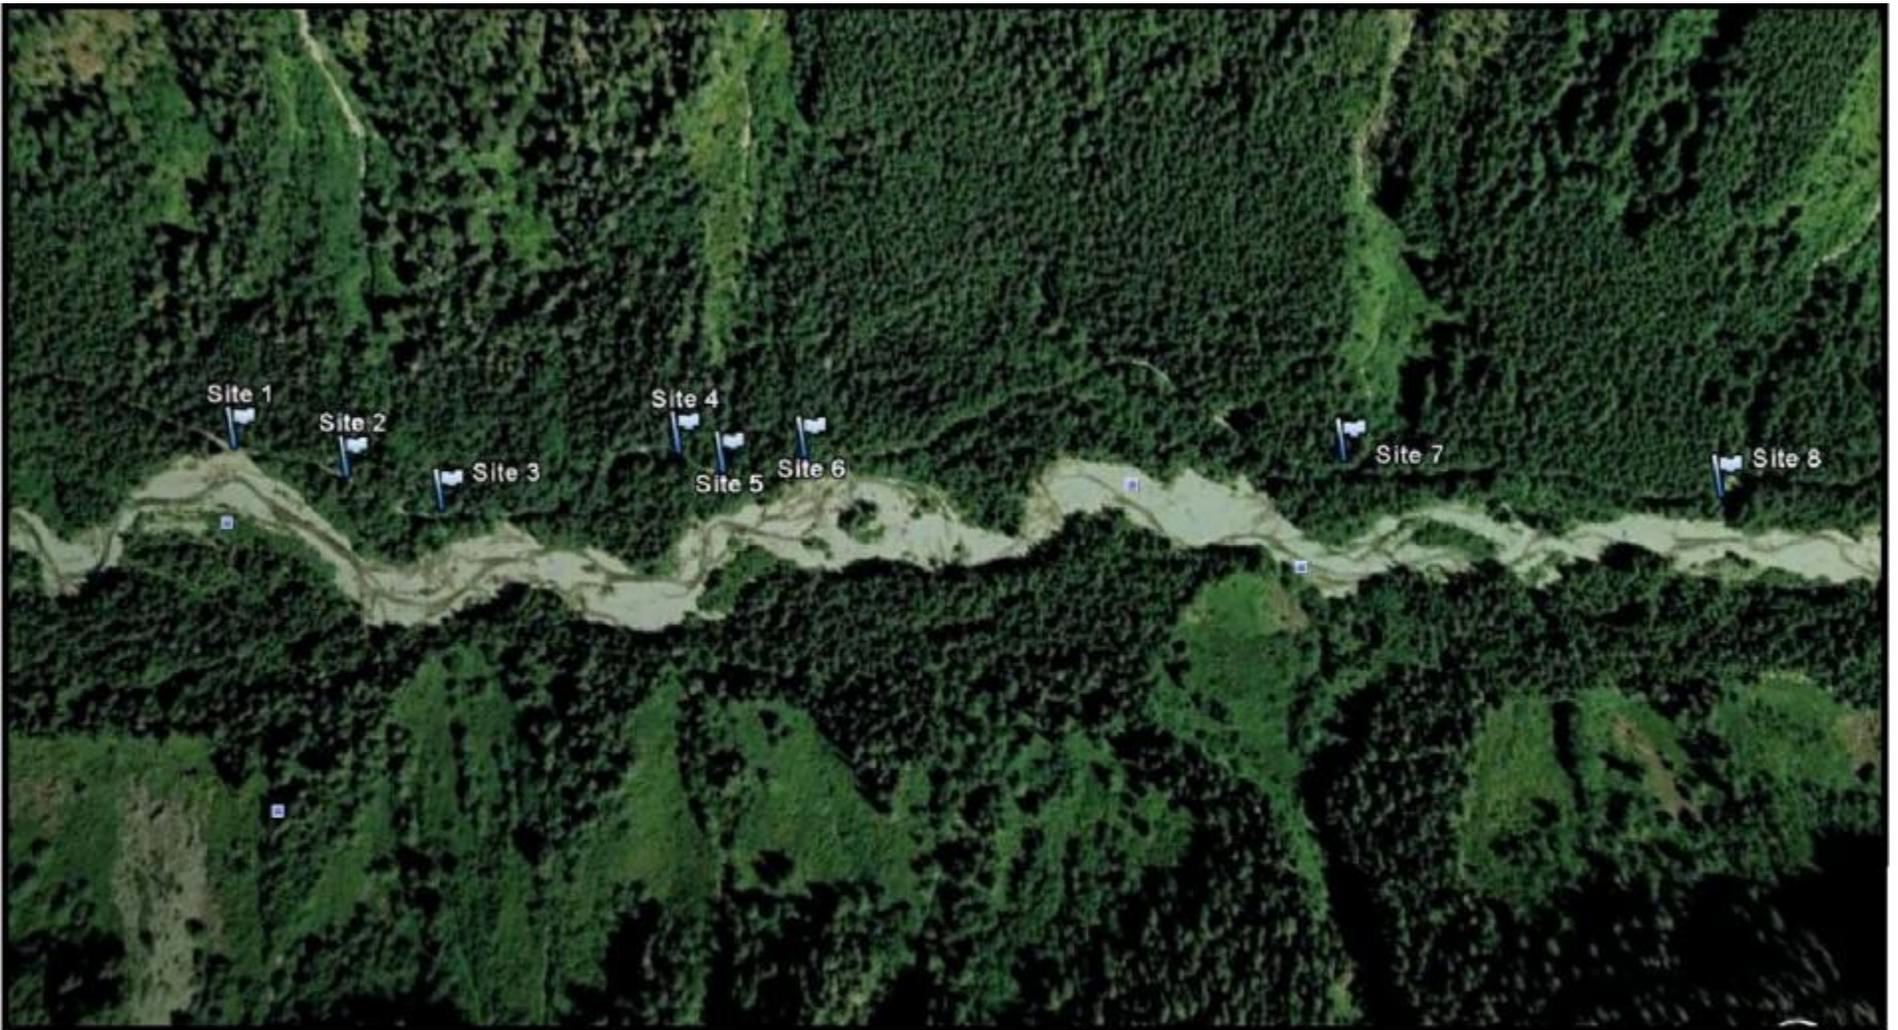
Figure 1. GPS Site Locations

The existing road is generally in good repair for the purposes of access for the proposed non-time critical Removal Action (RA) to be conducted under the Comprehensive Environmental Response, Compensation, and Liability Act (CERCLA). Eight specific sites were identified as needing repairs during the Condition Assessment. These include the following, which are outlined on Figure 1:

- Three stream-adjacent slope failures (Sites 1, 3, and 6)
- Two culvert crossings (Sites 2 and 8)
- Three areas of sediment transport/deposition (Sites 4, 5, and 7)
