Soil and Water Question 2a Appendix

Best Management Practices Implementation and Effectiveness Monitoring Thorne Bay Ranger District Road Storage Trip Report – Wolf Pup / Stoney Creek, Logjam; September 20-21, 2012

Summarized by Carol Seitz Warmuth

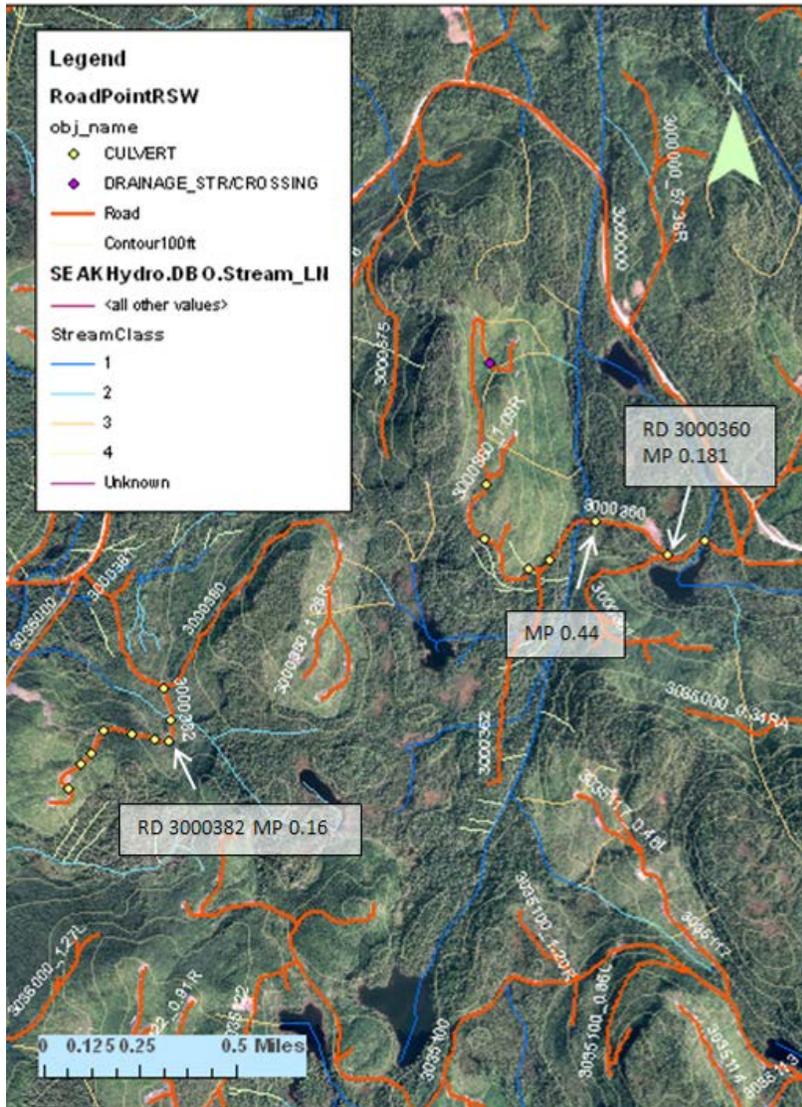
Figure 1. Road 3000360

Three culverts were removed from the road following the culvert removal typical for streams at these sites. Water bars were also excavated along the road to limit water eroding the running surface of the road. The stream at MP 0.09 is an un-cataloged anadromous tributary of Hatchery Creek. This stream was documented as a Class I channel with coho salmon and sculpin. The crossing at MP 0.09 was a relatively wide, low gradient crossing and showed water running through the crossing. The side slopes on the crossing were laid back to the 2:1 slope as shown on the contract drawings on the near side of the road; however, the slopes were relatively steep on the far side. The upstream reach of the stream channel showed a low gradient wetland area with a meandering channel. The stream crossing at MP 0.43 was a low gradient, braided channel with a gravel substrate. This uncataloged Class I stream contained coho salmon, cutthroat, and Dolly Varden. This same stream crosses the road at MP 0.44. At MP 0.44, the stream is a low gradient channel with gravel bars of rounded cobbles that meanders through a low gradient wet area. The stream reach is an un-cataloged Class I containing coho salmon, Dolly Varden, and cutthroat.

The sites at MP 0.43/ 0.44 were selected for focused monitoring since these crossings were Class I streams.

road prism was in good condition and showed only minimal sheet wash and water rills on the road near the stream crossing at MP 0.43. Ponded water was noted along the road between MP 0.43 and 0.44. The ponded water was shown along both sides of the road just past MP 0.44 for roughly 40 feet. Road maintenance should have been completed during the closure to mitigate the ponding by excavating a cross drain through the road prism at this site. Besides the noted problems near MP 0.44, there was no other evidence of sediment transport or water diversion on the running surface of the road.

Effectiveness monitoring completed by the IDT noted that the closure has eliminated the standard vehicle traffic on the road beyond MP 0.09. There is little erosion evidenced on the road and sediment transport was minimized. No diversion potential was noted relative to these crossings. The re-vegetation standard was met on the road. Grass seed had germinated and natural vegetation is growing on the stream banks. There was minimal evidence of stream cutting, natural channel re-alignment, sediment transport and deposition in the stream.

No specific corrective actions were identified, although a few notes on problems to follow up on to completion of the contract. Monitoring will be required to check the status of the water ponded near MP 0.44 and culvert at the end of the road. Adaptive management actions that are recommended by the IDT to improve implementation include:

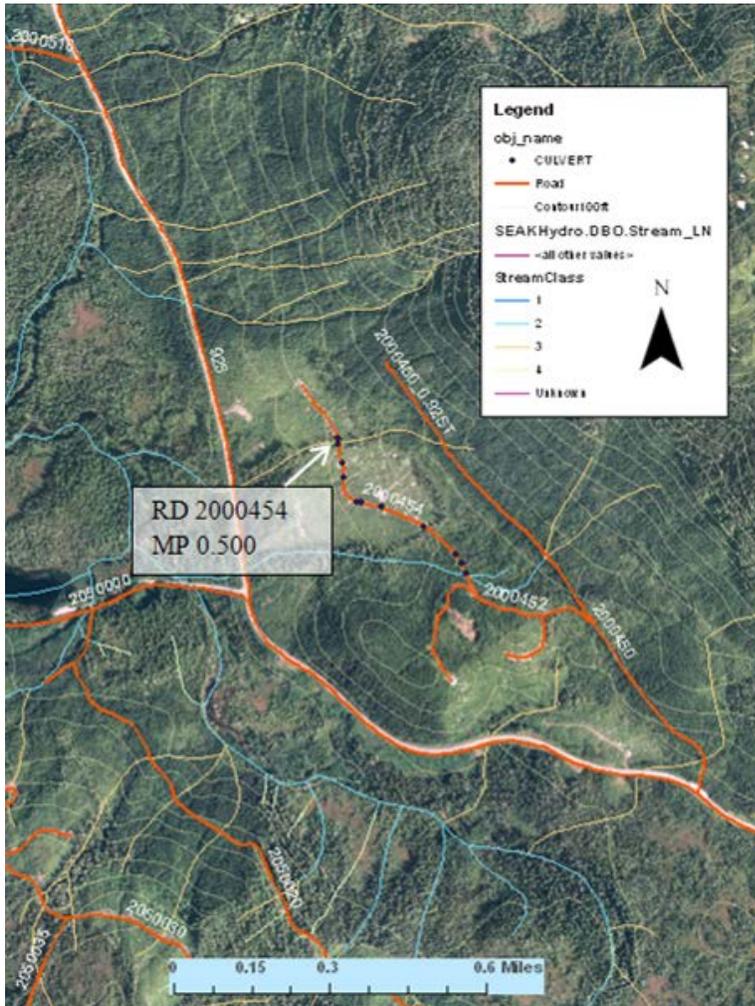
Figure 2. Road 2000454

road showed organic soils in the banks and wetland vegetation. The stream gradient at the removed crossing was roughly two percent slope gradient and water was flowing through the crossing. The substrate showed cobbles to boulders. There was some rock from the road fill that raveled into the stream; however, no erosion was noted on the banks.
