Engineering/Remediation
Resources Group, Inc.
616 First Ave, Suite 300
Seattle, WA 98104

Technical Memorandum
September 2013 Site Inspection Report
Blue Ledge Mine
Rogue River-Siskiyou National Forest

**Blue Ledge Mine Removal Project
Siskiyou County, California
Operation, Maintenance, and Monitoring Period**

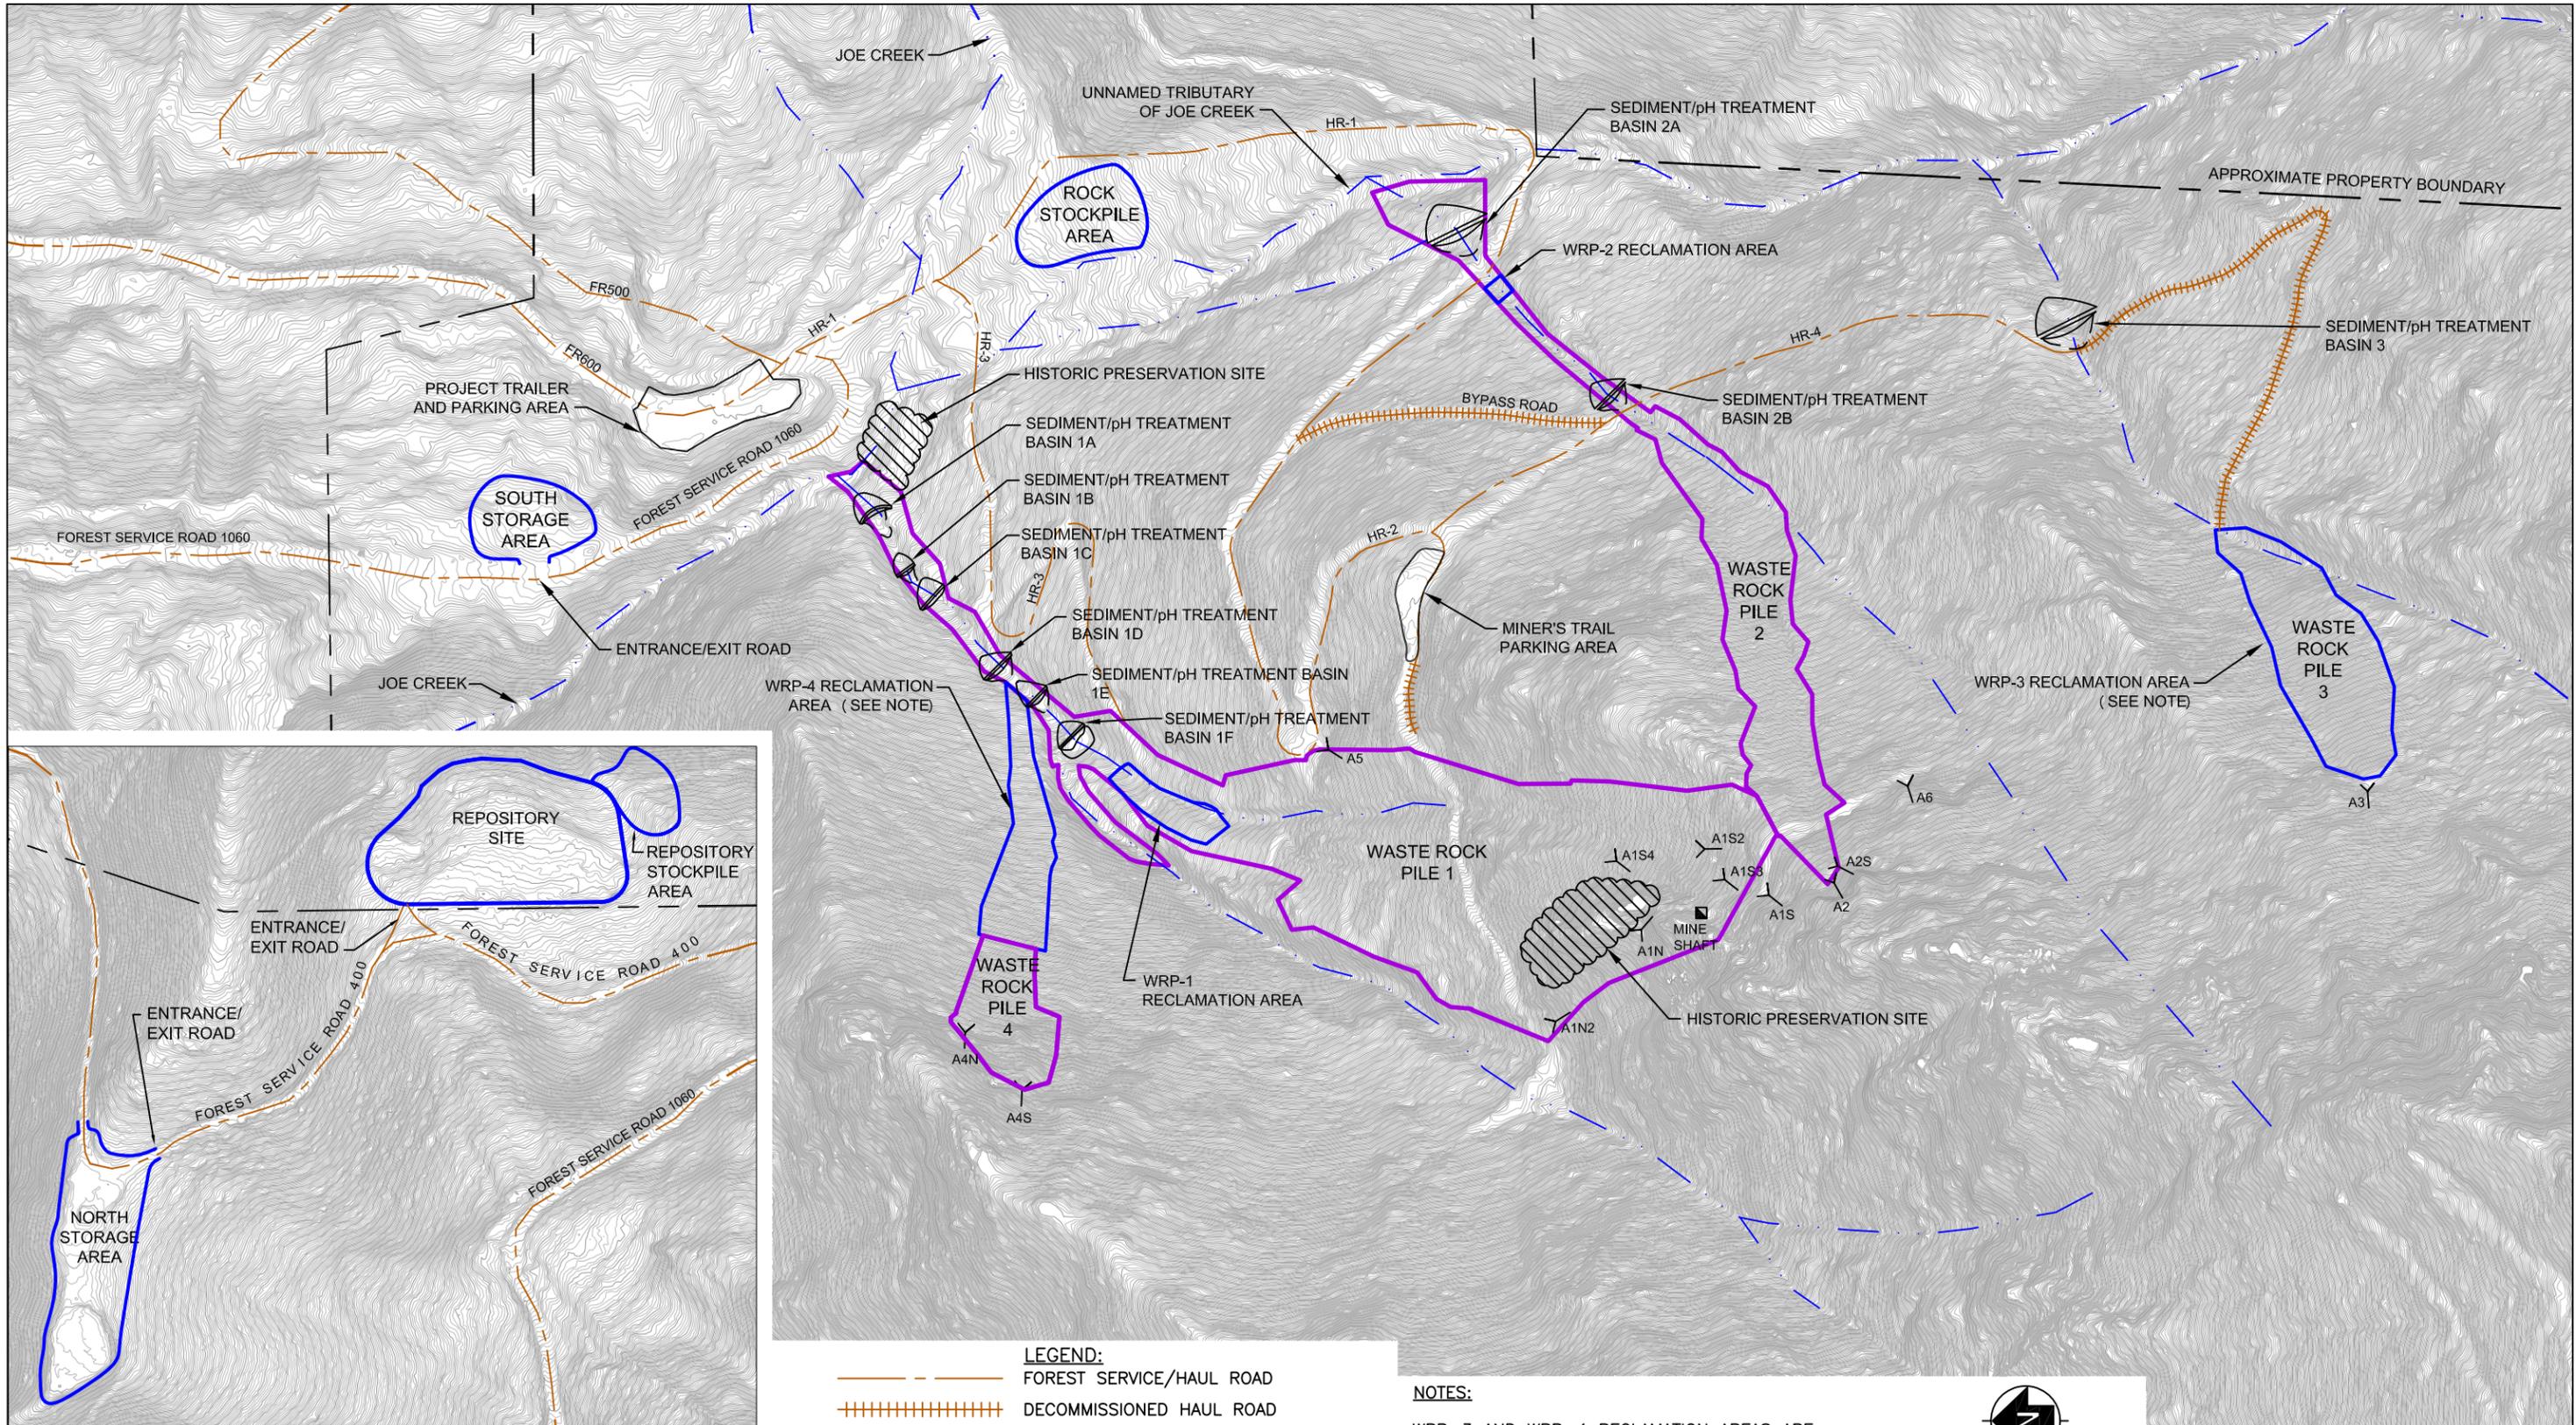
Enclosure 2. Overall Site Plan

4. Inspect BMPs along Haul Roads 1, 2, 3, and 4; the miner's trail parking area; and the decommissioned Haul Roads 2 and 4 (see Enclosure 2). Are BMPs in good condition? Yes No*

1. Inspect log wattles, straw wattles, and other BMPs at the reclamation areas on WRP-1 (See Enclosure 2). Are all BMPs in good condition? Yes No*

2. Inspect Flexterra and grass seeded areas at the reclamation areas on WRP-1 (see Enclosure 2). Are any repairs needed or any invasive species present? Yes* No

1. Inspect wattles, silt fence, and other BMPs at the reclamation areas on WRP-2 (see Enclosure 2). Are all BMPs in good condition? Yes No*

1. Inspect log wattles, straw wattles, and other BMPs at the reclamation areas on WRP-3 (see Enclosure 2). Are all BMPs in good condition? Yes No*

1. Inspect log wattles, straw wattles, and other BMPs at the reclamation areas on WRP-4 (see Enclosure 2). Are all BMPs in good condition? Yes No*

5. Inspect the reinforced slope stability fabric area at WRP-4 (see Enclosure 2). Is the fabric in good condition? Yes No*
