RE: **Rocky Gulch Salmonid Access and Habitat Restoration Project**  
**(Contract No. AWIP-N-1)**

## **ROCKY GULCH TIDEGATE COMPLETION: FINAL REPORT**

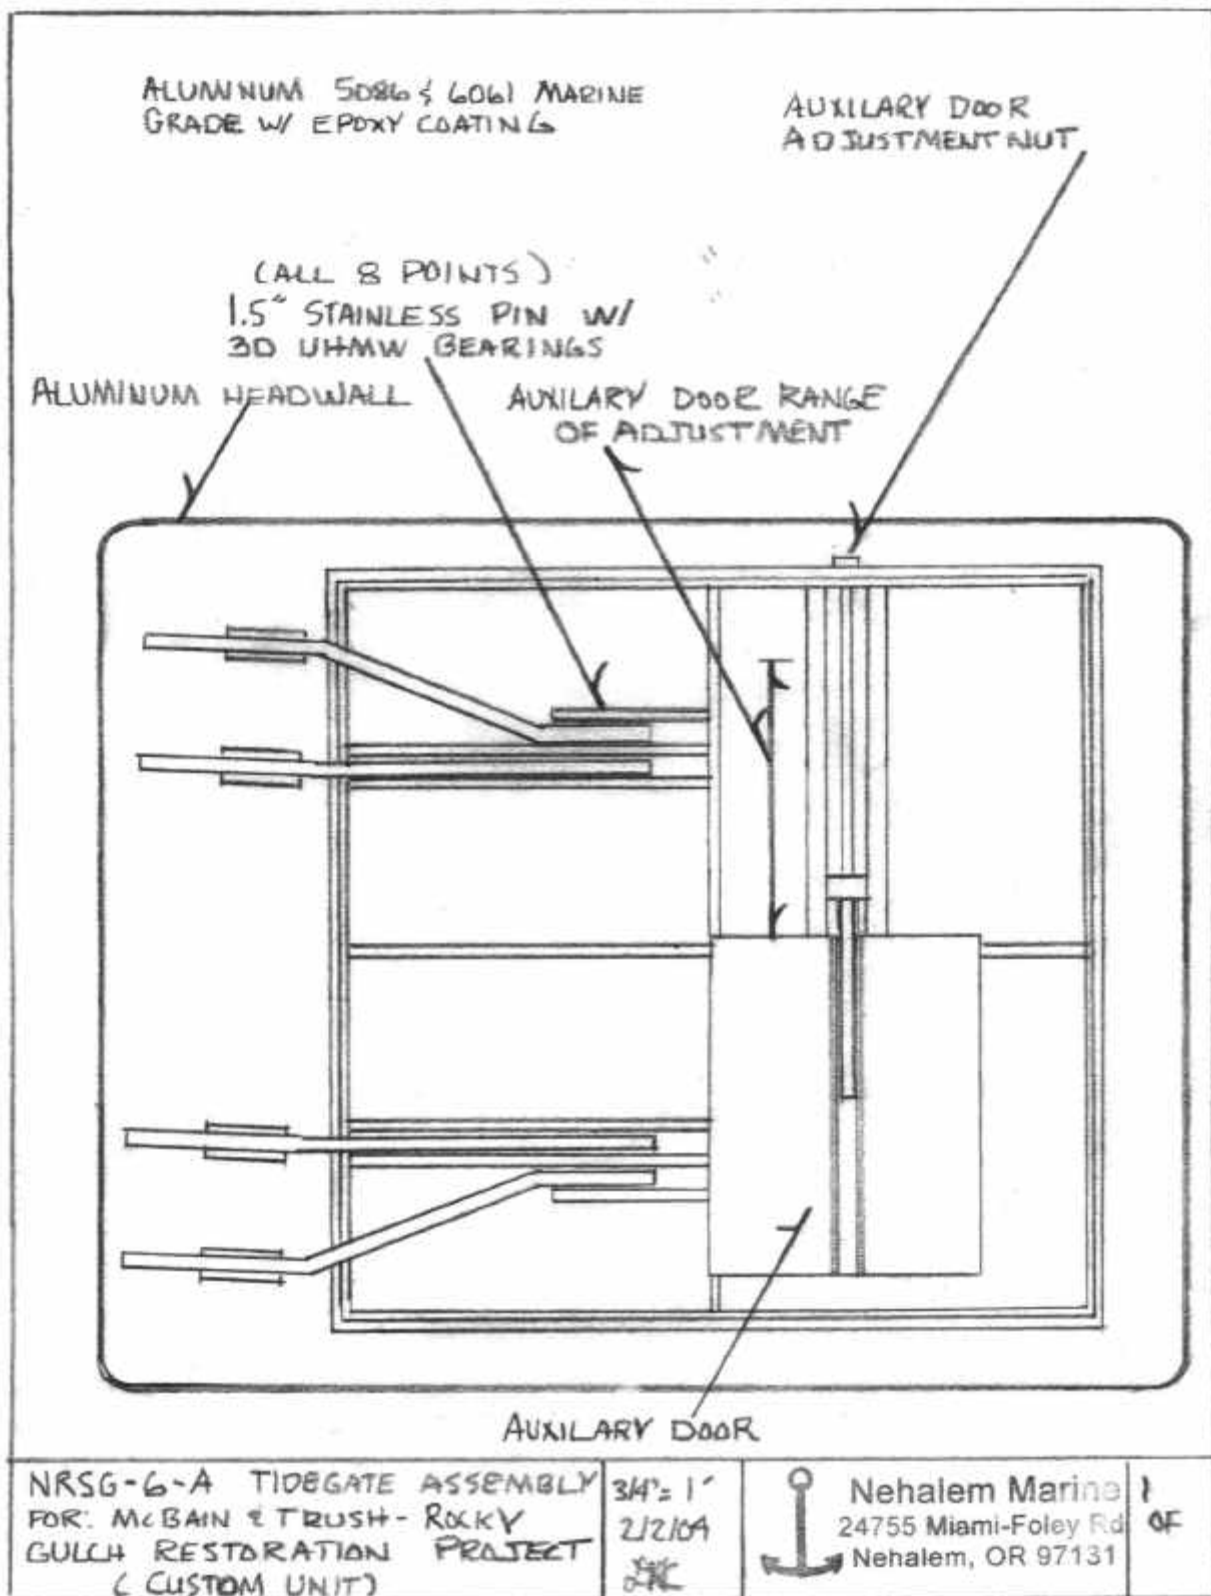
The subcontractor Nehalem Marine, owned and operated by Leo Kuntz, constructed the new tidegate for Rocky Gulch and installed the structure during the week of 11/29/04 to 12/3/04. The new tidegate is a custom-fabricated, side-hinged aluminum gate mounted on the wing-walls of the existing structure (Figure 3). The new tidegate has a muted opening with an adjustable “guillotine-style” auxiliary door with maximum aperture of 1 ft wide by 2 ft tall. The auxiliary door is a top-hinged gate mounted on a track

Figure 3. Design drawing of the new side-hinged aluminum tidegate and headwall assembly, by Nehalem Marine.
